Construction and Stormwater Inspection

Date: 07/23/2024

Operator: NOBLE ENERGY INC - 100322

Location ID: 483510

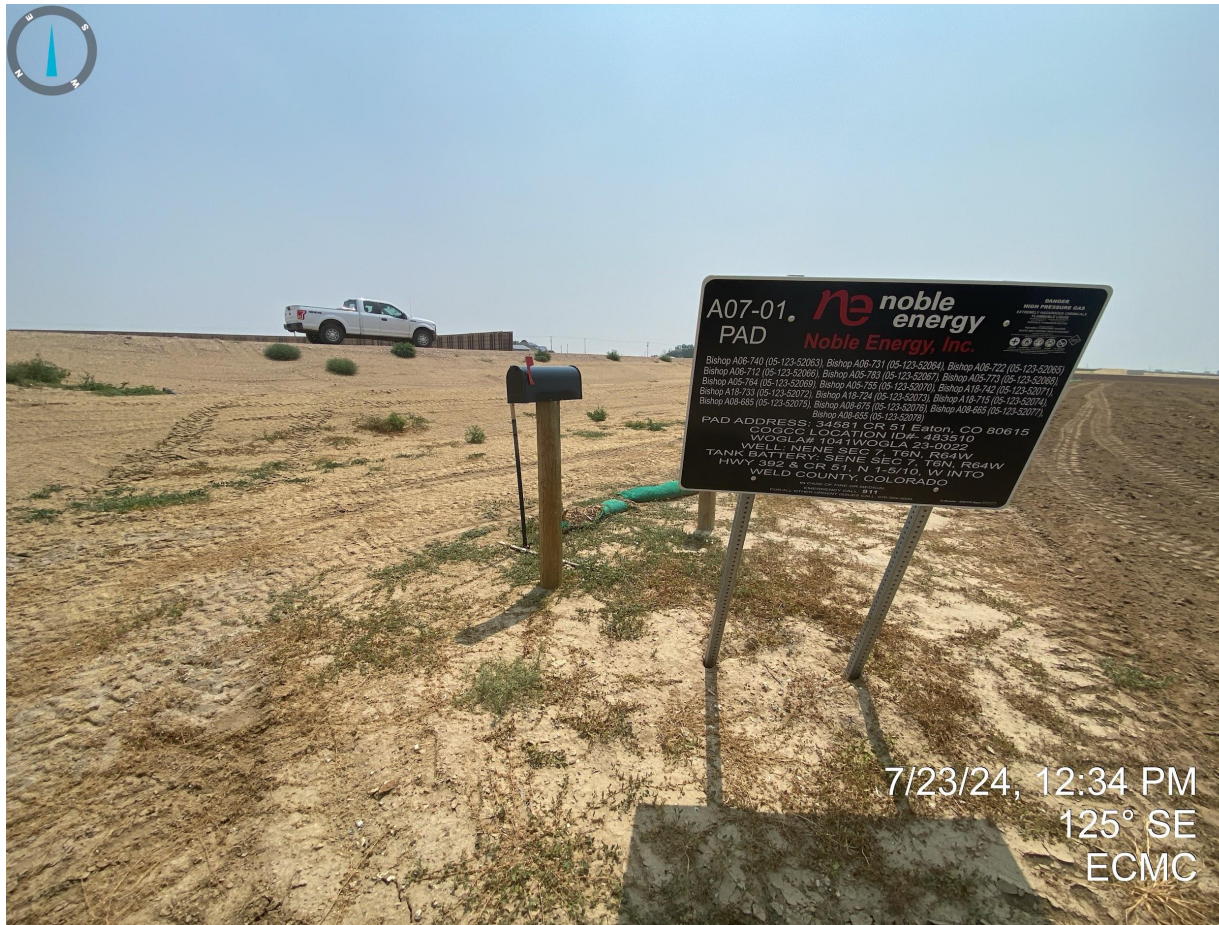
Photo 1. Form 2A posted on location.

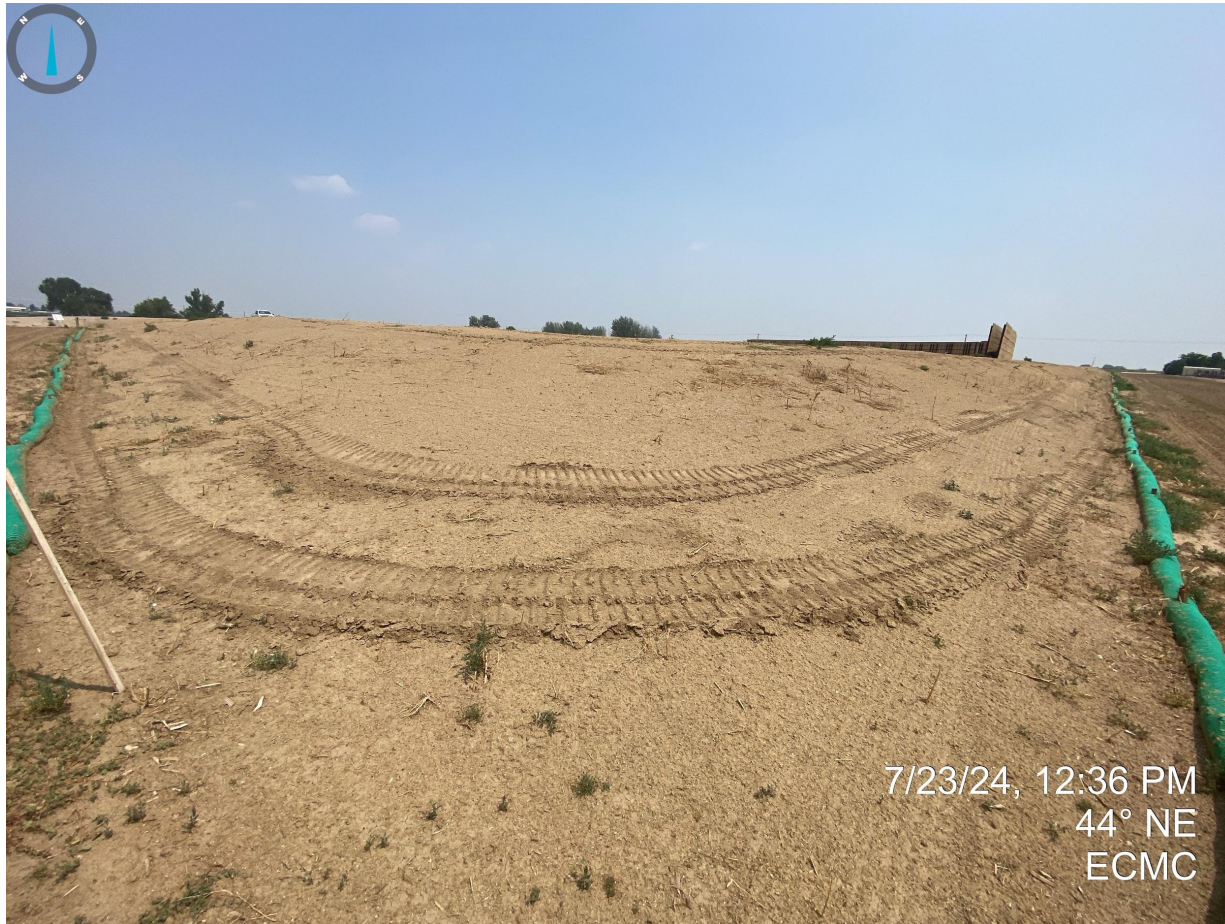
Photo 2. Southwest corner of the construction area. Photo illustrates a portion of the topsoil stockpile and perimeter control measures (e.g. filtrex wattles). Equipment tracks on the hydromulch appear to have disturbed the application; no germination of desirable species observed at the time of this inspection.

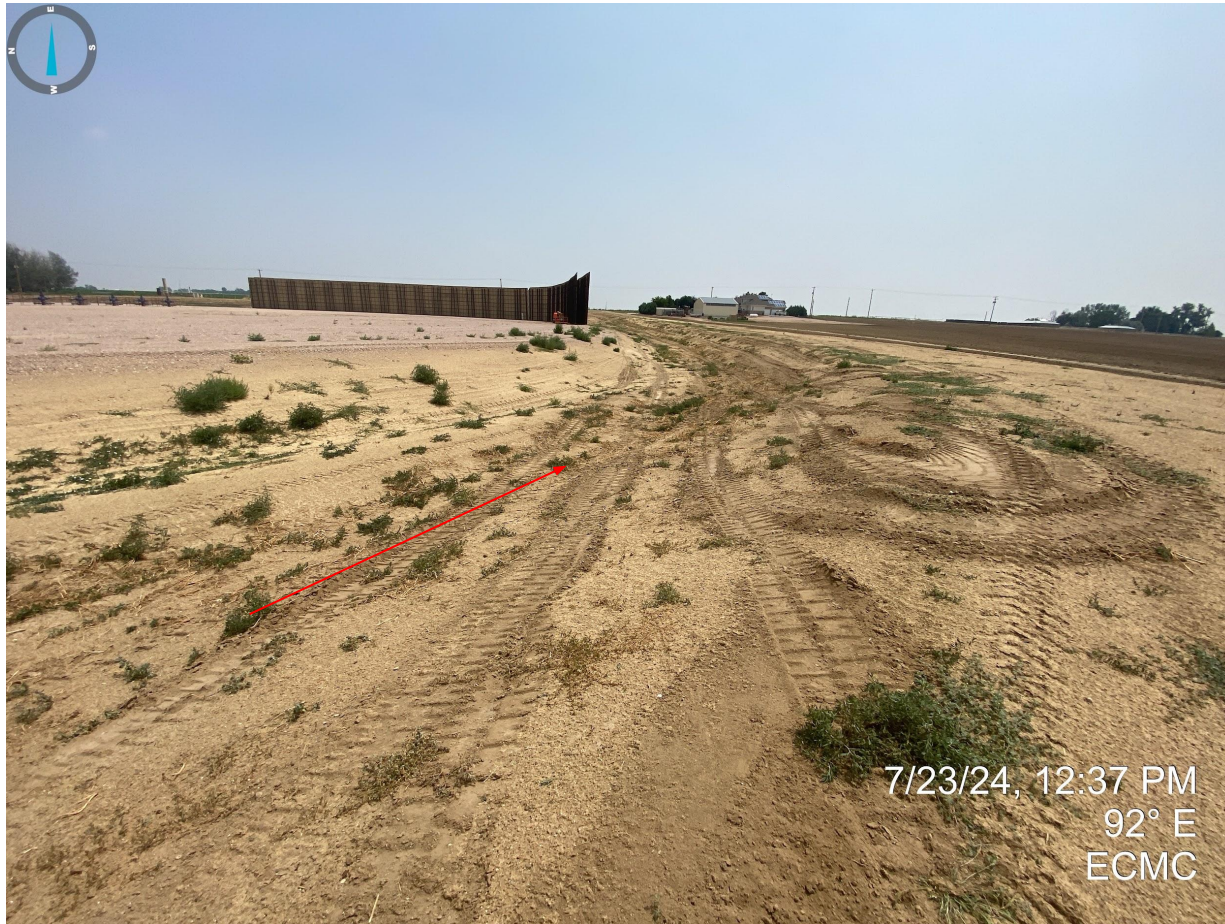
Photo 3. Southwest corner of the drilling pad. Photo illustrates stormwater ditch indicated by red arrow. Undesirable vegetation appears to have recently been mowed or sprayed with herbicide; equipment tracks on the hydromulch appear to have disturbed the application; no germination of desirable species observed at the time of this inspection.

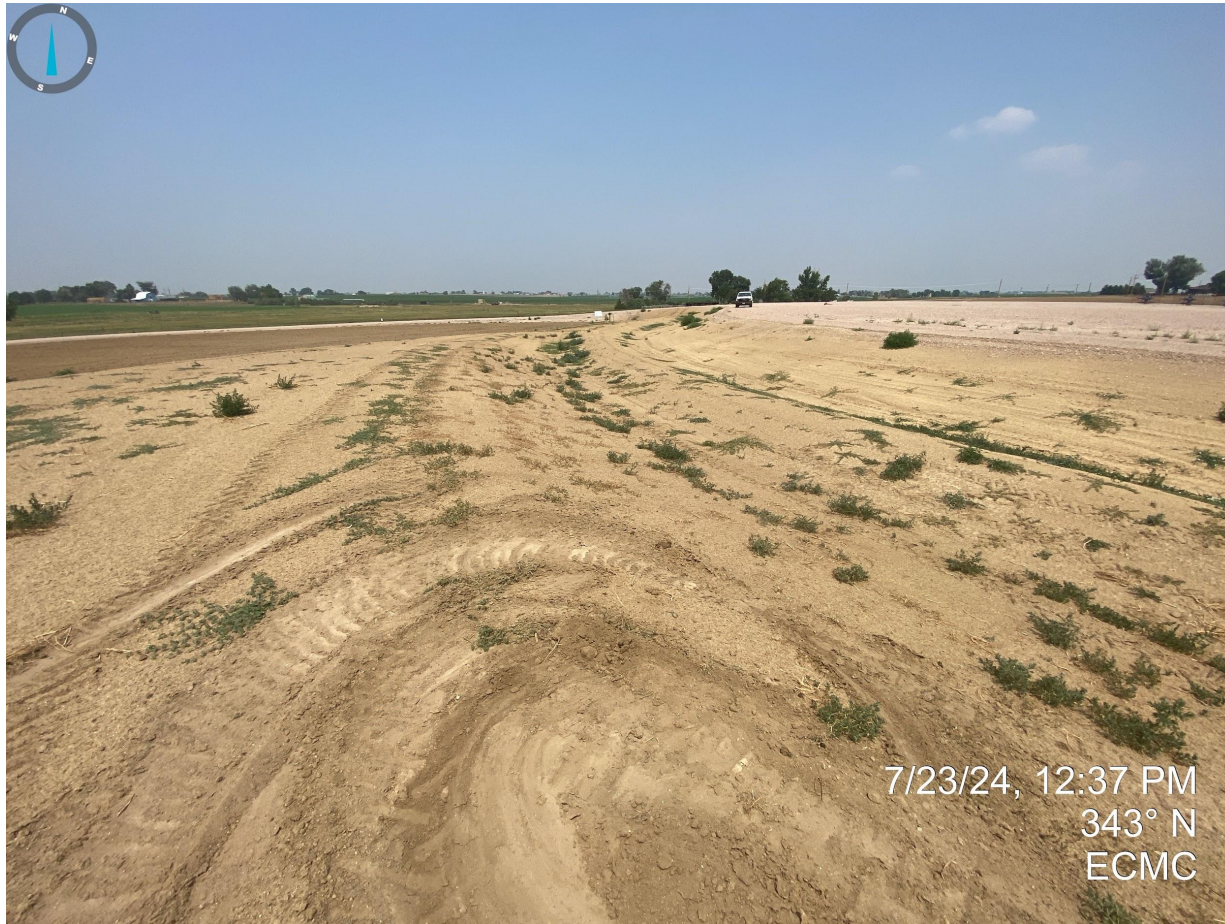
Photo 4. Continued from Photo 3; facing north.

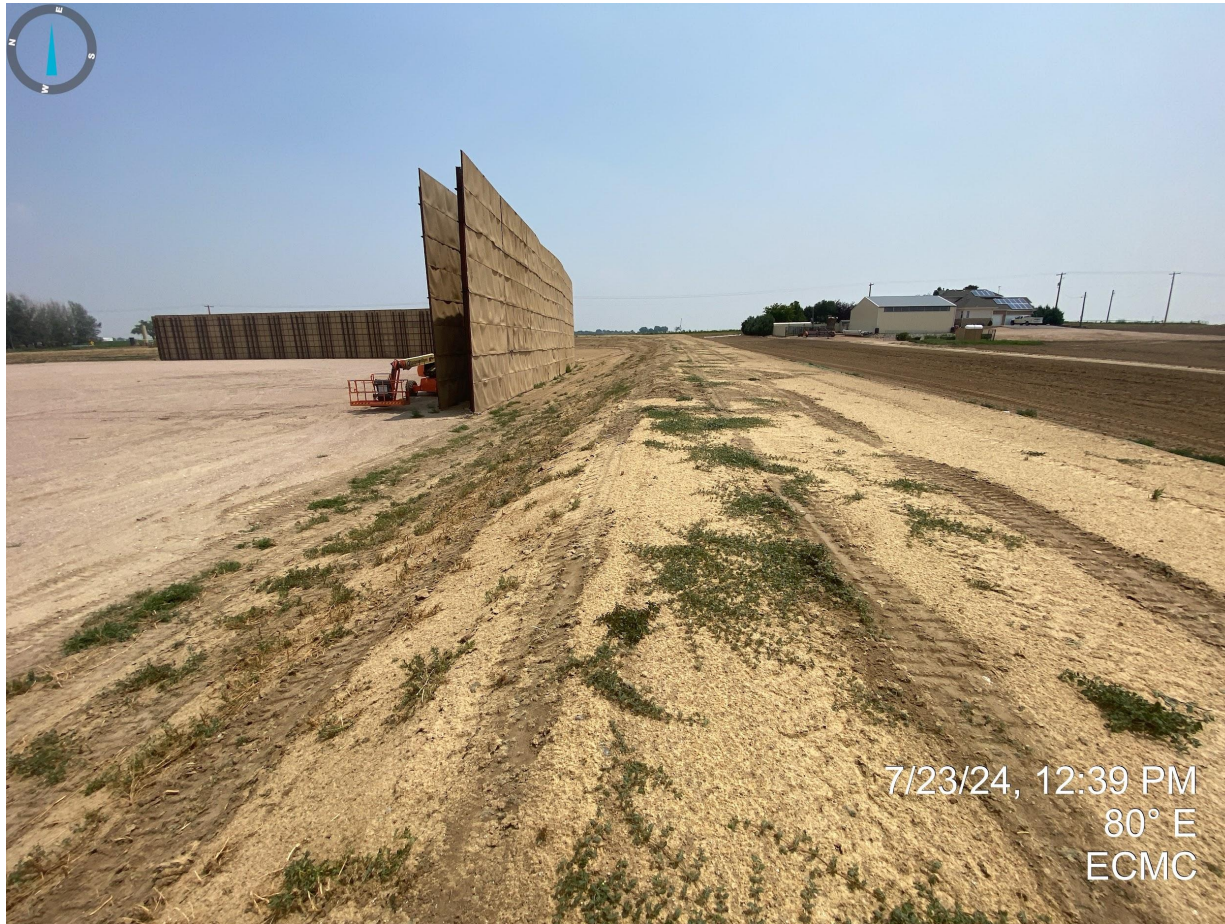
Photo 5. Southern portion of the topsoil stockpile. Equipment tracks on the hydromulch appear to have disturbed the application; no germination of desirable species observed at the time of this inspection.

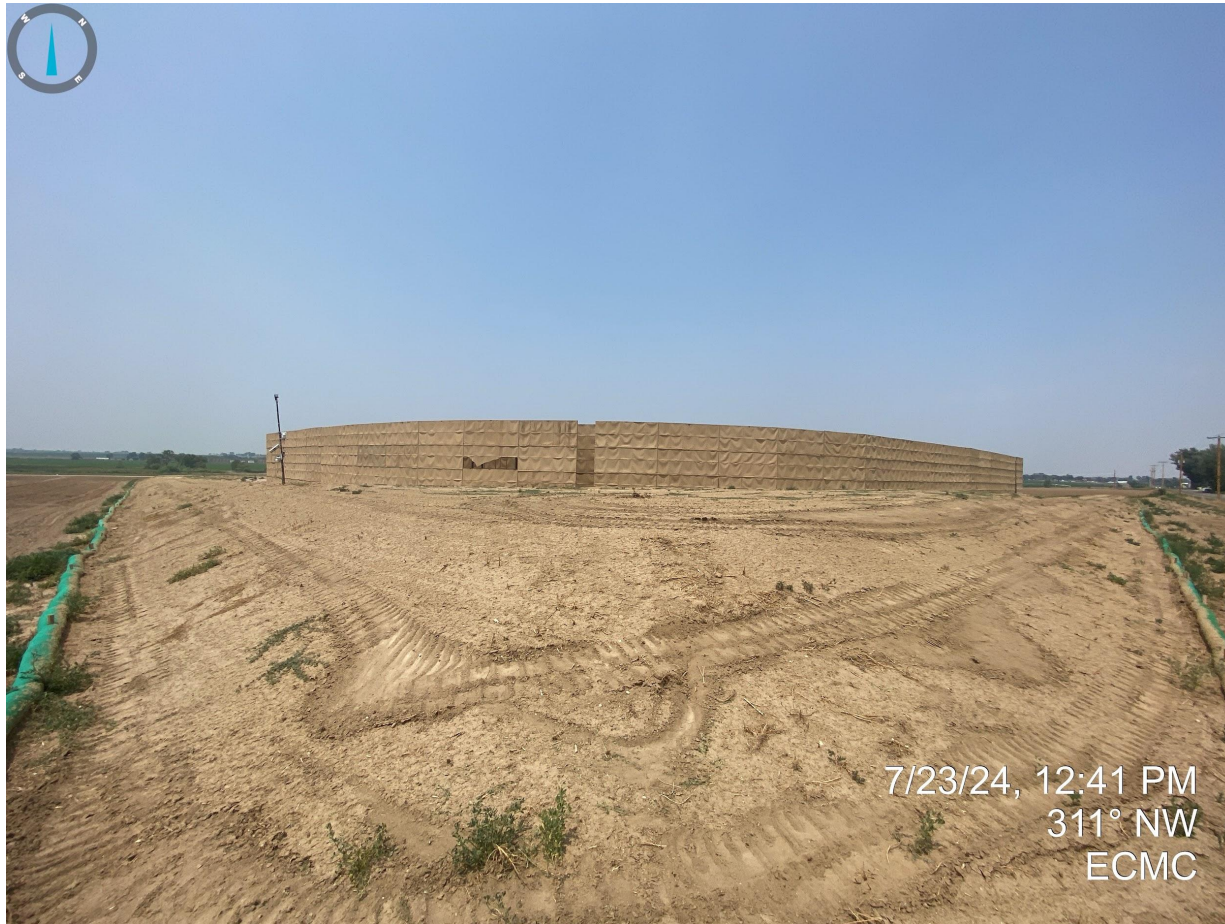
Photo 6. Southeast corner of the construction area. Photo illustrates a portion of the topsoil stockpile and perimeter control measures (e.g. filtrex wattles). Equipment tracks on the hydromulch appear to have disturbed the application; no germination of desirable species observed at the time of this inspection.

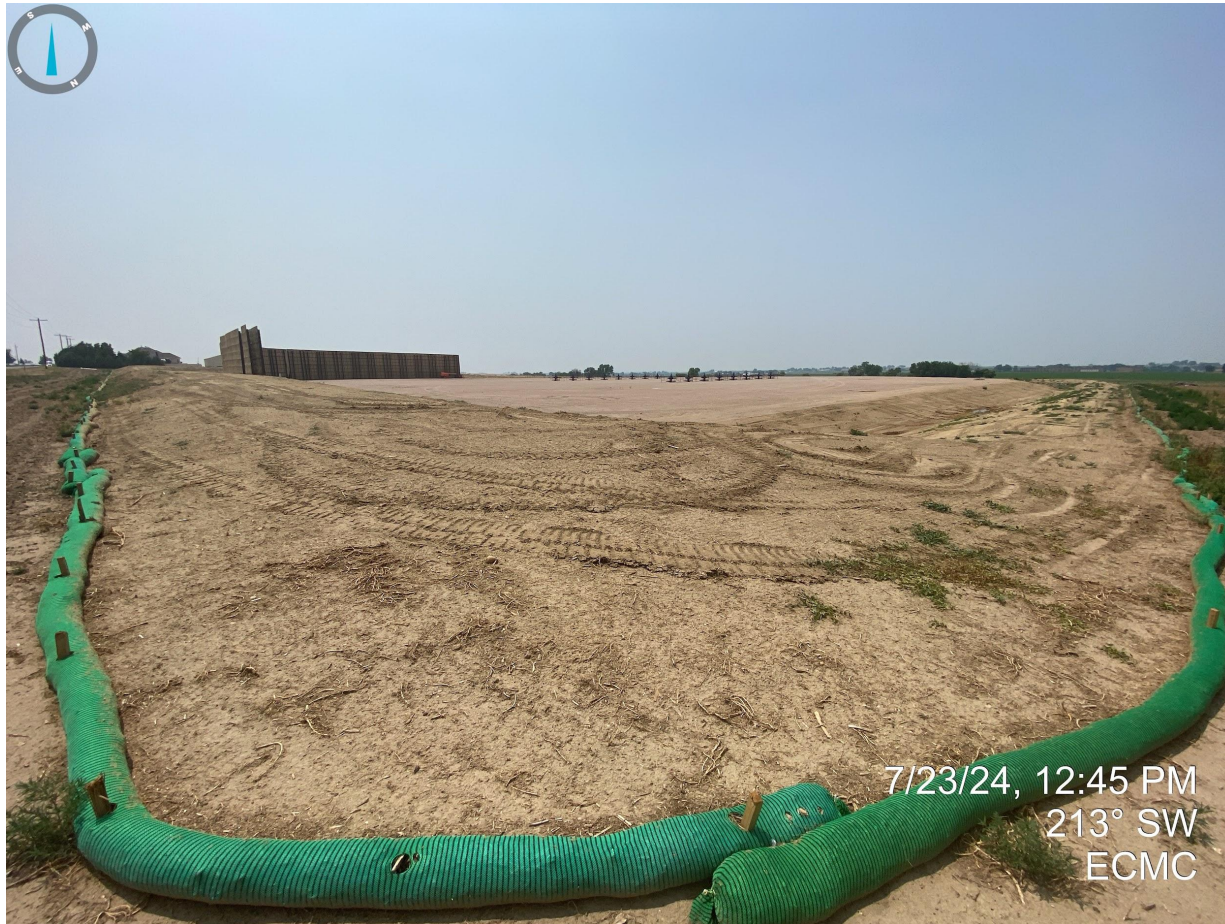
Photo 7. Northeast corner of the construction area. Photo illustrates a portion of the topsoil stockpile and perimeter control measures (e.g. filtrex wattles). Equipment tracks on the hydromulch appear to have disturbed the application; no germination of desirable species observed at the time of this inspection.

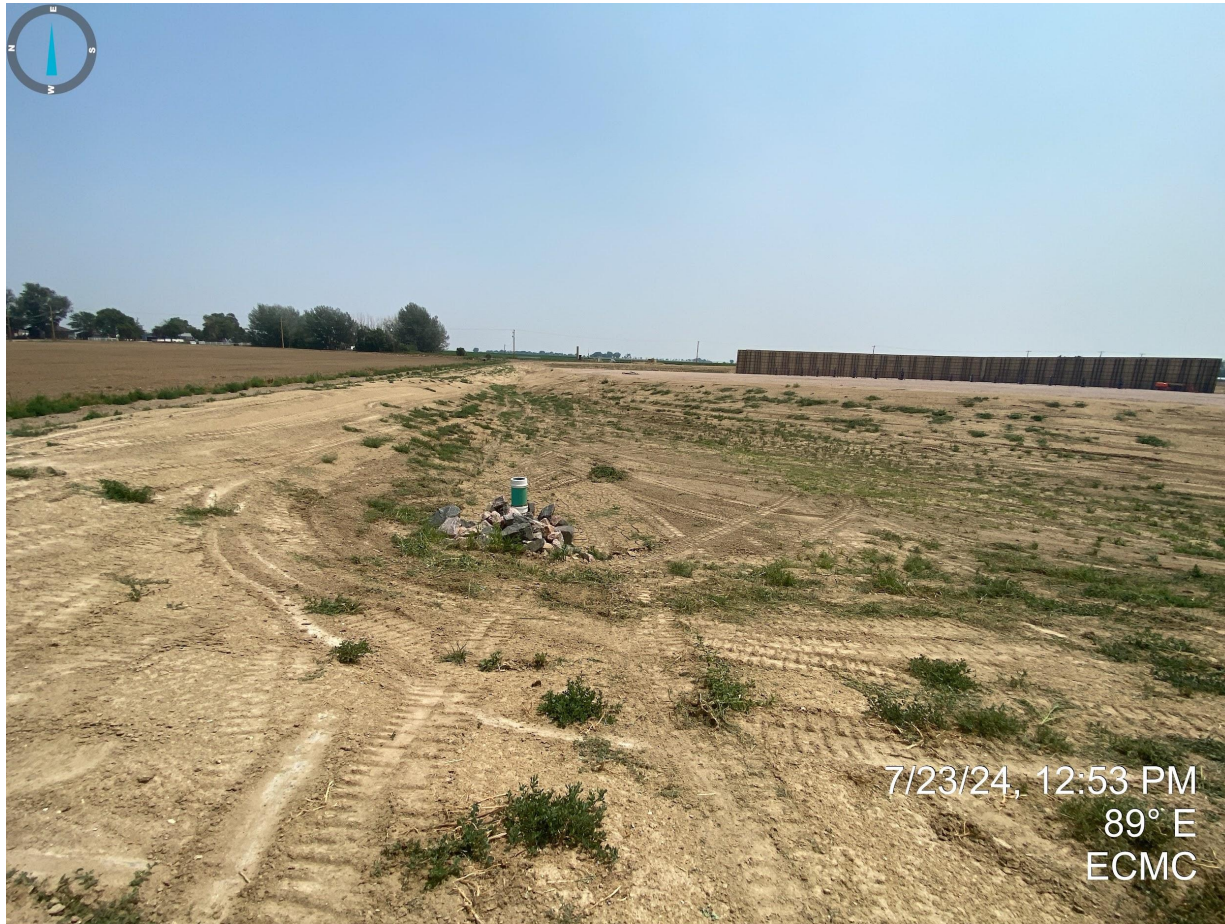
Photo 8. Northwest corner of the location, near the stormwater detention area. Undesirable vegetation appears to have recently been mowed or sprayed with herbicide. Equipment tracks on the hydromulch appear to have disturbed the application; no germination of desirable species observed at the time of this inspection.

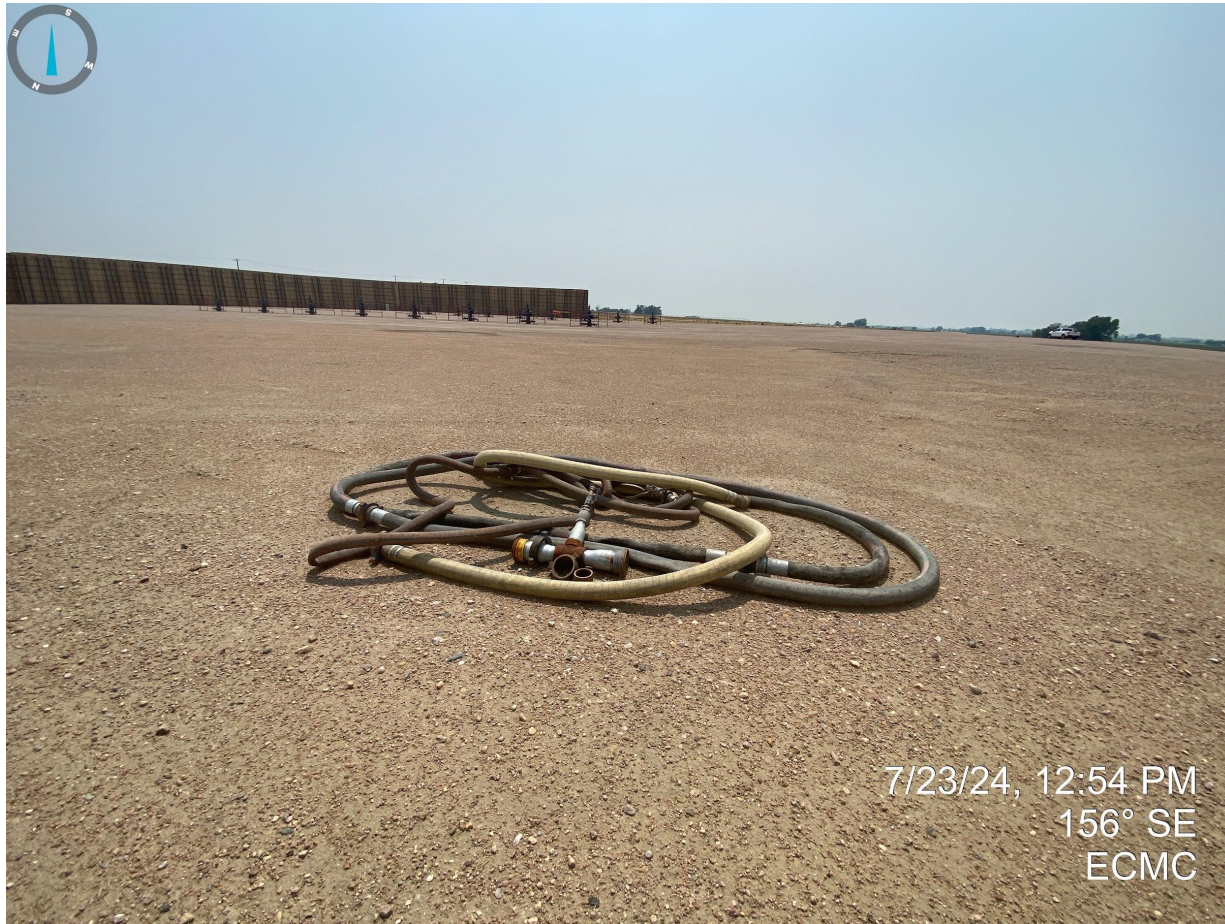
Photo 9. Unused equipment on location.

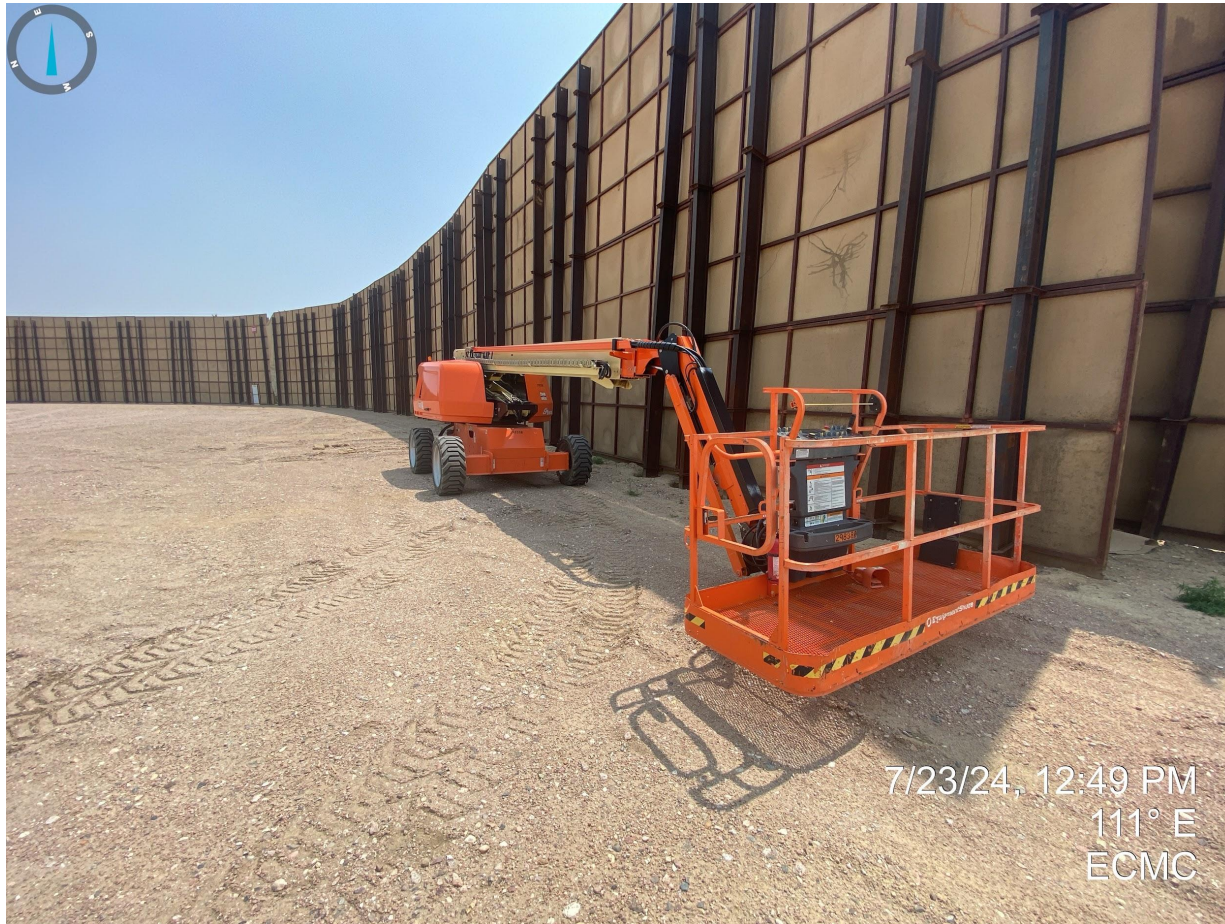
Photo 10. Unused equipment on location.

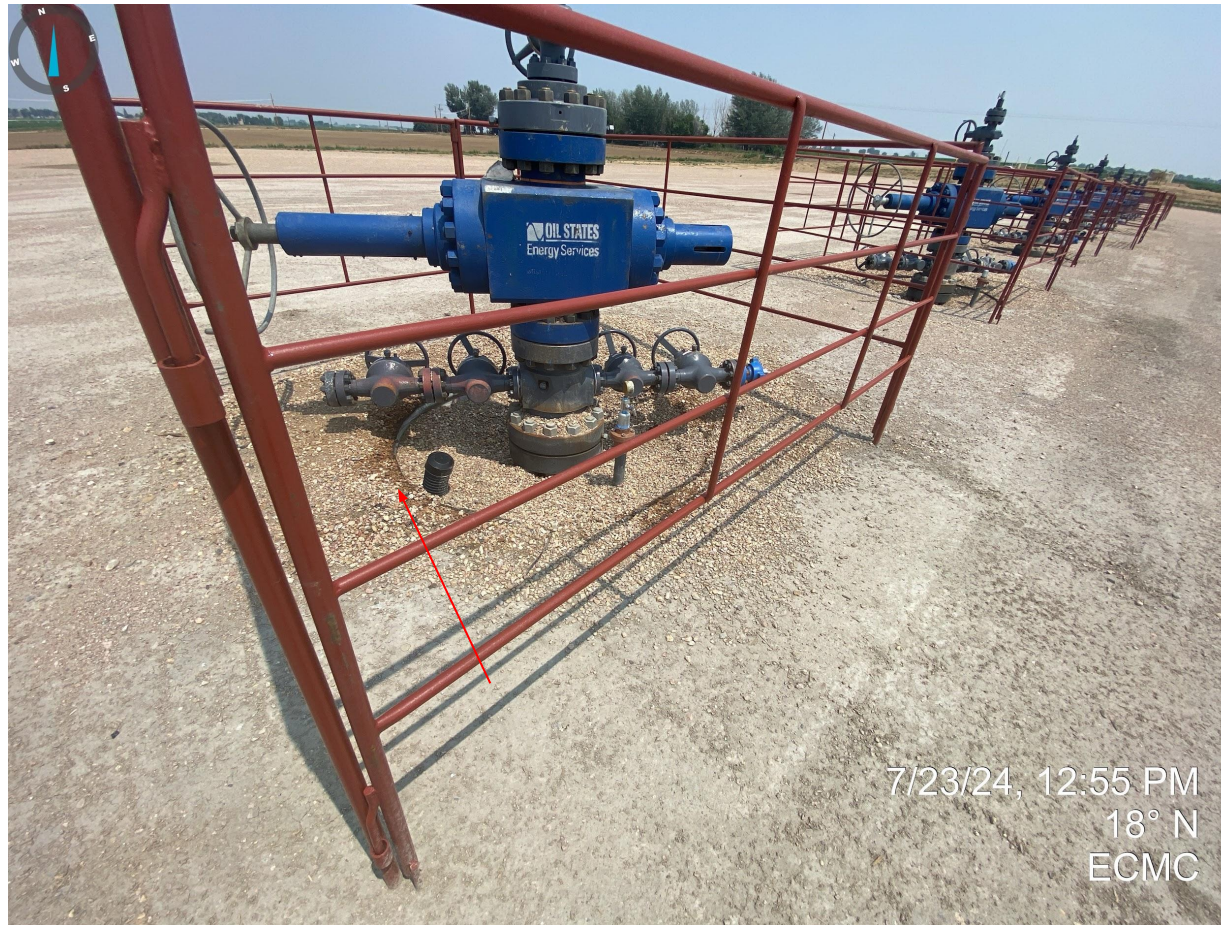
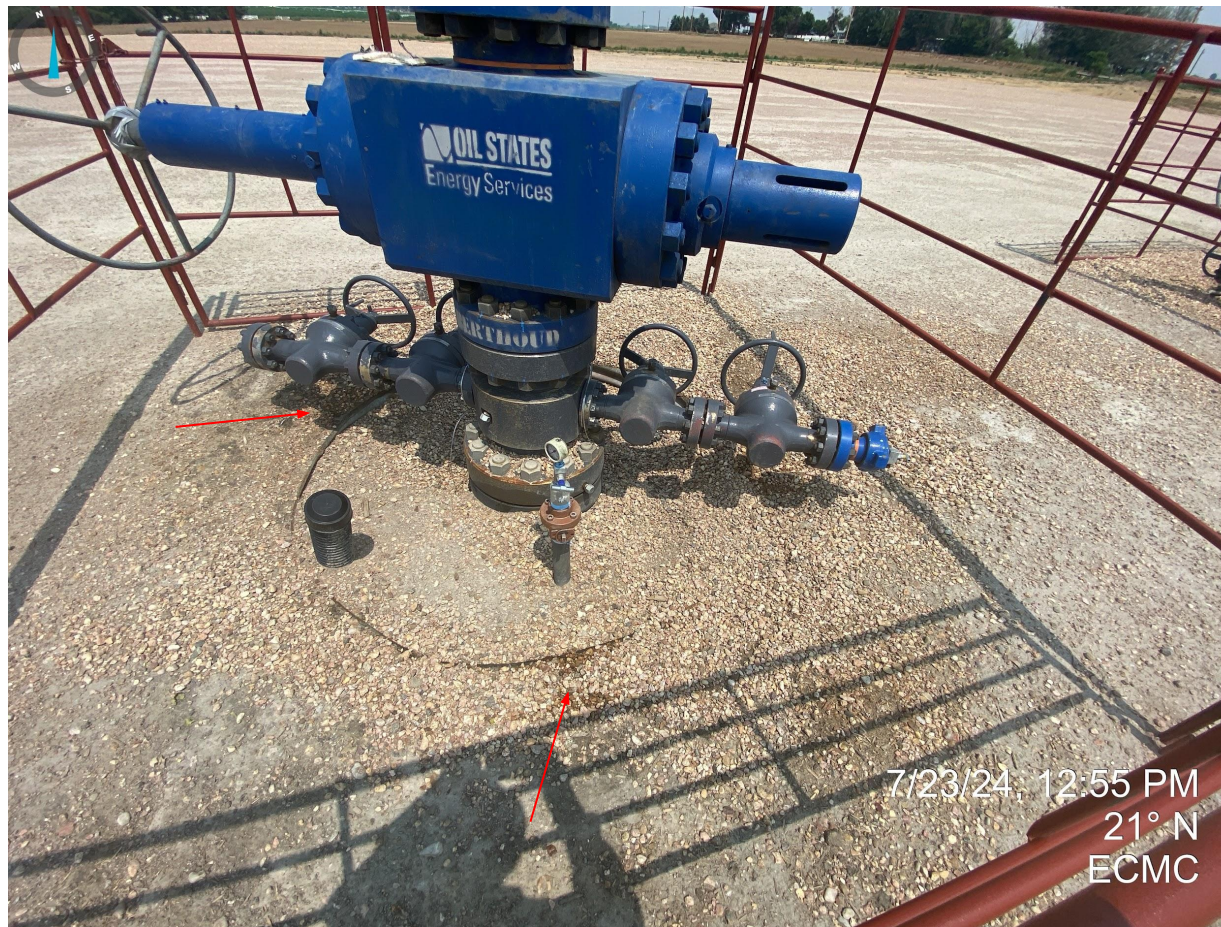
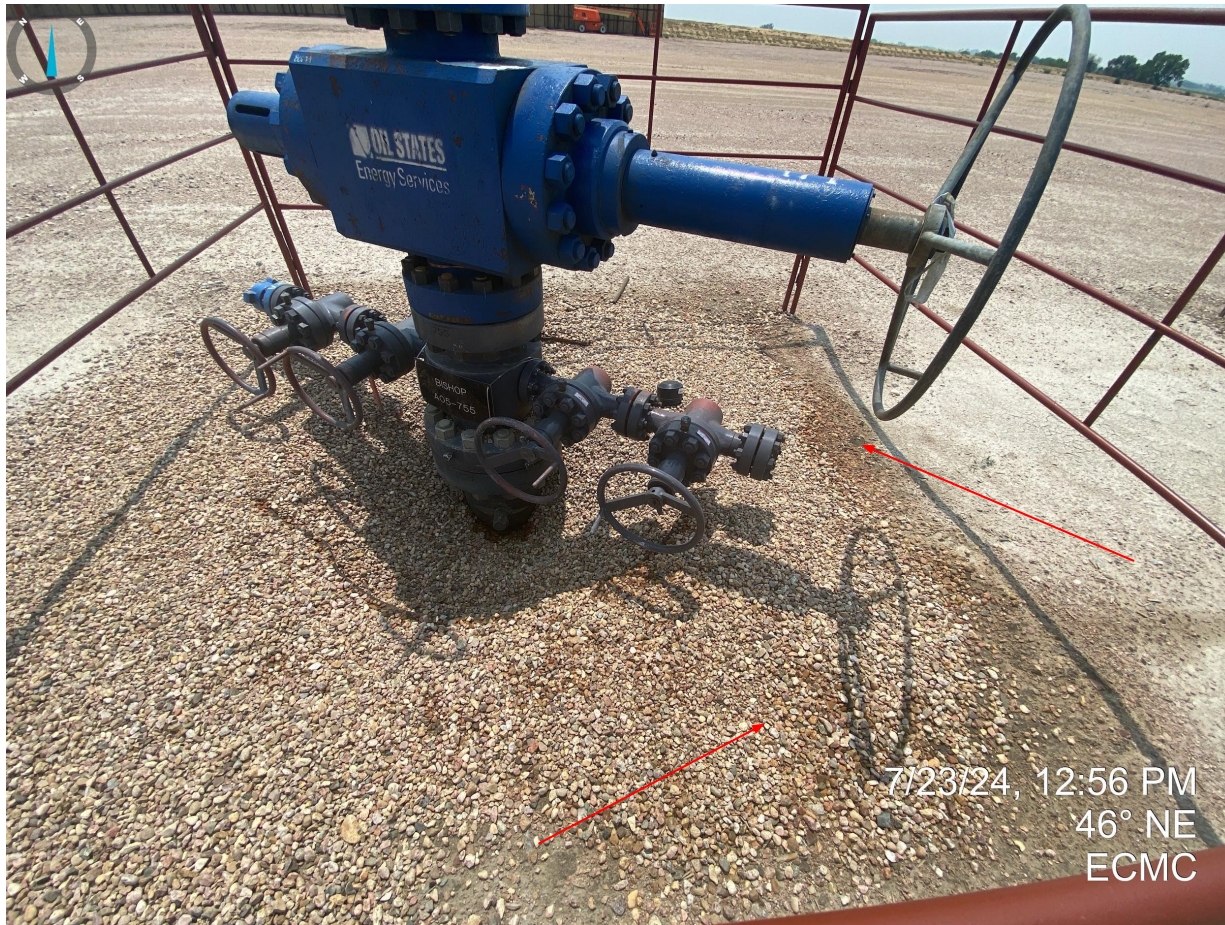
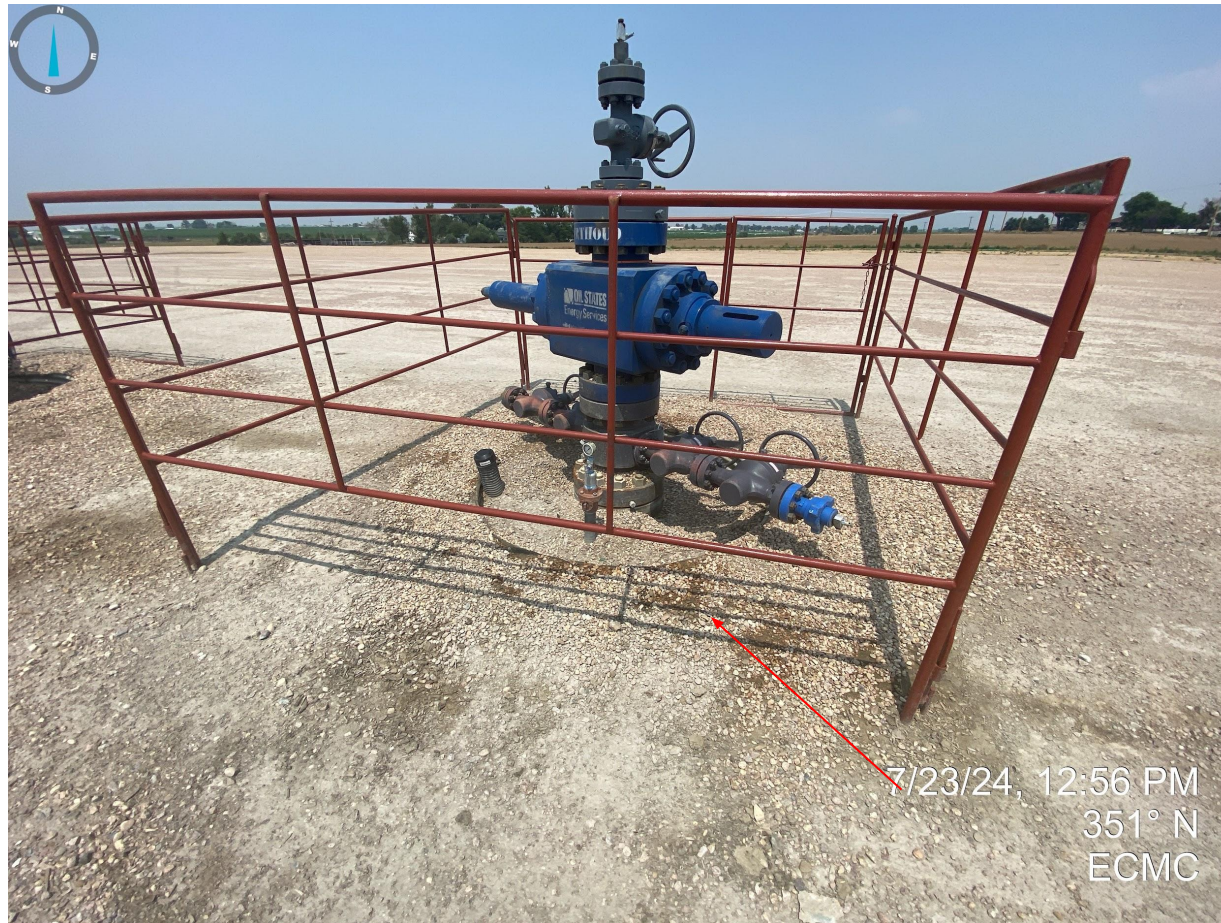
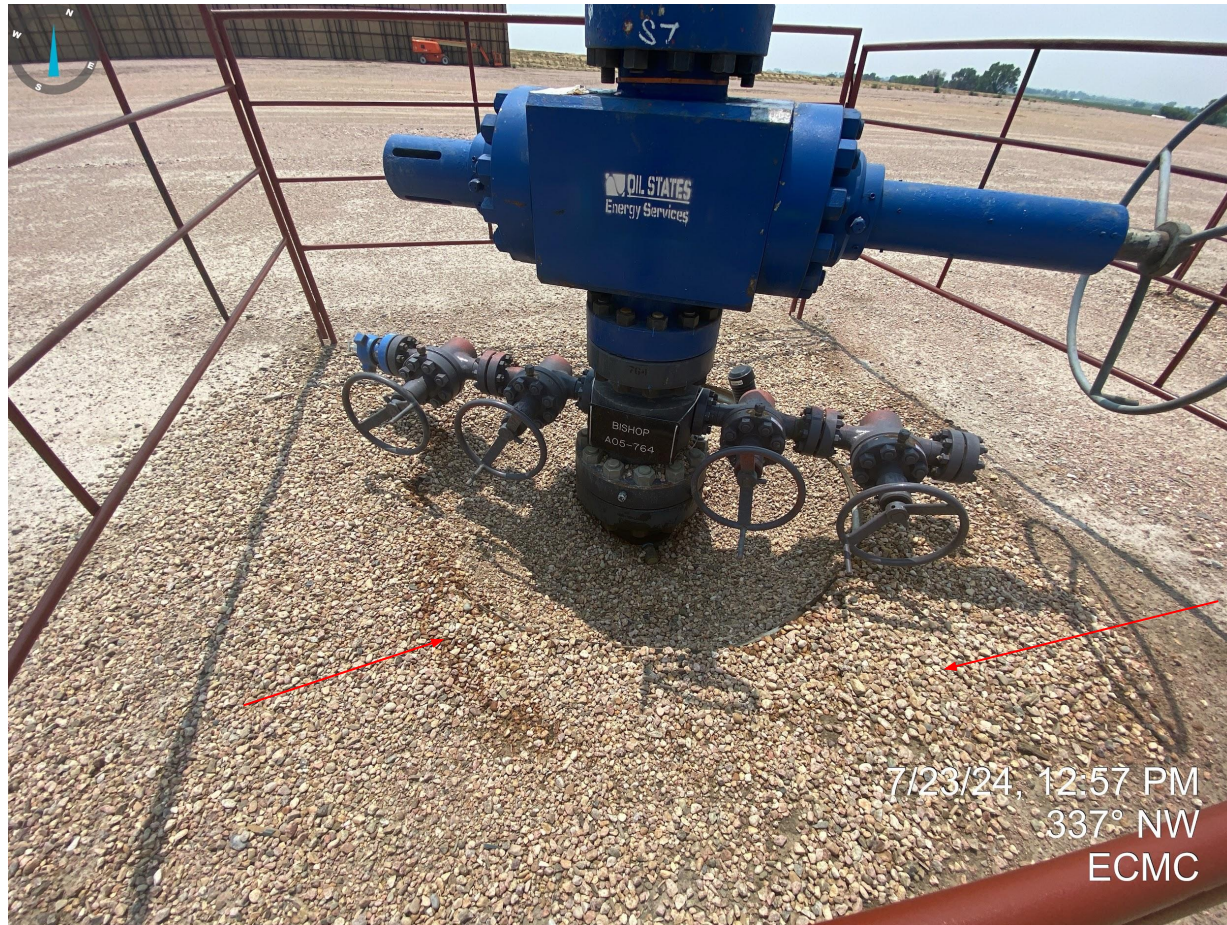
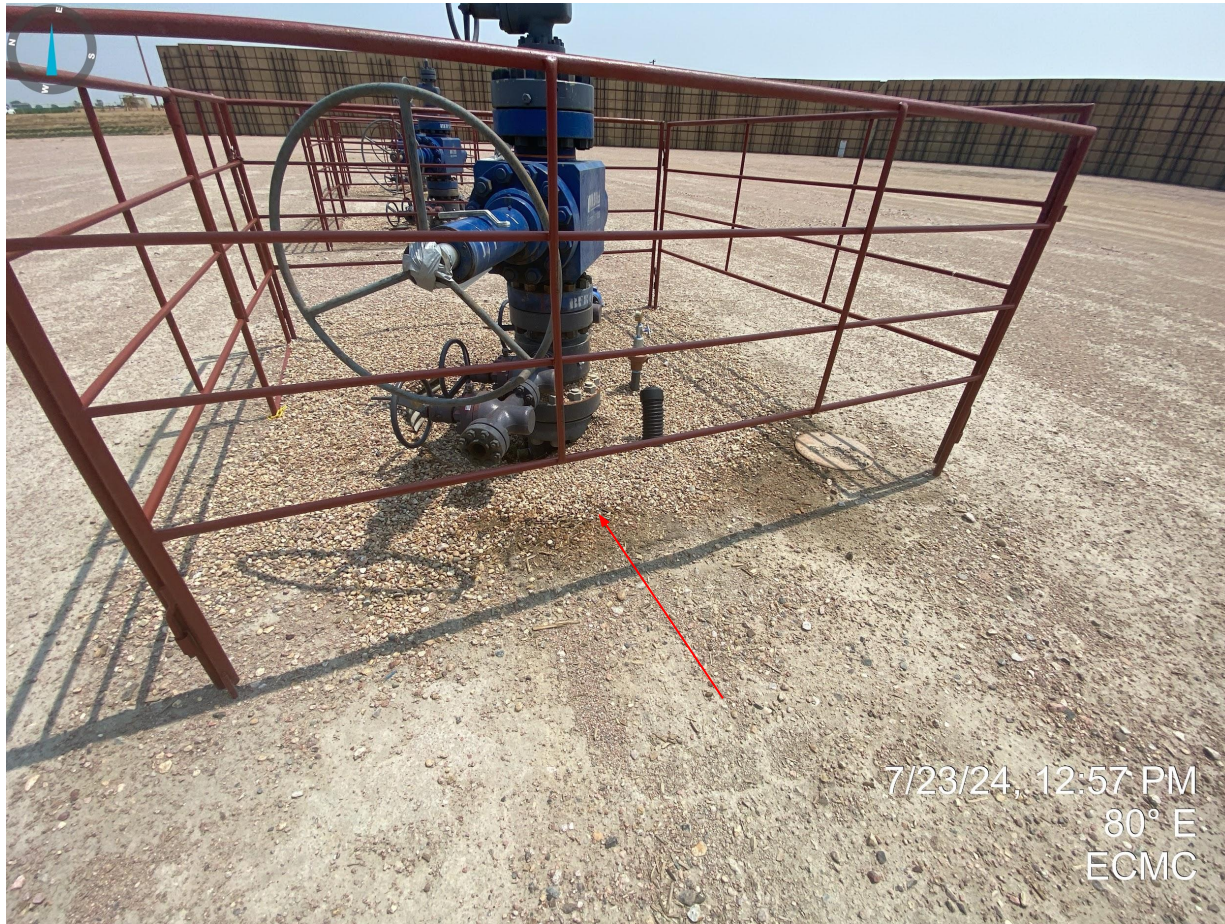
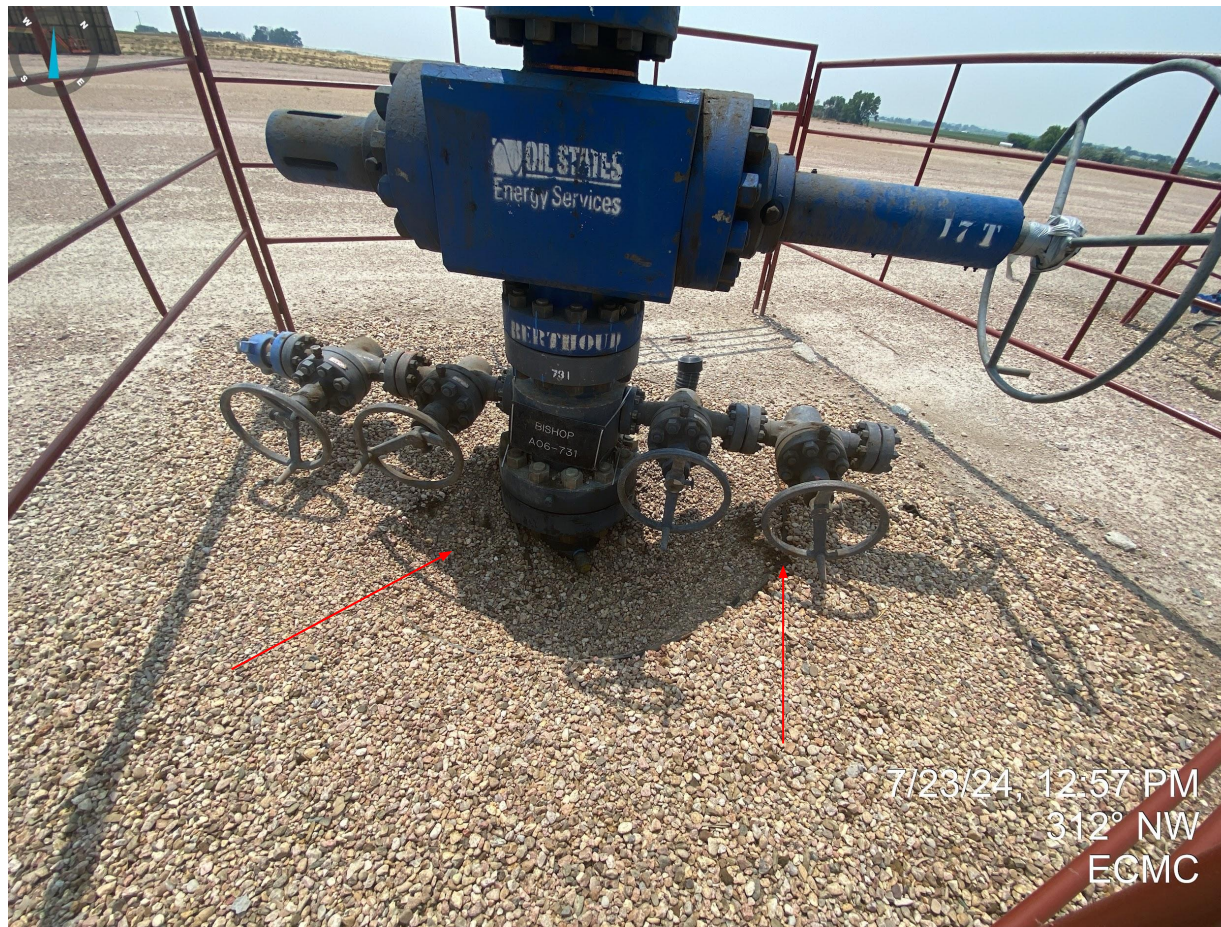
Photo 11. Stained soil observed around conductor at wellhead. Operator shall self inspect all conductors and dispose of stained soils properly.

Photo 12. See comments in Photo 11.

Photo 13. See comments in Photo 11.

Photo 14. See comments in Photo 11.

Photo 15. See comments in Photo 11.

Photo 16. See comments in Photo 11.

Photo 17. See comments in Photo 11.
