Inspection Photos

Location Name: TEP ROCKY MOUNTAIN LLC CB-TG Land NW 11D-20-692 Pad

Location #: 418555

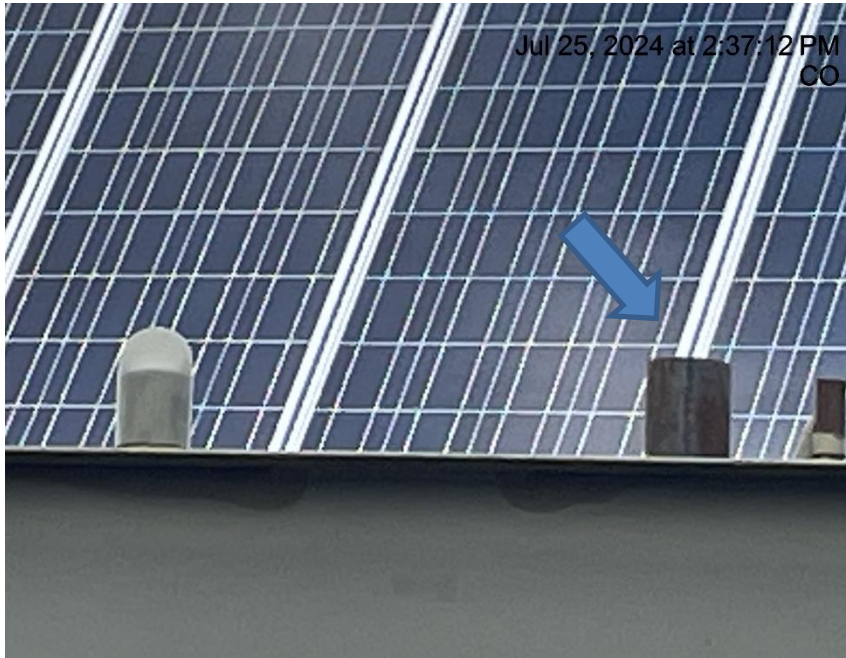
Photo # 3511 PRV vent line on separator unit does not comply with CECMC pressure safety device rules

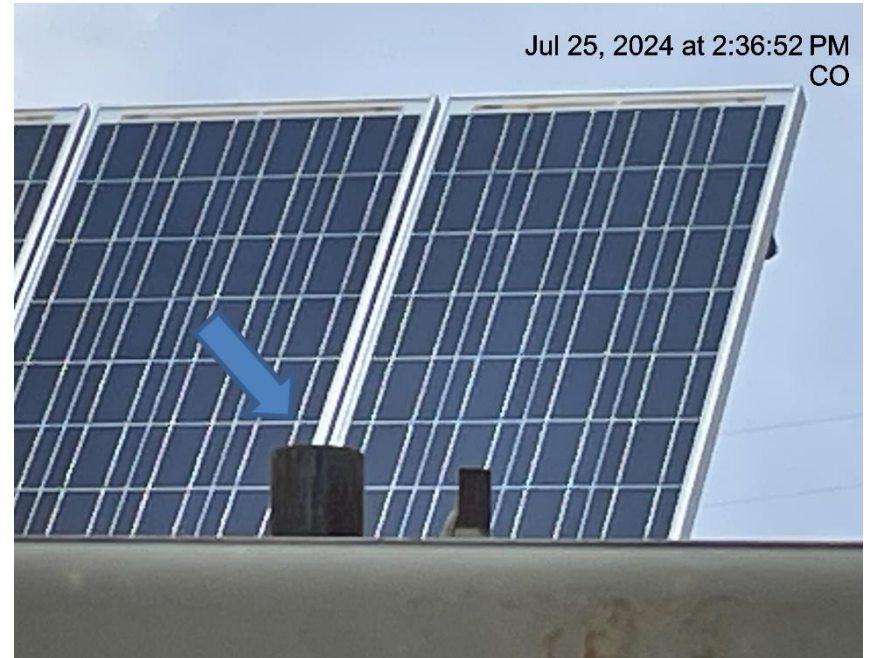
Photo # 3512 PRV vent line on separator unit does not comply with CECMC pressure safety device rules

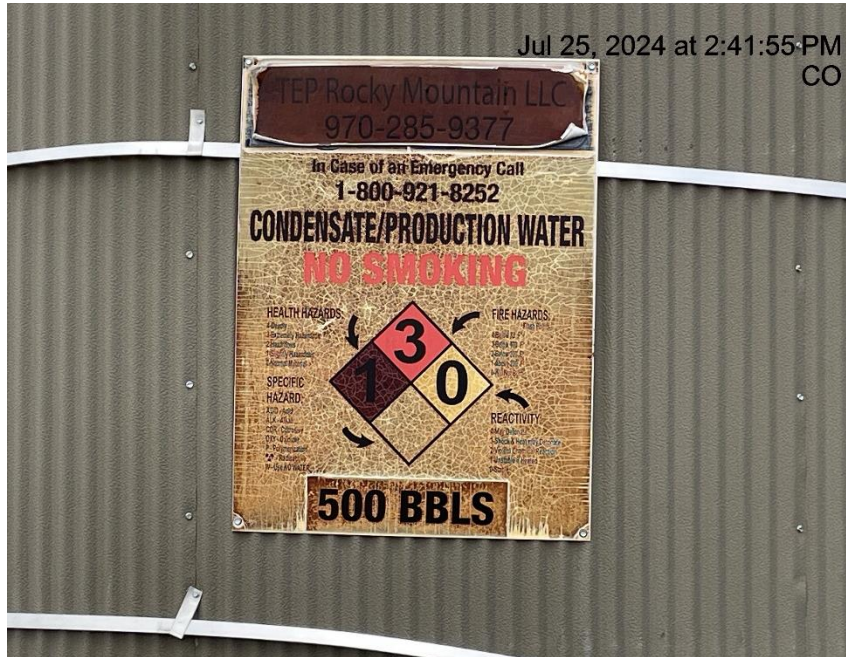
Photo # 3513 Tank label weathered & some required info is starting to become illegible

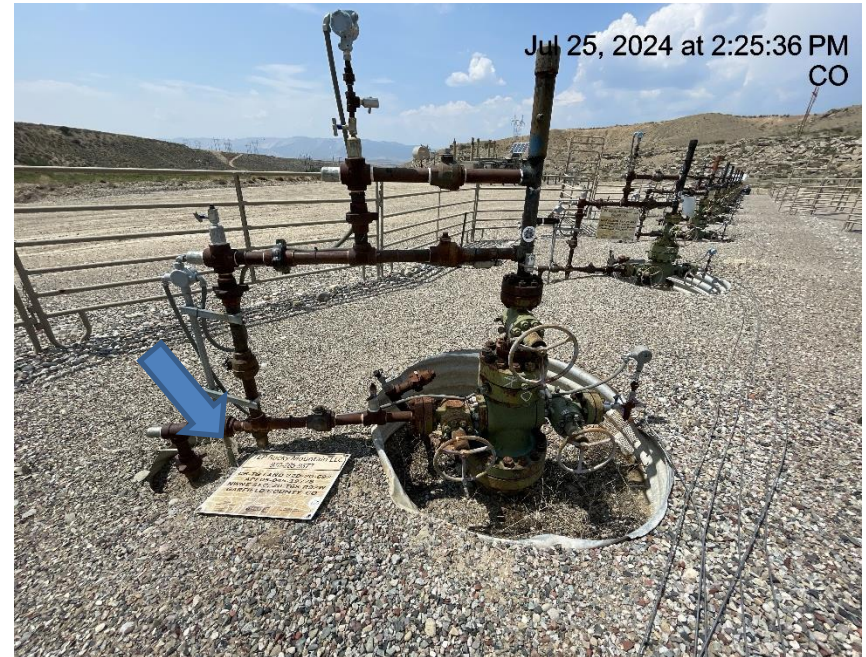
Photo # 3514 Wellhead sign laying on ground & not properly posted
