Interim Reclamation and Stormwater Inspection

Operator: GMT EXPLORATION COMPANY LLC #10243

Location ID: 479194

Inspection Document #: 697505393

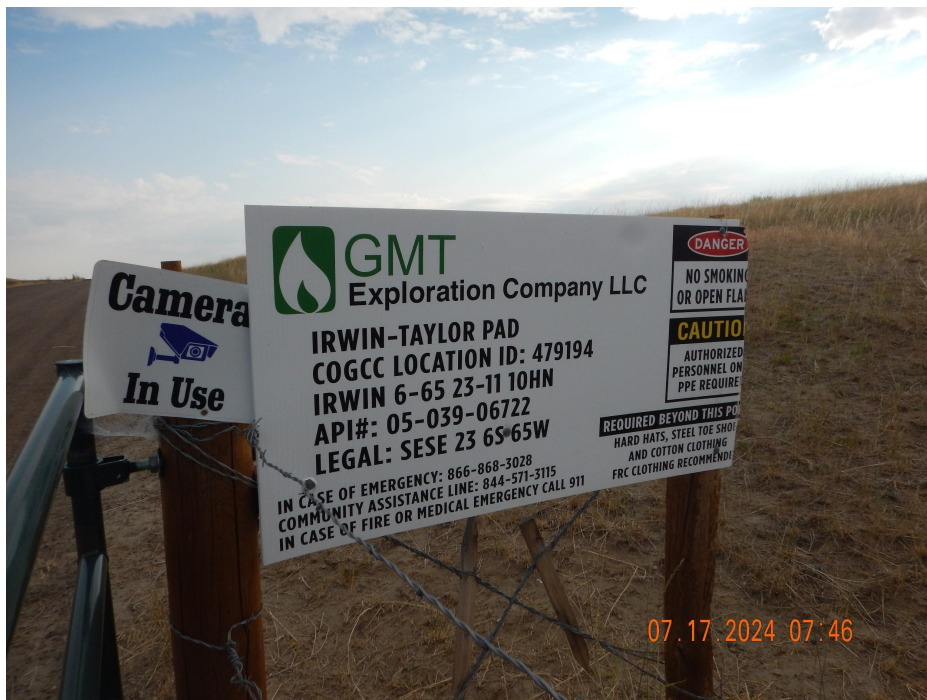
Photo 1. Photo taken from the entrance of location off of the county road, illustrating the Operator sign.

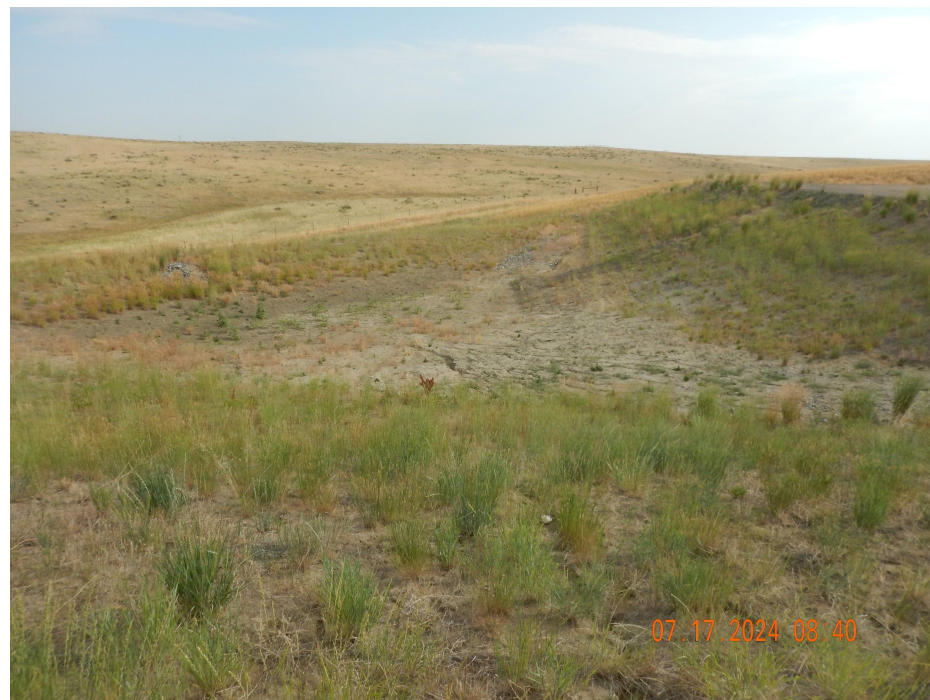
Photo 2. Photo taken along the northwestern working pad surface, facing Northwest. Photo illustrates a retention pond with a stabilized outlet.

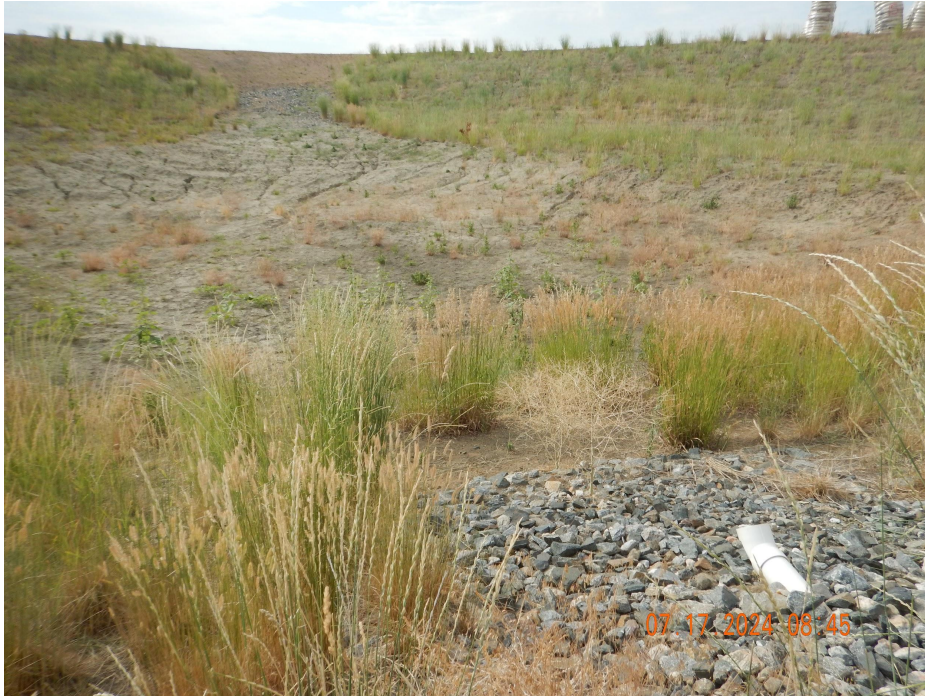
Photo 3. Close up photo taken from the stabilized outlet, facing Southeast. Photo illustrates rill erosion along the banks of the retention pond.

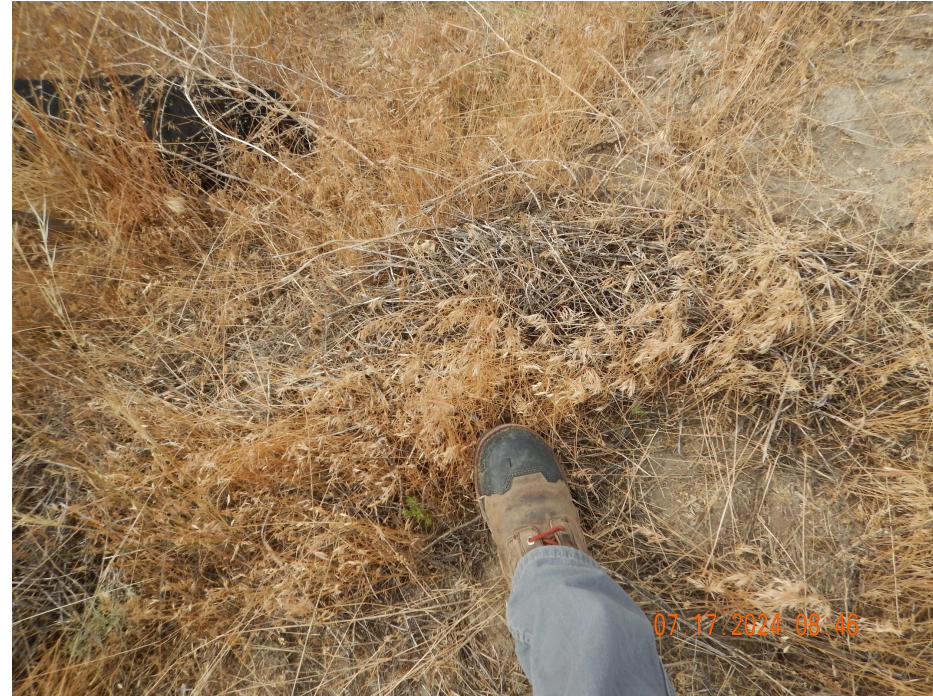
Photo 4. Photo taken along the northwestern perimeter of location illustrating cheatgrass.

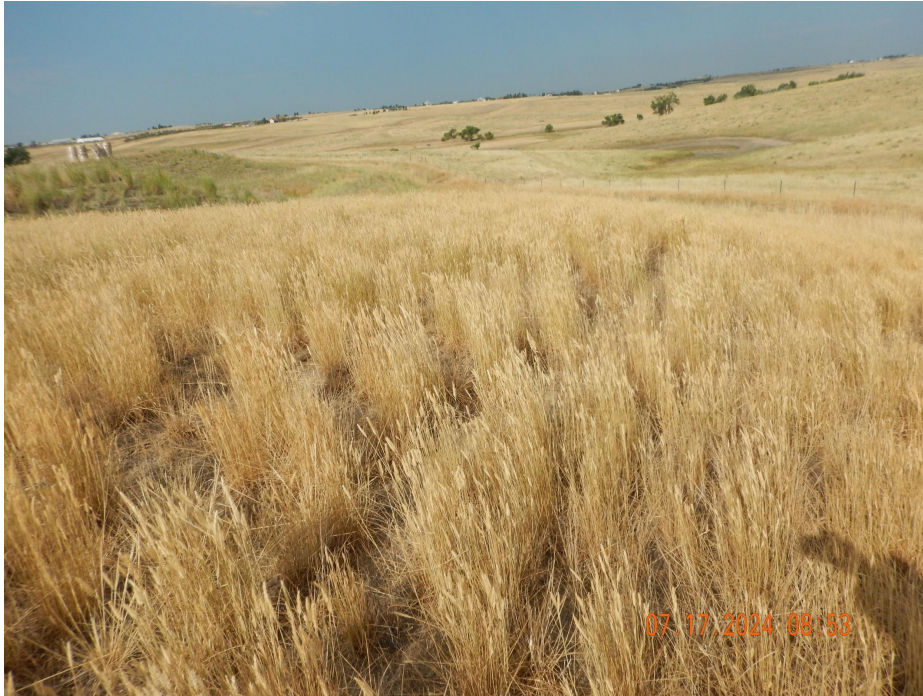
Photo 5. Photo taken from the northern topsoil stockpile, facing West. Photo illustrates the stockpile has been stabilized with an introduced grass species, Crested wheatgrass.

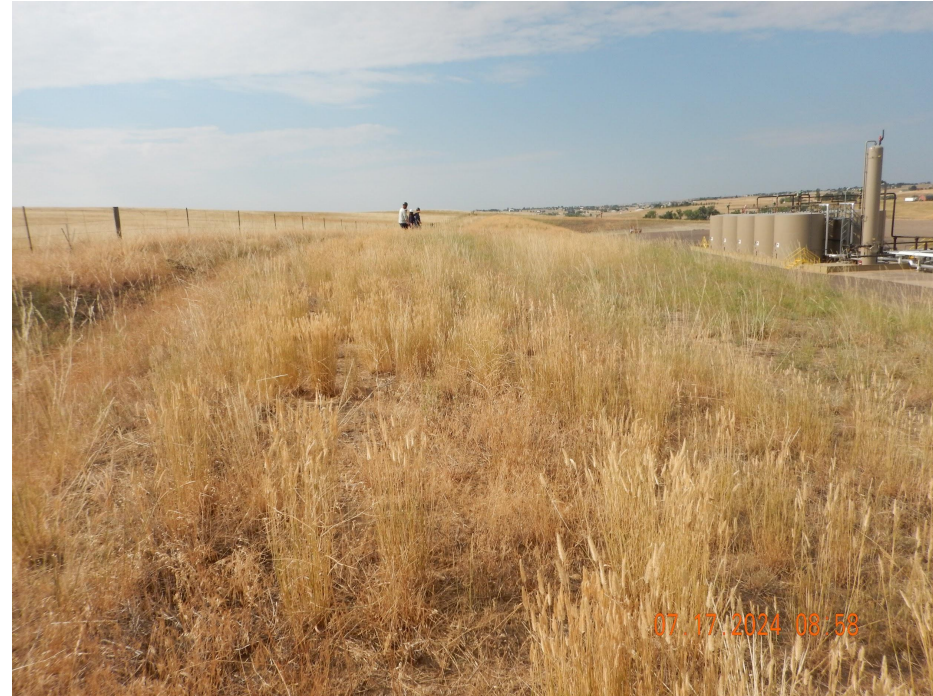
Photo 6. Photo taken along the northeastern perimeter of location, facing South. Photo illustrates the reclamation construction areas are in process of vegetation establishment. Note- the seed mix appears to be an introduced/native grass mix.

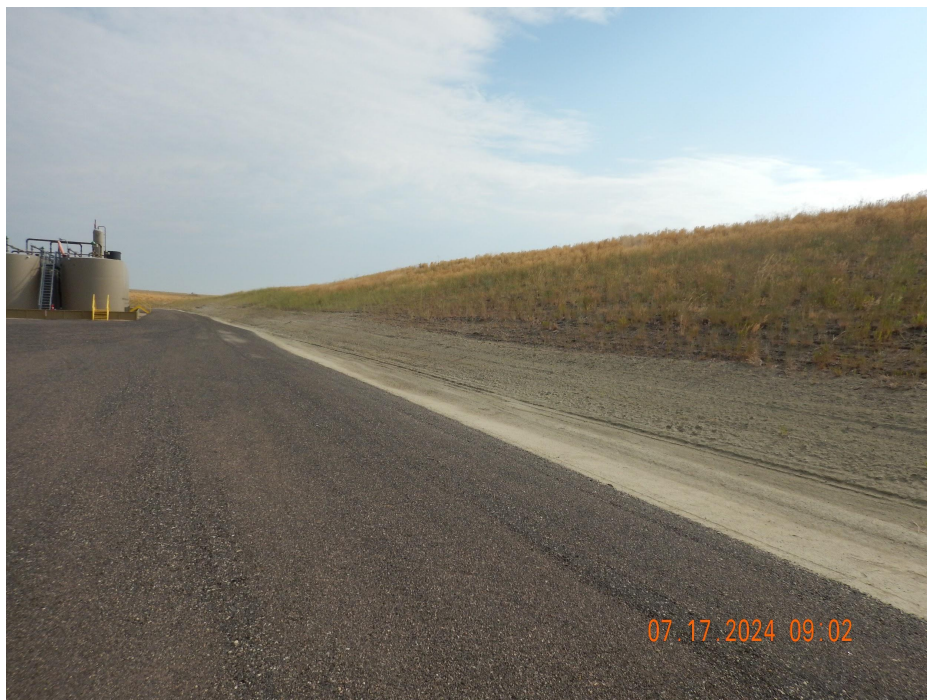
Photo 7. Photo taken from the eastern working pad surface, facing Northeast. Photo illustrates a portion of a cut slope that would require additional stabilization. Operator indicated stormwater repairs were conducted along the toe of the slope.

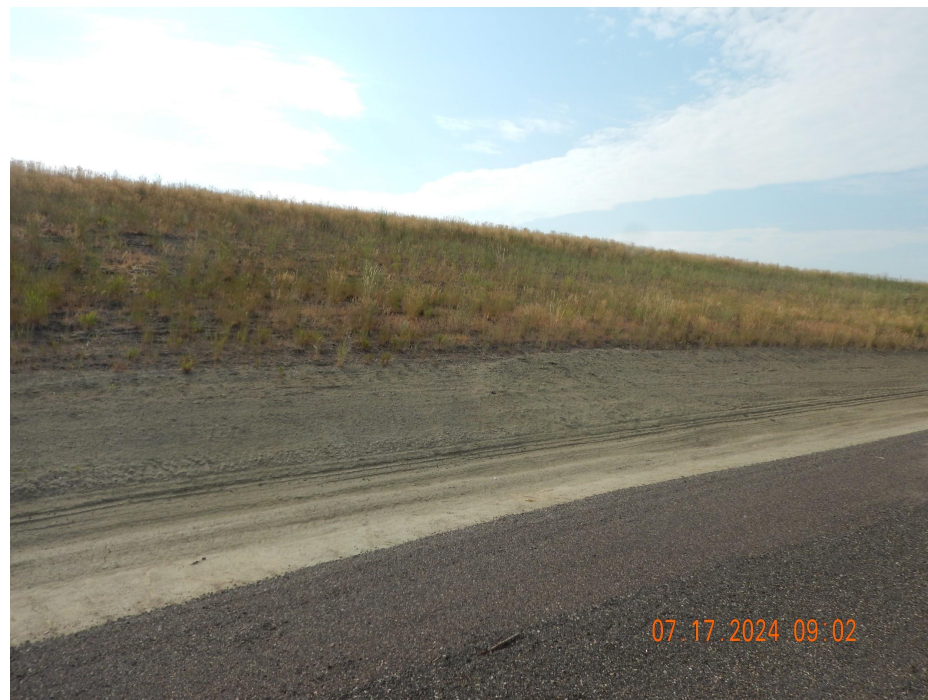
Photo 8. Photo taken from the eastern working pad surface, facing Southeast. See comments under Photo 7.

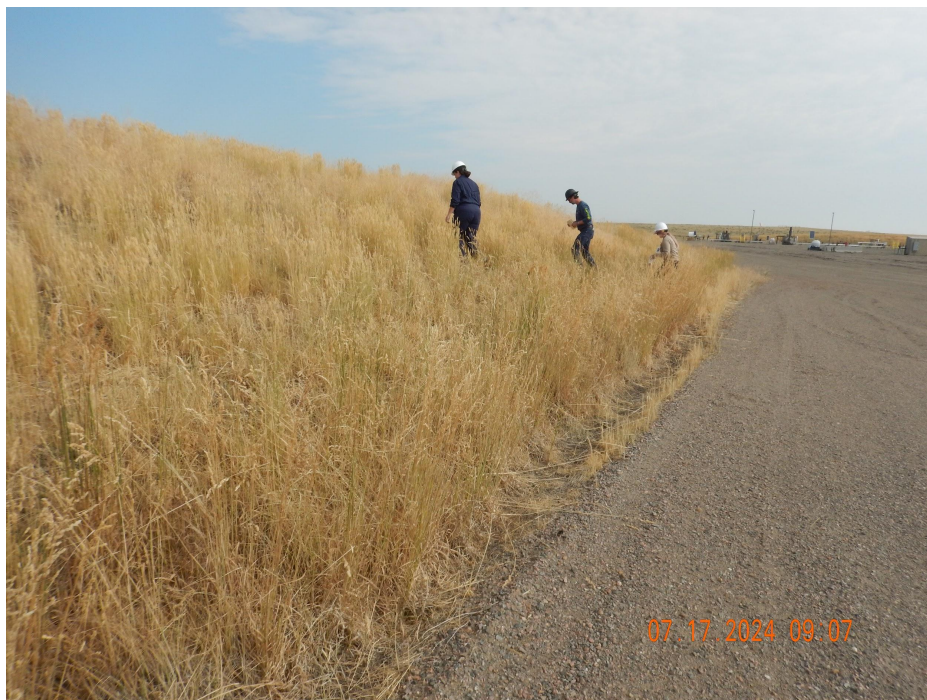
Photo 9. Photo taken from the southern topsoil stockpile, facing North. See comments under Photo 5.

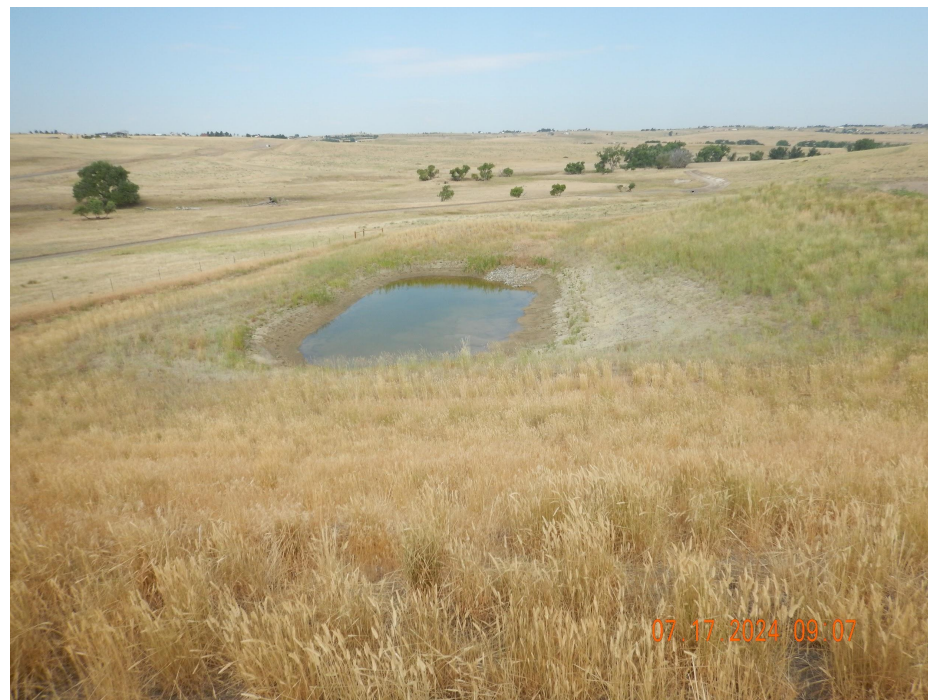
Photo 10. Photo taken along the southwestern working pad surface, facing West. Photo illustrates a retention pond and reclamation construction areas are in process of vegetation establishment.

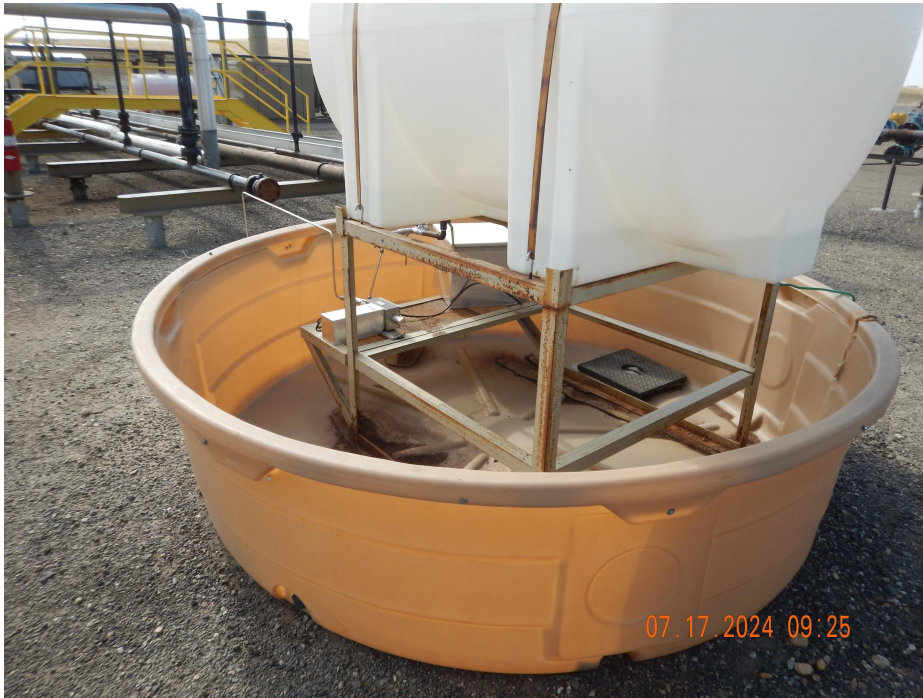
Photo 11. Photo taken from the northern production area illustrating the secondary containment lacks wildlife protection.

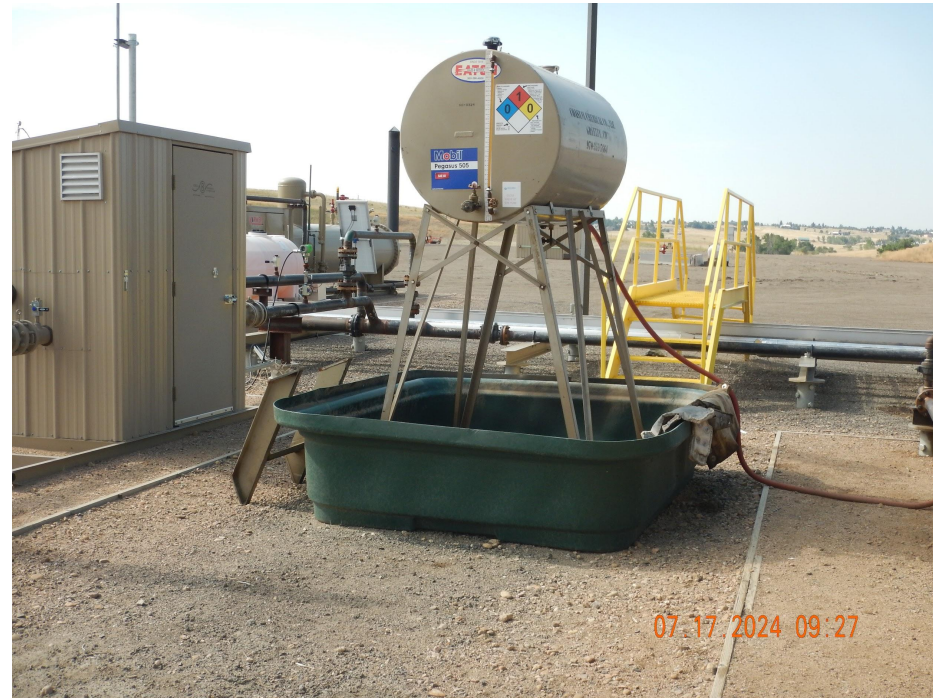
Photo 12. Photo taken from the northern production area illustrating the secondary containment lacks wildlife protection. Note- there was no observed fluids within the secondary containment at the time of this inspection.

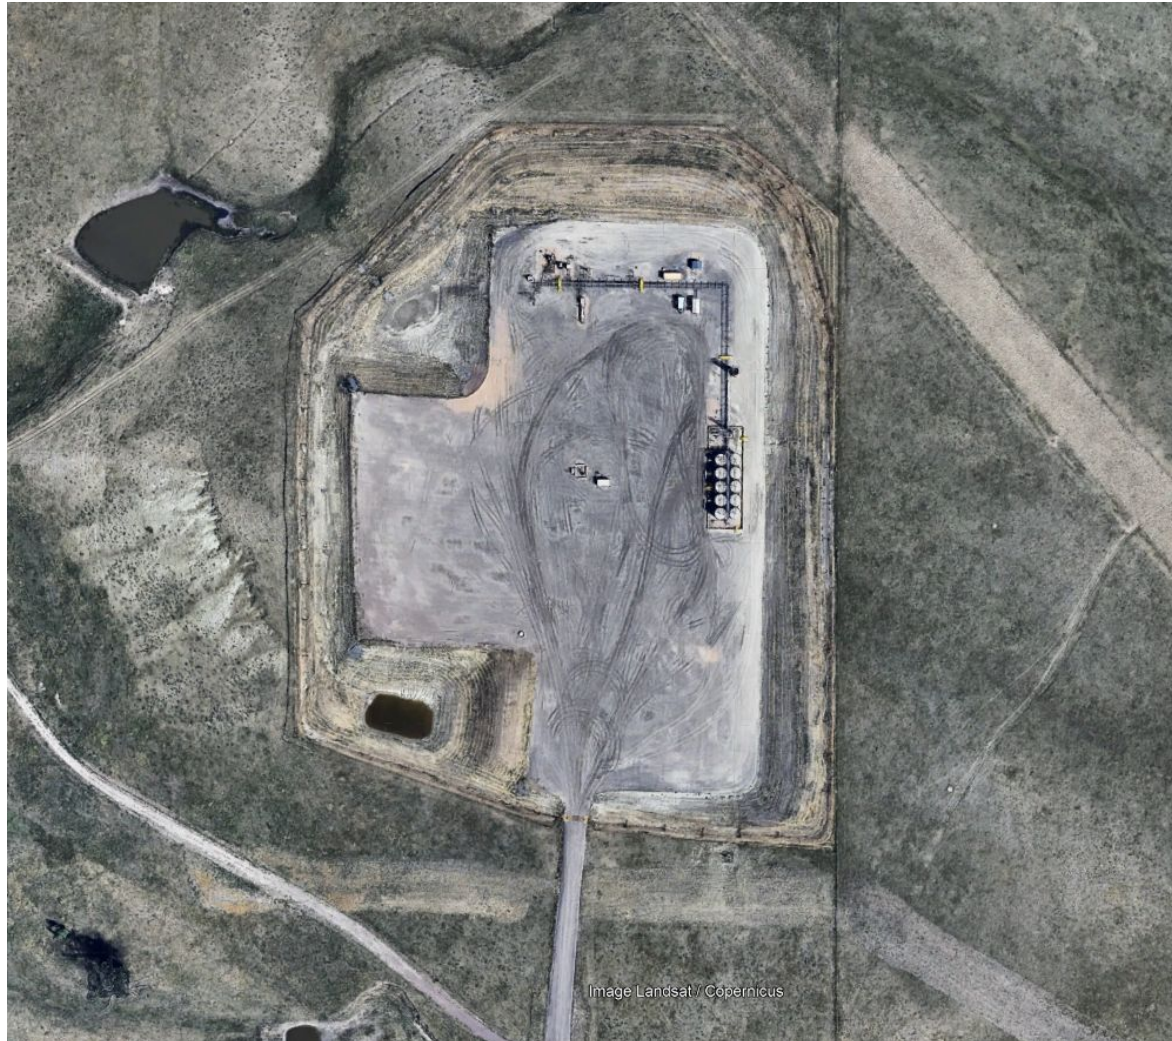
Photo 13. Google Earth aerial imagery from 9/4/2023 illustrates the location and the northern portion of the access road.
