Interim Reclamation and Stormwater Inspection

July 17, 2024

Operator: GMT EXPLORATION COMPANY LLC #10243

Location ID: 479197

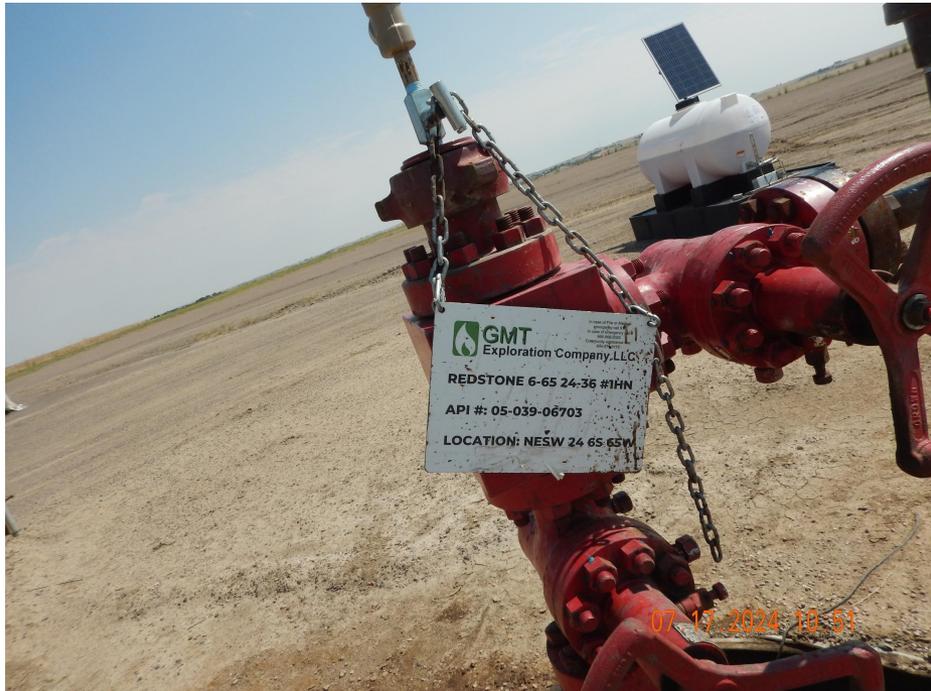
Photo 1. Photo taken from a wellhead, illustrating the Operator sign.

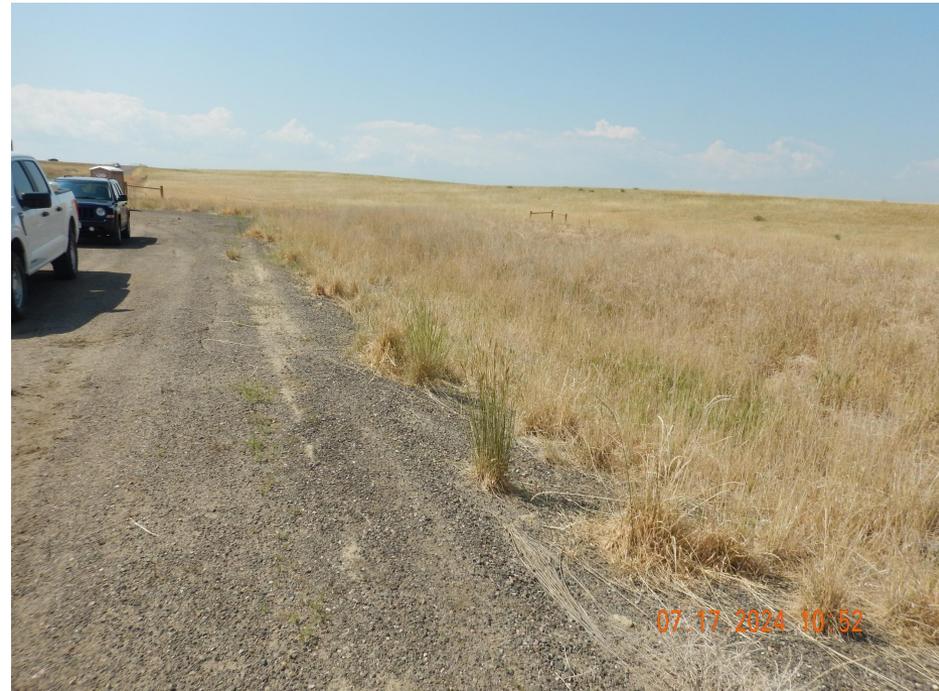
Photo 2. Photo taken along the western working pad surface, facing South. Photo illustrates the reclamation construction areas are in process of vegetation establishment.

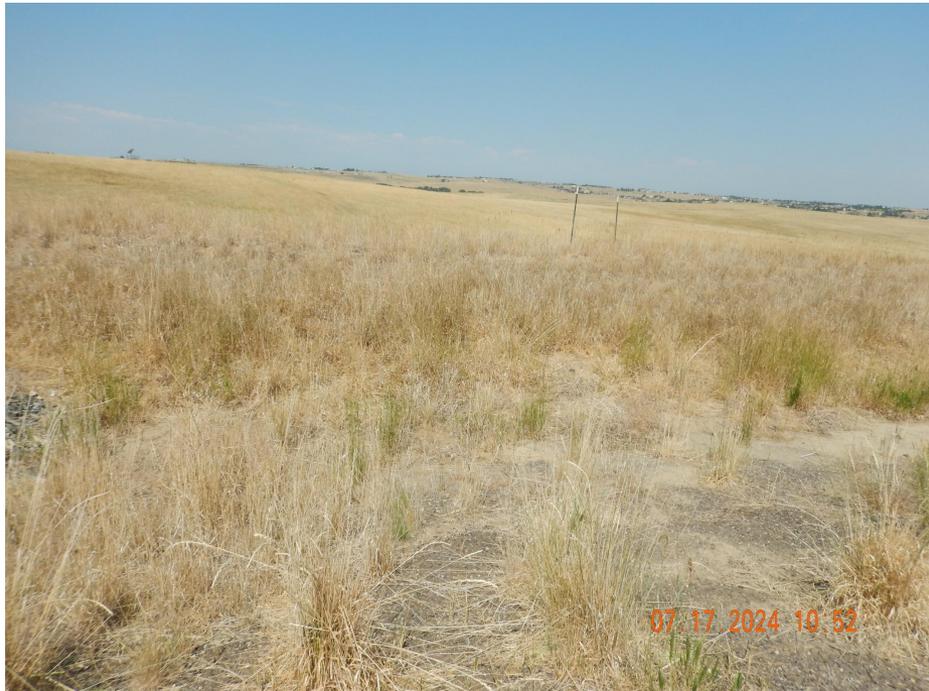
Photo 3. Photo taken along the western working pad surface, facing West. Photo illustrates the topsoil stockpile has been stabilized with an hybrid introduced/native grass mix.

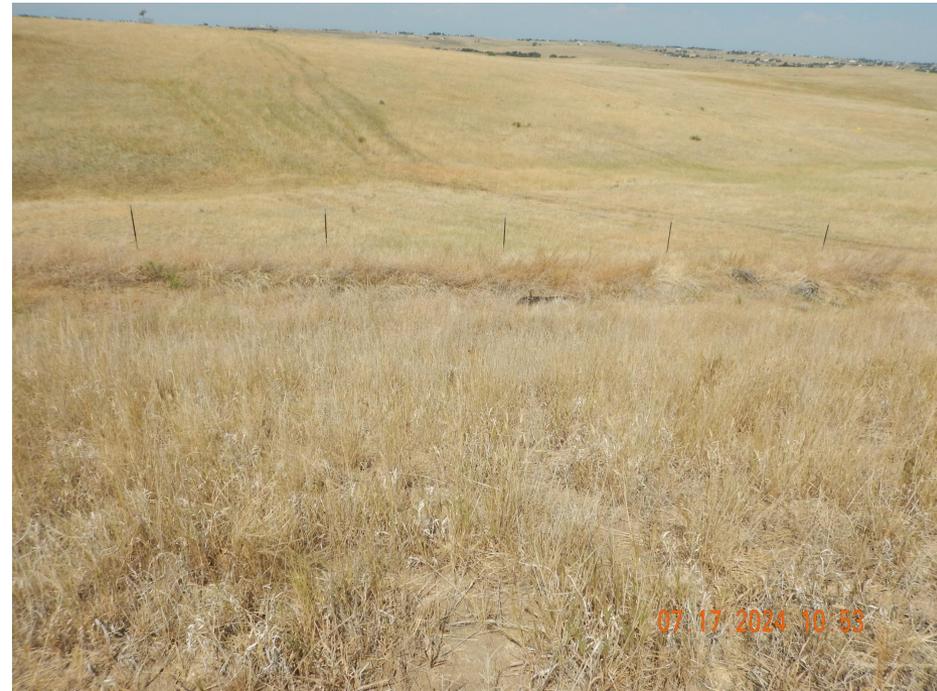
Photo 4. Photo taken along the northwestern perimeter of location, facing West. See comment under Photo 2.

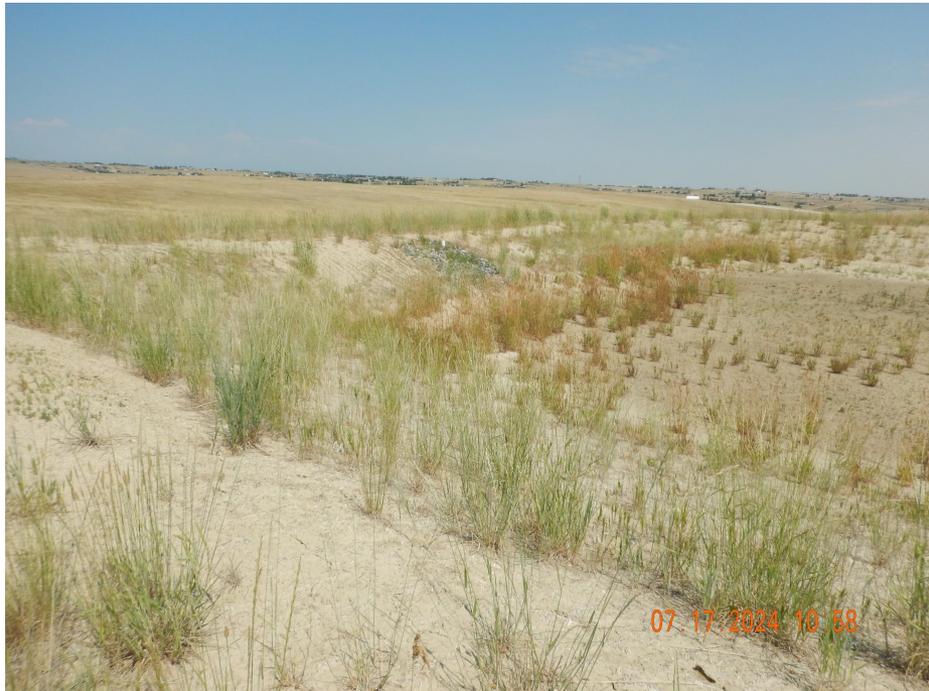
Photo 5. Photo taken along the northwestern perimeter of location, facing Northwest. Photo illustrates a retention pond with a stabilized outlet.

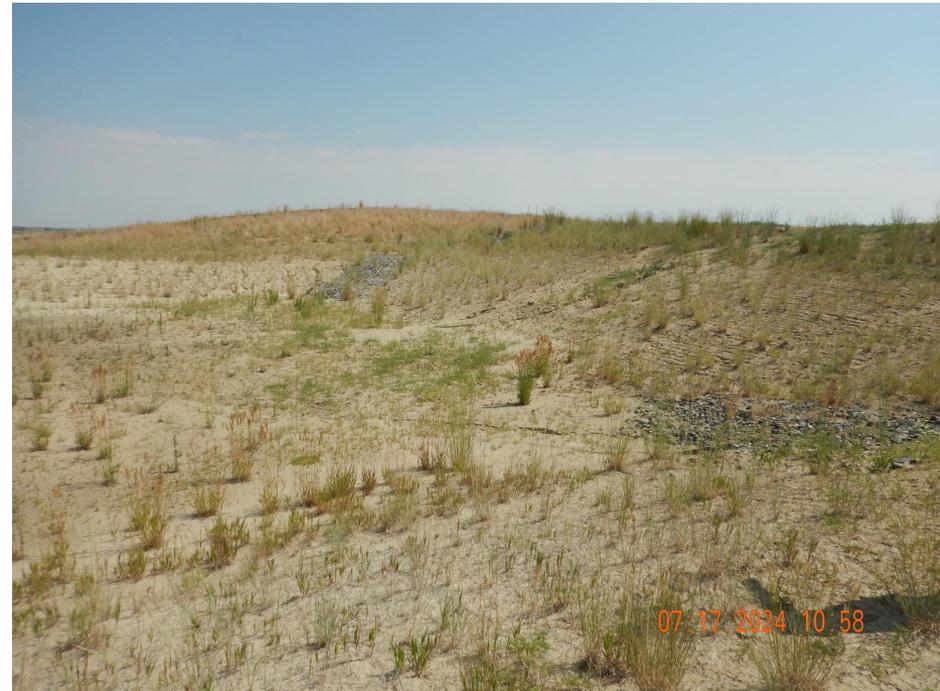
Photo 6. Photo taken along the northwestern perimeter of location, facing North. Some rill erosion was observed along the slopes of the retention pond.

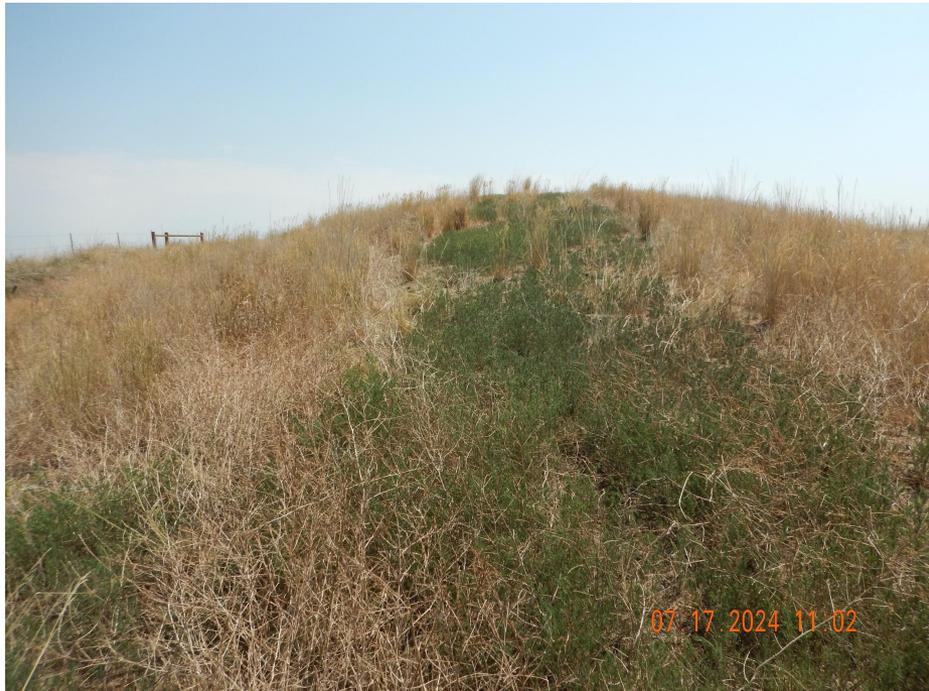
Photo 7. Photo taken along the northern perimeter of location, facing East. Photo illustrates weedy, annual vegetation establishment on the topsoil stockpile. Note- there was some establishment of desirable species on the south-facing slope.

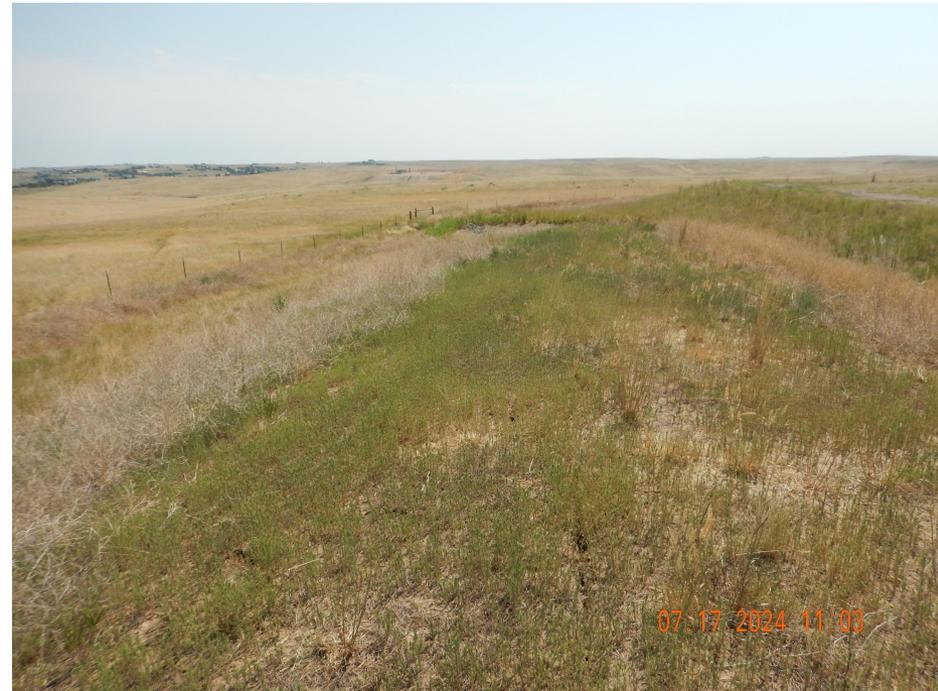
Photo 8. Photo taken along the northern perimeter of location, facing East. See comments under Photo 7.

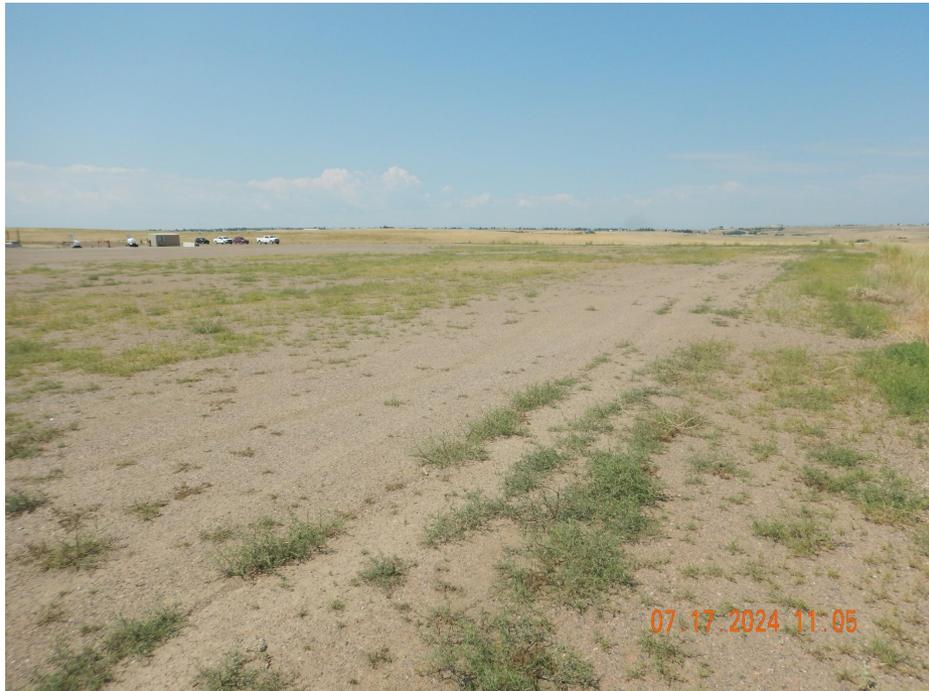
Photo 9. Photo taken along the northeastern working pad surface, facing West. Photo is an overview of the location.

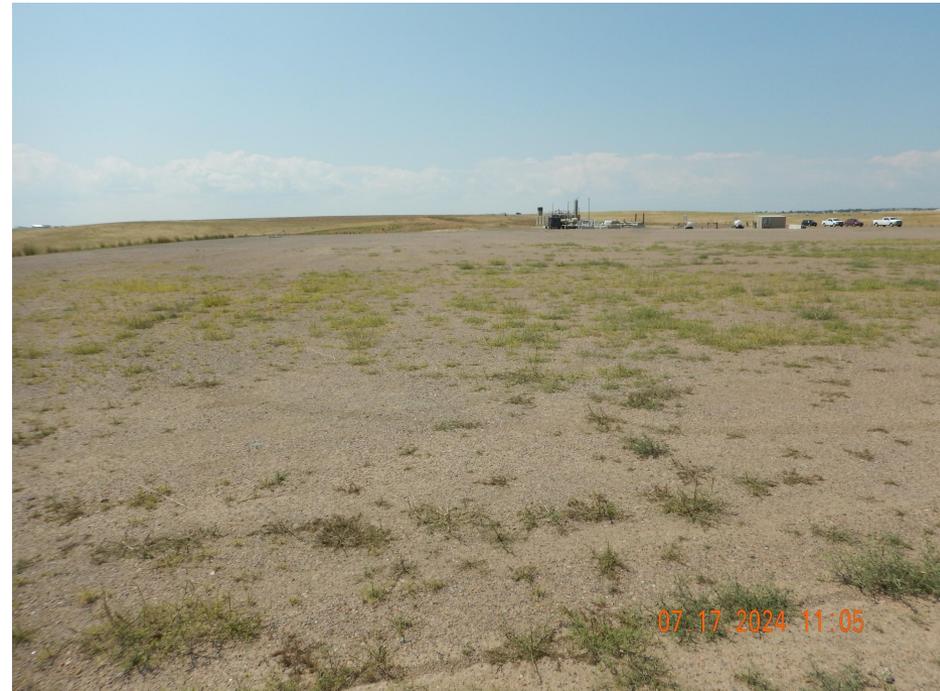
Photo 10. Photo taken along the northeastern working pad surface, facing South. See comment under Photo 9.

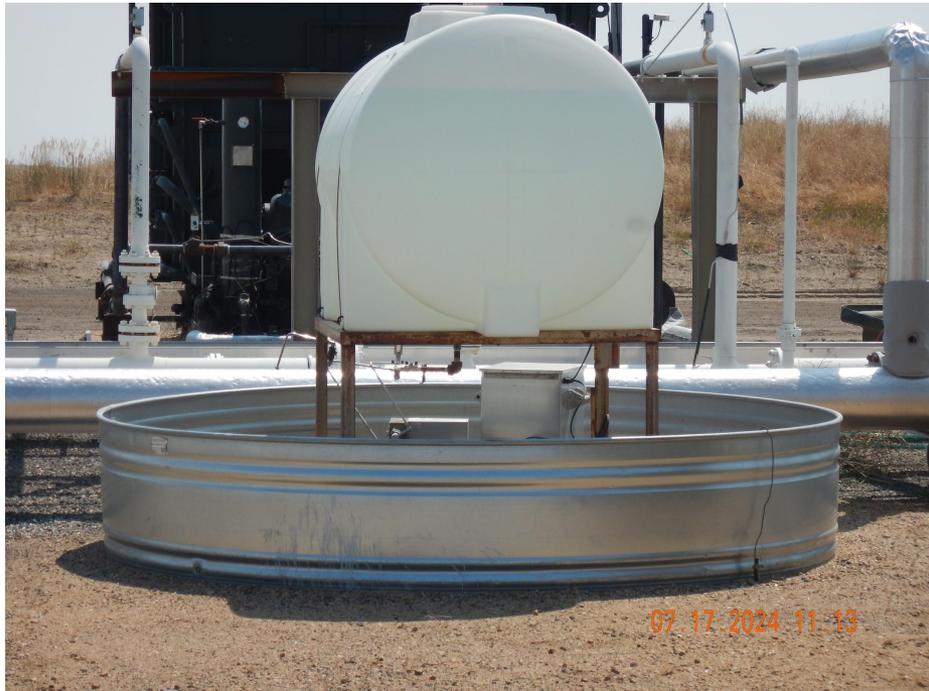
Photo 11. Photo taken along the southern production area, facing East. Photo illustrates wildlife protection devices (netting) are missing for secondary containment BMPs.

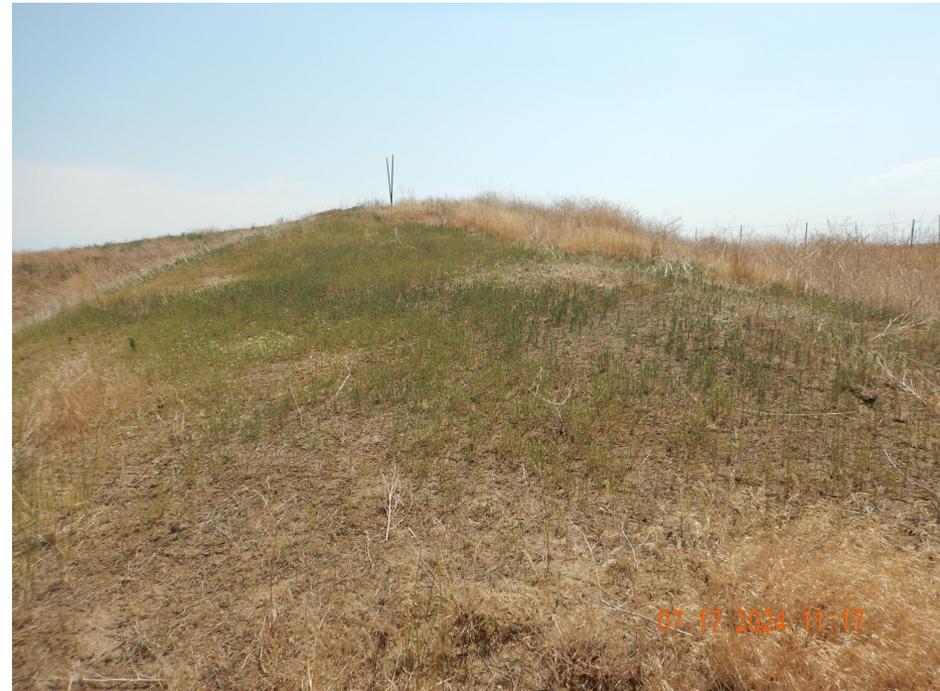
Photo 12. Photo taken along the southeastern perimeter of location, facing East. Photo illustrates the reclamation construction area is in process of vegetation establishment; however, there is a lack of desirable vegetation.

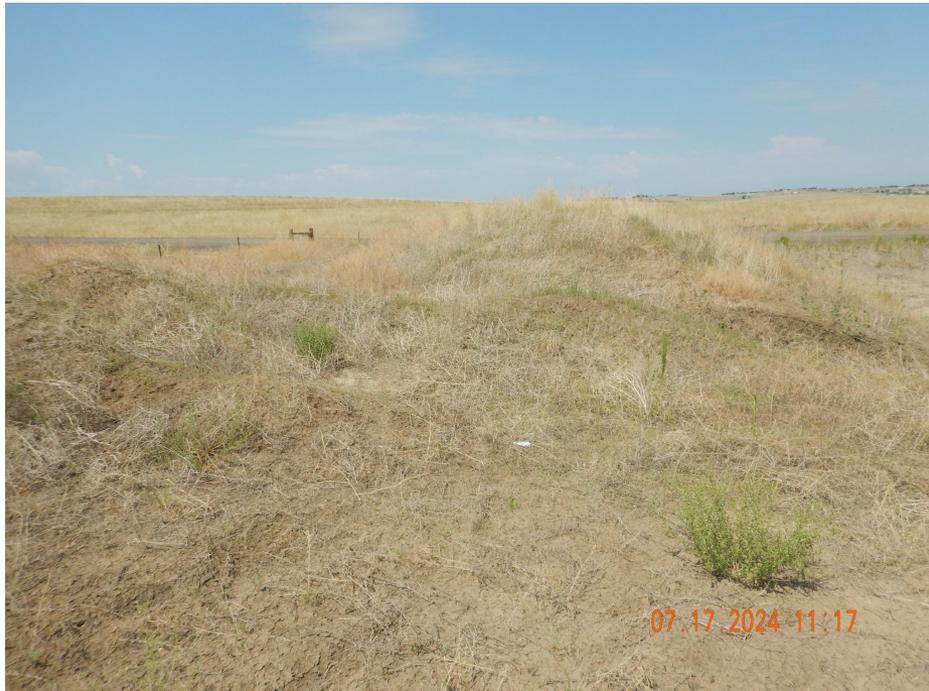
Photo 13. Photo taken along the southern perimeter of location, facing West. See comments under Photo 12.

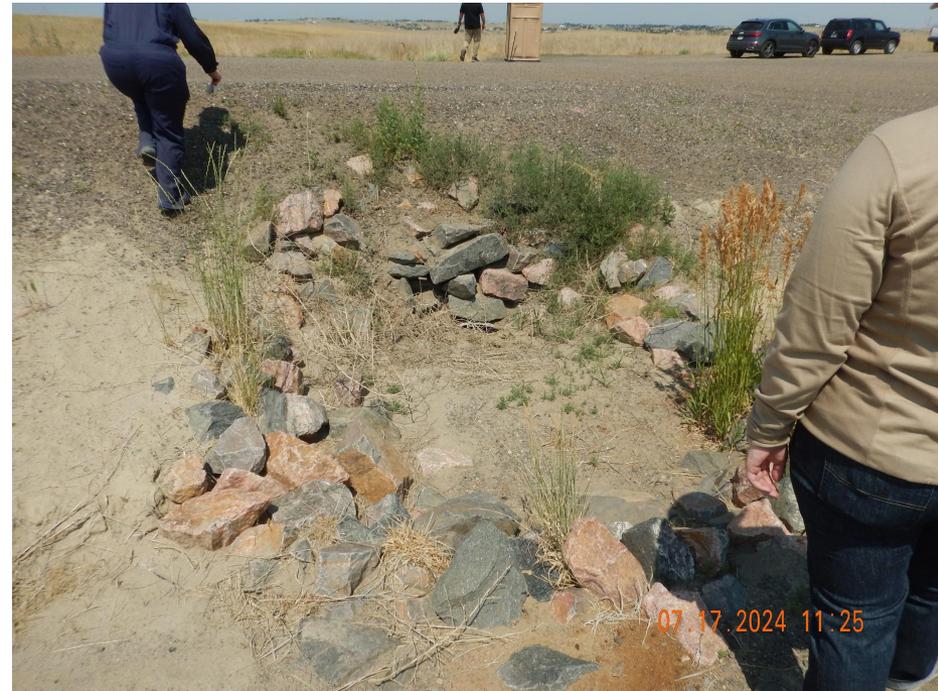
Photo 14. Photo taken along a portion of the access road west of the production facility, facing West. Photo illustrates a culvert in need of maintenance.

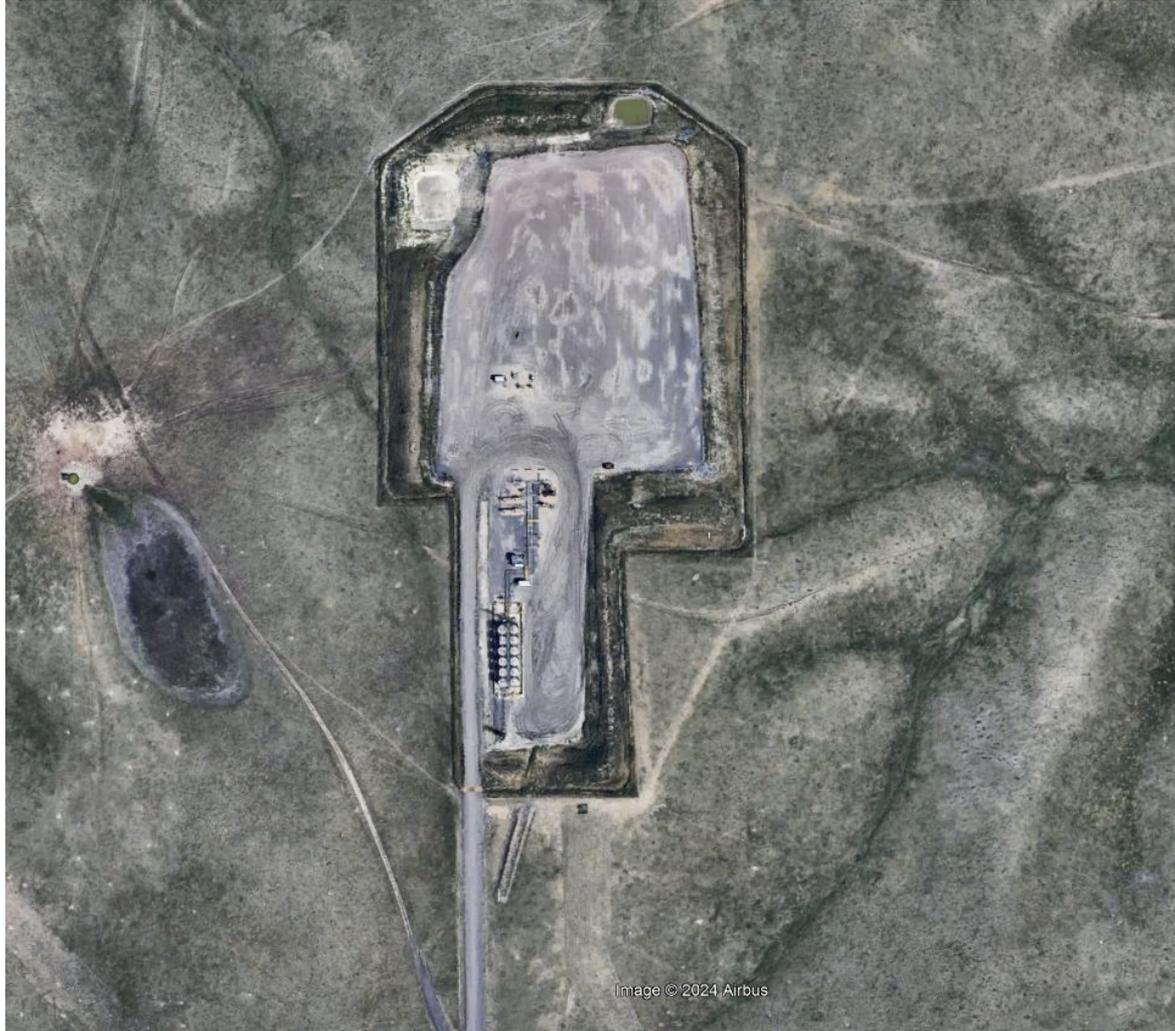
Photo 15. Google Earth aerial imagery from 9/4/2023 illustrates the location and the northern portion of the access road.
