Interim Reclamation and Stormwater Inspection

Operator: GMT EXPLORATION COMPANY LLC #10243

Location ID: 484179

Inspection Document #: 697505399

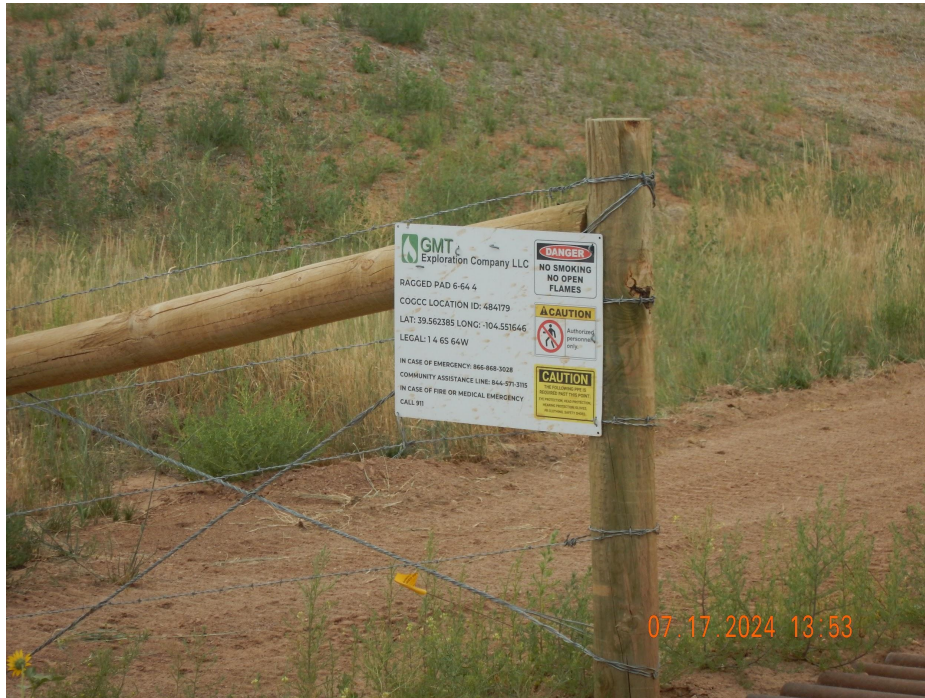
Photo 1. Photo taken from the entrance of location, illustrating the Operator sign.

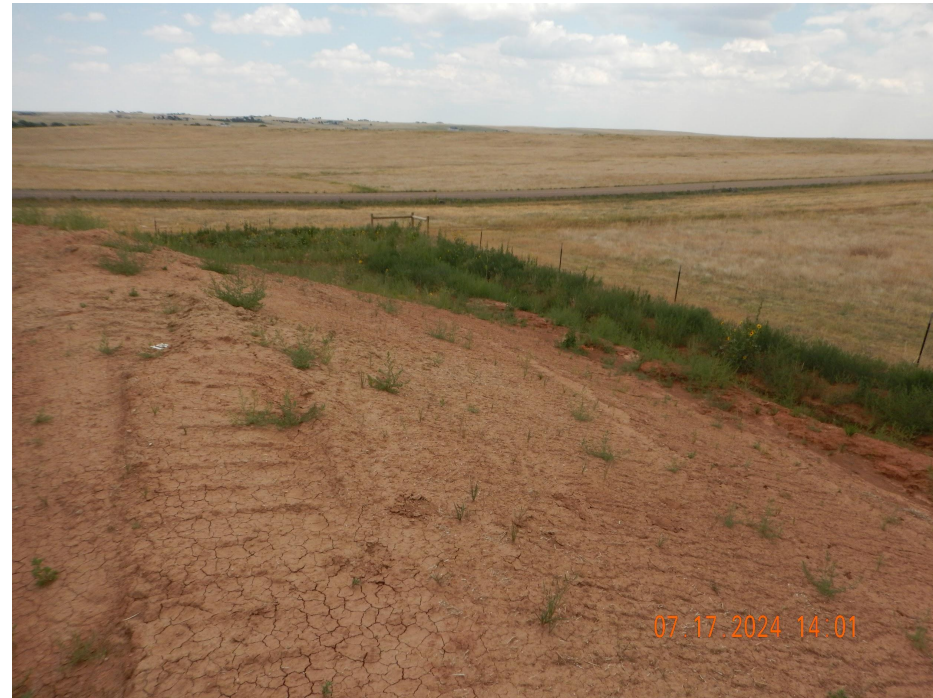
Photo 2. Photo taken along the southeastern working pad surface, facing East. Photo illustrates the reclamation construction areas appears to have been repaired from stormwater erosion. Note- tumbleweed is establishing along the perimeter of the location.

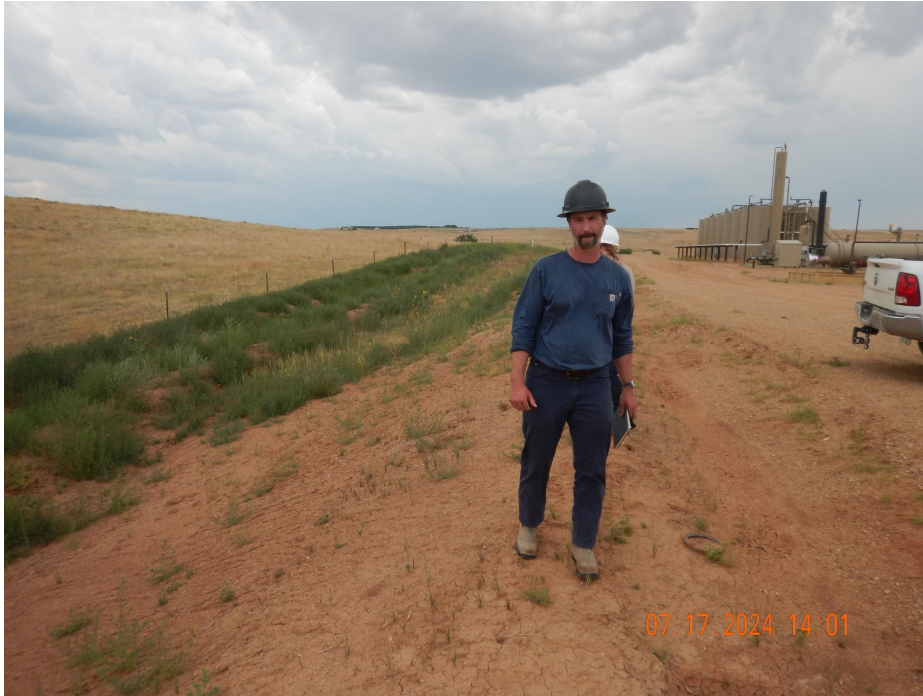
Photo 3. Photo taken along the southeastern working pad surface, facing West. See comments under Photo 2.

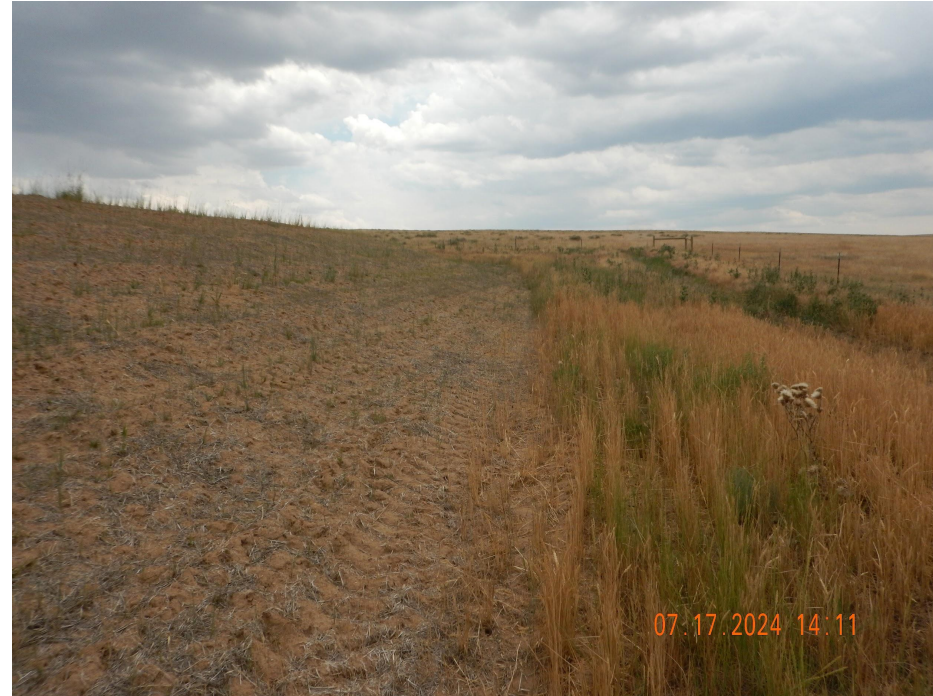
Photo 4. Photo taken along the southwestern perimeter of location, facing South. Photo illustrates the reclamation construction area is in process of vegetation establishment.

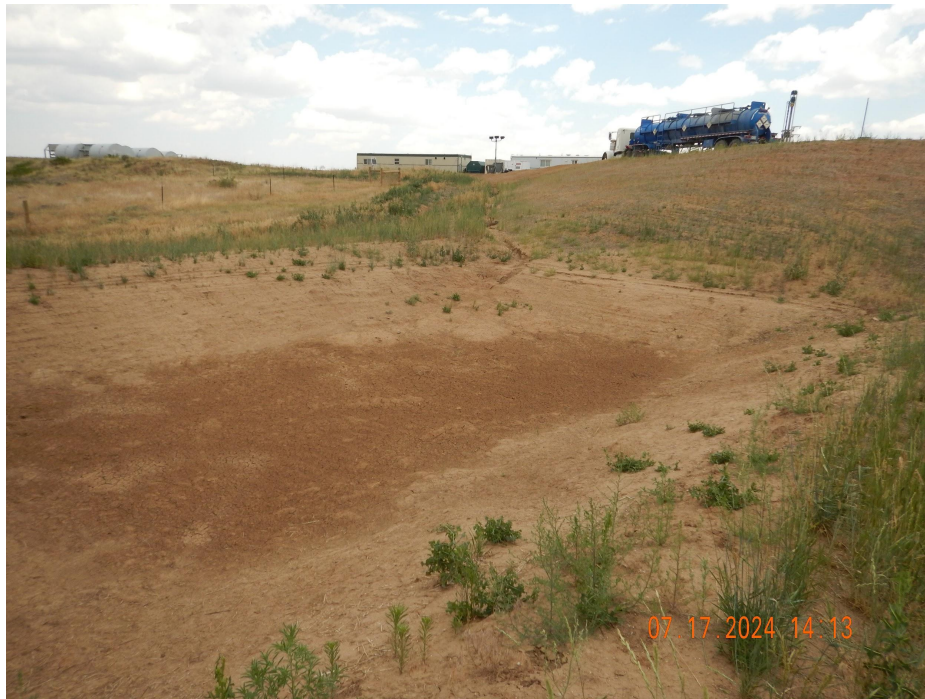
Photo 5. Photo taken along the western perimeter of location, facing Northeast. Photo illustrates some rill erosion coming into the inlet area.

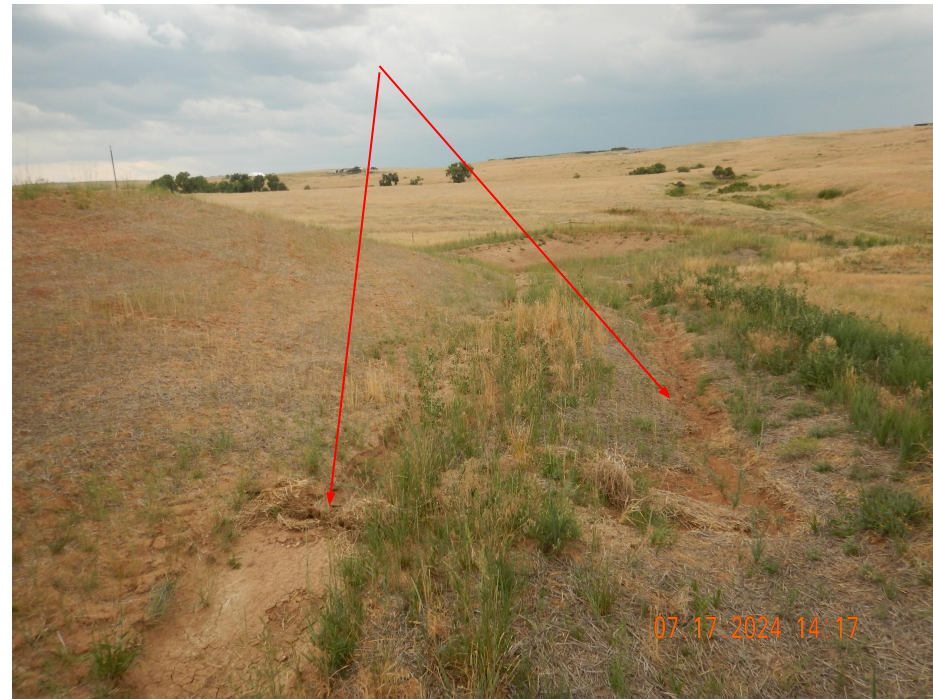
Photo 6. Photo taken along the western perimeter of location, facing West. Photo illustrates straw mulch blockage in the ditch BMP directed to the retention pond; this resulted in stormwater erosion bypassing the retention pond but mostly staying within the outer perimeter berm BMP.

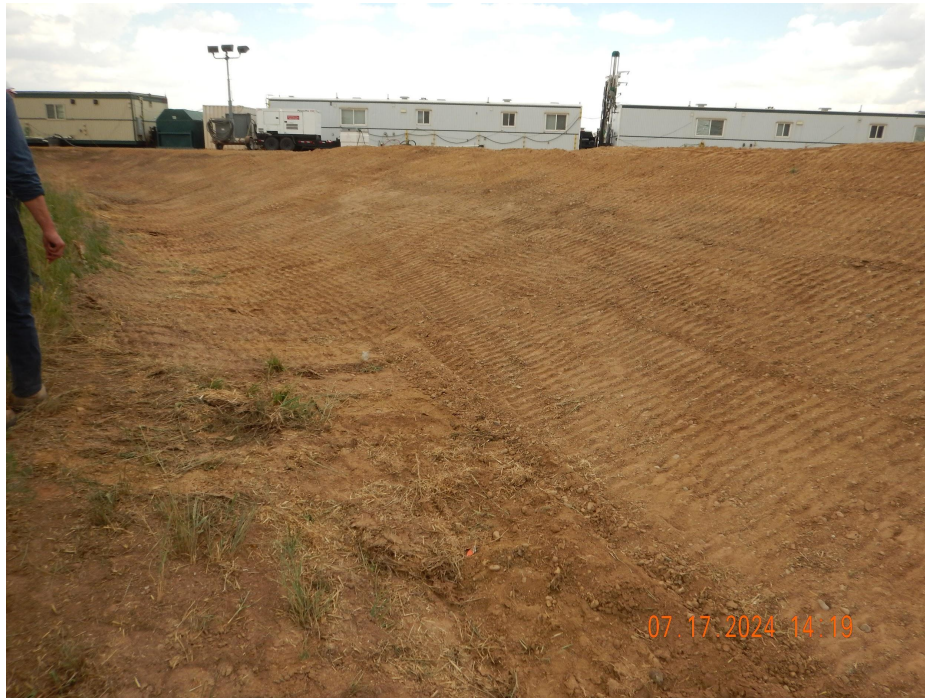
Photo 7. Photo taken along the western perimeter of location, facing East. Photo illustrates slope tracking has not been implemented properly.

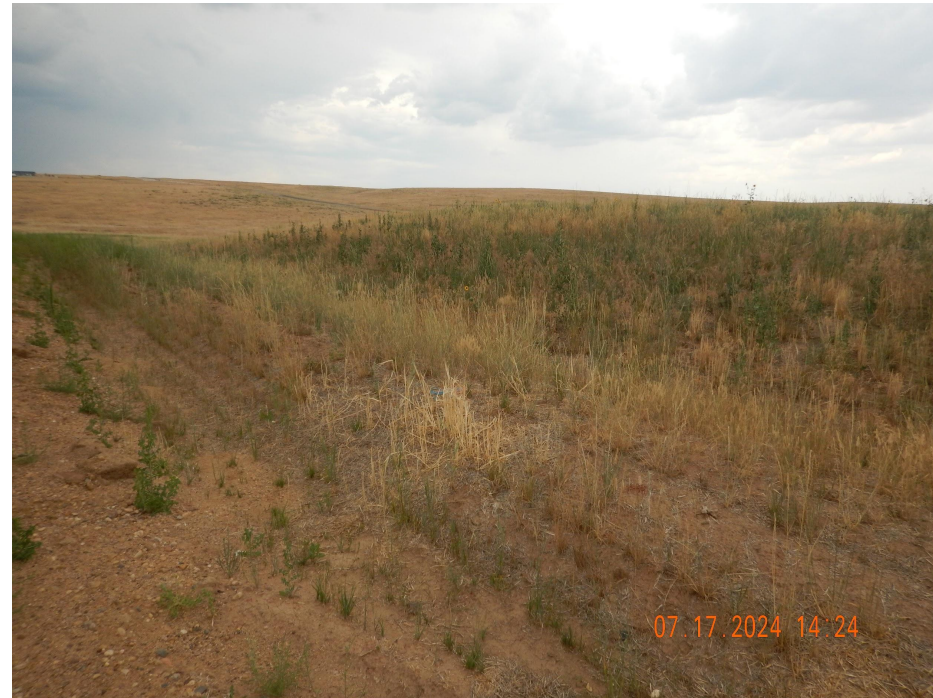
Photo 8. Photo taken along the northwestern perimeter of location, facing West. Photo illustrates the topsoil stockpile is in process of vegetation establishment.

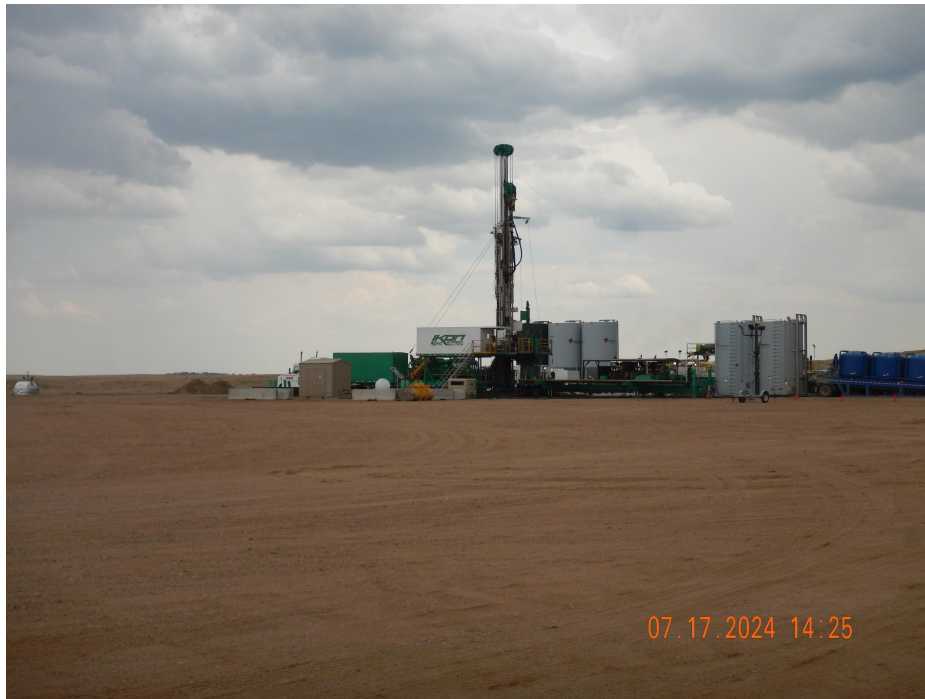
Photo 9. Photo taken along the northern working pad surface, facing South. Photo illustrates active drilling operations.

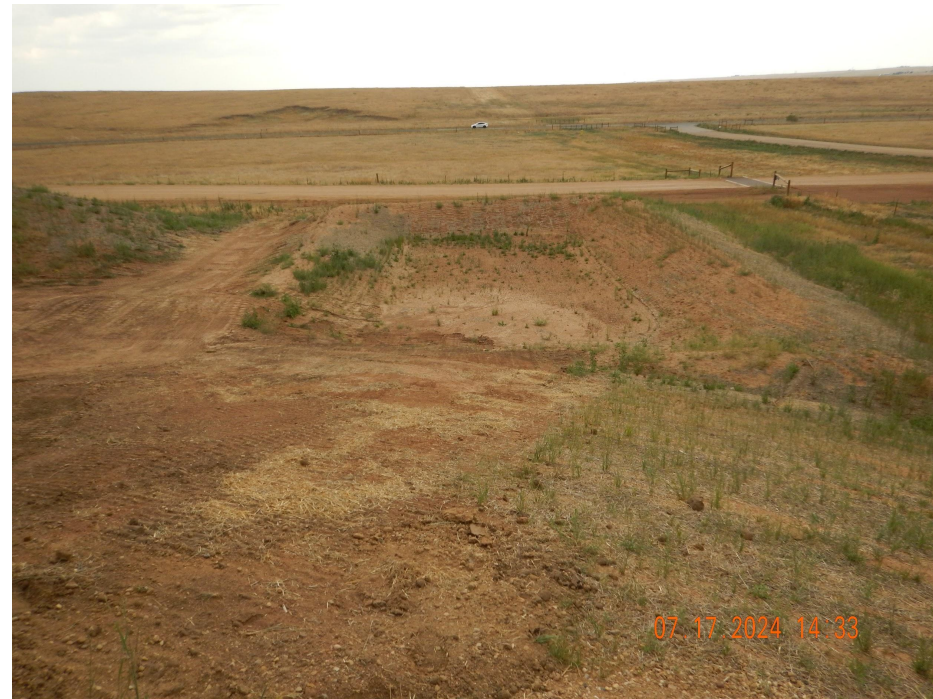
Photo 10. Photo taken along the northeastern working pad surface, facing North. Photo illustrates a retention pond and areas appears to have been repaired from stormwater erosion.

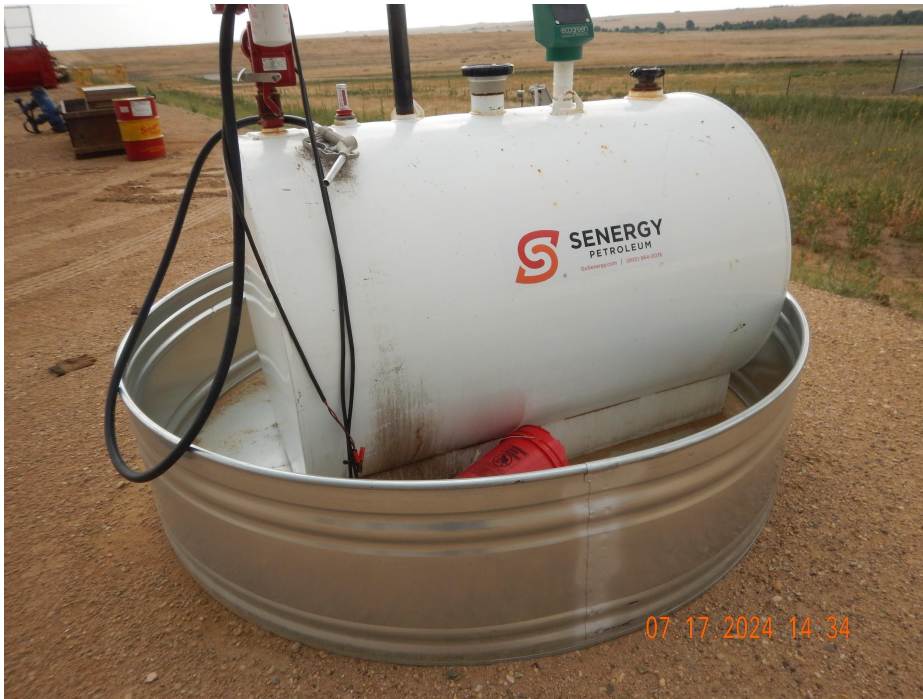
Photo 11. Photo taken along the eastern working pad surface, facing Northeast. Photo illustrates wildlife protection devices (netting) are missing for secondary containment BMPs.

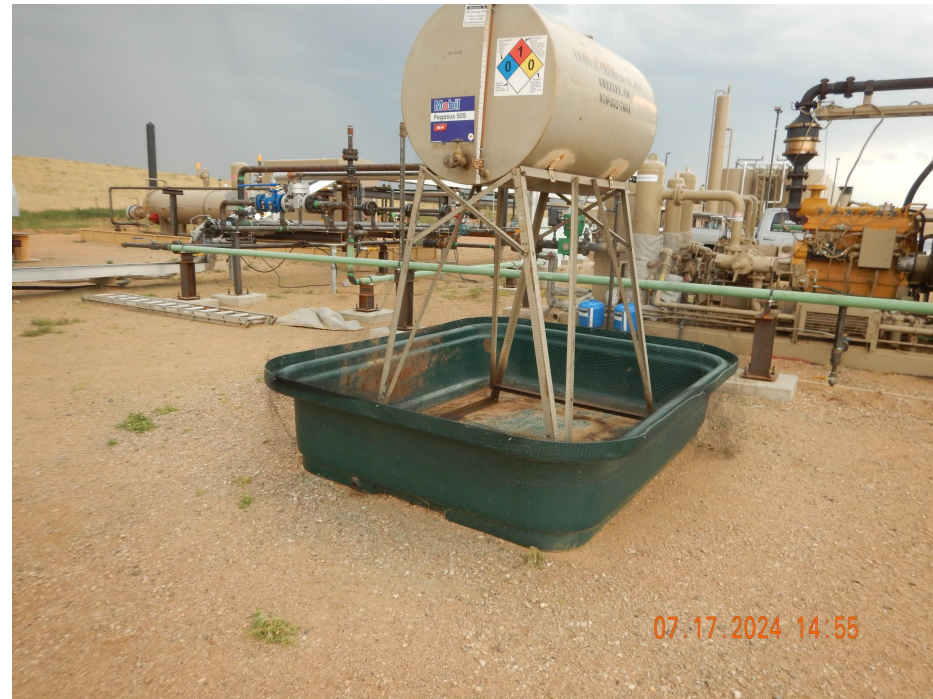
Photo 12. Photo taken along the southern production area, facing South. Photo illustrates wildlife protection devices (netting) are present for secondary containment BMPs.

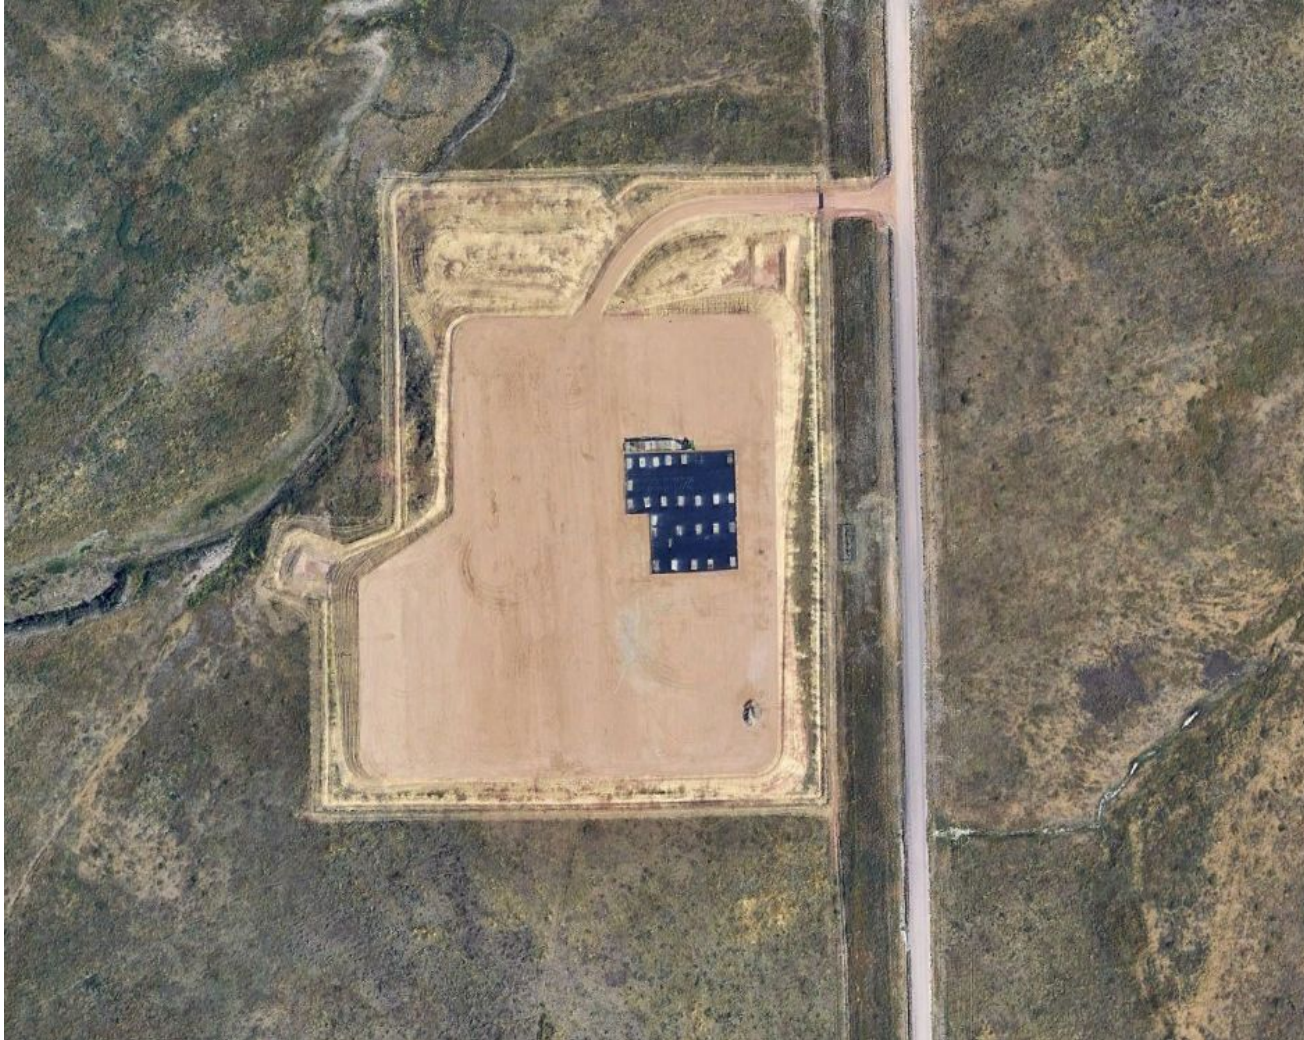
Photo 13. Google Earth aerial imagery from 9/4/2023 illustrates the location and access road.
