Inspection Photos

Location Name: TEP ROCKY MOUNTAIN LLC RWF 342-33 Pad

Location ID: 311599

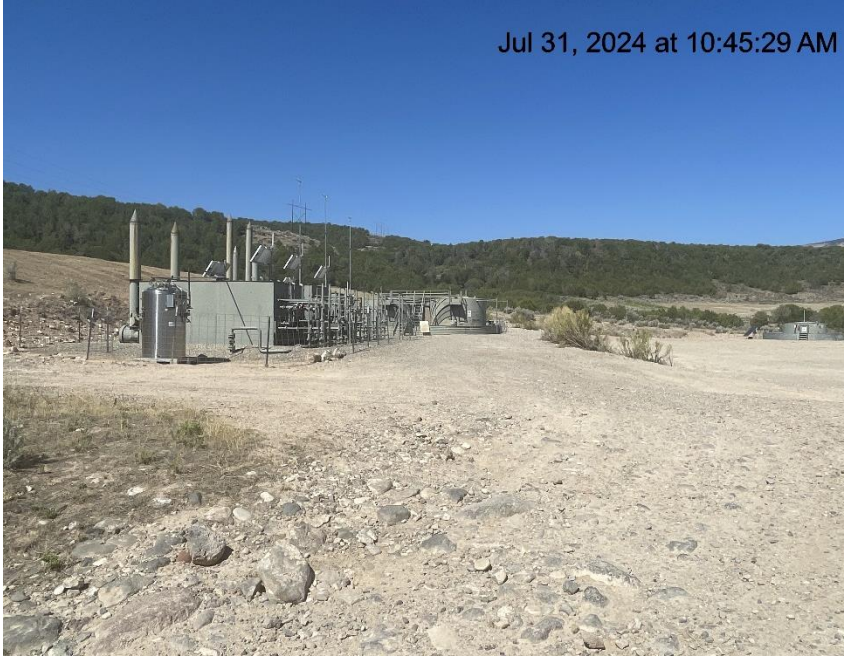
Photo # 4115 From entrance to location

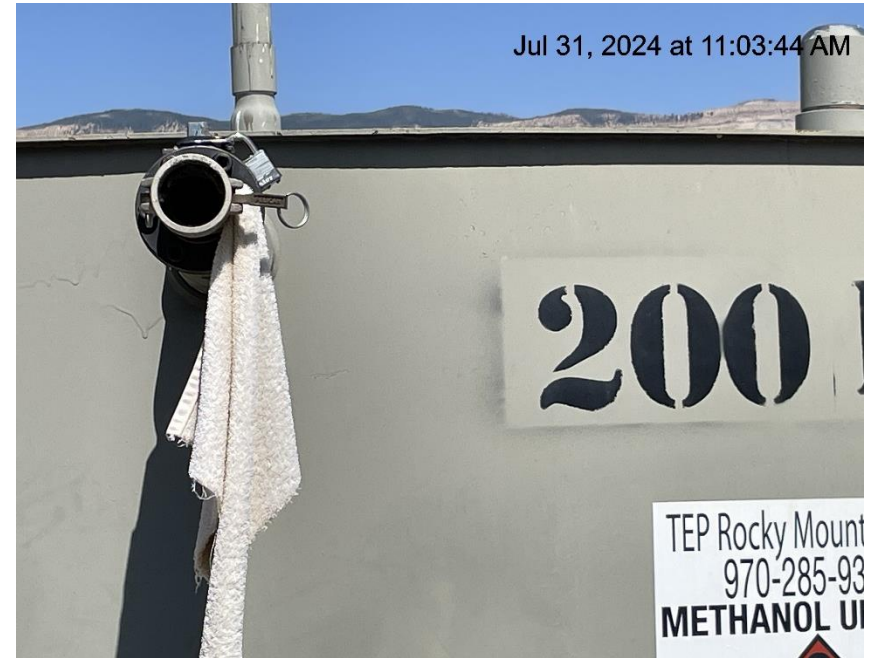
Photo # 4128 Open ended load line

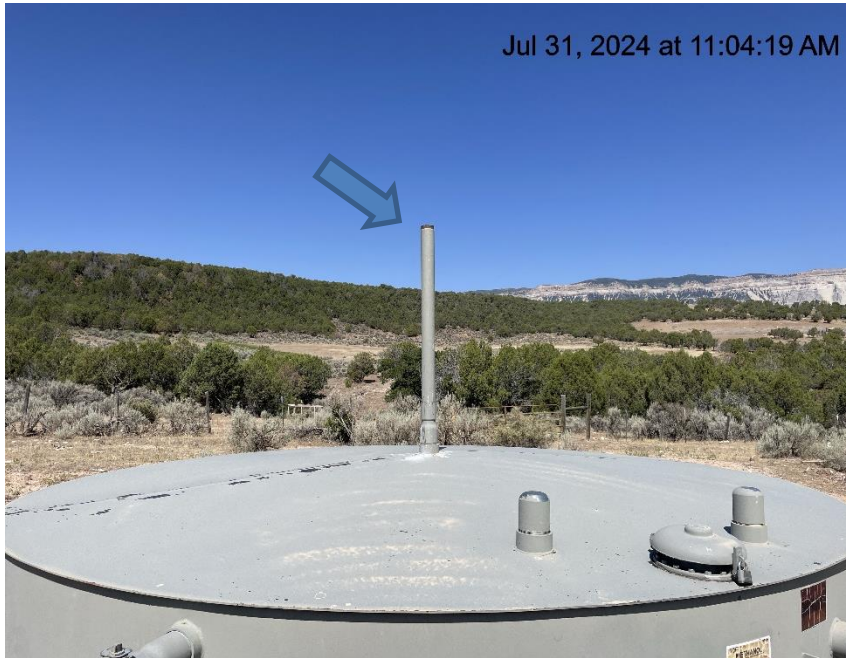
Photo # 4129 Open ended piping on methanol tank/wildlife hazard

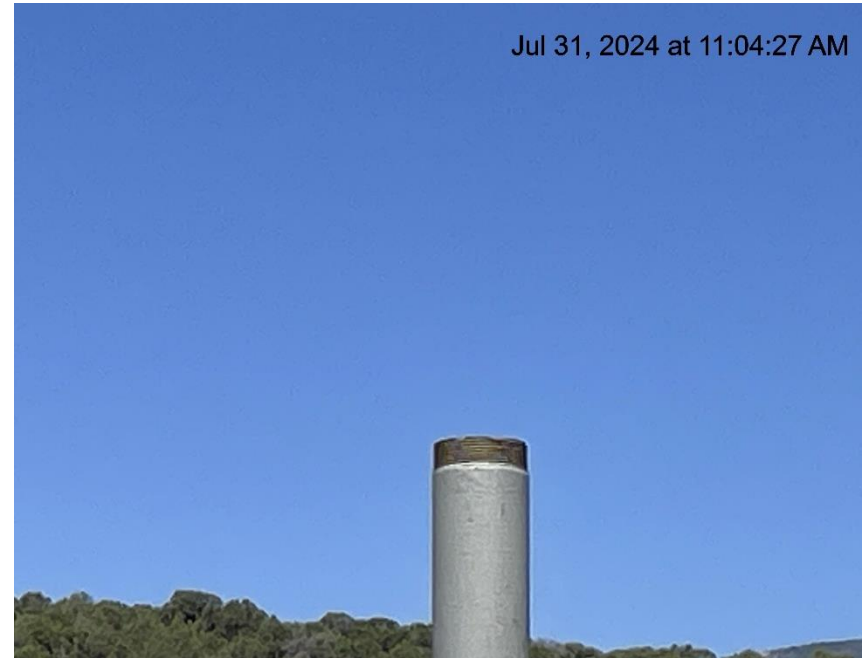
Photo # 4130 Open ended piping on methanol tank/wildlife hazard

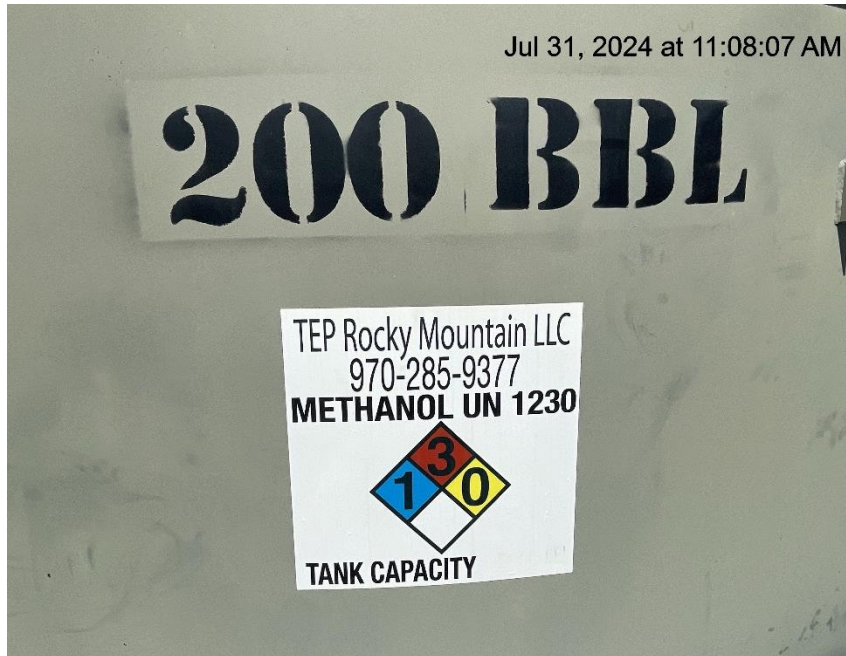
Photo # 4131 Incorrect capacity on methanol tank

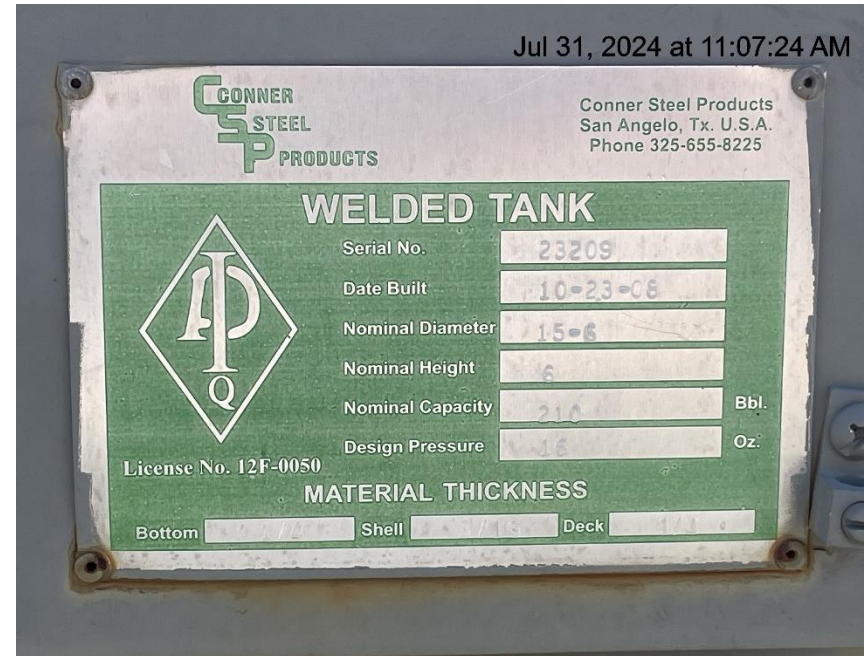
Photo # 4132 Correct tank capacity

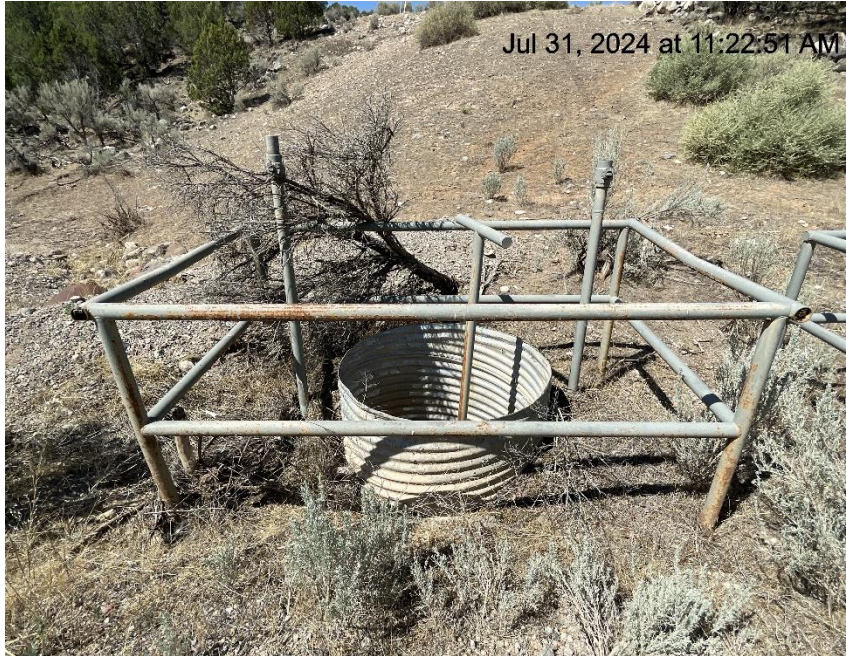
Photo # 4133 Cellar lacks cover/open to entry by wildlife /wildlife hazard (on lease road approximately 75 yards from entrance to location)

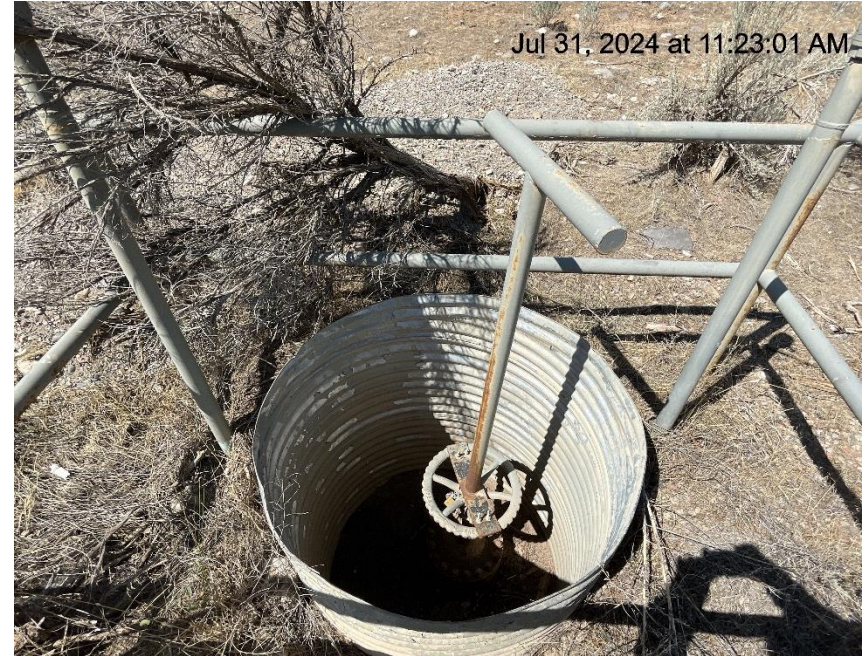
Photo # 4134 Cellar lacks cover/open to entry by wildlife /wildlife hazard (on lease road approximately 75 yards from entrance to location)
