Final Reclamation and Stormwater Inspection

Operator: PDC Energy Inc - 69175

Location ID: 323503

Inspection Document #: 713900821

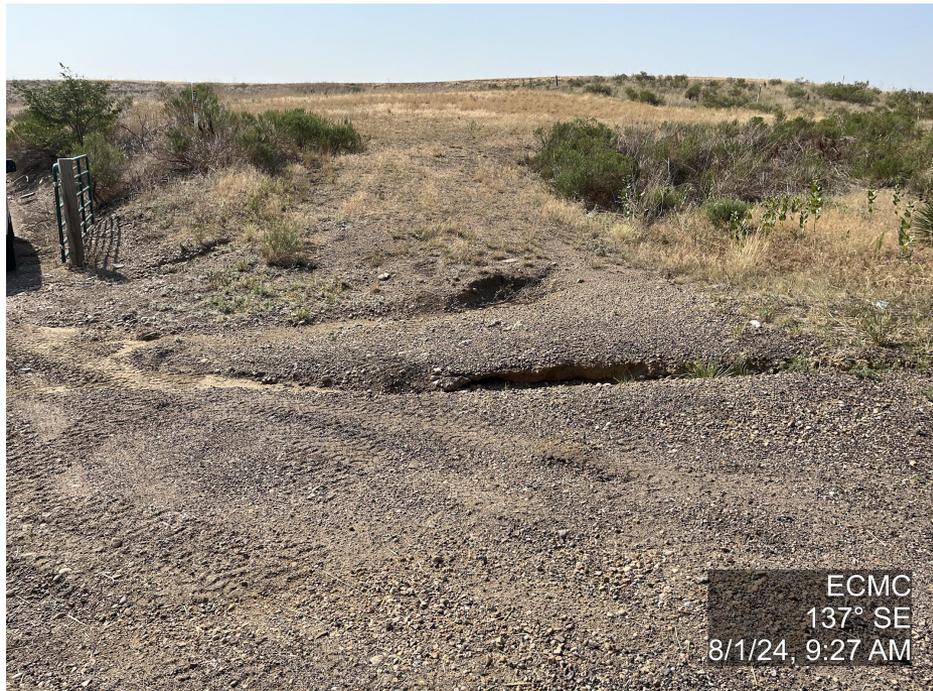
Photo 1. The photo was taken at the entrance to the tank battery location facing Southeast. The photo illustrates erosion at the entrance to the tank battery.

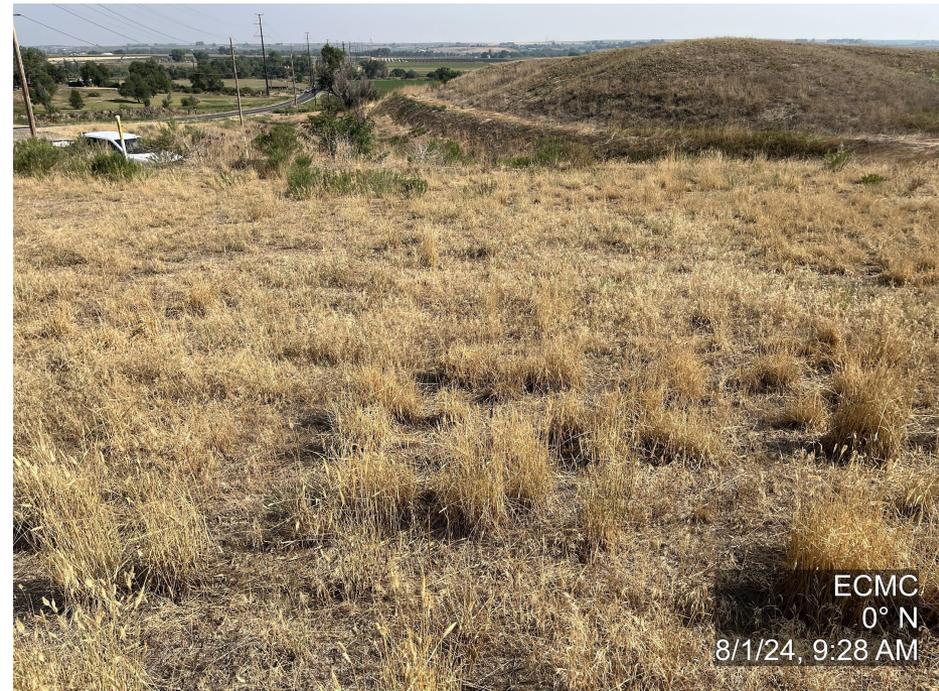
Photo 2. The photo was taken at the tank battery location facing North. The photo illustrates the tank battery is dominated with crested wheatgrass and cheatgrass. However, there were some perennial grasses were observed germinating.

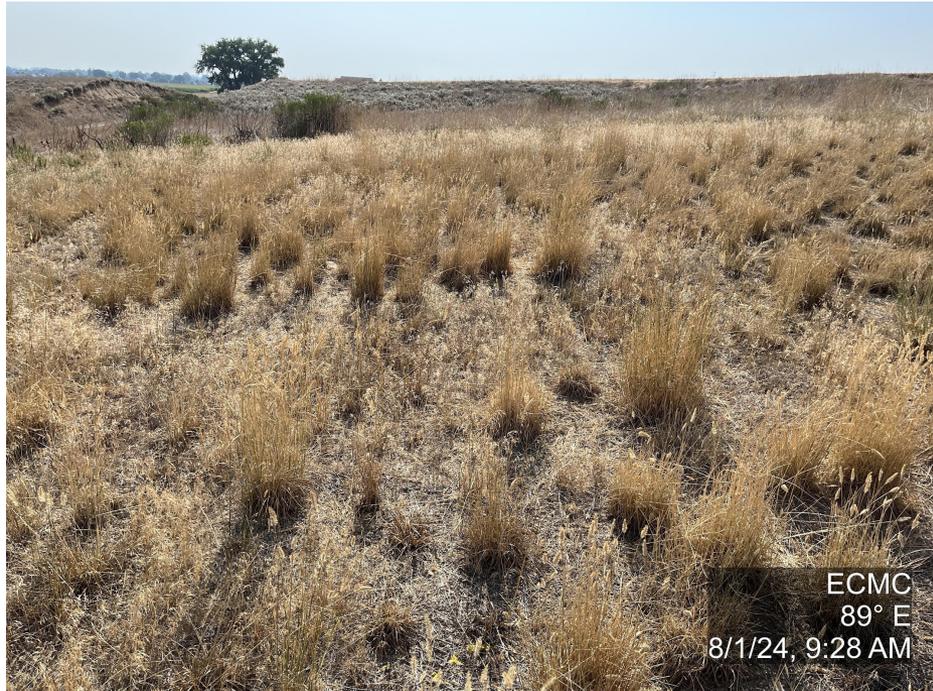
Photo 3. The photo was taken at the tank battery location facing East. Refer to the comment for photo 2.

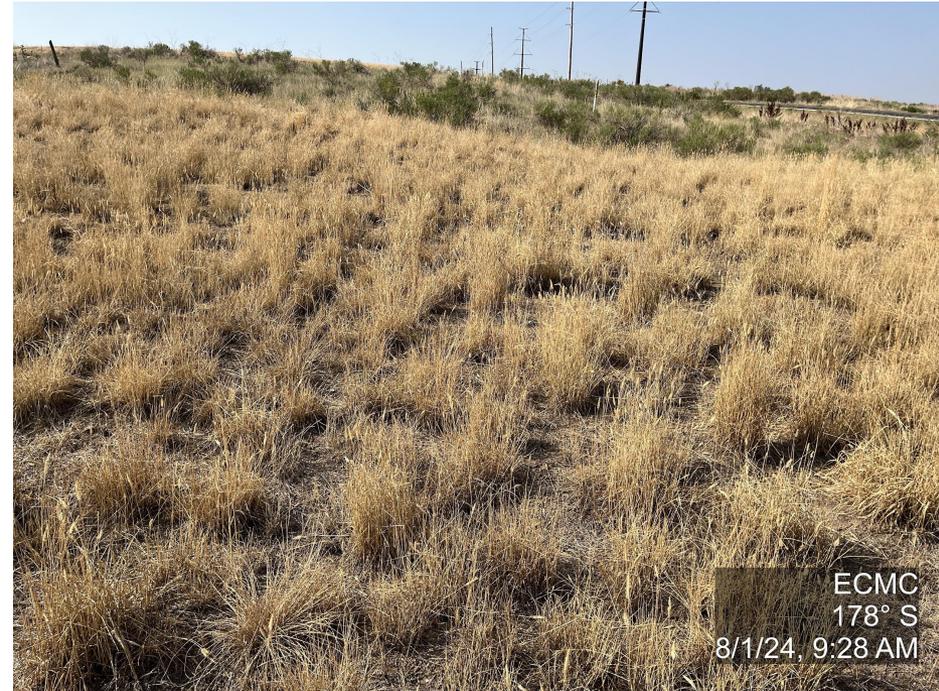
Photo 4. The photo was taken at the tank battery location facing South. Refer to the comment for photo 2.

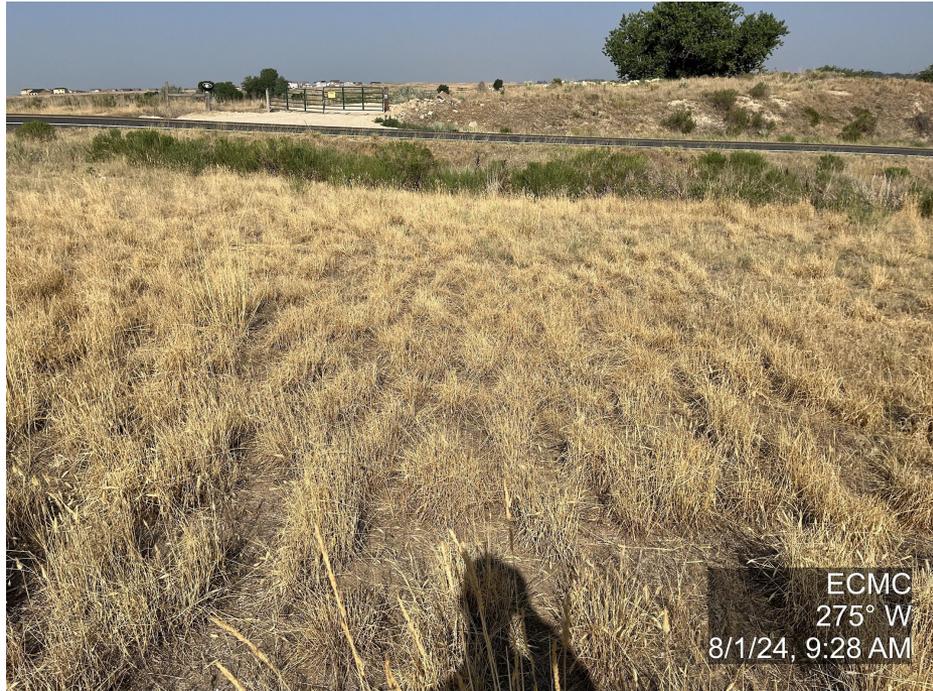
Photo 5. The photo was taken at the tank battery location facing West. Refer to the comment for photo 2.

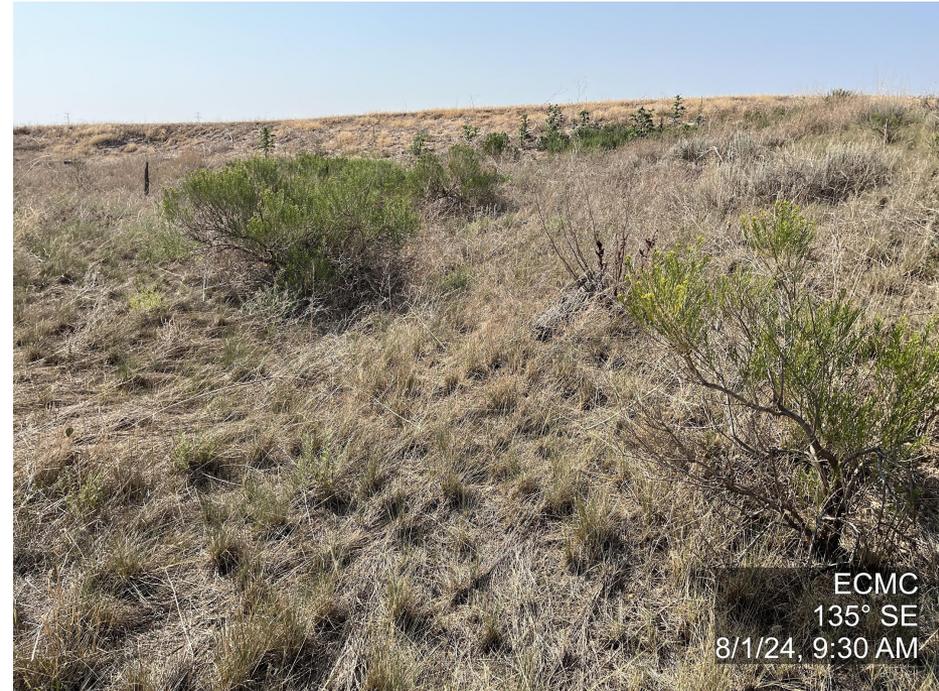
Photo 6. The reference photo was taken near the tank battery location facing Southeast. Reference areas were dominated by sandberg bluegrass, rabbitbrush and yucca.

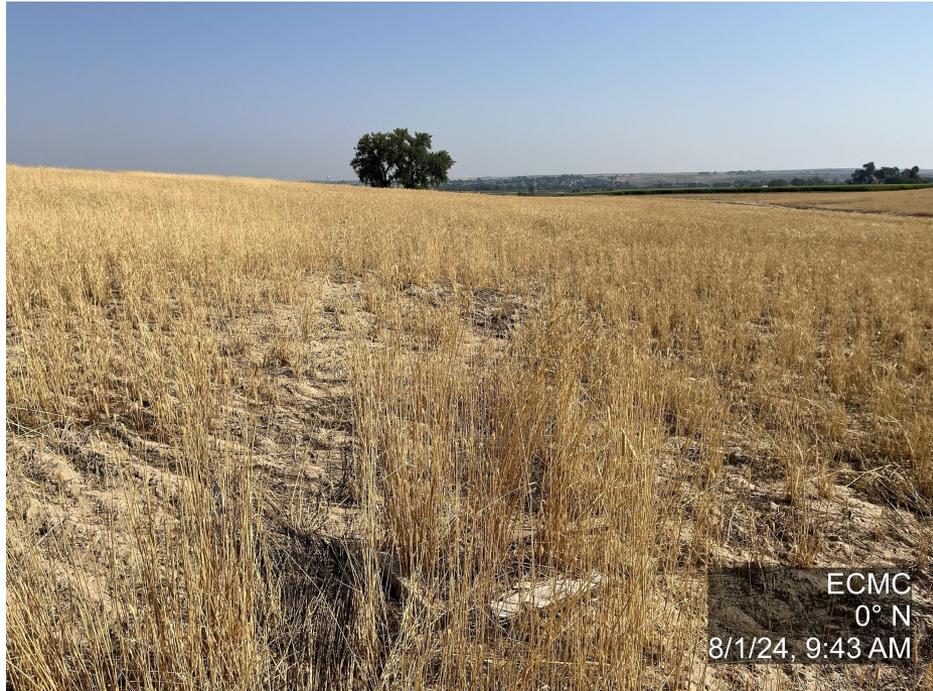
Photo 7. The photo was taken at the well location facing North. The photo illustrates some growth of wheat with large areas bare soil and cereal rye throughout.

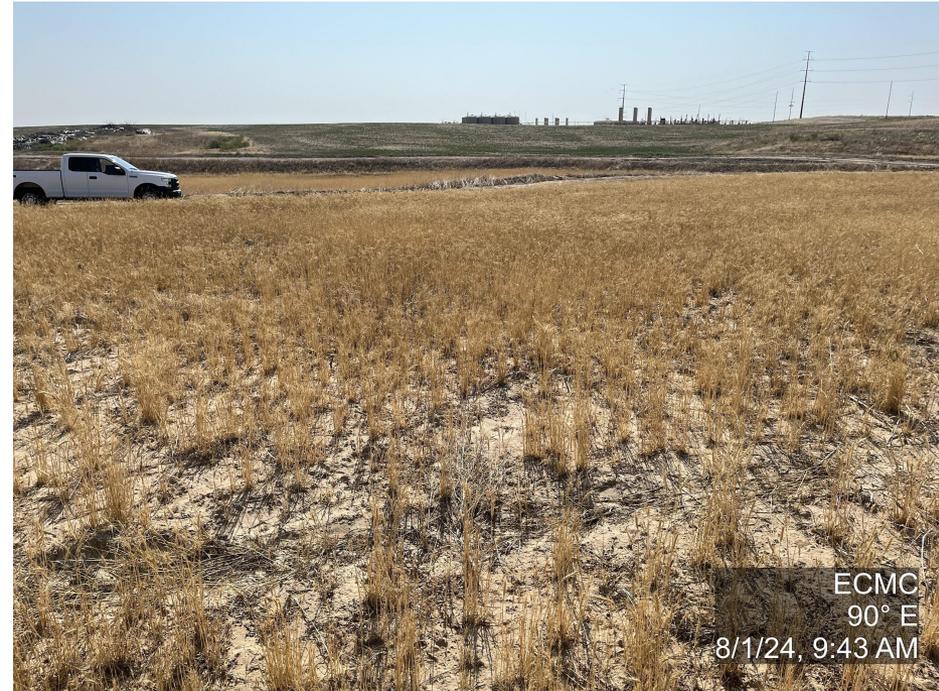
Photo 8. The photo was taken at the well location facing East. Refer to the comment for photo 7.

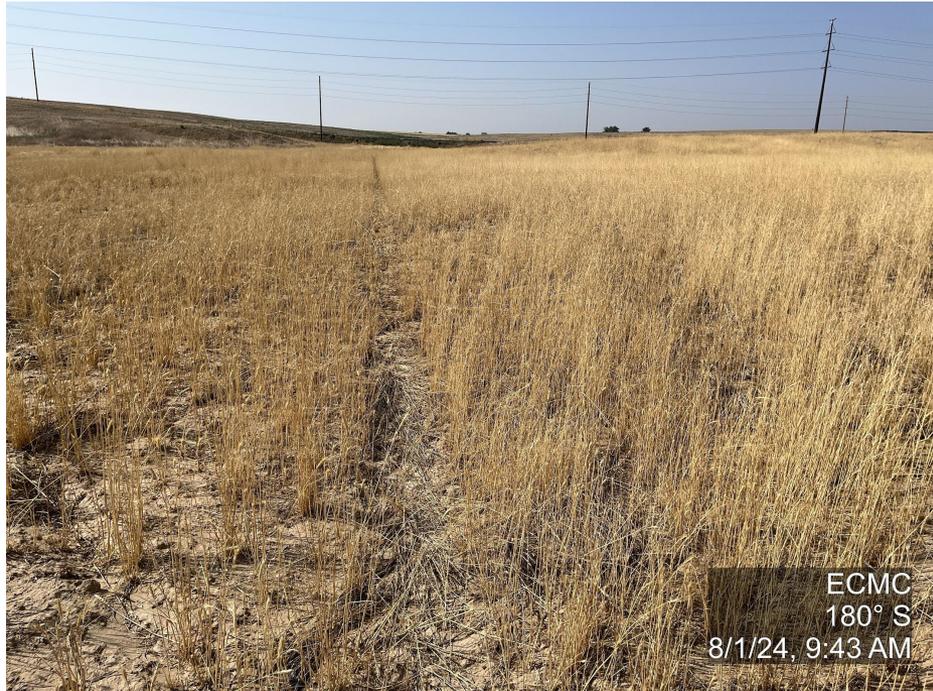
Photo 9. The photo was taken at the well location facing South. Refer to the comment for photo 7.

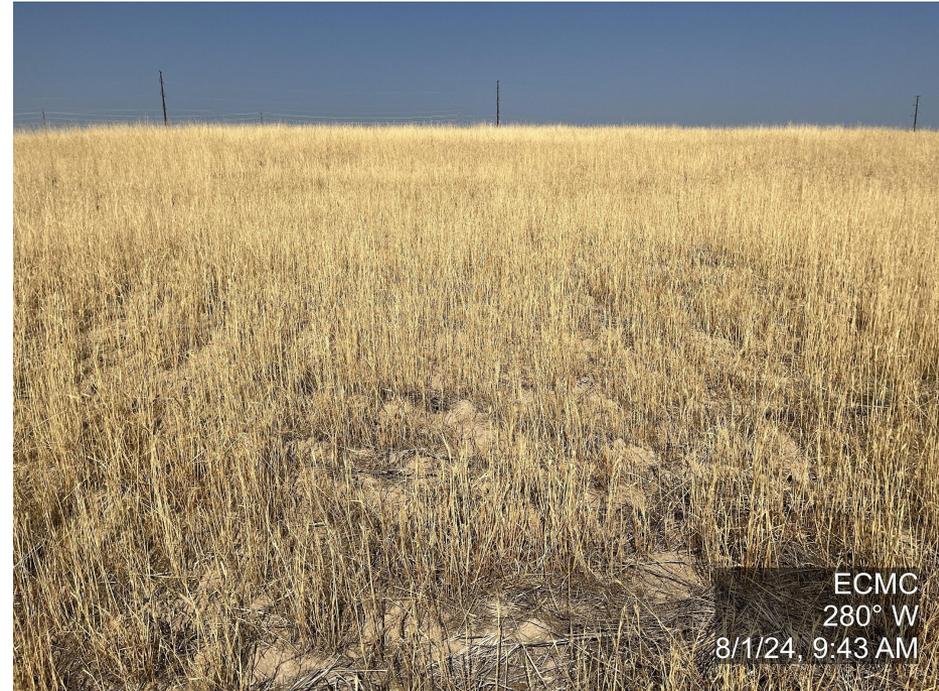
Photo 10. The photo was taken at the well location facing West. Refer to the comment for photo 7.

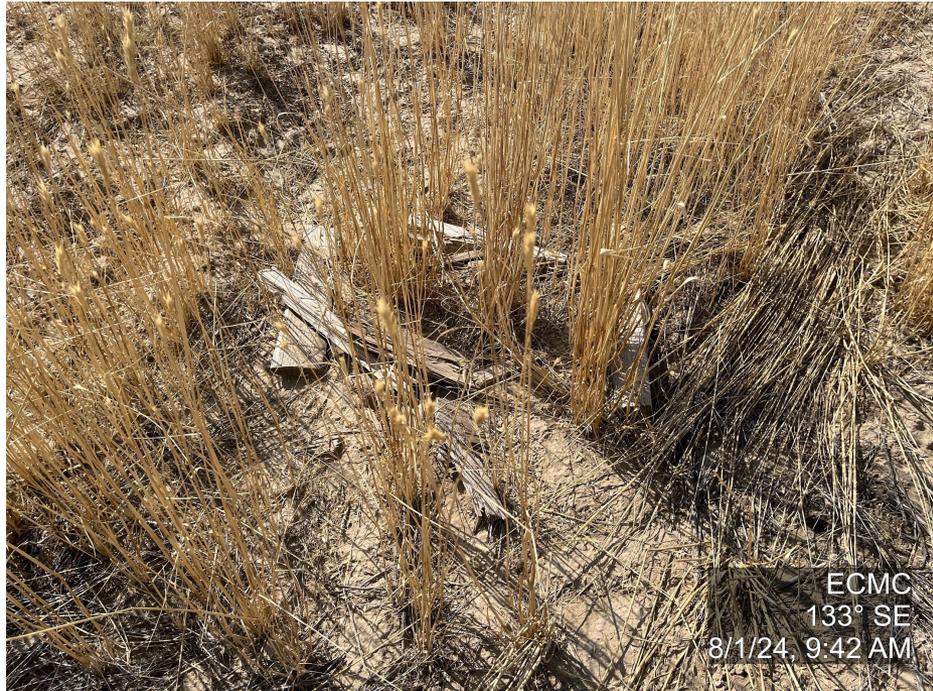
Photo 11. The photo was taken at the well location facing Southeast. The photo illustrates a frame of wood that appears to be located at the former wellhead.

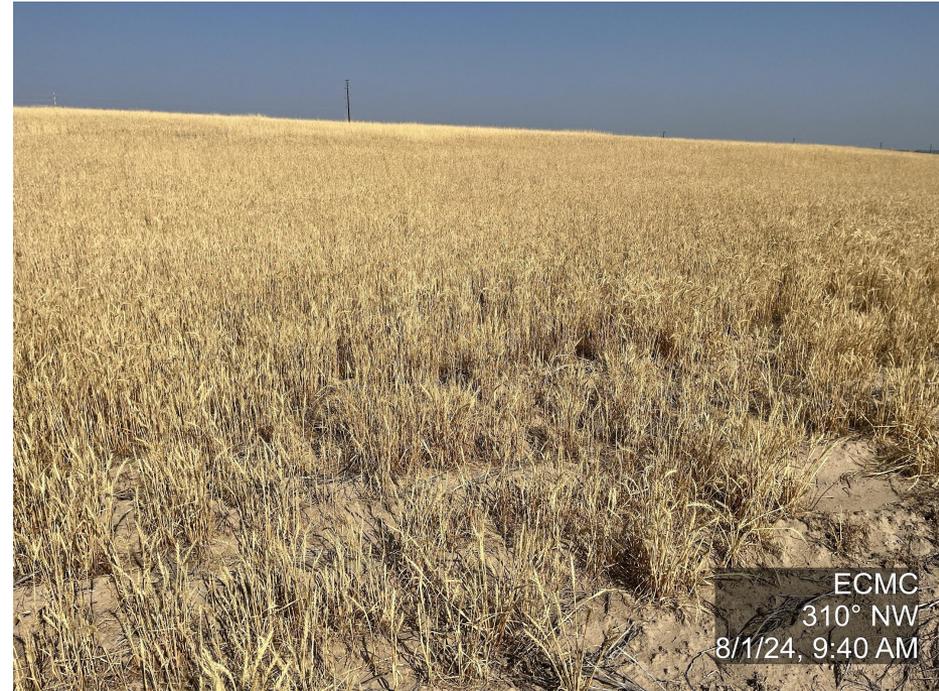
Photo 12. The reference photo was taken at the well location facing Northwest. The photo illustrates reference areas are dominated with wheat.
