Well Site Inspection

Operator: KP KAUFFMAN COMPANY INC - 46290

Location ID: 333124

Inspection Photos
Location Name: Nessu-Kinder 16
Location ID: 333124

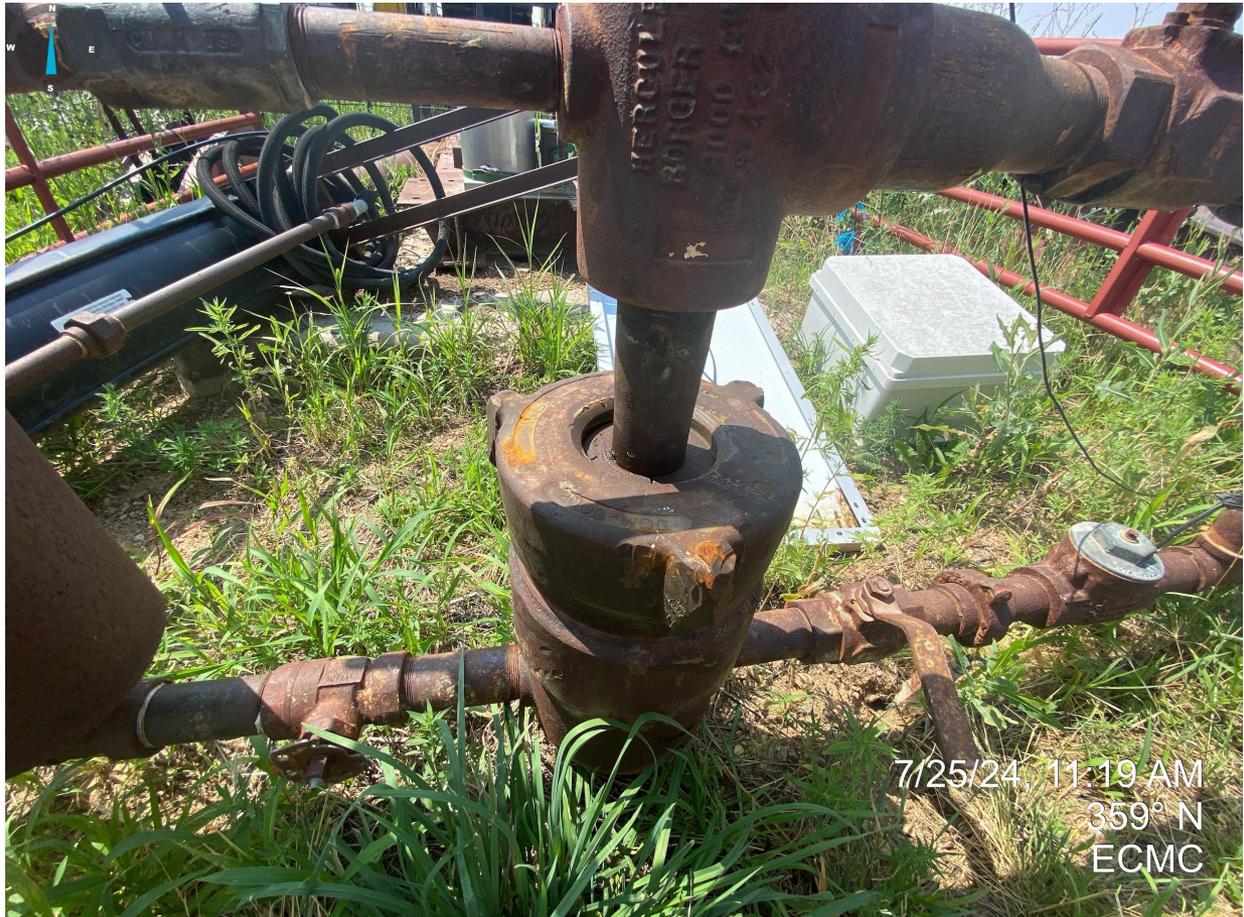
Photo 1. Wellhead casing appears to have been repaired; no visible or auditory indications of venting equipment observed at the time of this inspection.

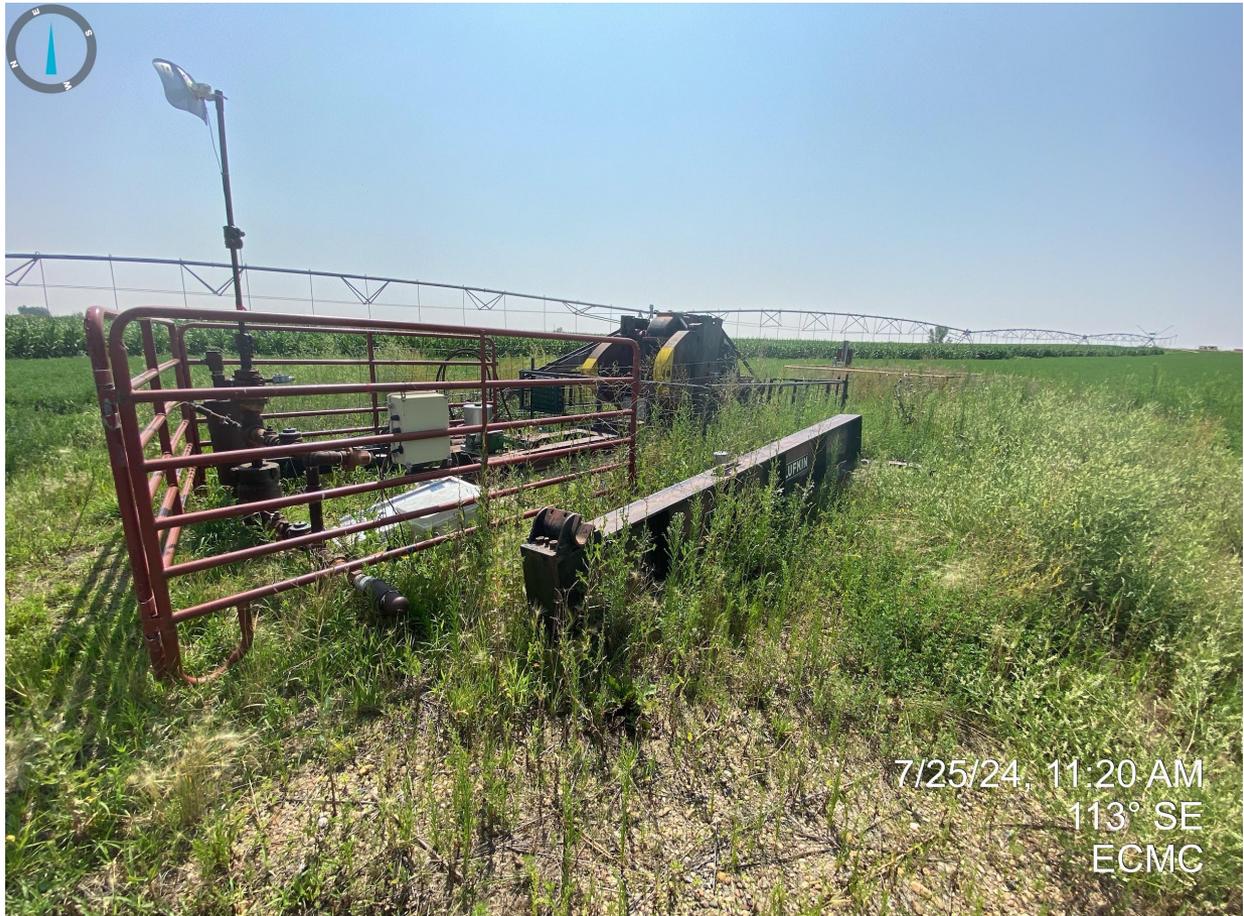
Photo 2. Pump jack is disassembled and unused equipment needs to be removed from the location or returned to service.

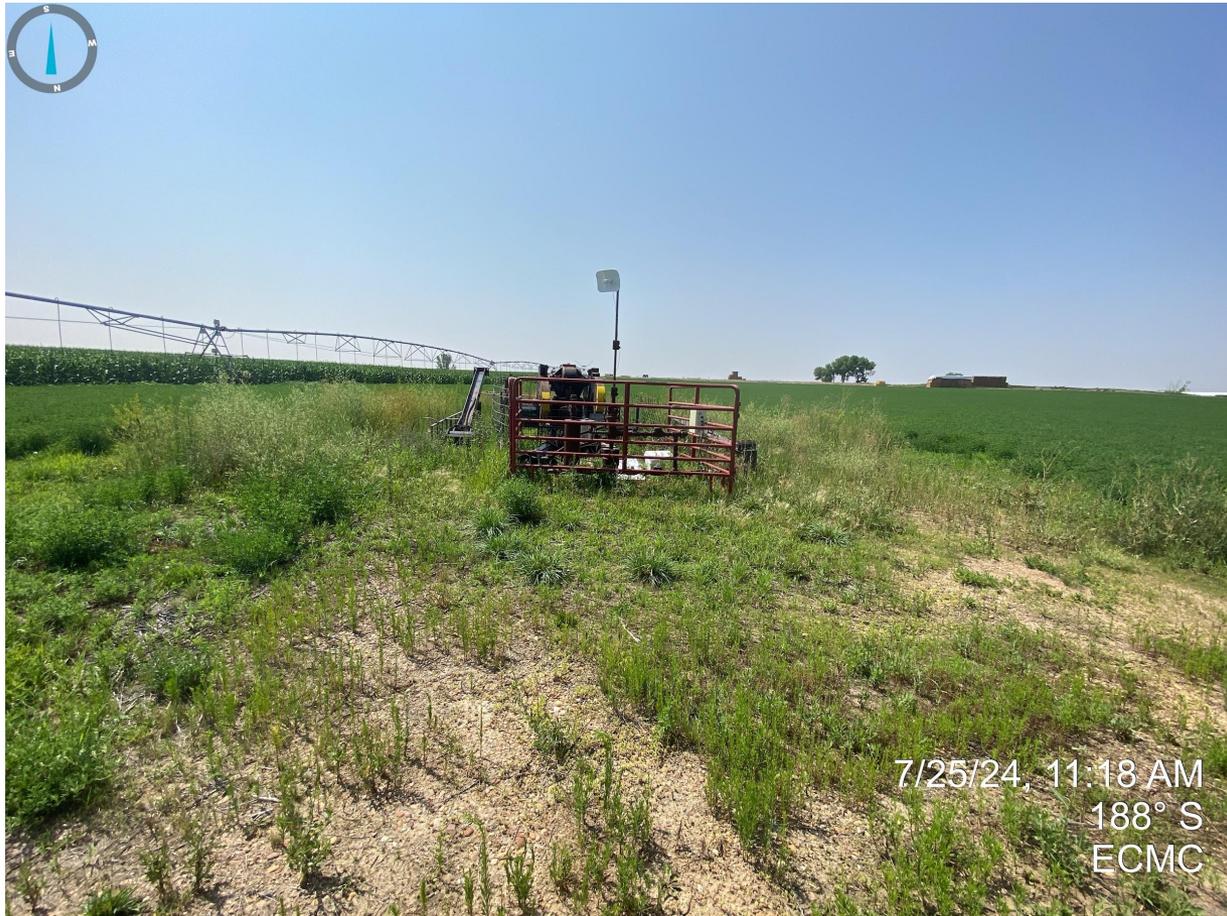
Photo 3. Undesirable vegetation and noxious weeds were observed throughout the location. It does not appear that undesirable/noxious vegetation has been managed for since the previous inspection.

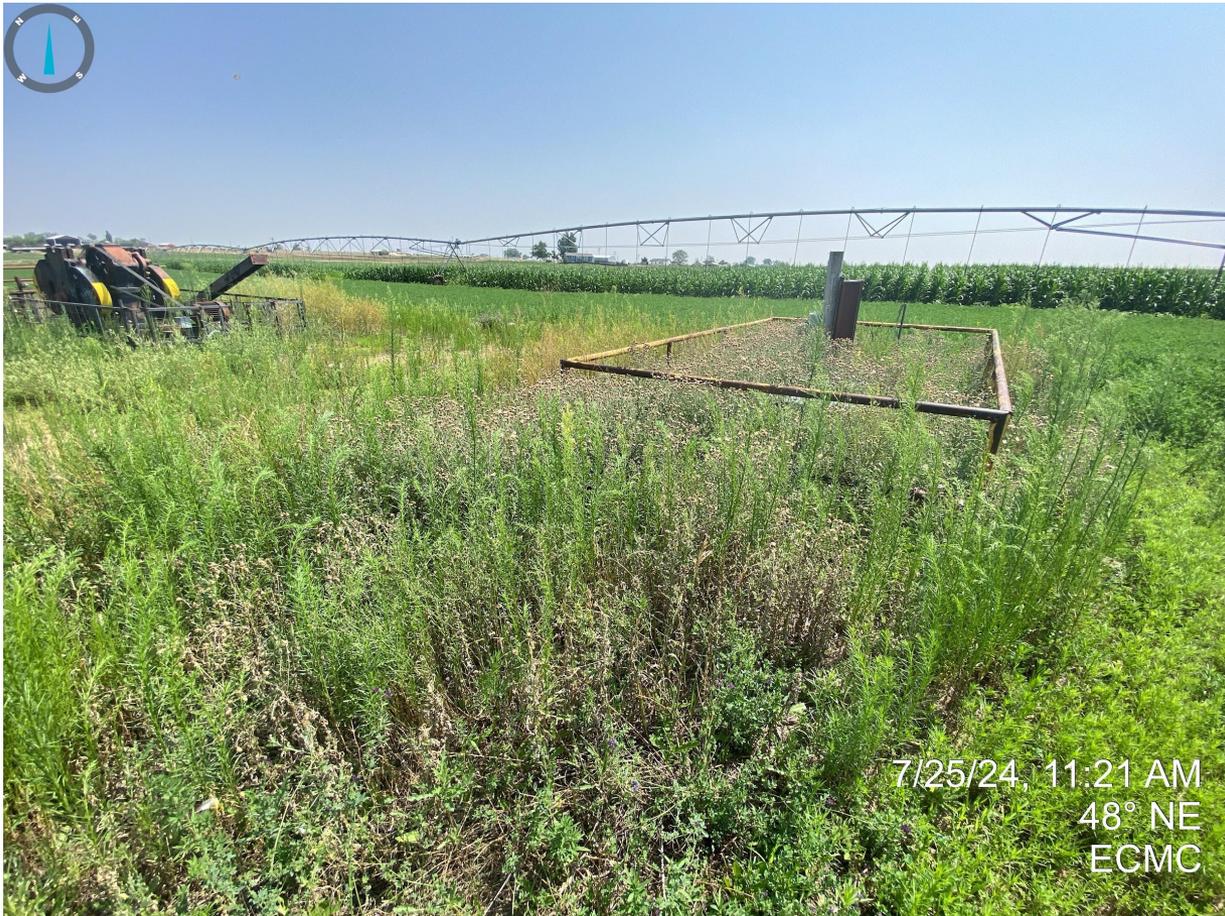
Photo 4. Continued from Photo 3. CO List C Noxious Weed (canada thistle) observed on the south end of location.

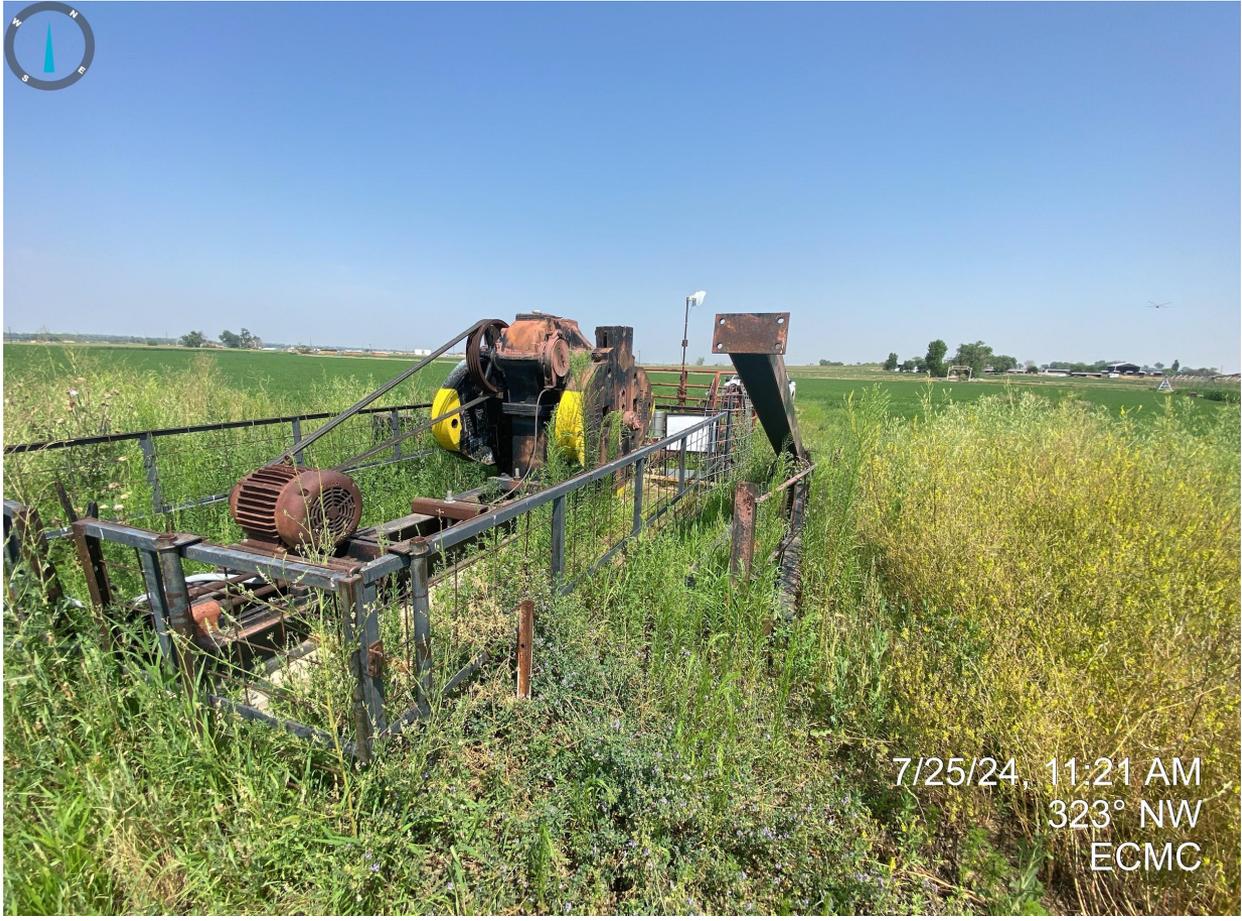
Photo 5. Pump jack is disassembled and unused equipment needs to be removed from the location or returned to service.
