Interim Reclamation and Stormwater Inspection

Date: 07/29/2024

Operator: WESTERN OPERATING COMPANY - 95620

Location ID: 312292

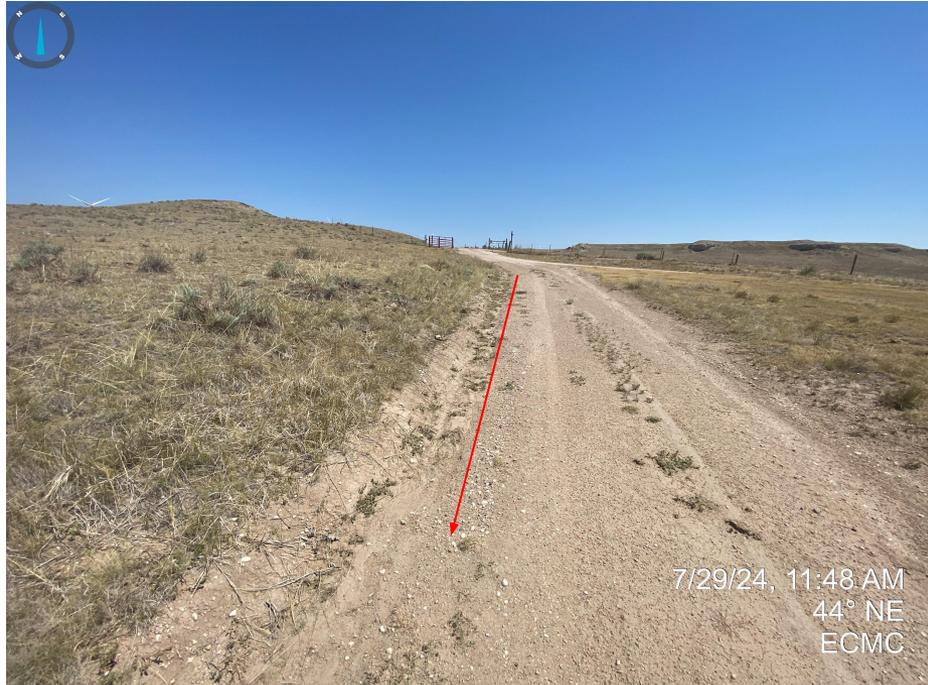
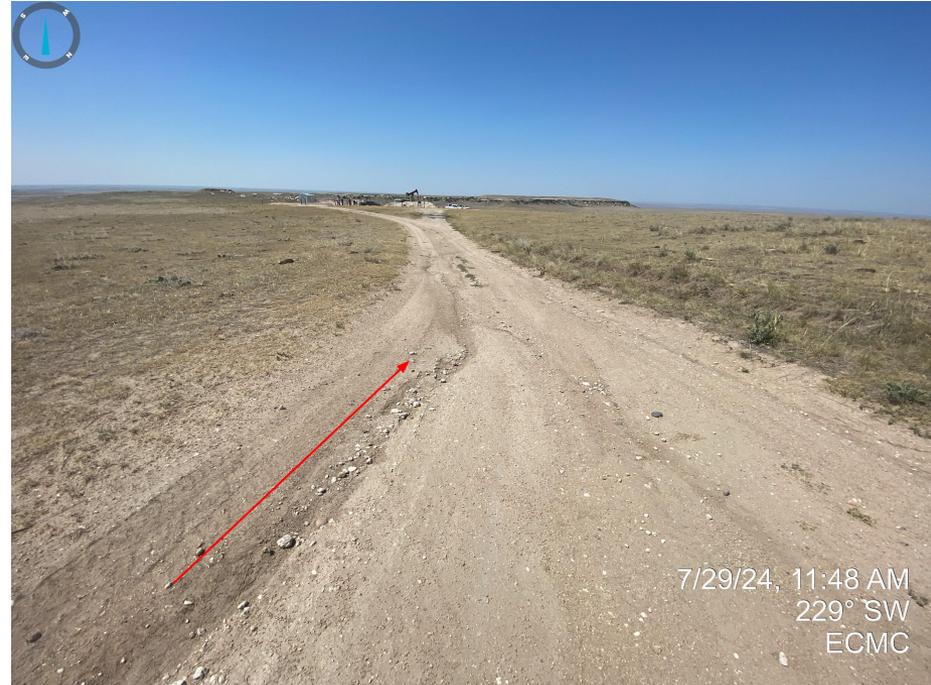
Photo 1. Erosion degradation (riling) occurring along the access road near the locations entrance.

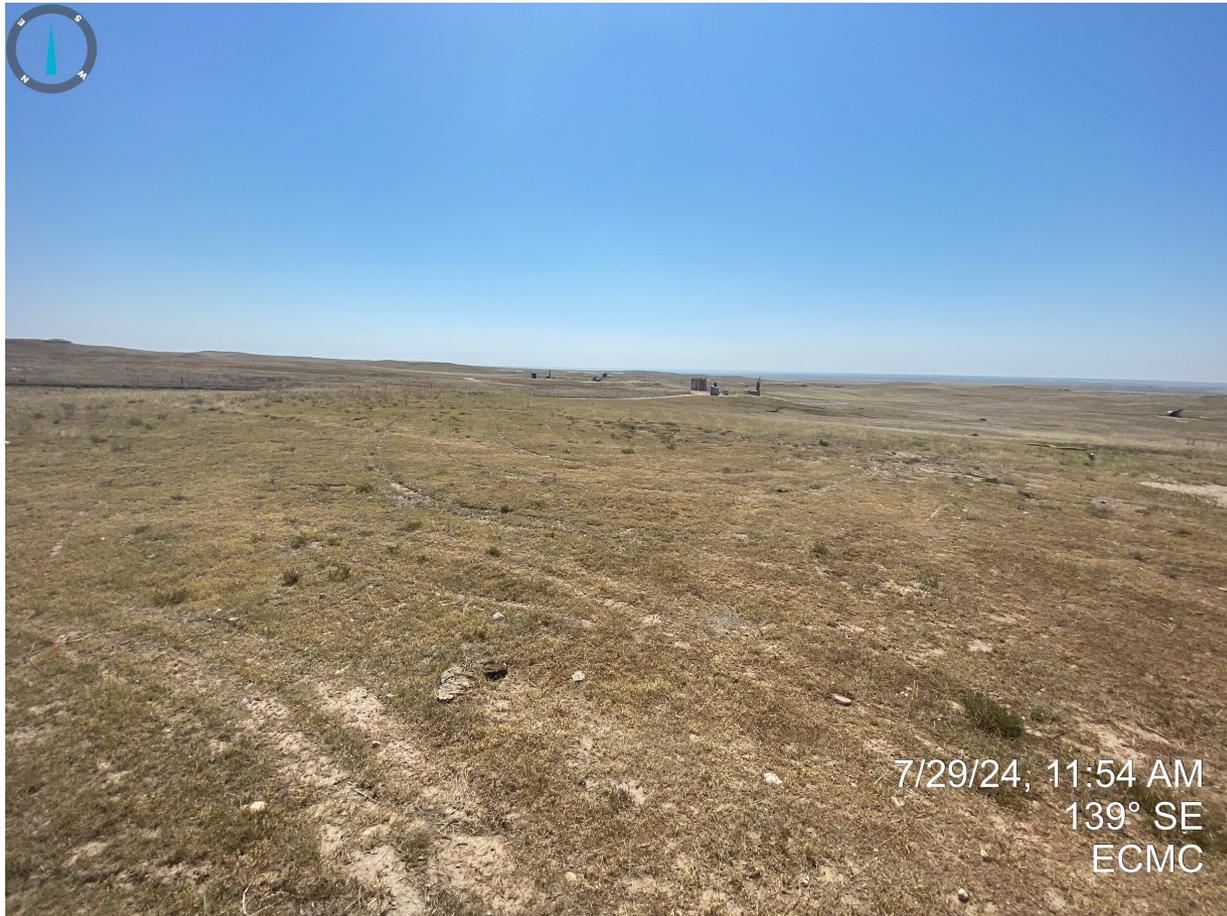
Photo 2. Facing southeast towards the spill/release area where misting occurred on adjacent lands on April 29th, 2024.

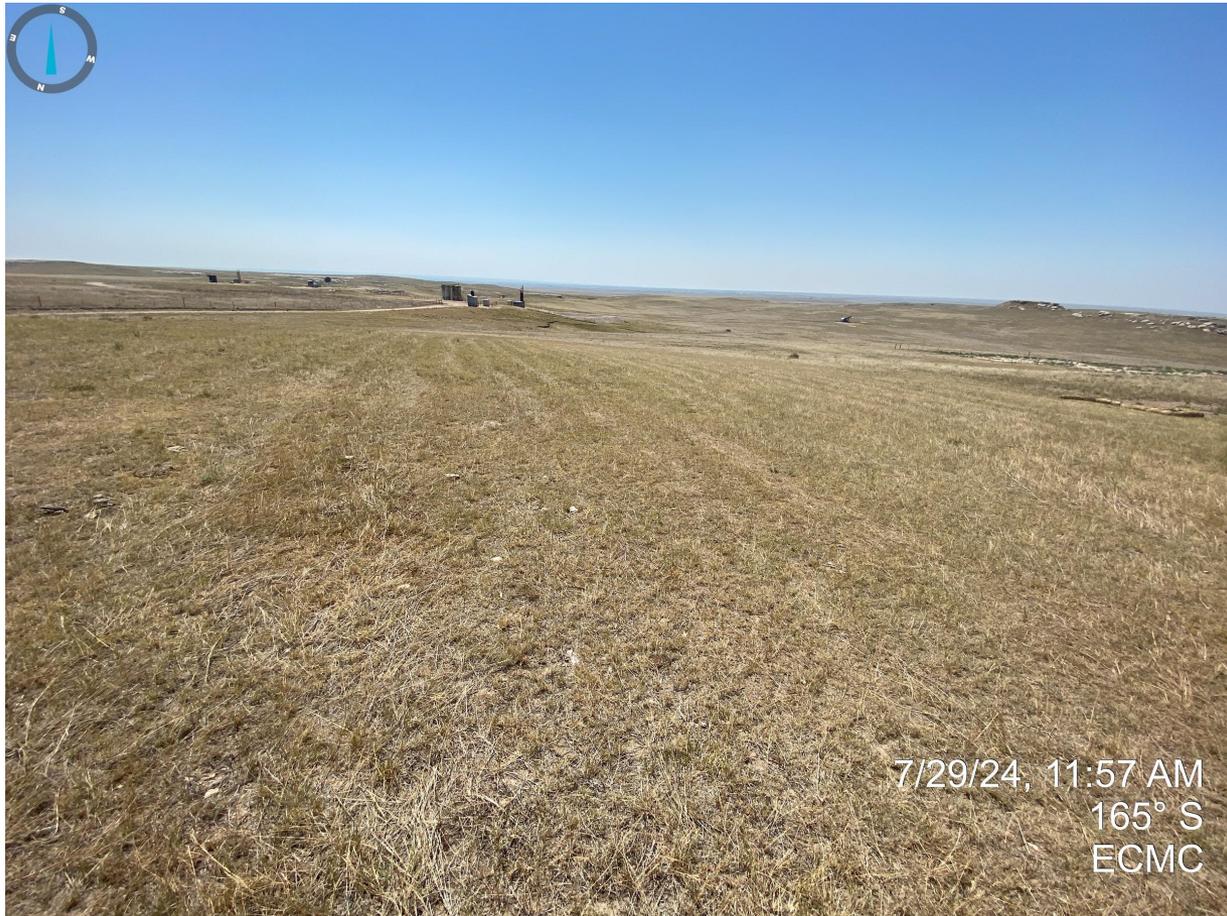
Photo 3. Facing south; see comments in Photo 2.

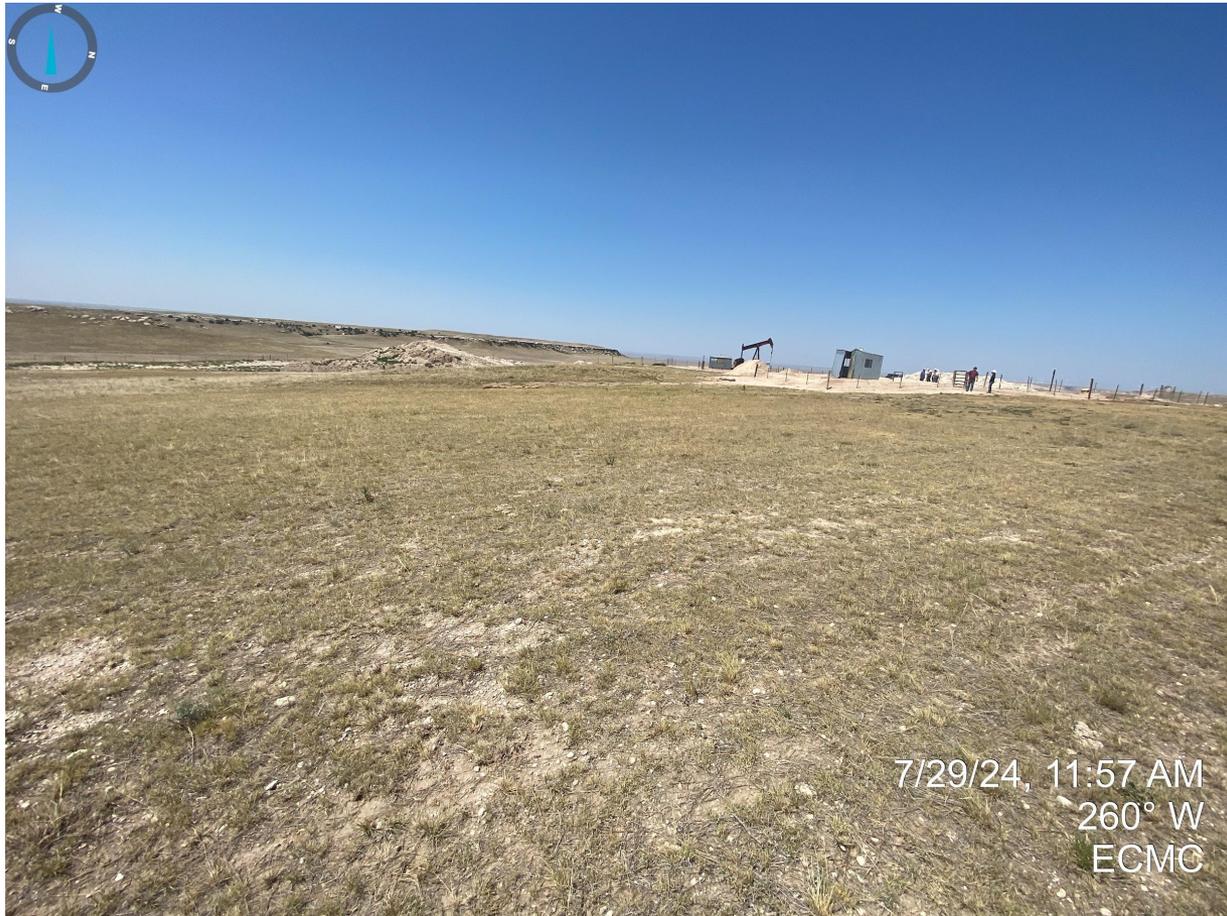
Photo 4. Facing west; see comments in Photo 2.

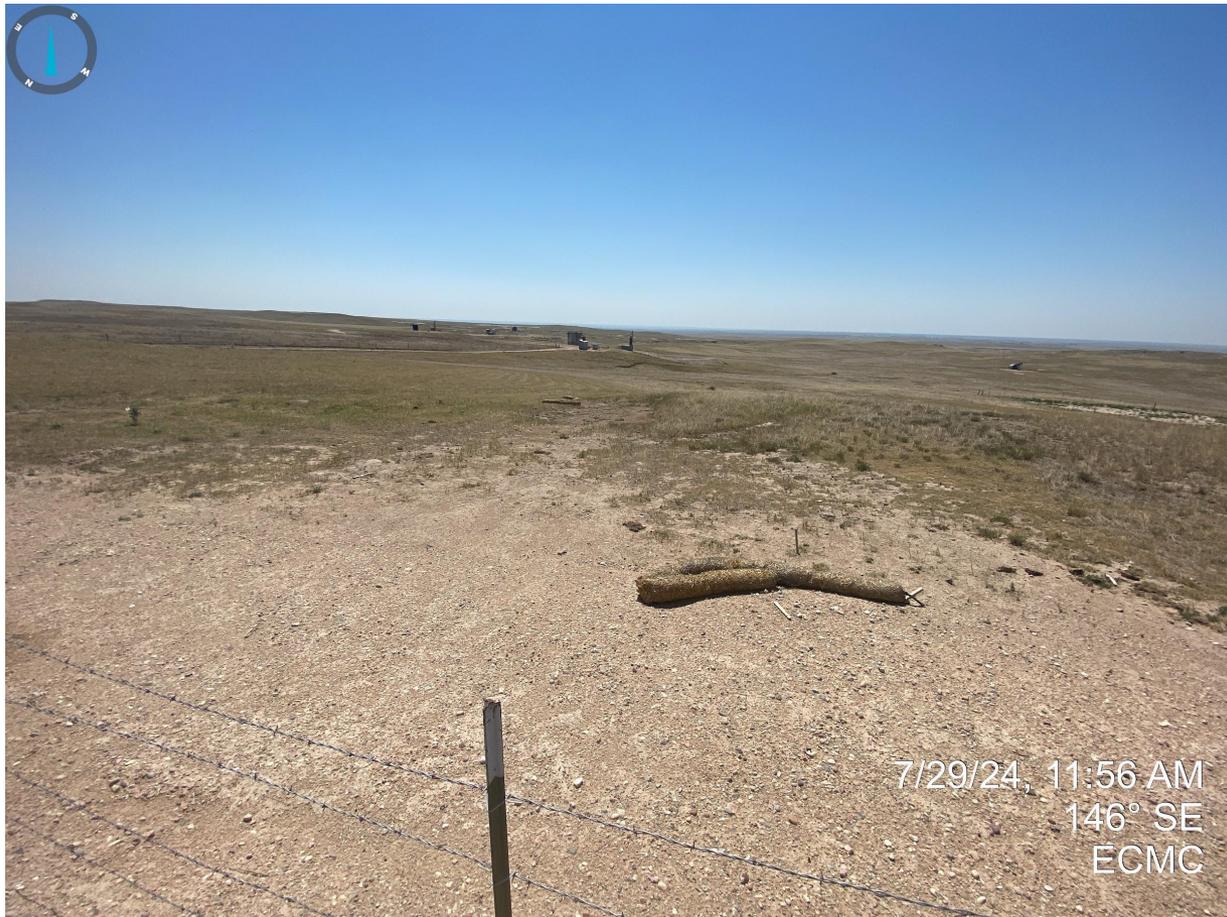
Photo 5. Facing southeast at the former heater treater (removed at the time of this inspection). Stormwater control measures (straw wattles) do not appear to be installed per good engineering practices (trenched and backfilled) and require maintenance and or replacement.

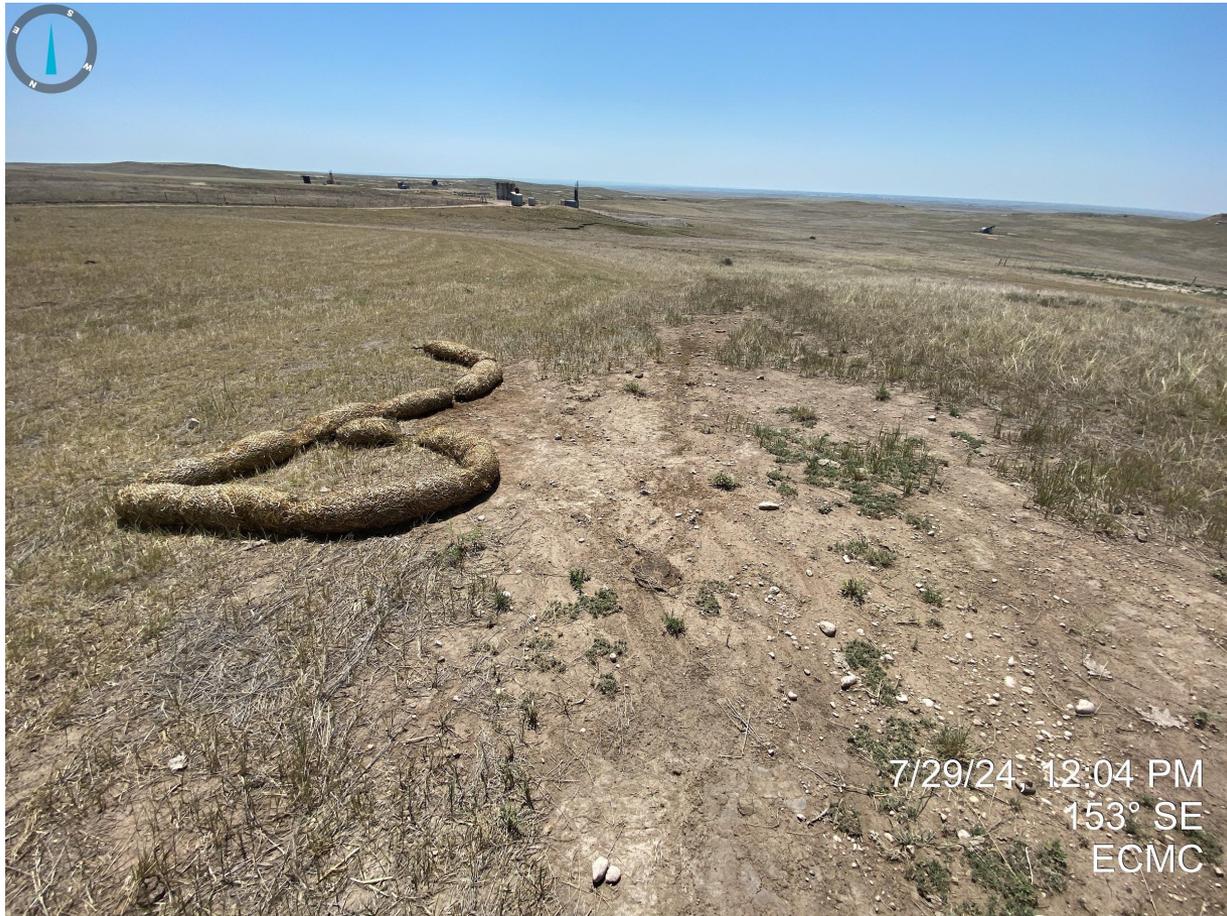
Photo 6. Continued from Photo 5, facing southeast.

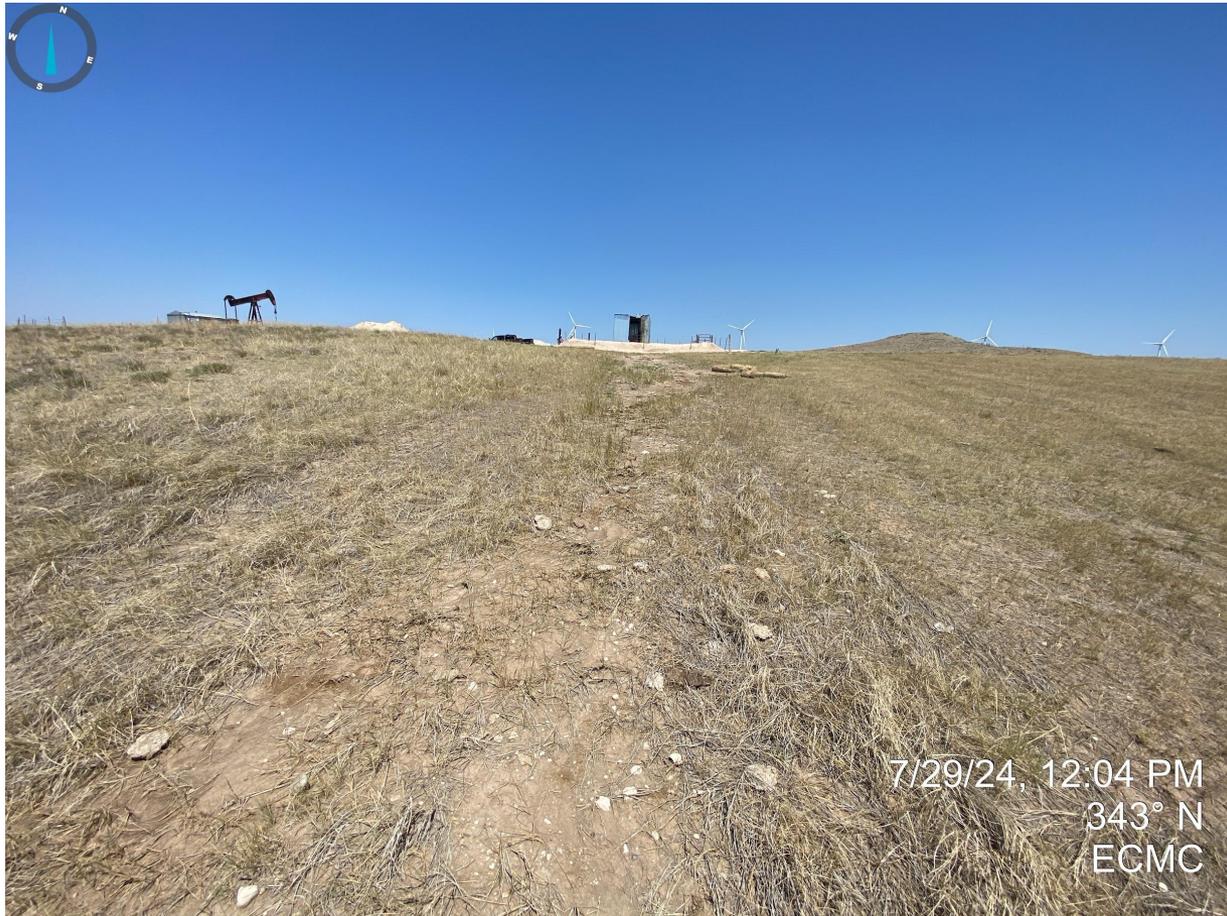
Photo 7. South of the former location of the vertical heater treater. Photo illustrates unstabilized soils and lack of proper stormwater controls measures that would prevent erosion degradation. Sediment deposition observed.

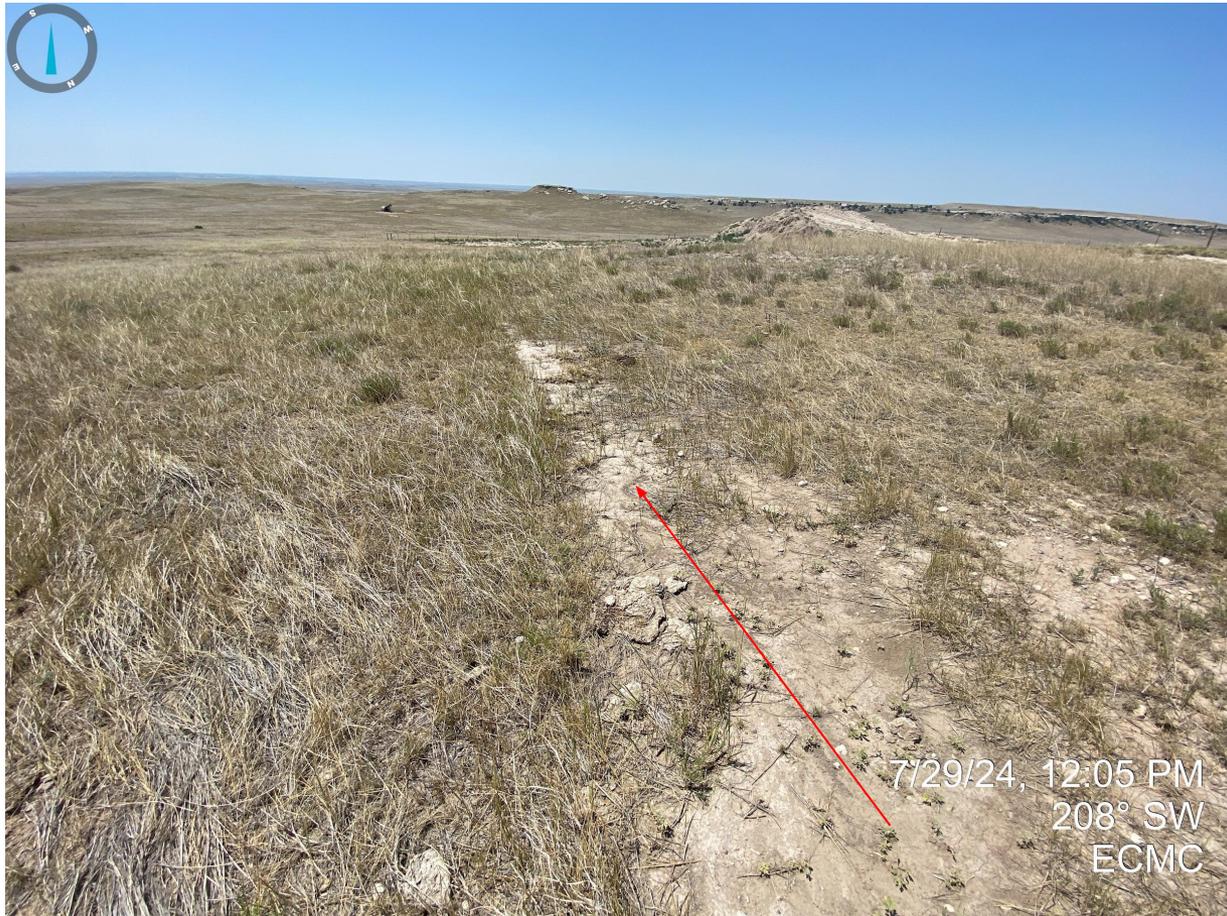
Photo 8. Sediment deposition observed southwest of the former location of the vertical heater treater. Stormwater control measures remain inadequate to prevent continued erosion degradation.

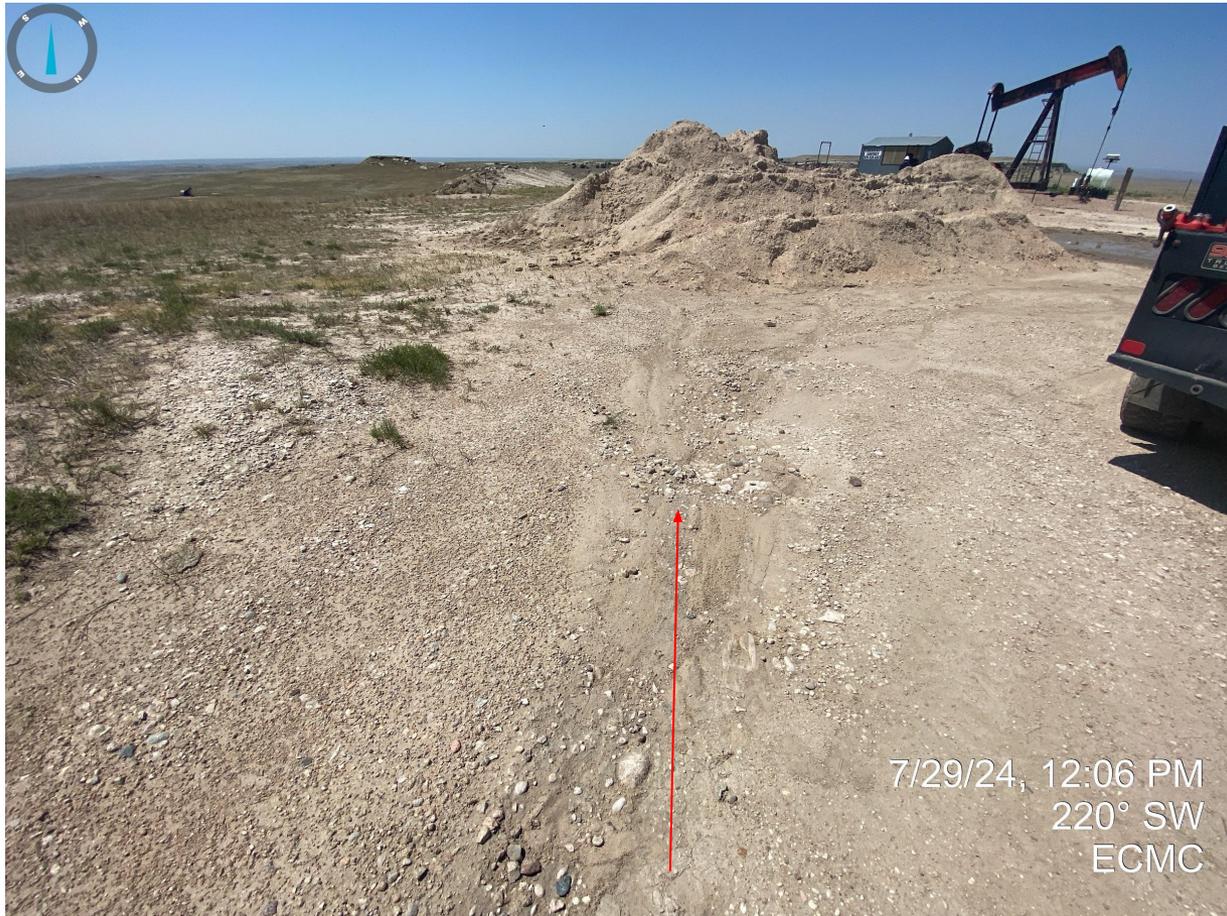
Photo 9. Erosion degradation occurring on the pad area; no visible stormwater control measures observed.

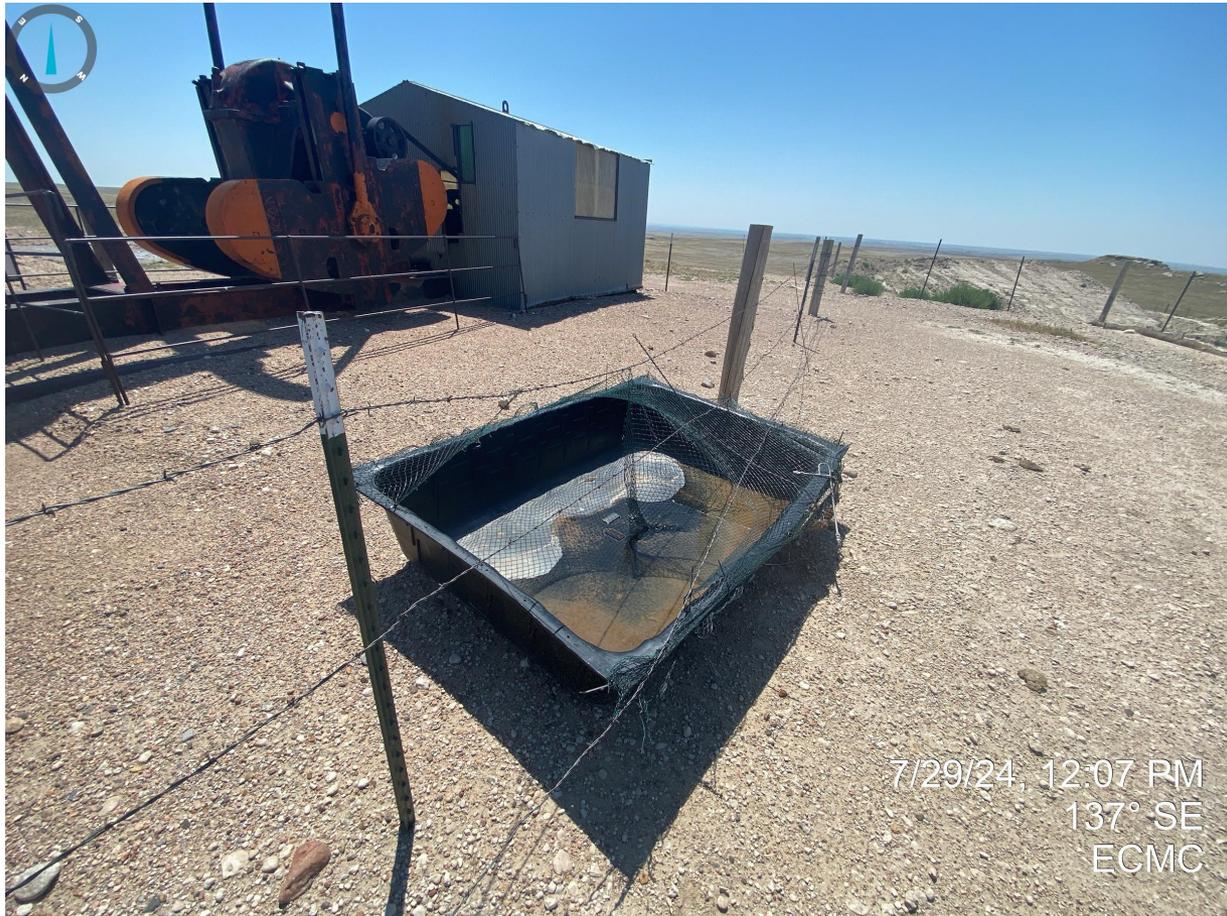
Photo 10. Secondary containment at wellhead does not appear to be in use.

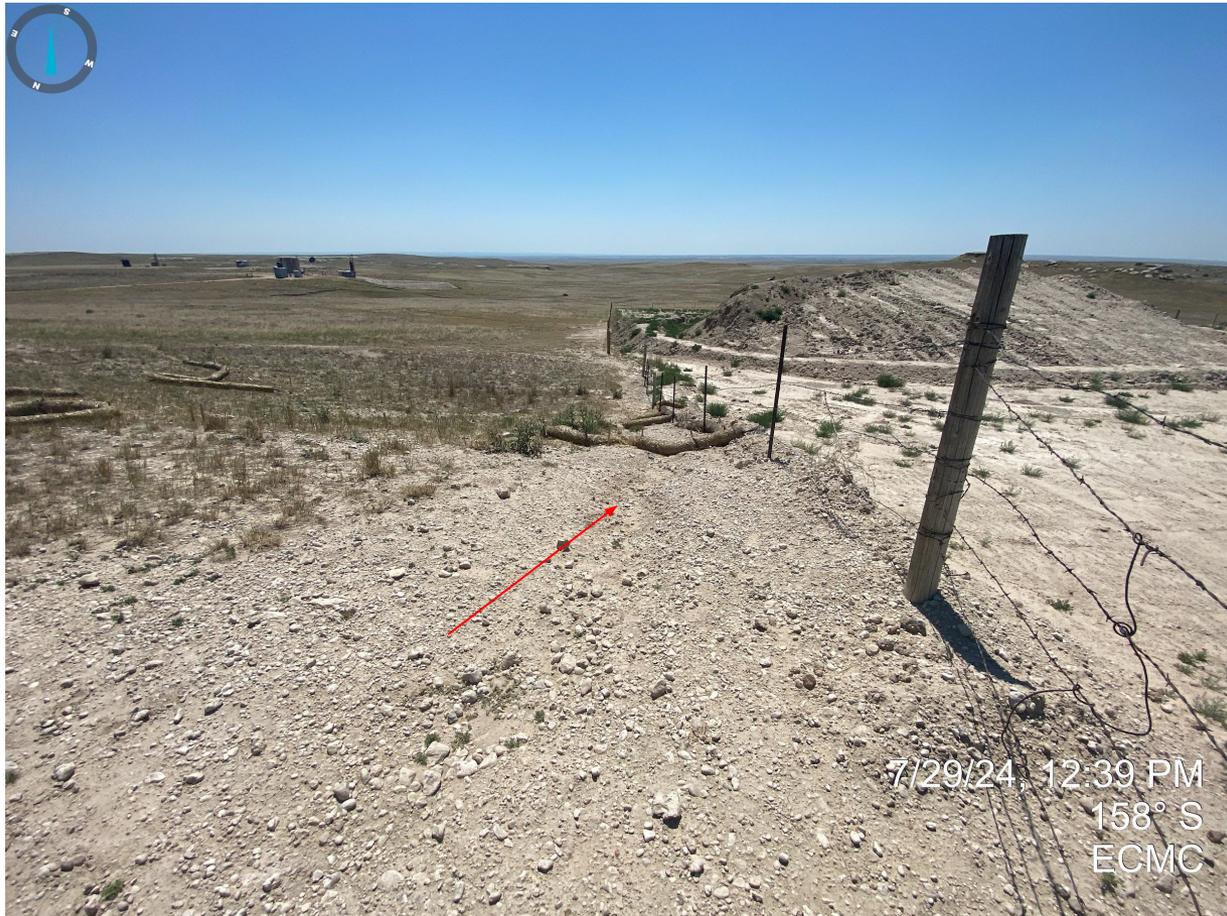
Photo 11. East side of pit. Erosion degradation identified in previous inspections does not appear to have been repaired and stabilized. Stormwater control measures do not appear to be properly installed per good engineering practices.

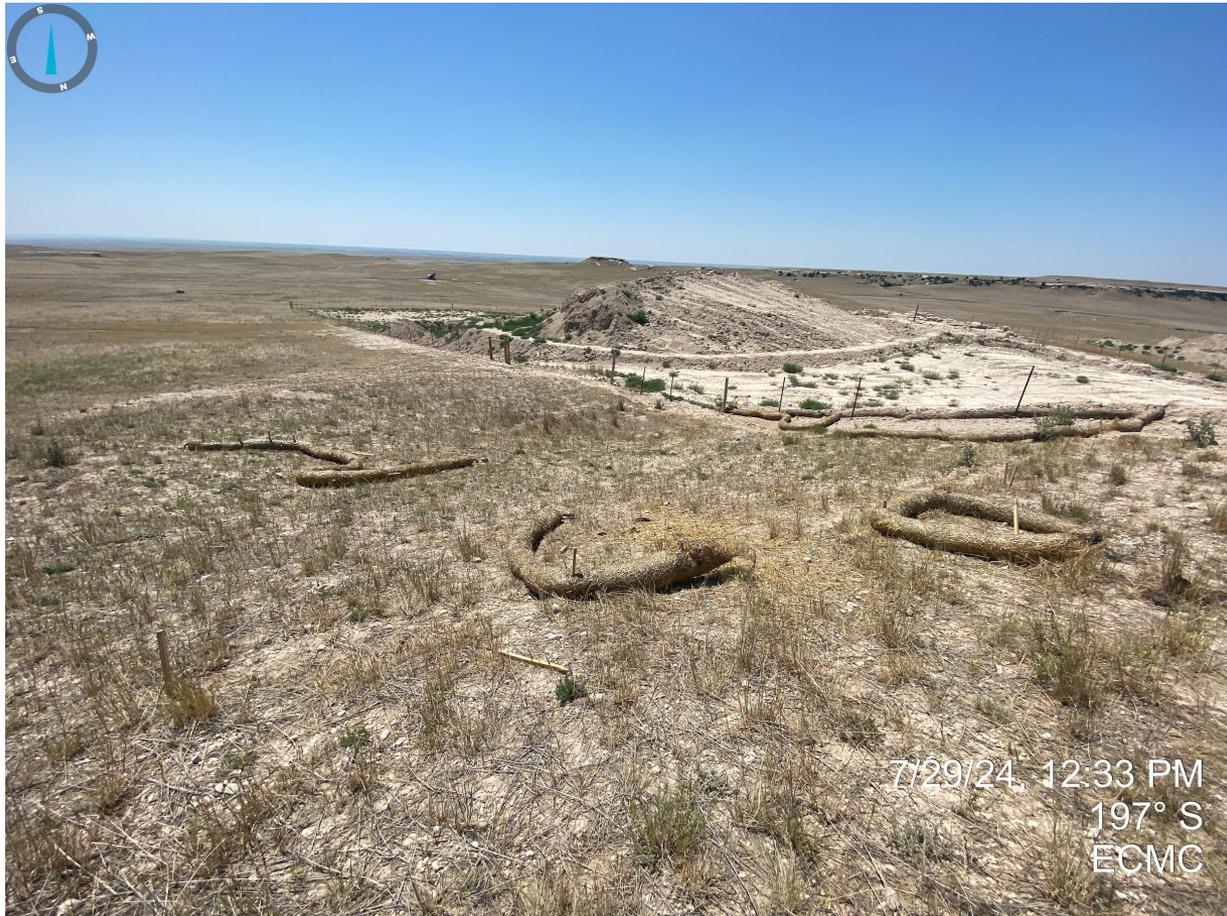
Photo 12. Continued from Photo 11; east of pit.

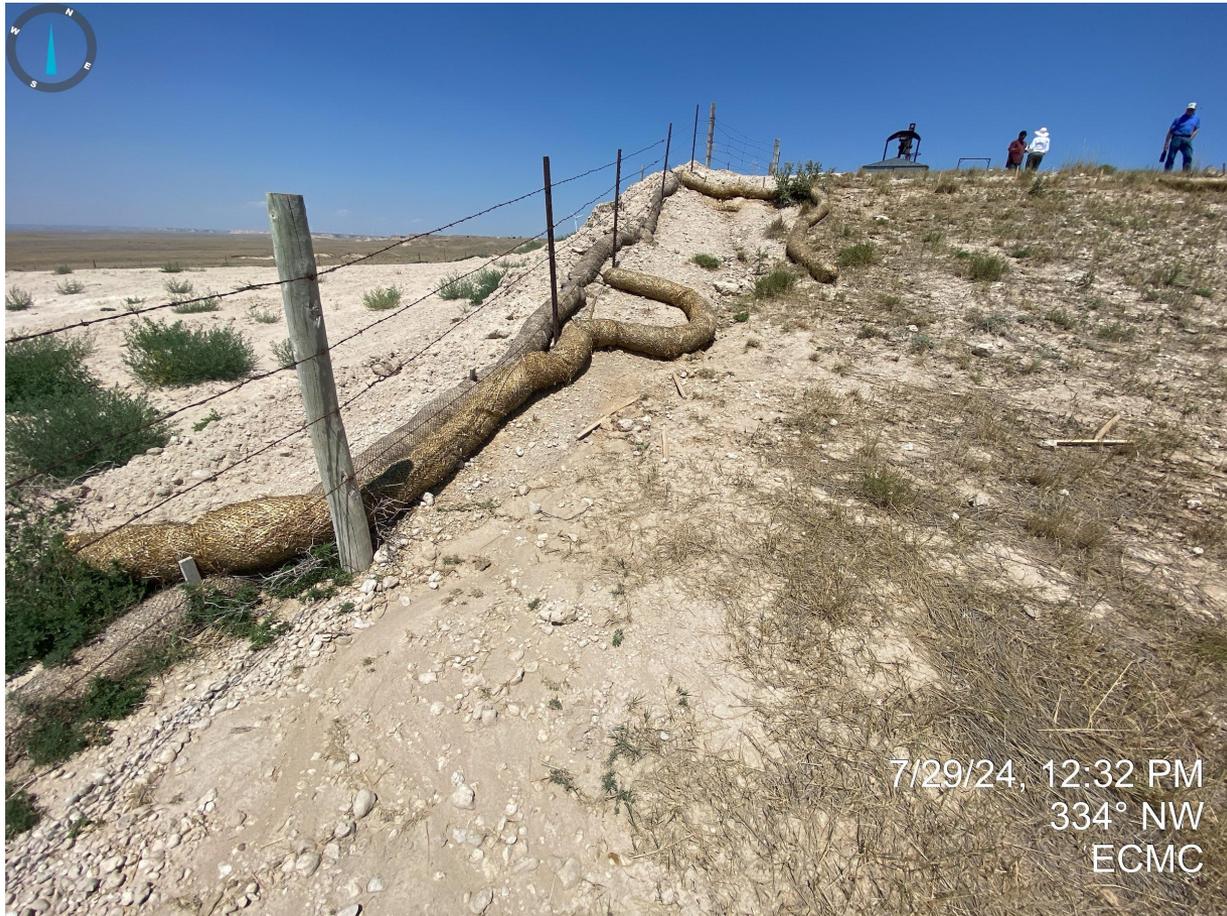
Photo 13. Continued from Photo 11; east of pit.

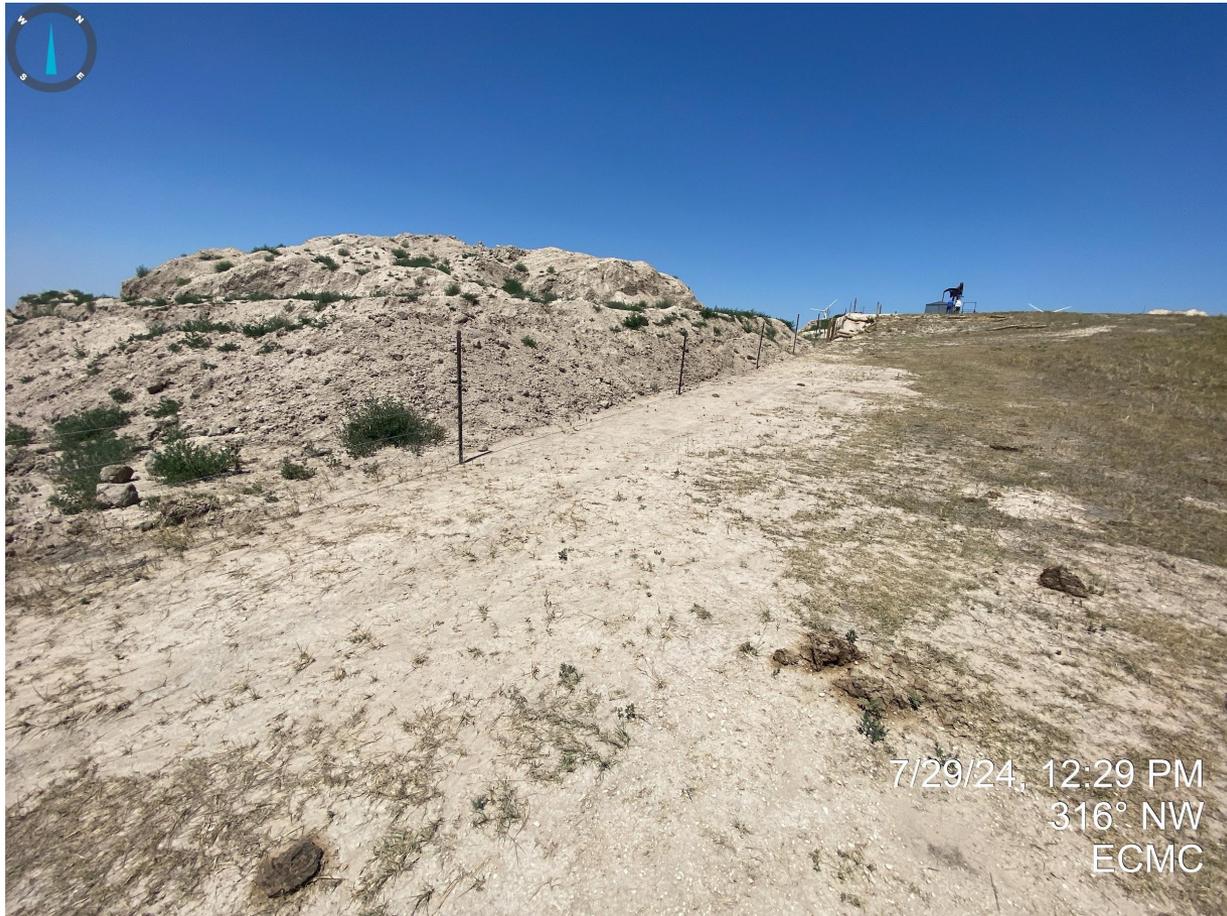
Photo 14. East side of stockpiled pit soils. Photo illustrates that both the stockpile and berms have been left unconsolidated. Unconsolidated materials can become a potential pollution source as it is not properly stabilized. Berms also appear to be built out of impacted material from the salt kill/pit excavation.

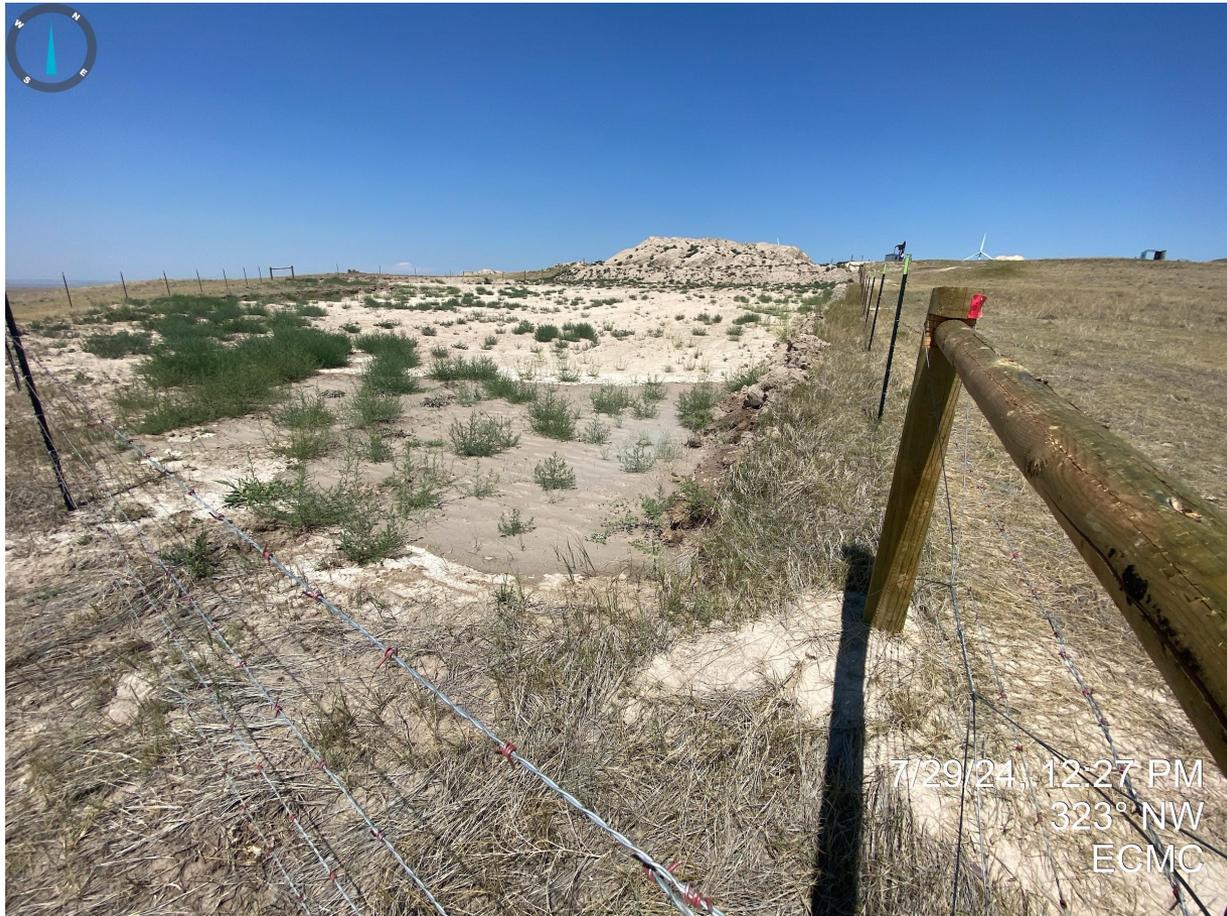
Photo 15. Southern excavated areas do not have any evidence of perimeter stormwater control measures and undesirable vegetation (russian thistle and kochia) was observed growing throughout.

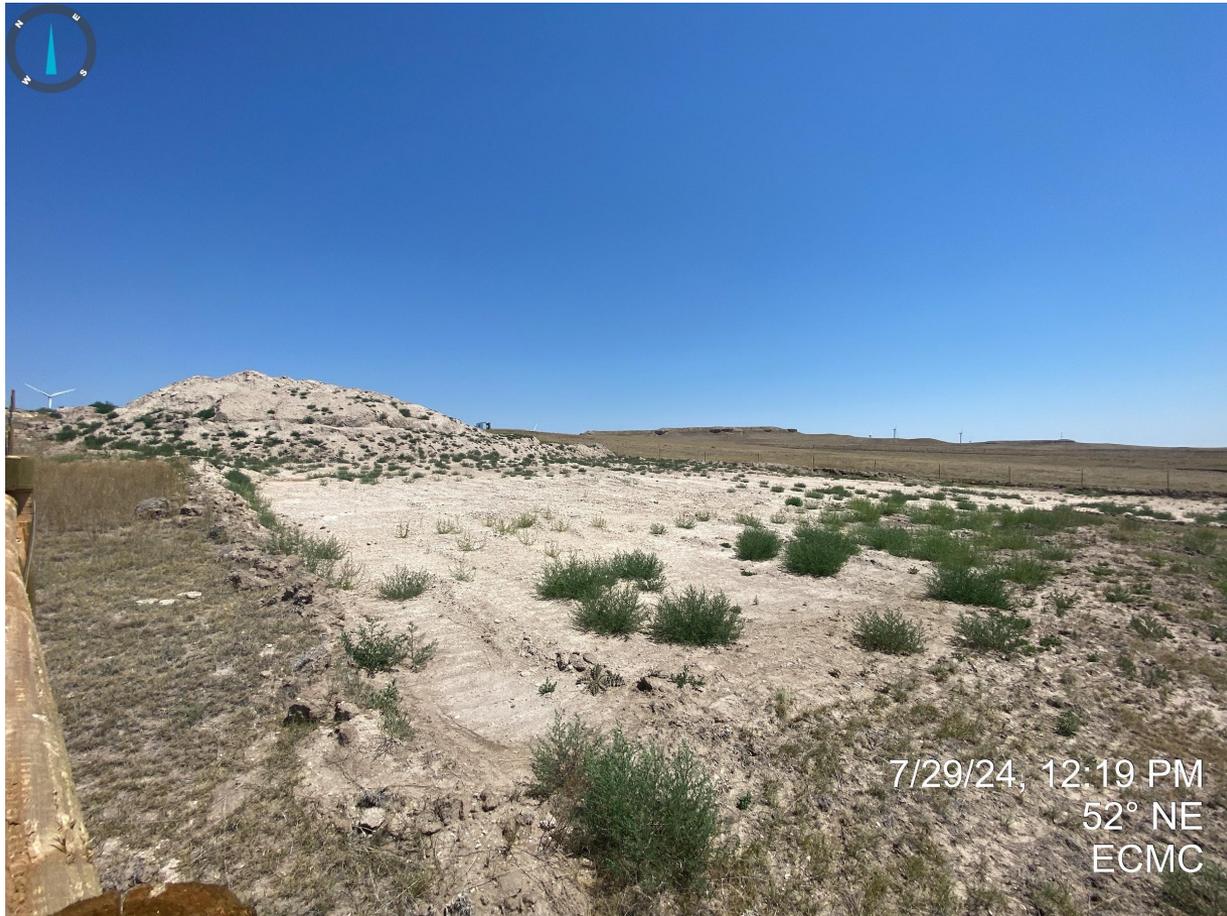
Photo 16. Southern excavated areas, facing northeast. See comments in Photo 15.

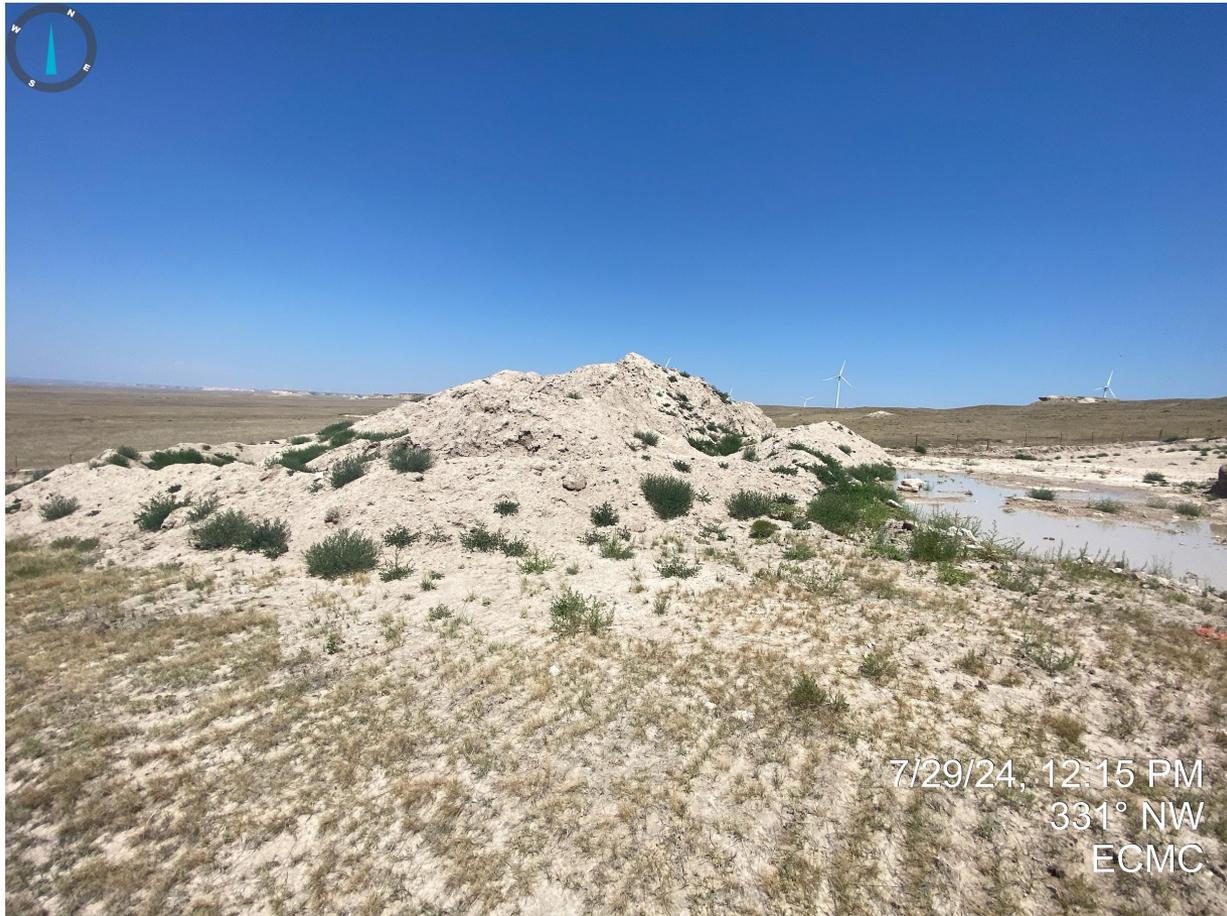
Photo 17. Western stockpiled material is not properly stabilized with evidence of unconsolidated materials. No perimeter stormwater control measures observed.

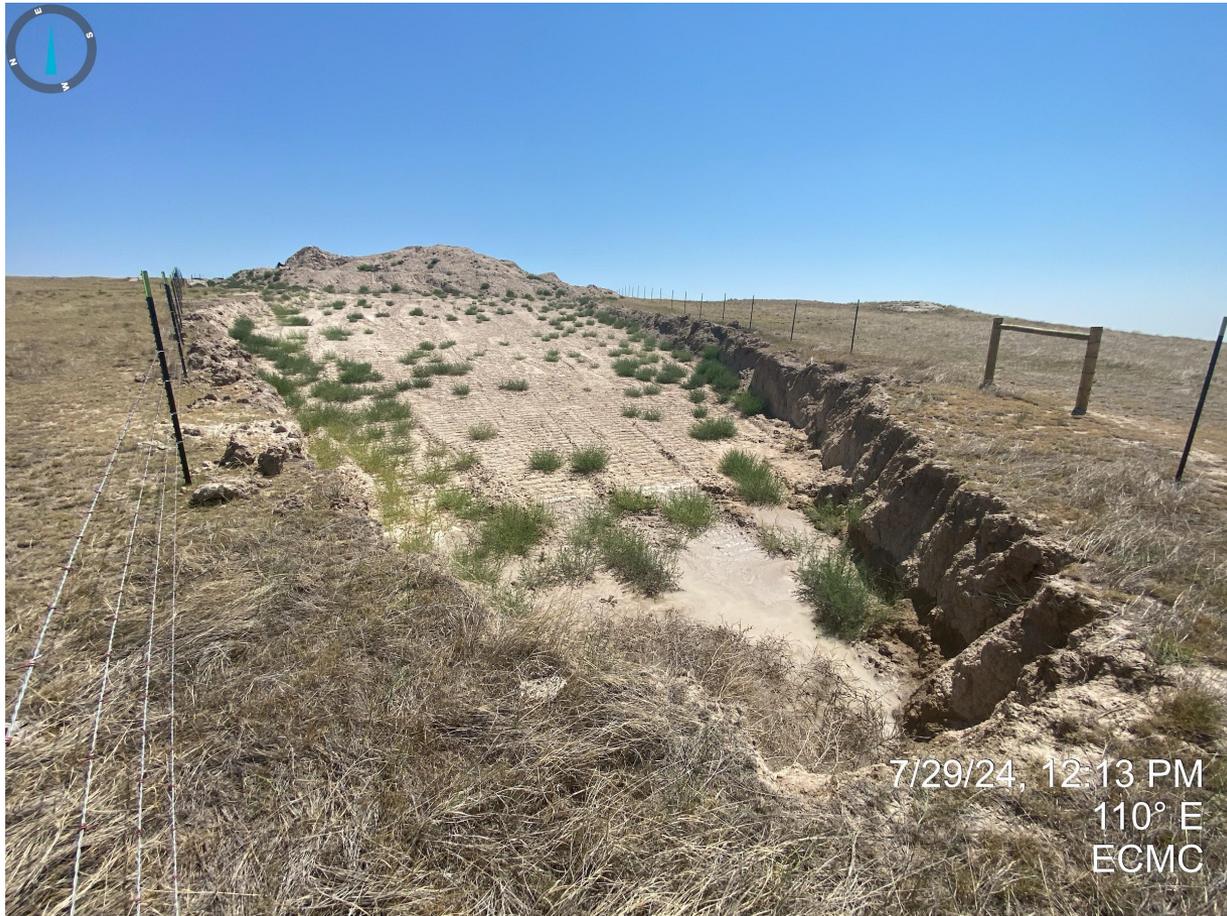
Photo 18. Undesirable vegetation growing throughout the excavated portions.

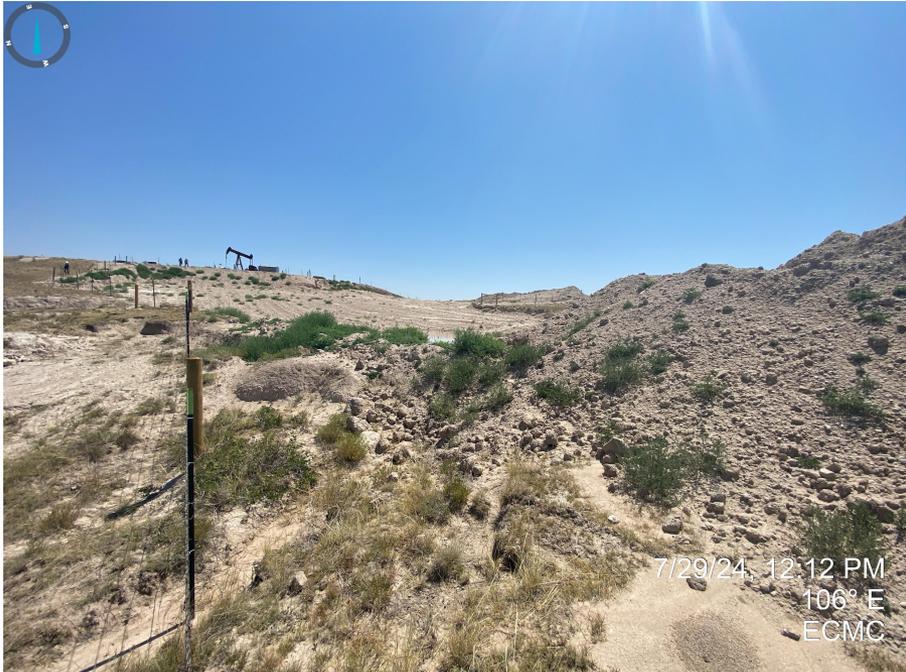
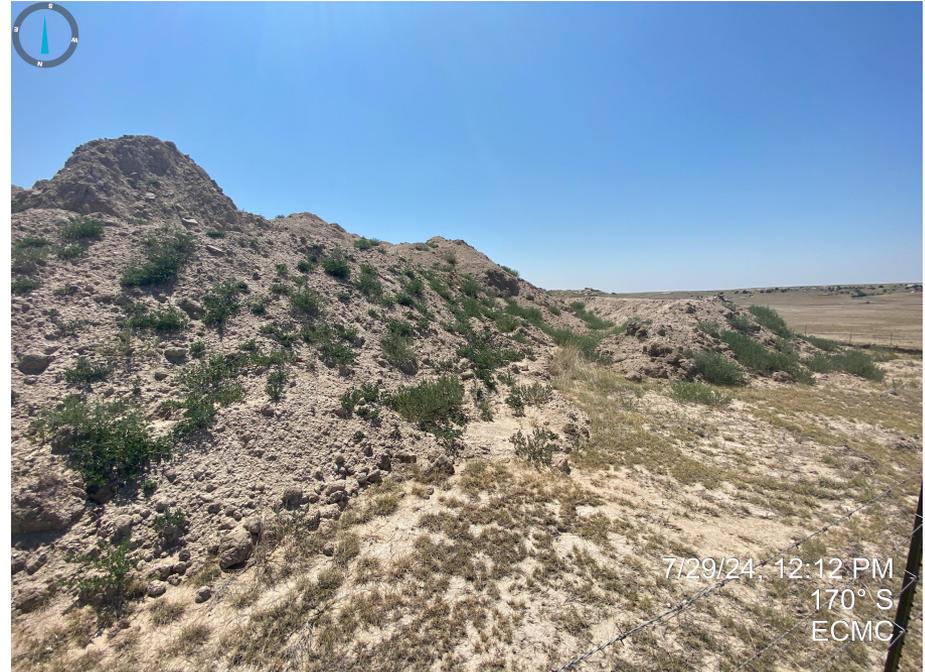
Photo 19. North side of excavation. No stormwater control measures/BMPs were observed around the perimeter of the excavated area or stockpiles that would prevent off location stormwater discharge from entering nearby drainage. Undesirable vegetation observed throughout stockpiles and disturbance areas.
