Interim Reclamation and Stormwater Inspection

Date: 07/29/2024

Operator: WESTERN OPERATING COMPANY - 95620

Location ID: 312292

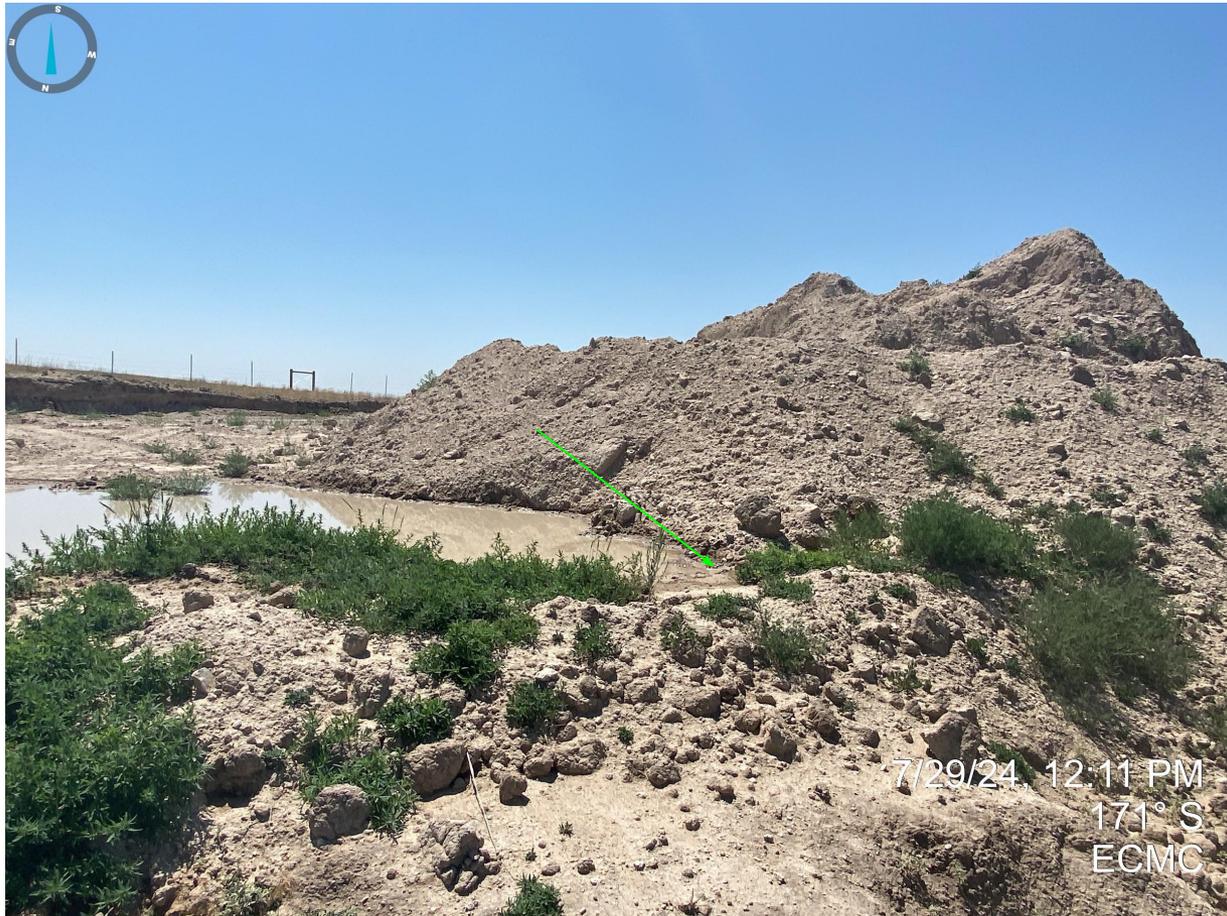
Photo 20. No stormwater control measures/BMPs were observed around the perimeter of the excavated area or stockpiles that would prevent off location stormwater discharge from entering nearby drainage. Stormwater is close to spilling over the excavated area; there is approximately 3 inches of free board (indicated by green arrow).

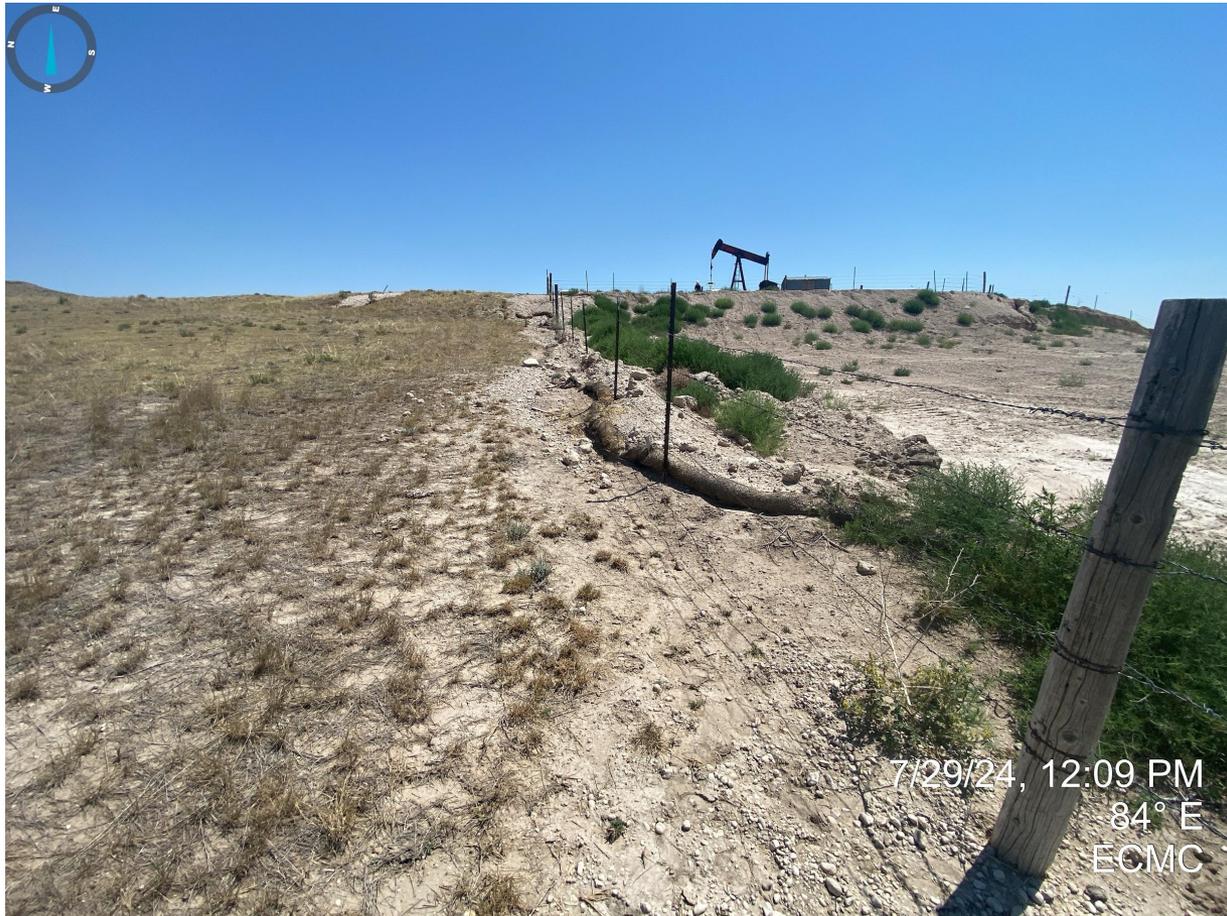
Photo 21. Taken from the north side of the pit. It does not appear that any erosion degradation has been properly stabilized or repaired, and stormwater control measures remain inadequate as the straw wattles are degraded and not properly functioning

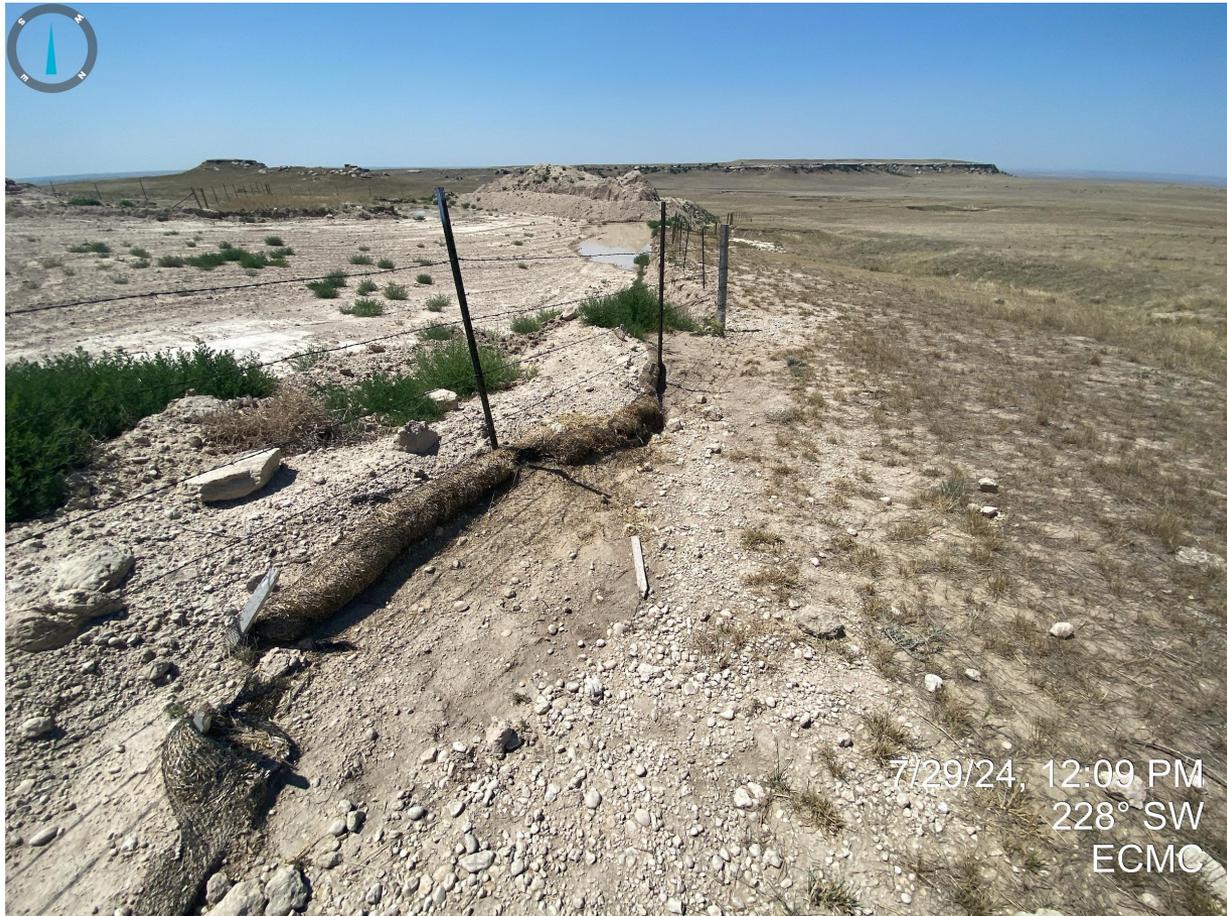
Photo 22. Continued from Photo 21; facing southwest.

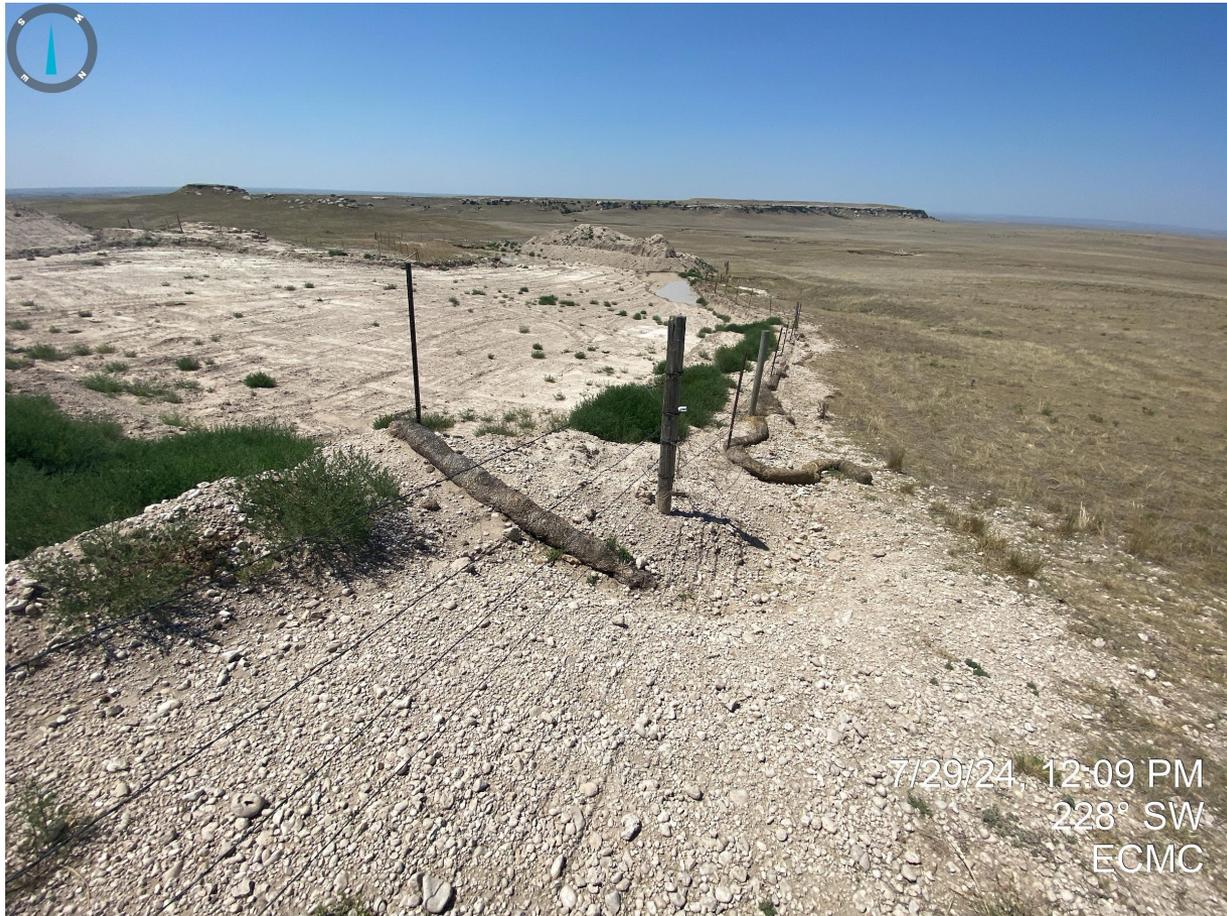
Photo 23. Continued from Photo 21; facing southwest.
