Interim Reclamation and Stormwater Inspection

Date: 07/29/2024

Operator: WESTERN OPERATING COMPANY - 95620

Location ID: 312291

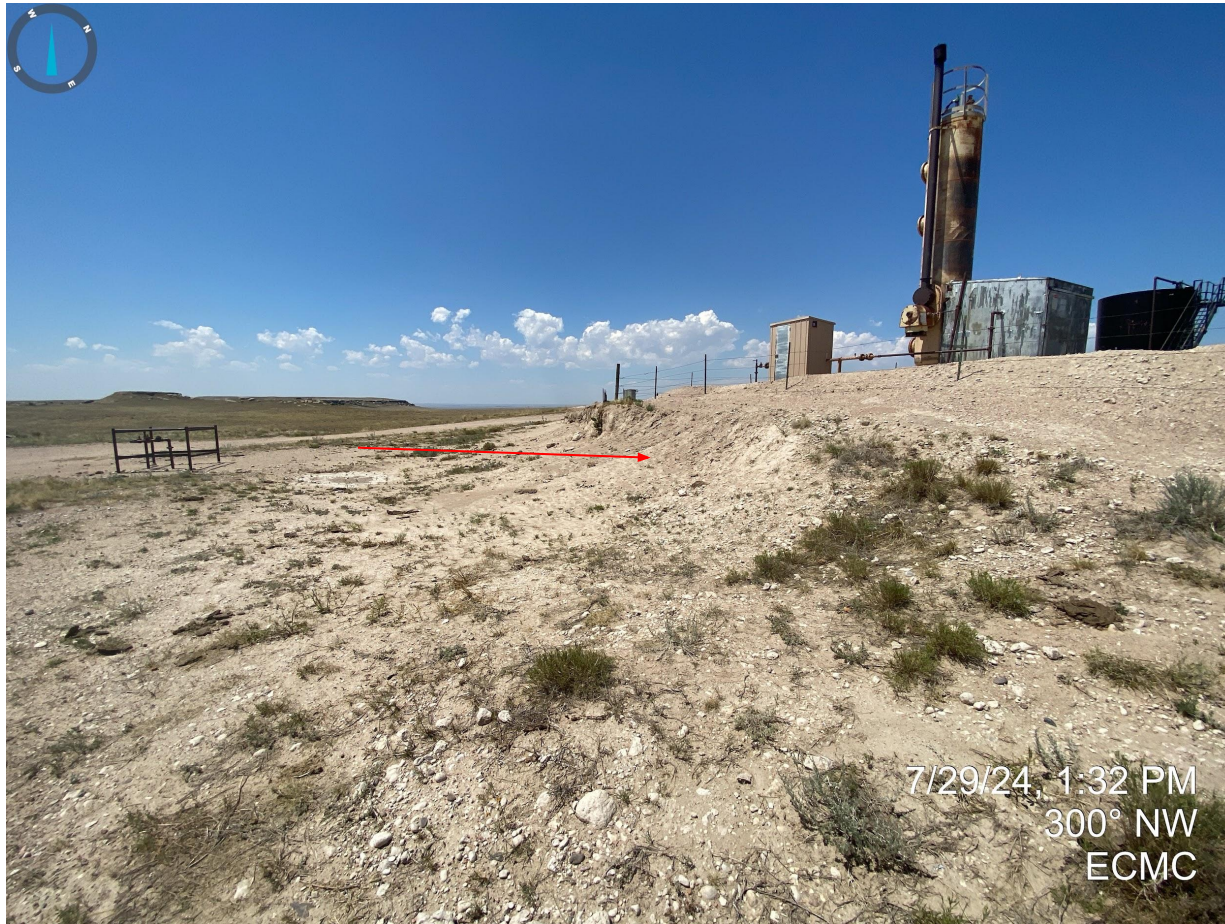
Photo 1. Areas experiencing erosion degradation throughout the production areas do not appear to have been repaired/stabilized and there is no evidence of stormwater controls measures/BMPs having been implemented.

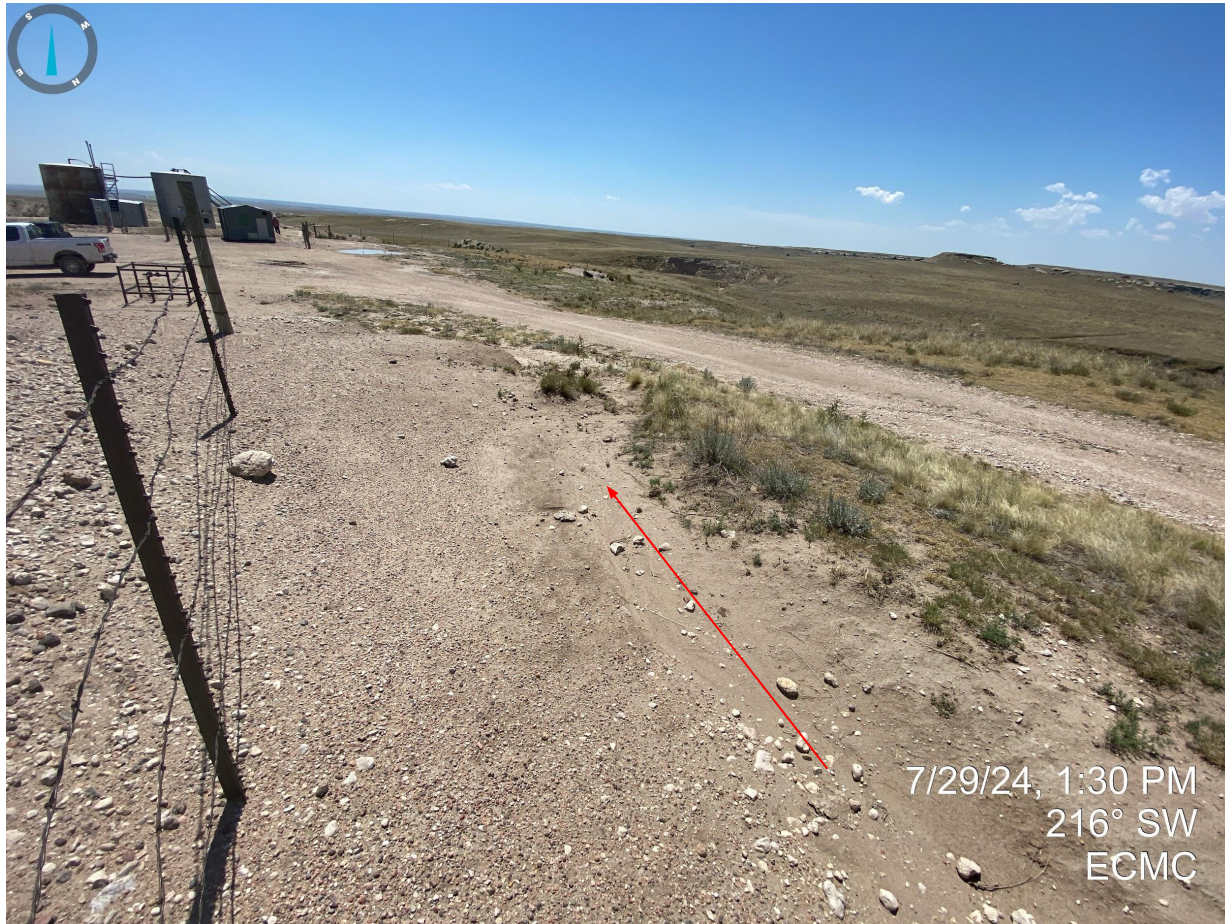
Photo 2. Continued from Photo 1.

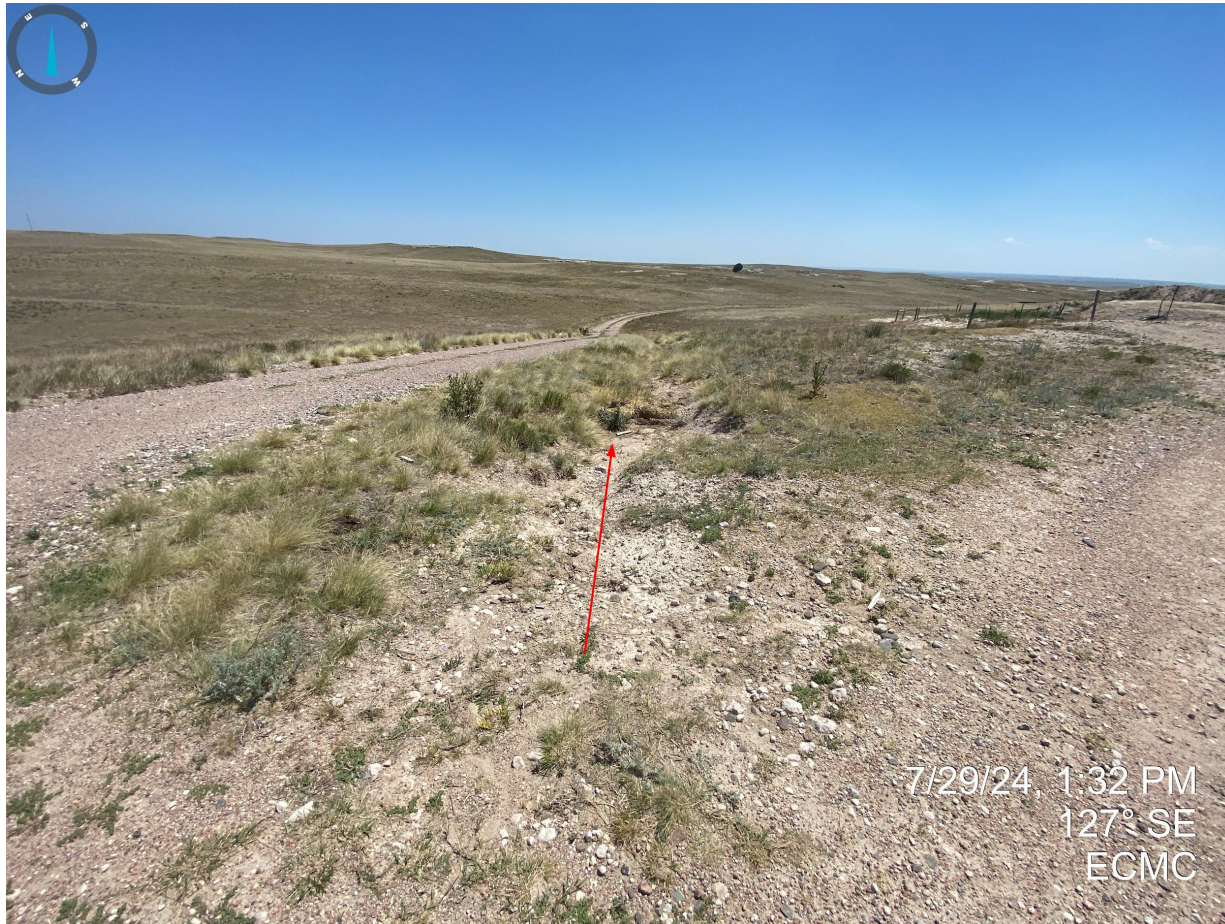
Photo 3. Taken north of pit. Evidence of erosion degradation, previously documented, does not appear to have been repaired/stabilized with no evidence of control measures/BMPs observed that would prevent further erosion of the production areas and access roads.

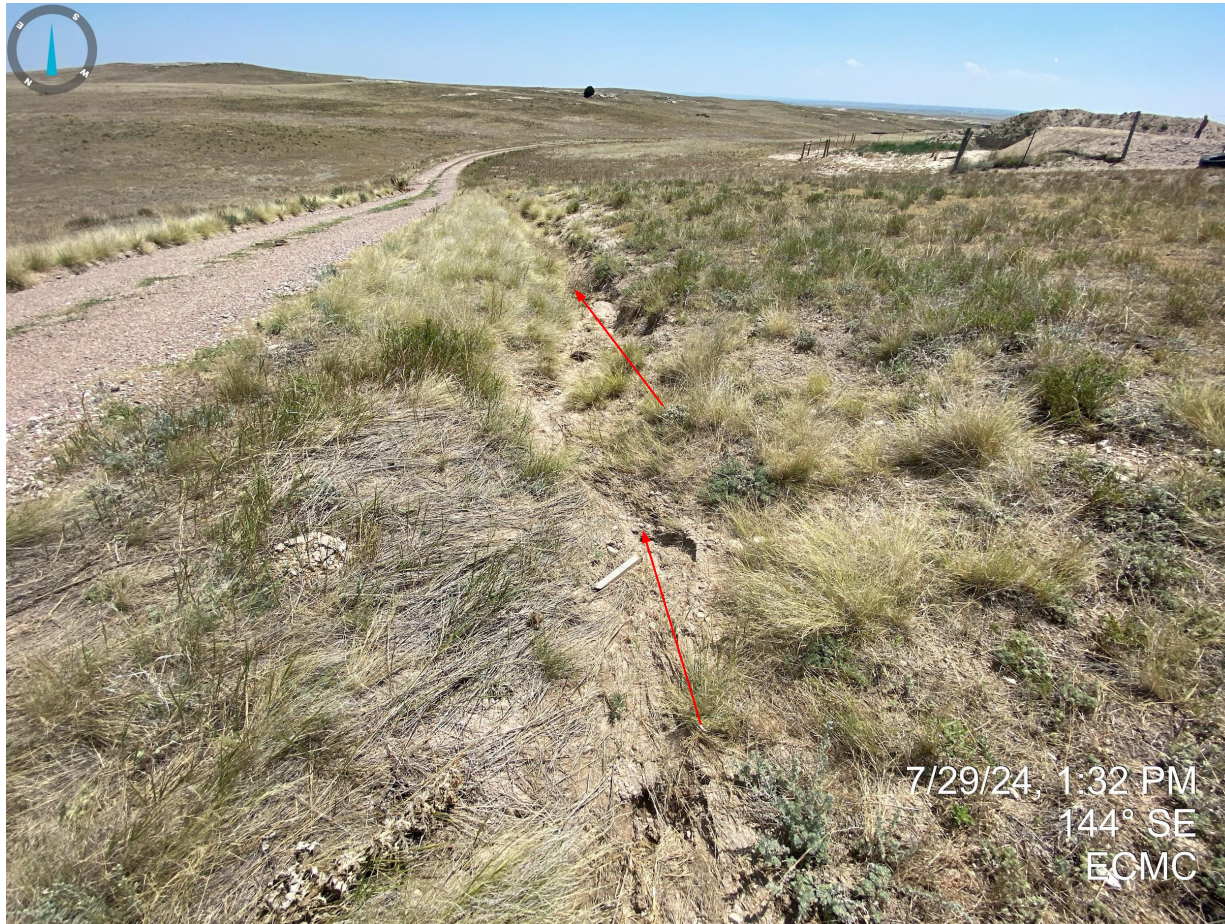
Photo 4. Continued from Photo 3.

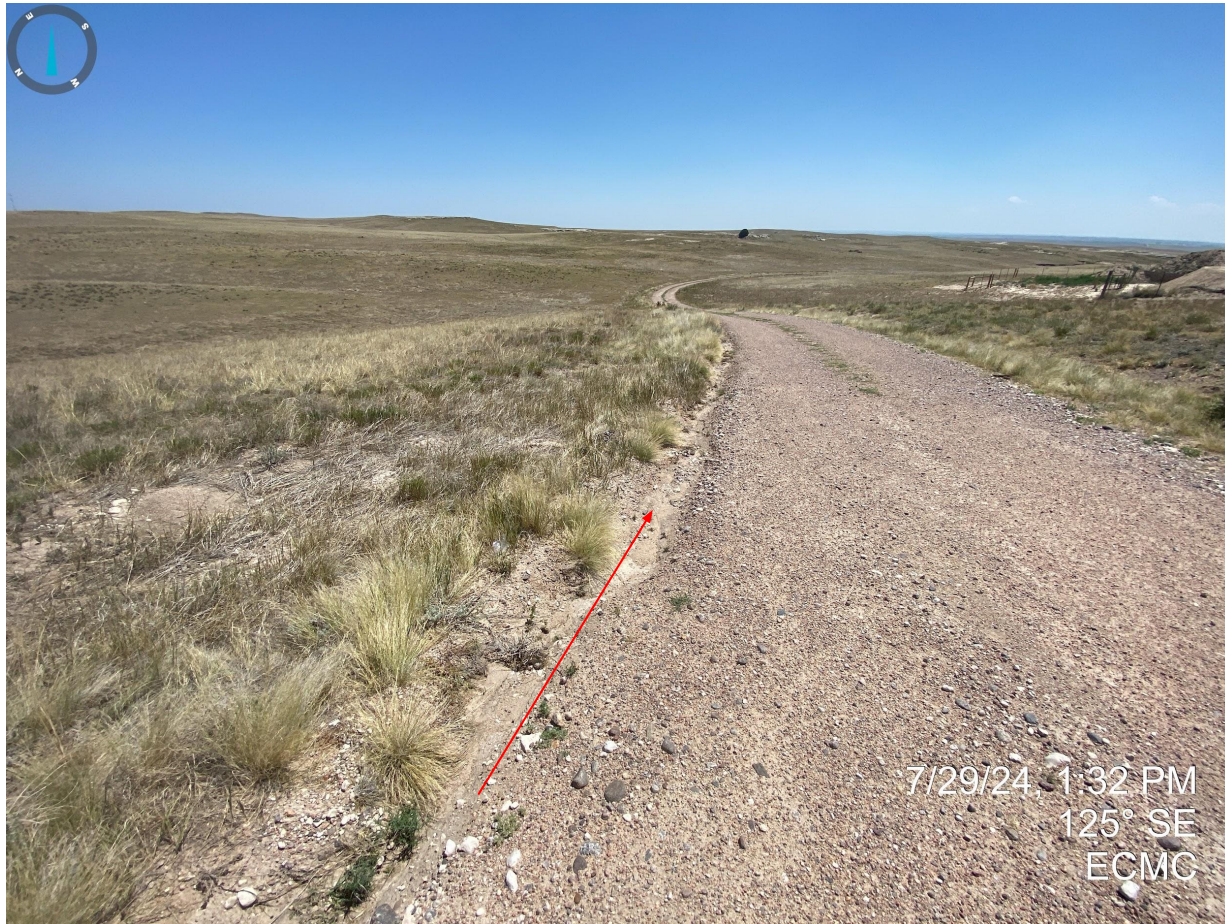
Photo 5. Taken from the access road northeast of the pit. See comments in Photo 3.

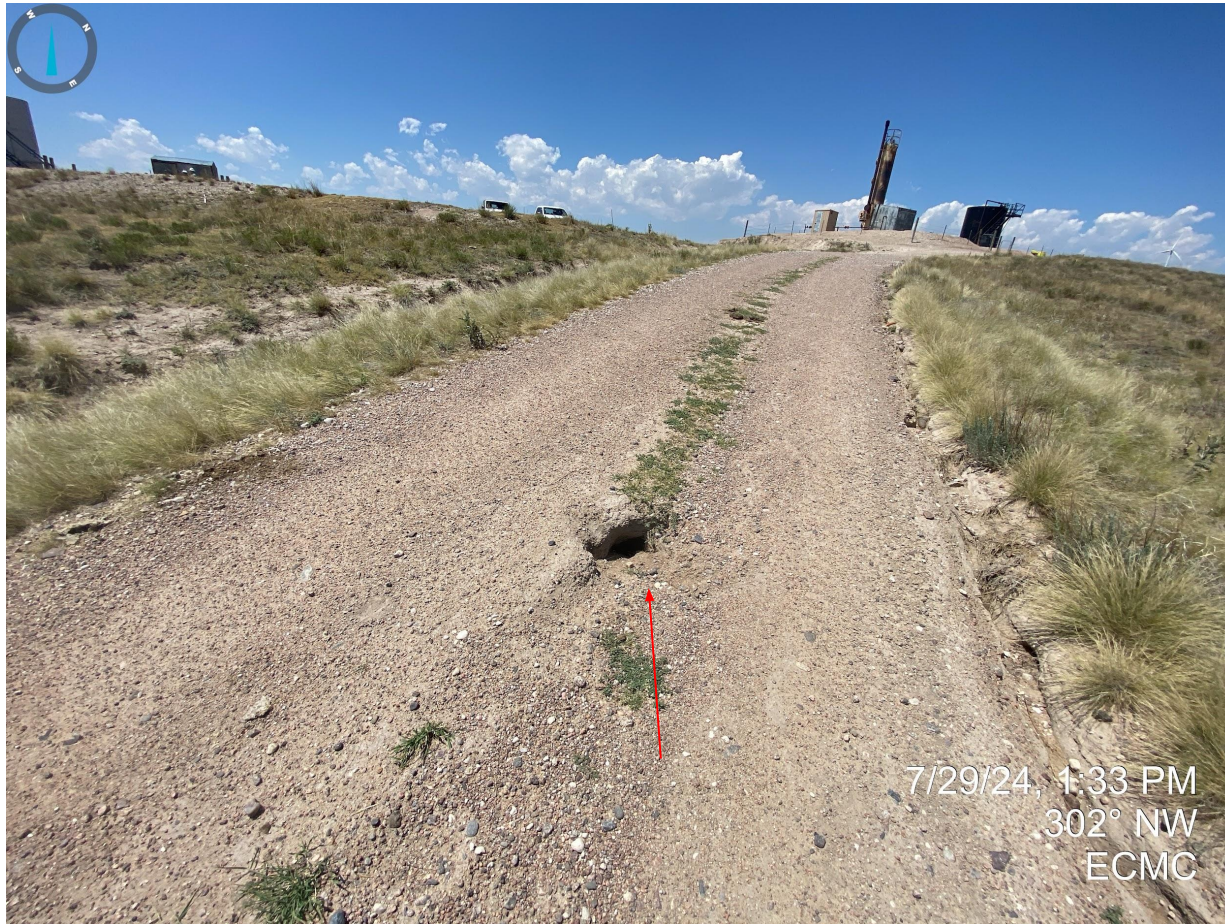
Photo 6. Pothole/subsidence observed along the access road.

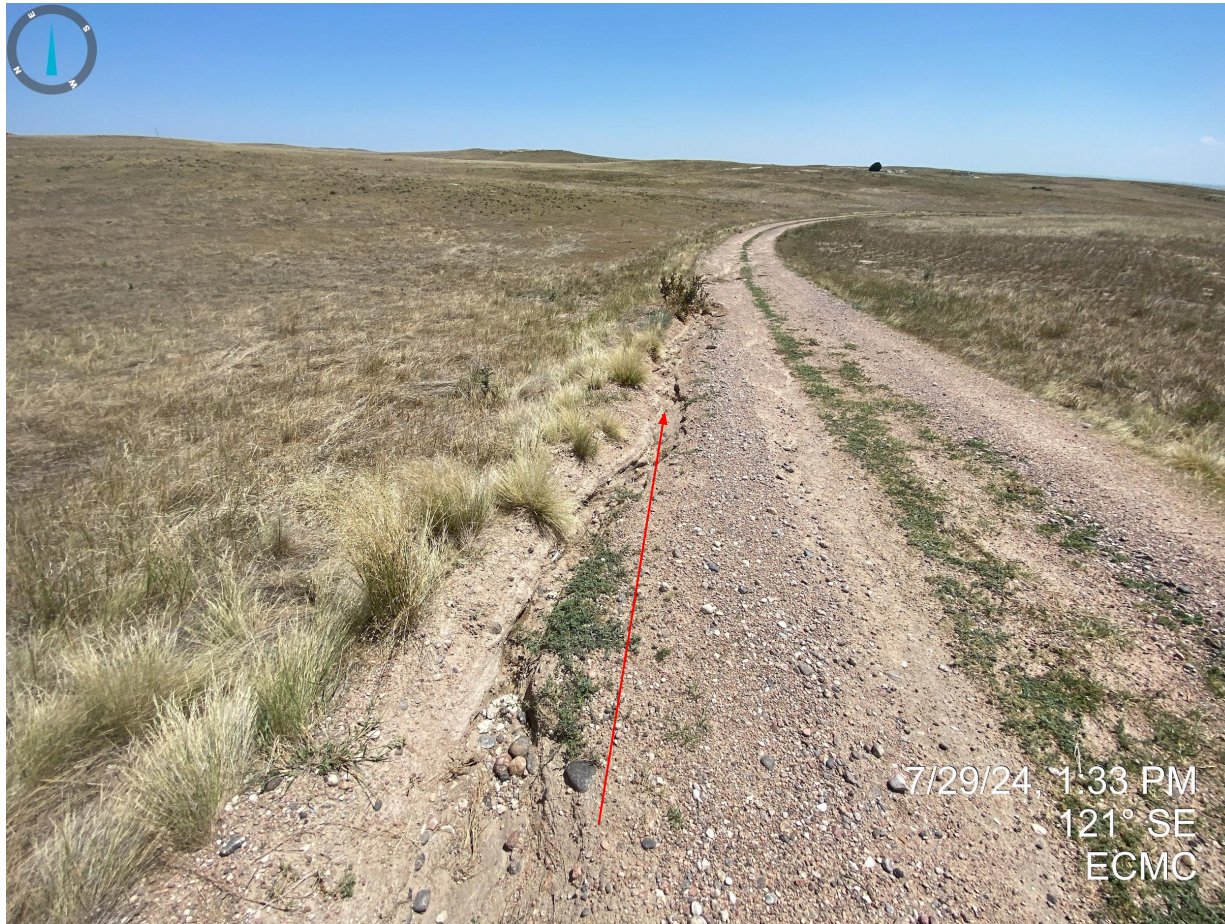
Photo 7. Facing southeast along the access road; see comments in Photo 3.

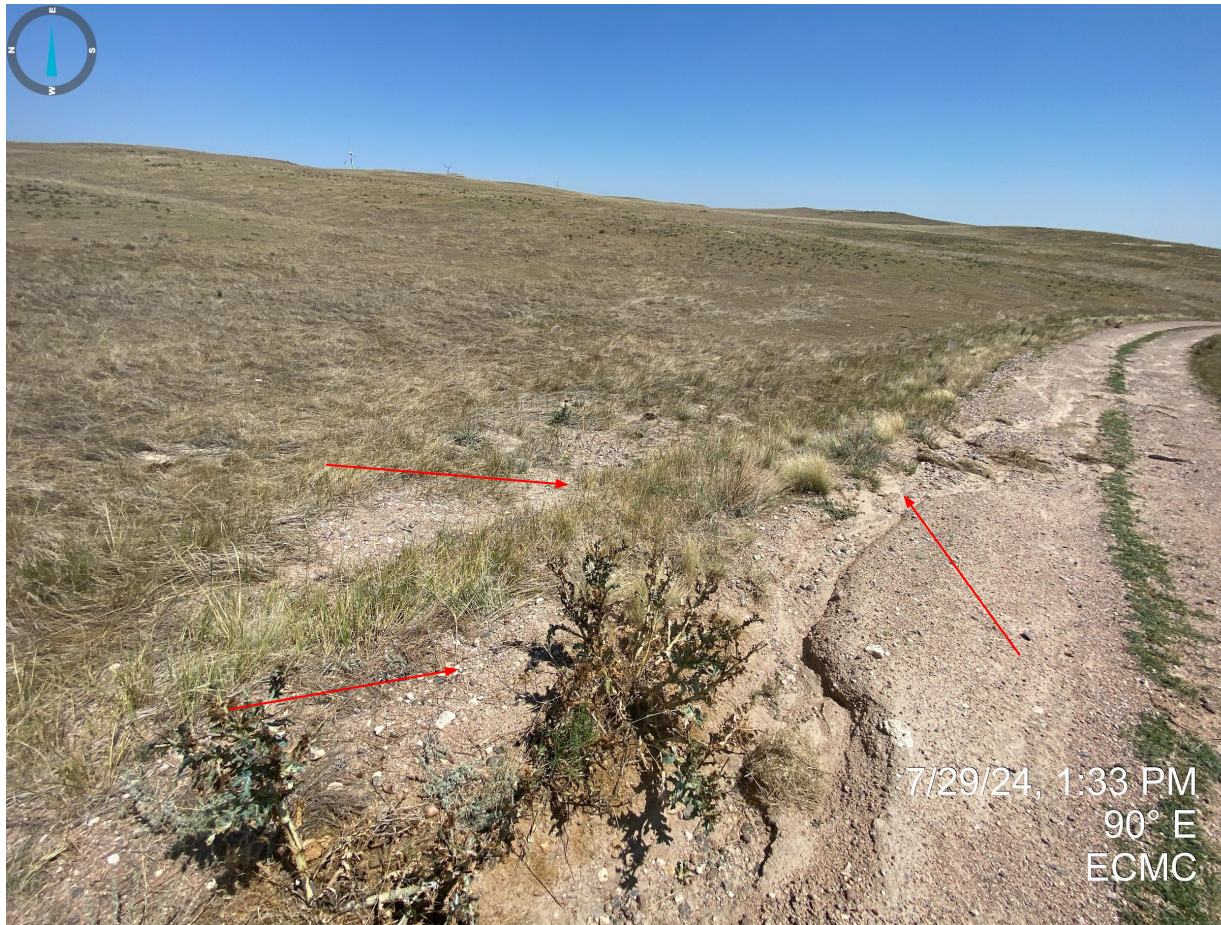
Photo 8. Sediment deposition and erosion degradation along the access road, east of pit.

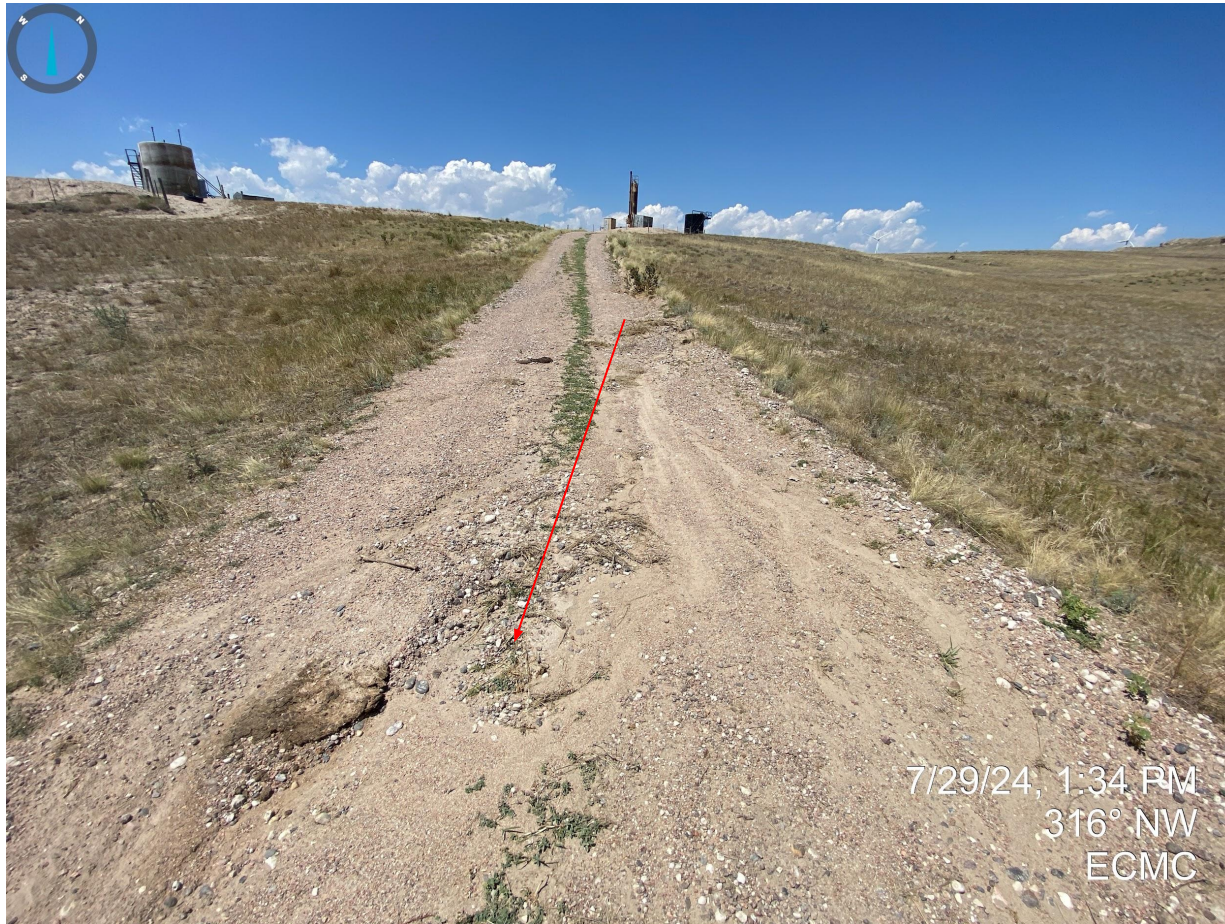
Photo 9. Facing northwest along the access road; see comments in Photo 3.

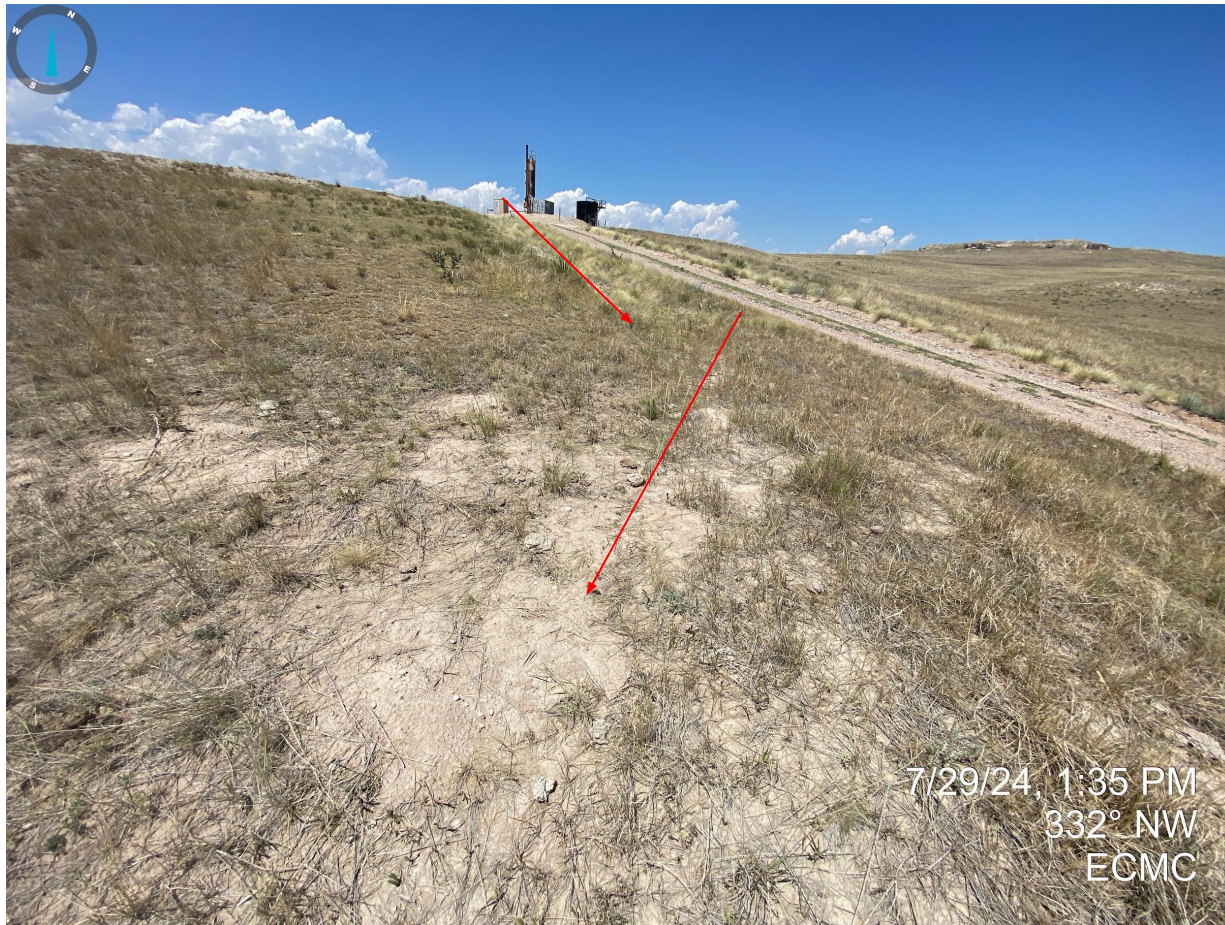
Photo 10. Sediment deposition and erosion degradation south of the access road, near the pit.

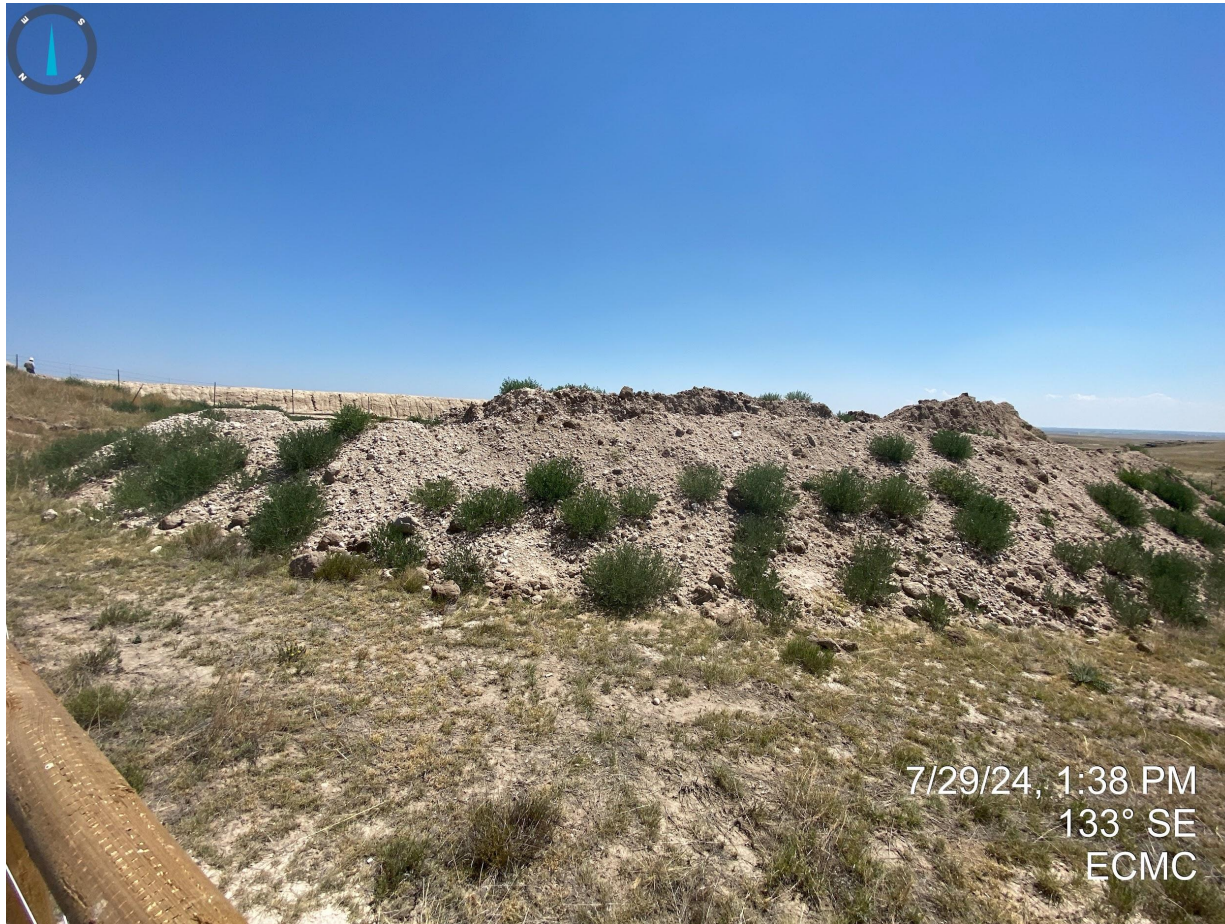
Photo 11. Taken from the north side of the stockpiled soils. No perimeter stormwater control measures/BMPs, or impermeable liners underneath the stockpile were observed during this inspection. Impacted soils appear to have been placed directly on top of undisturbed lands. Additionally, it does not appear that topsoil has been salvaged Per Rule 1002.b prior to stockpiling the soil on undisturbed portions of land.

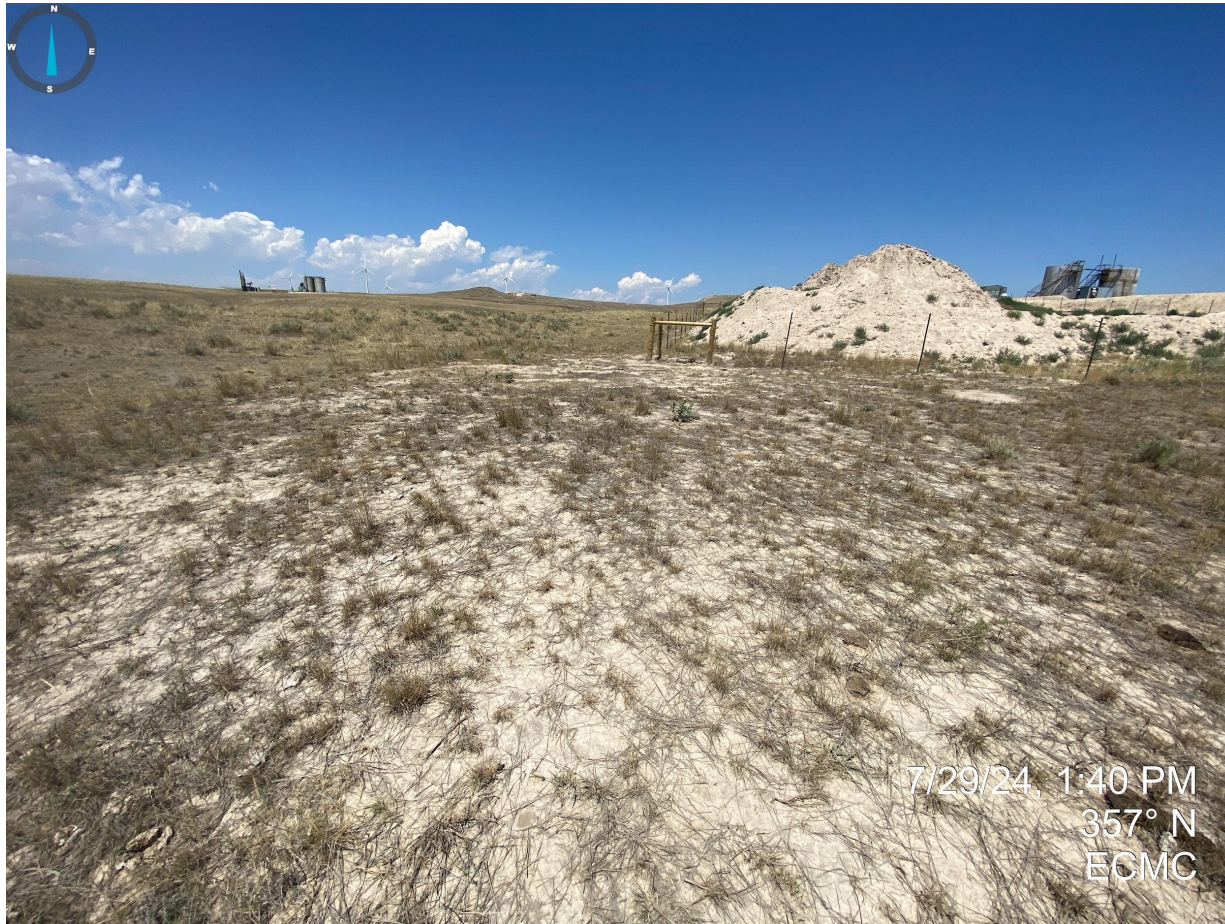
Photo 12. Sediment deposition resulting from unstabilized stockpiles, southwest corner of the pit.

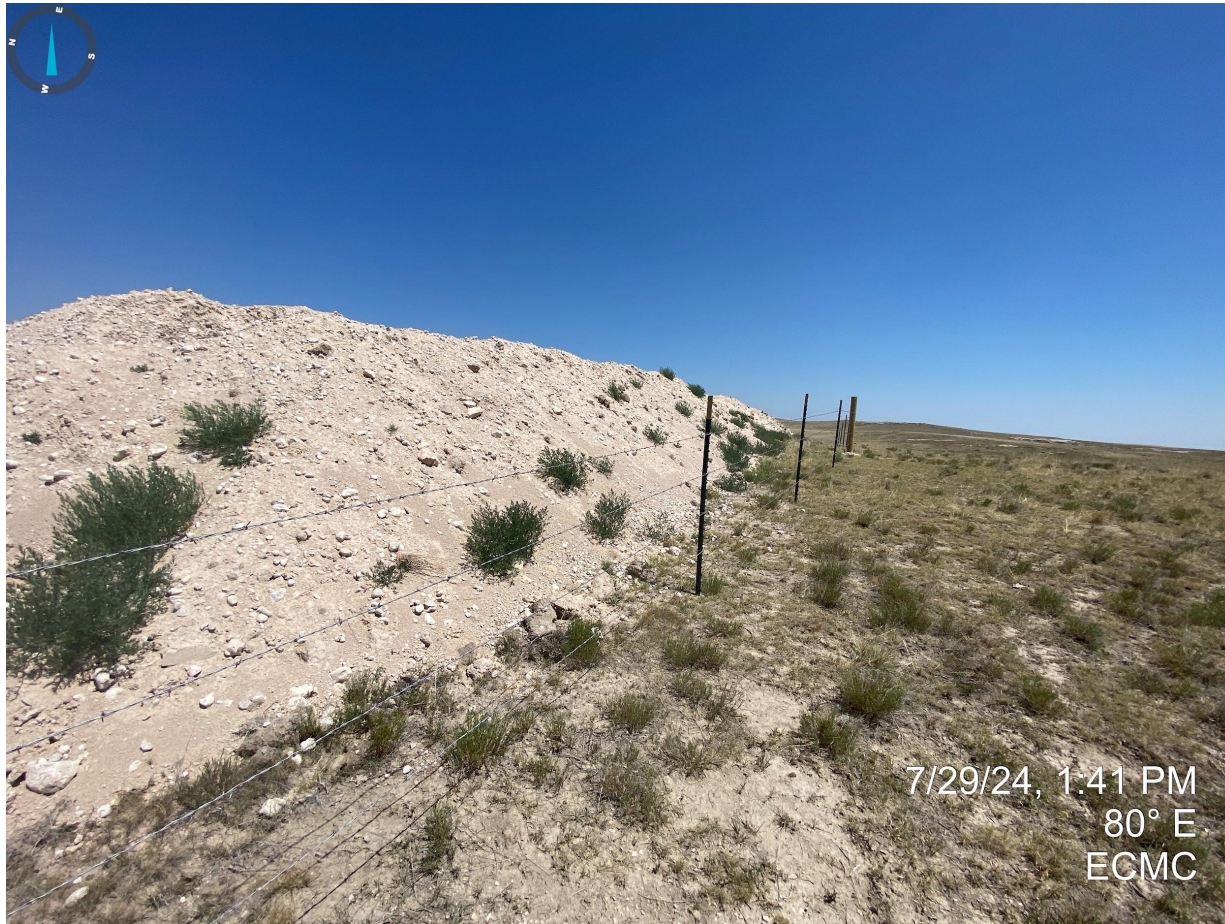
Photo 13. Taken from the southern portion of the stockpiled material; see comments in Photo 11.

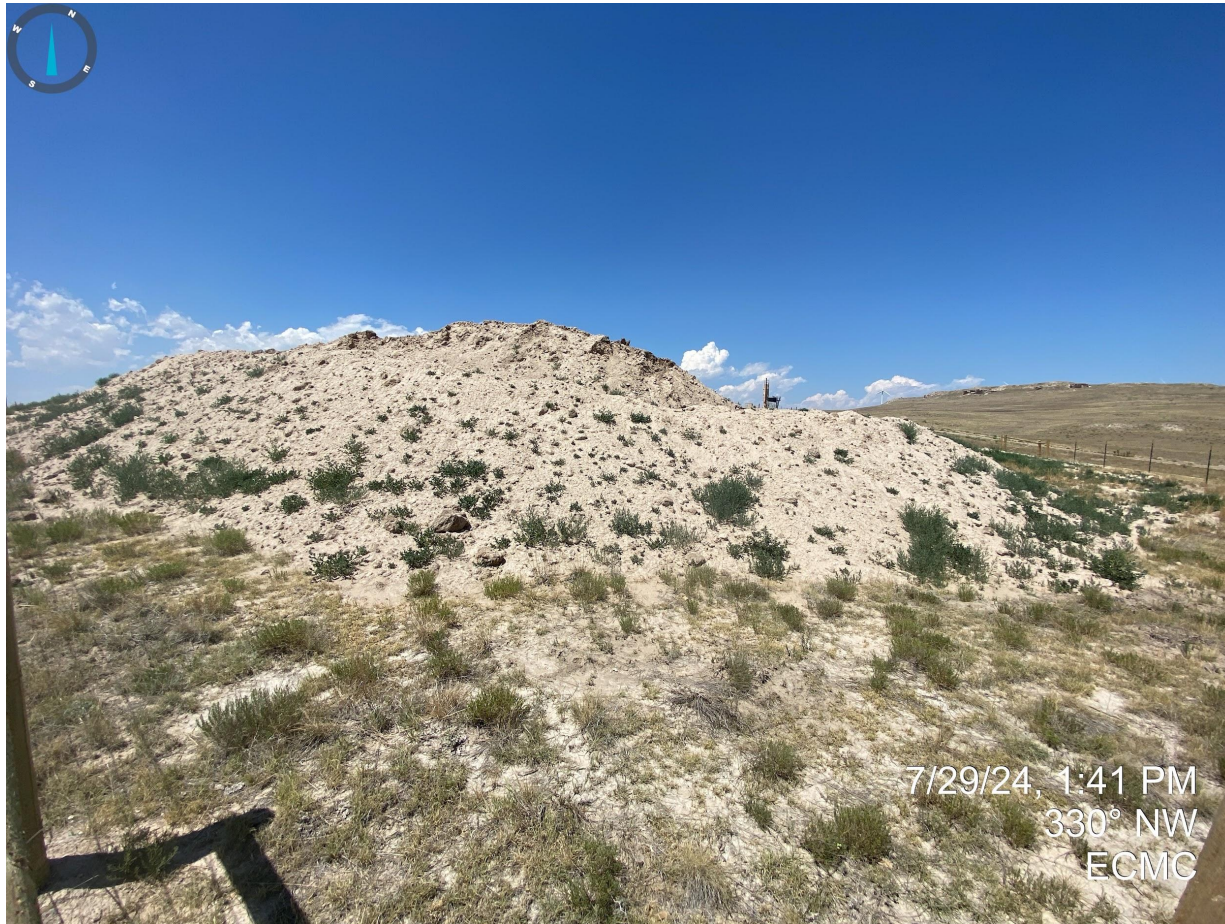
Photo 14. Taken from the southeast corner of the stockpiled material; see comments in Photo 11.

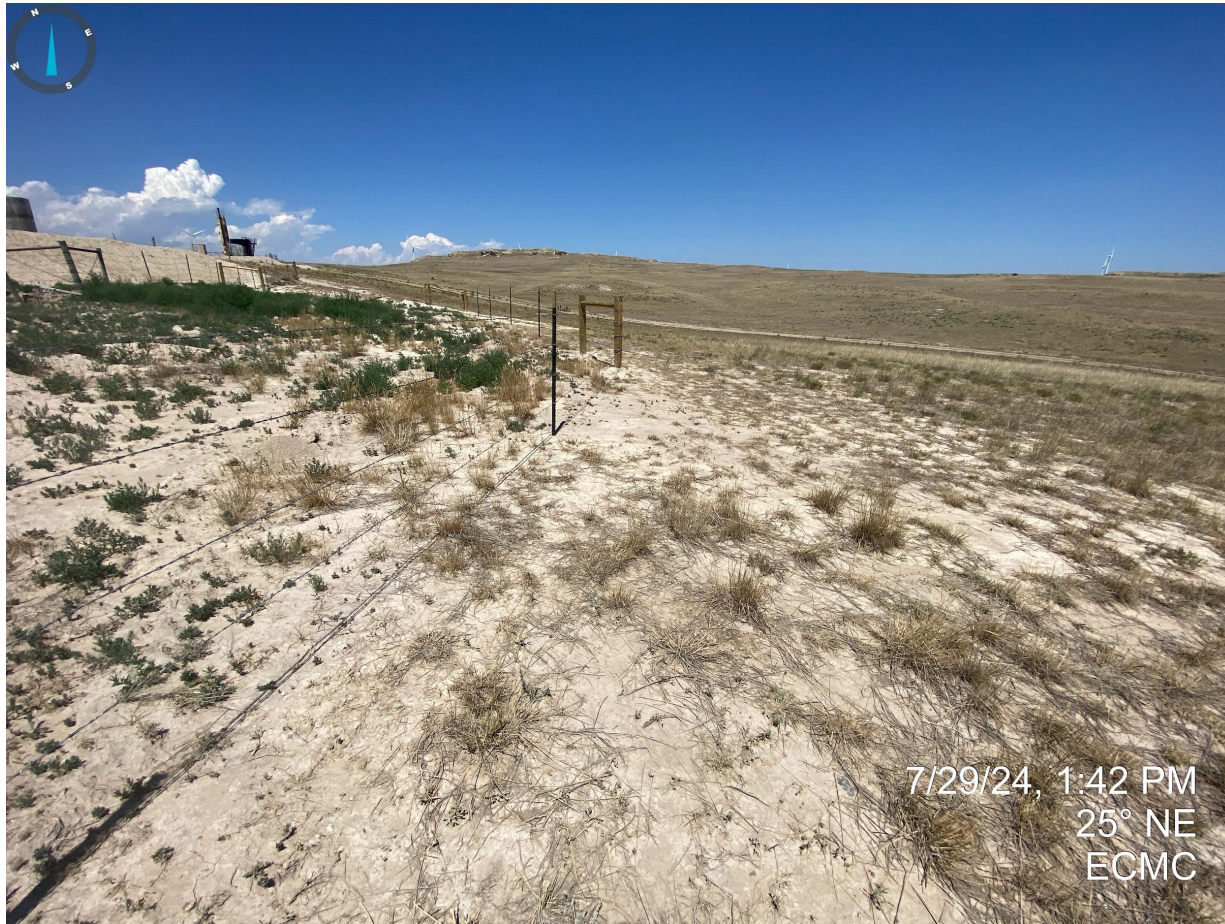
Photo 15. Taken southeast of the excavated area and stockpiled material; see comments in Photo 11.

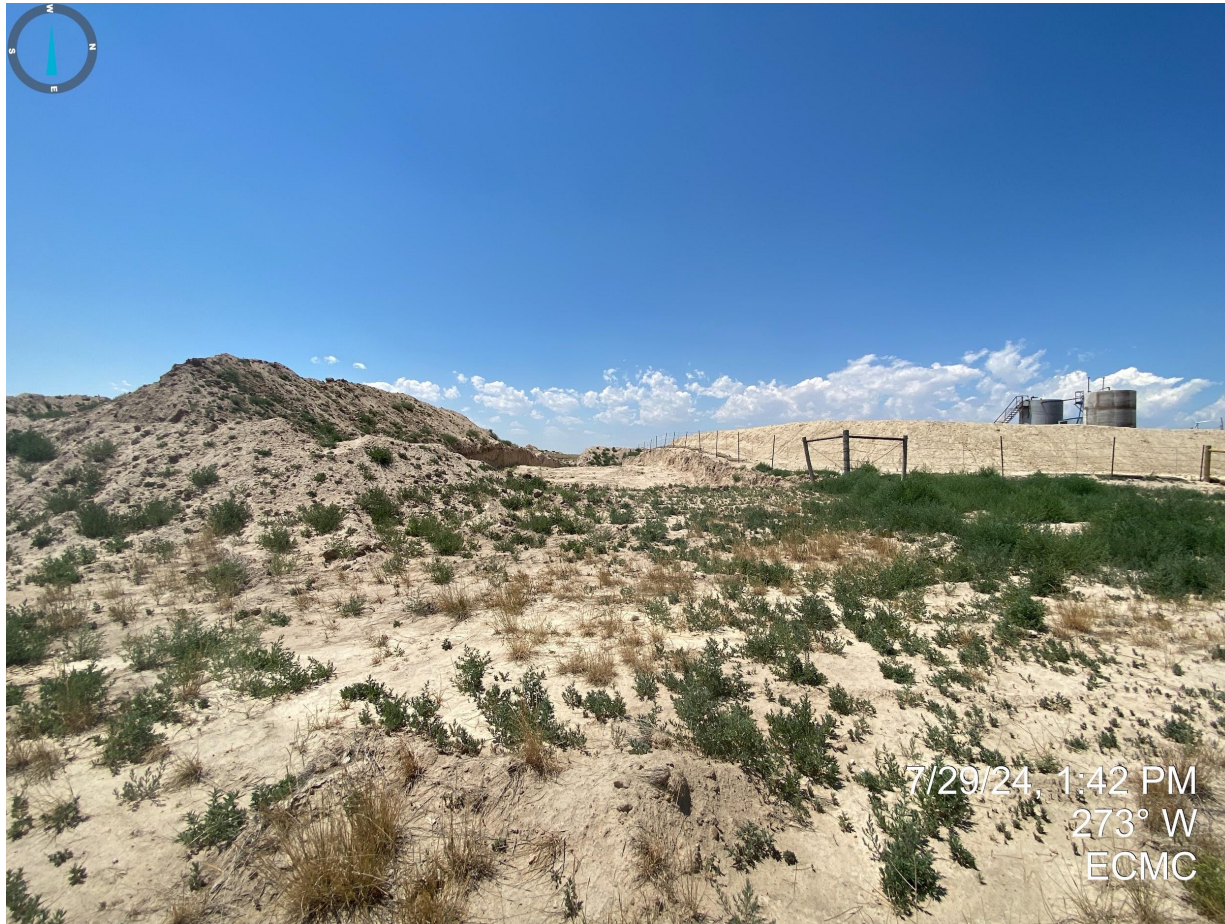
Photo 16. Undesirable vegetation (kochia and russian thistle) observed throughout the location and excavation areas.

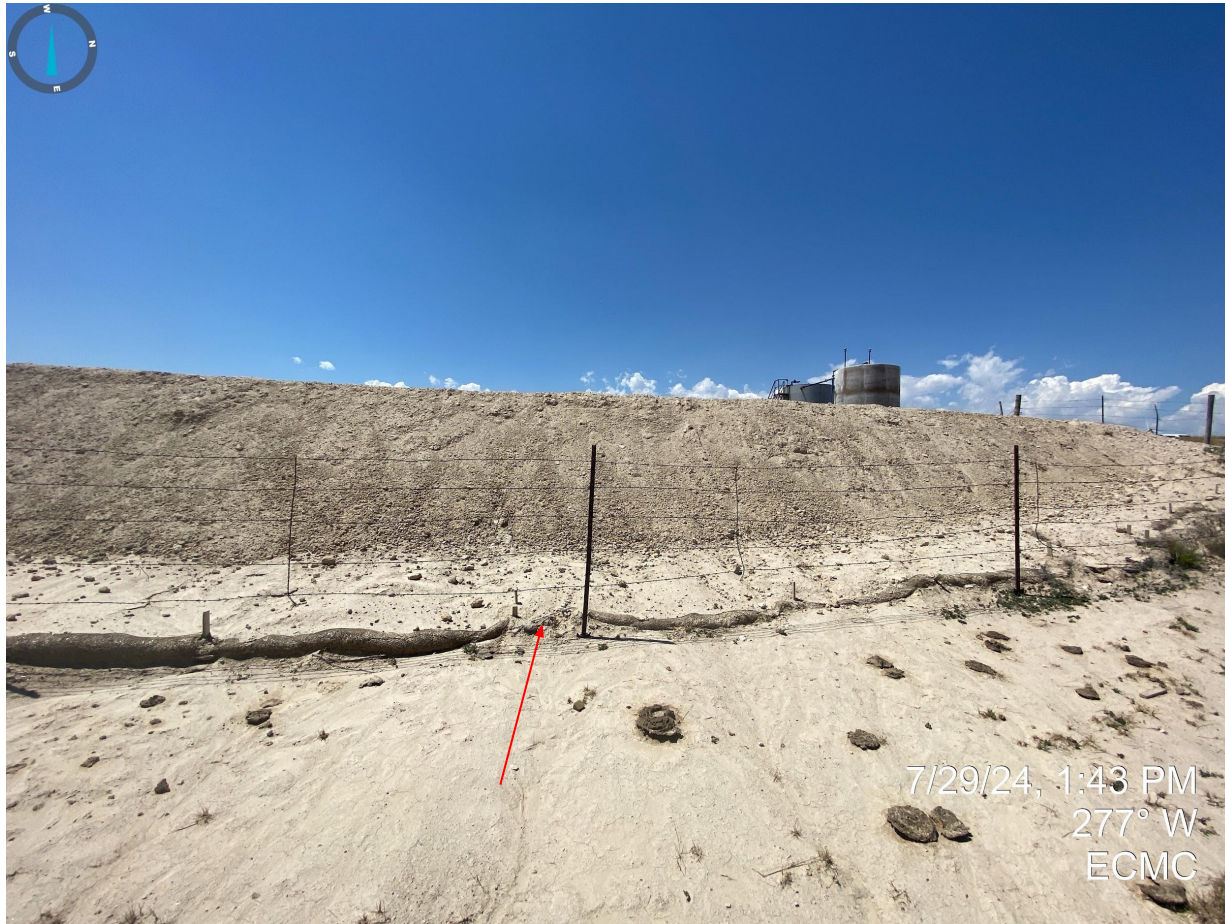
Photo 17. Erosion degradation appears to have been repaired on the eastern pit walls. Stormwater control measures remain inadequate.

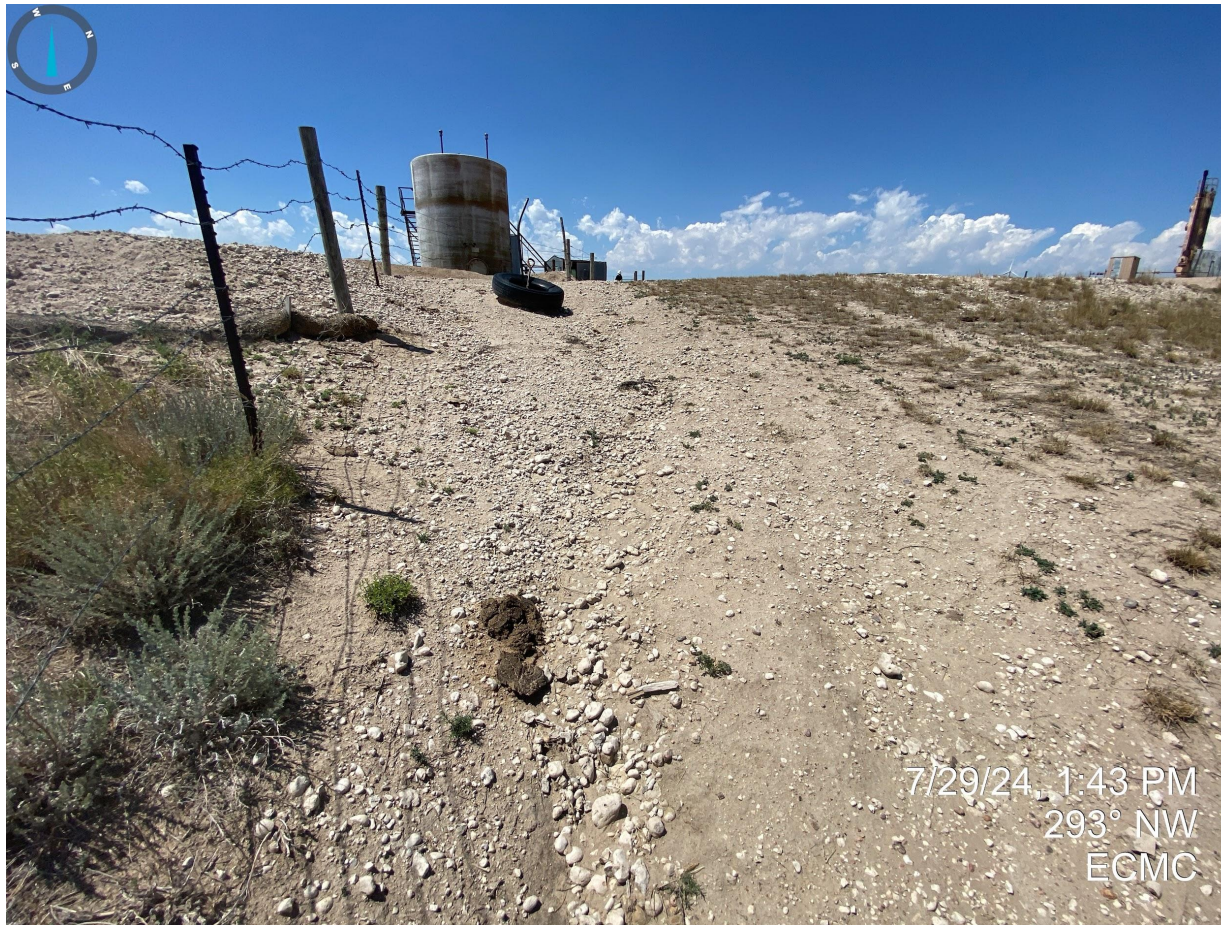
Photo 18. Erosion degradation occurring on the northern/eastern portion of the production areas, near the pit; stormwater control measures remain inadequate.

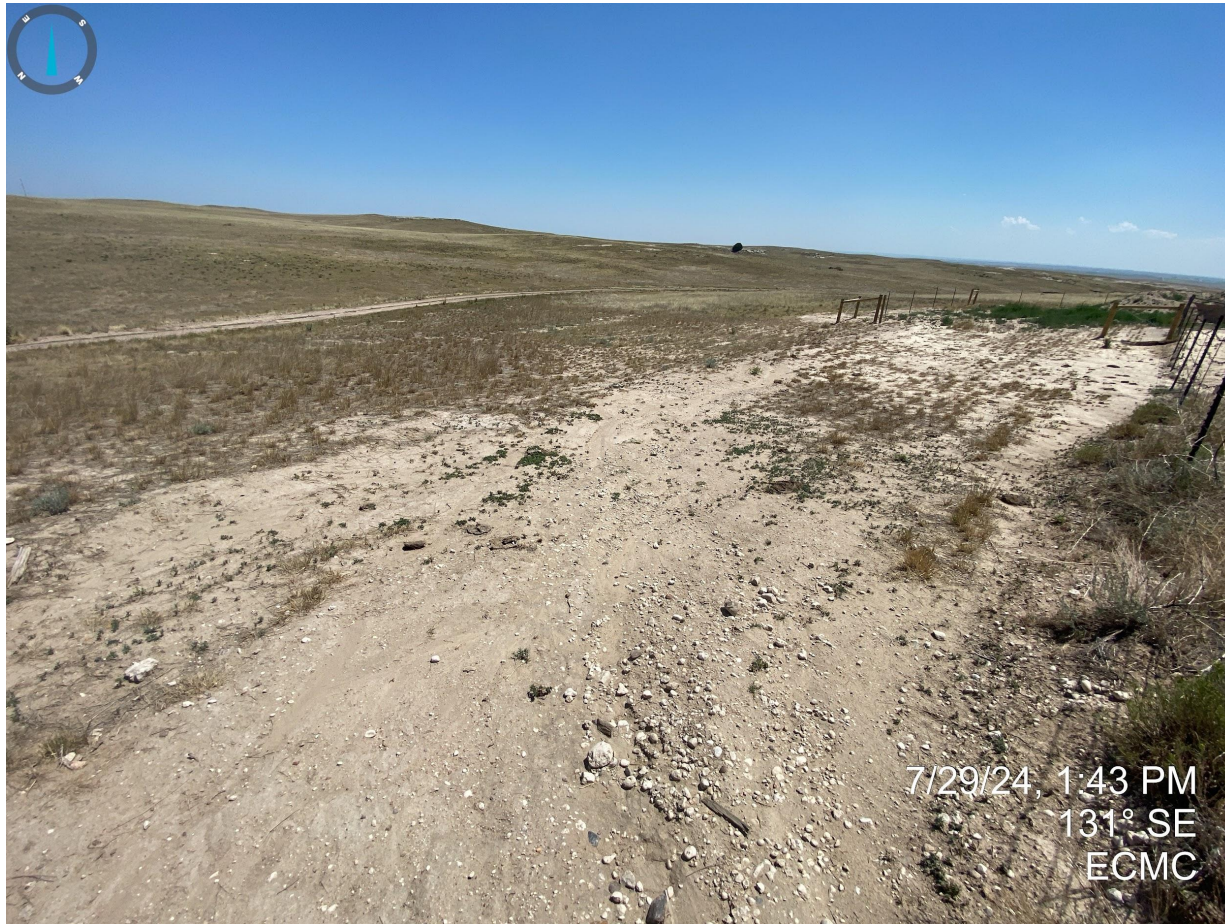
Photo 19. Continued from Photo 18, facing southeast.

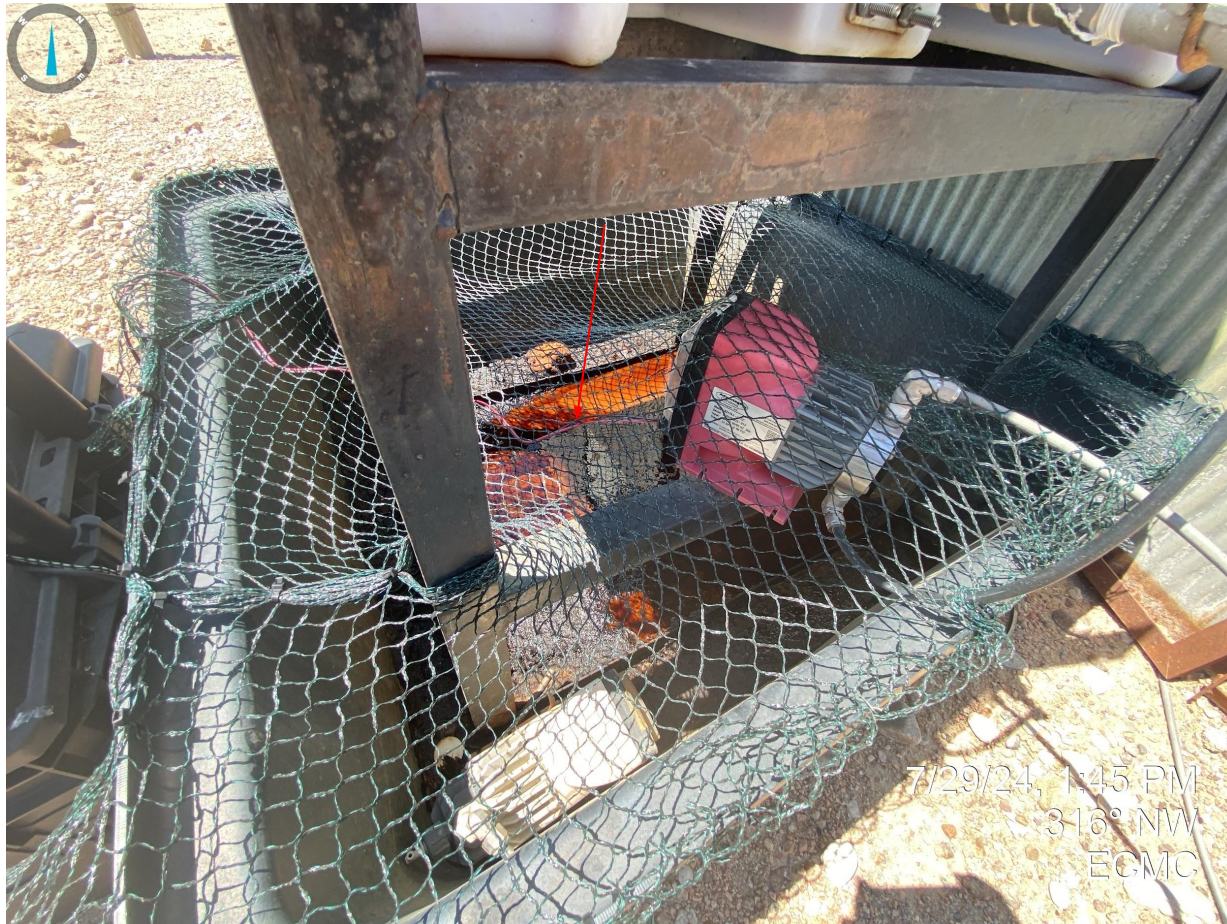
Photo 20. Free fluids observed within secondary containment have not been properly disposed of.
