**KT Resources LLC
Ant Hill Unit 19-44
Location ID: 316310**

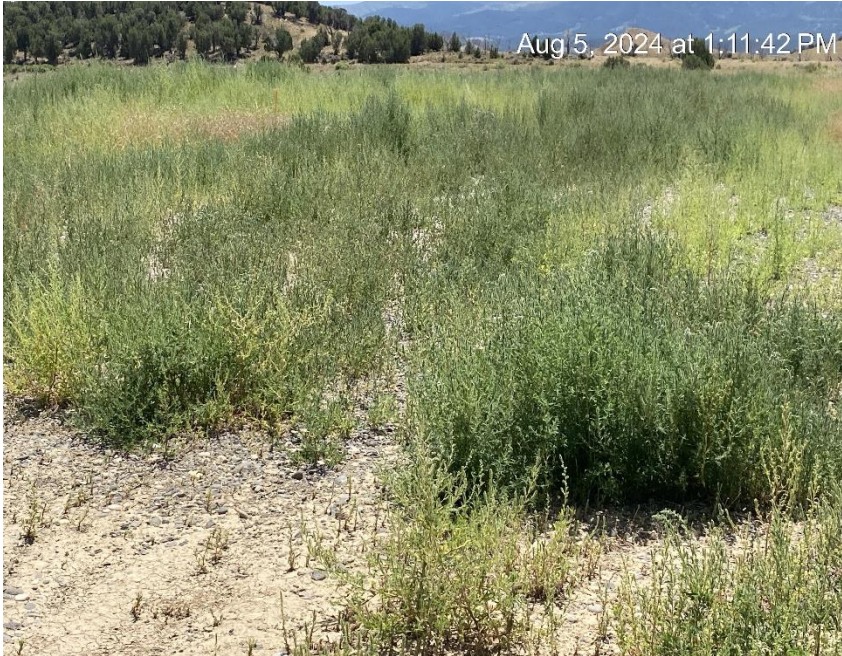
Weeds

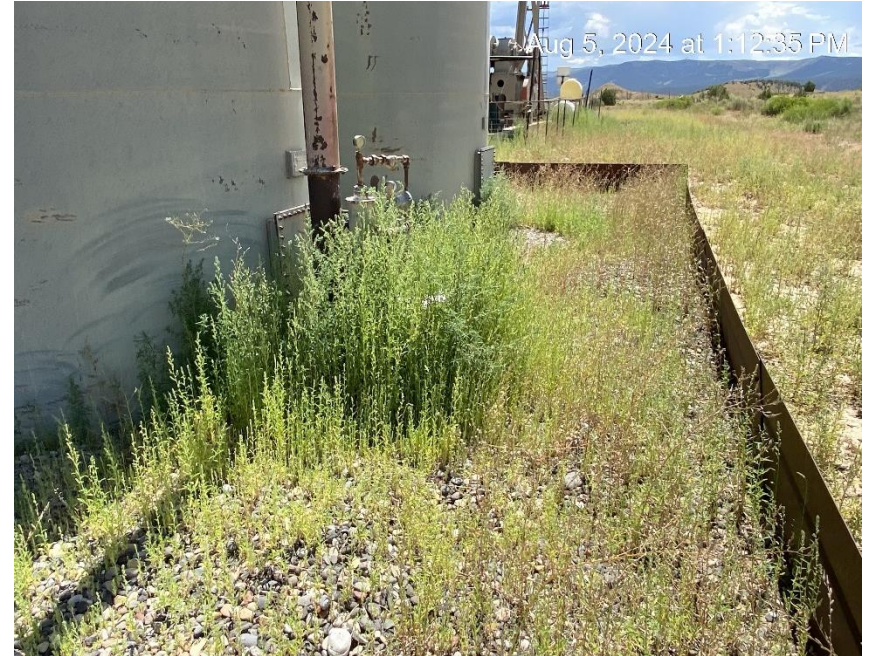
Weeds

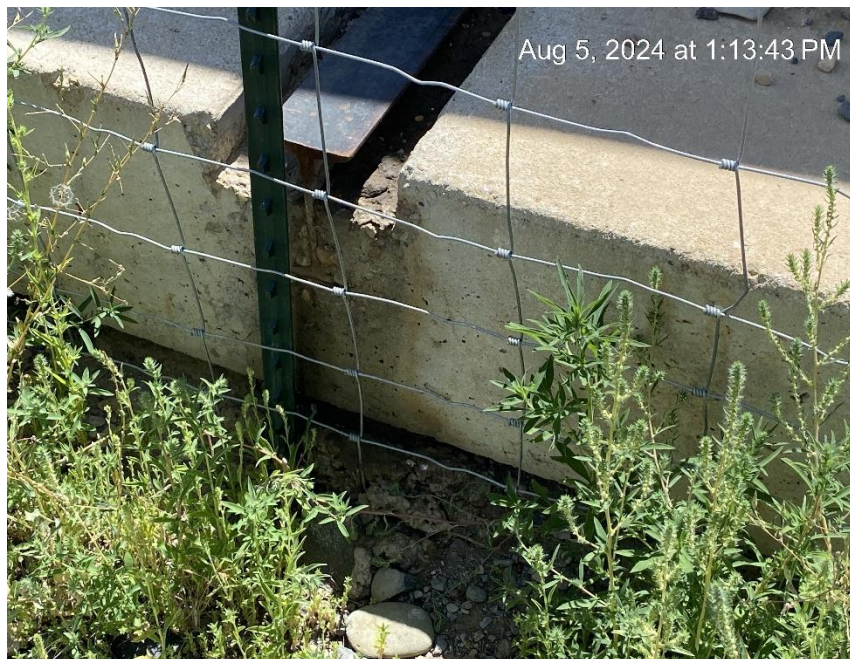
Oily waste and stained soil

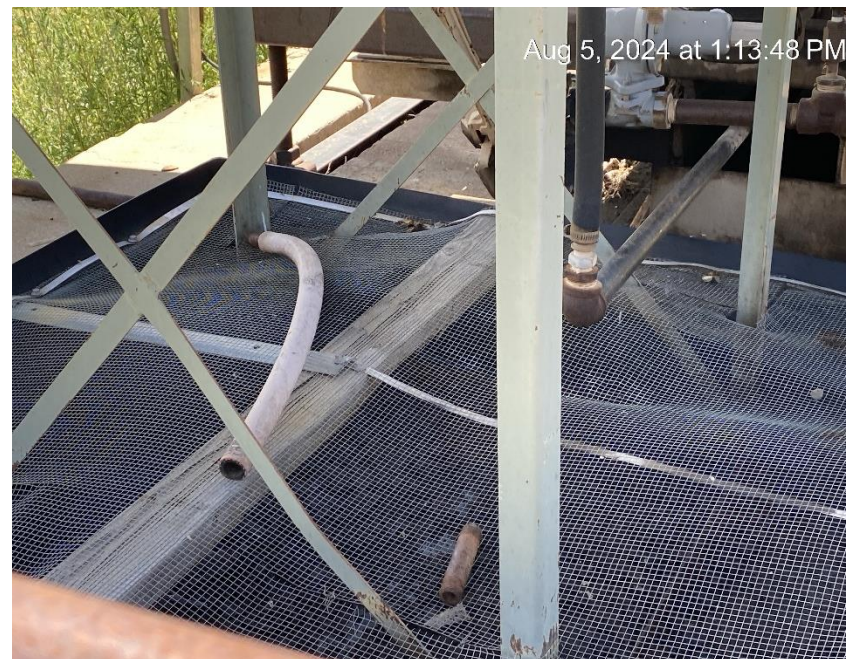
Debris

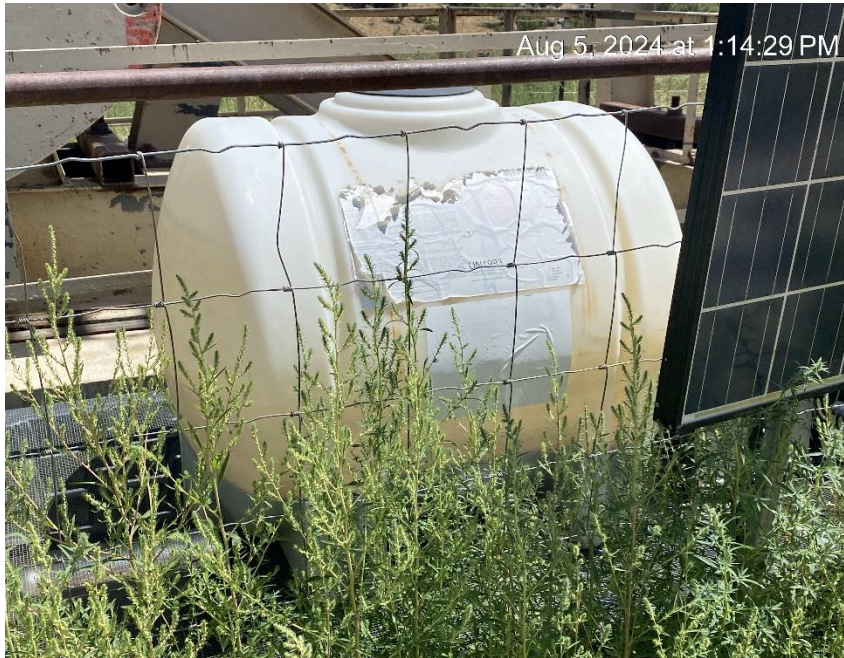
Label illegible

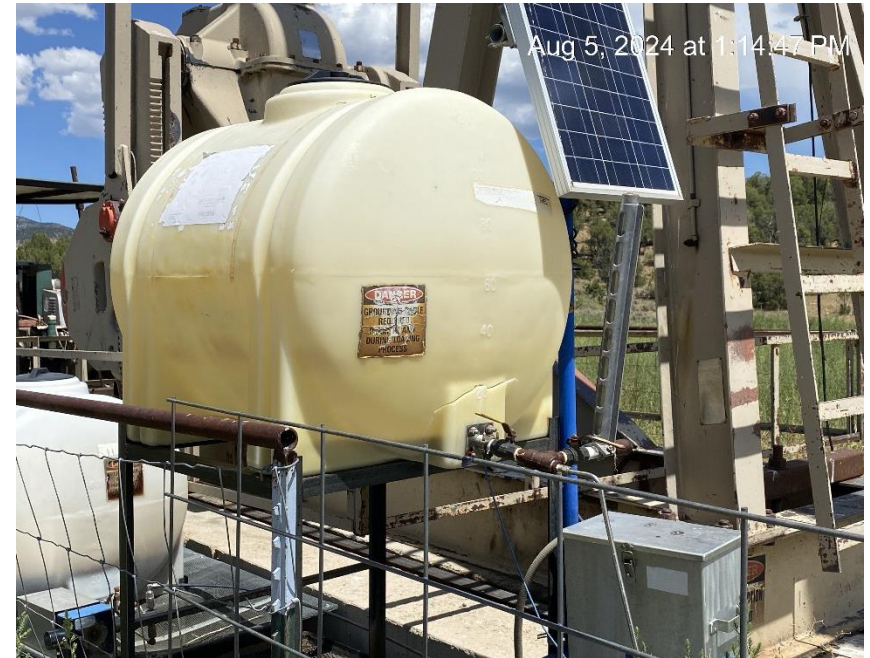
Damaged and unusable equipment

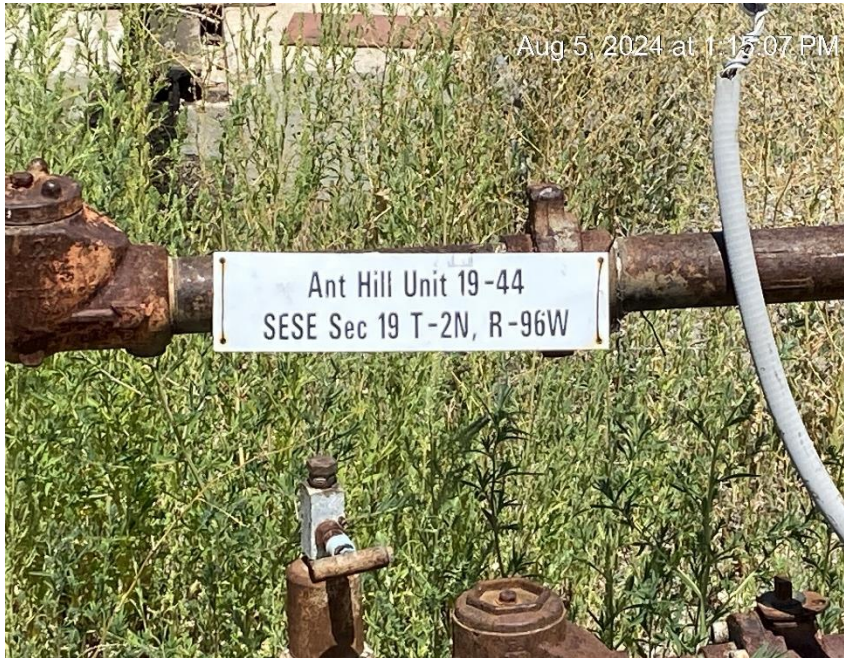
Additional information required when replaced

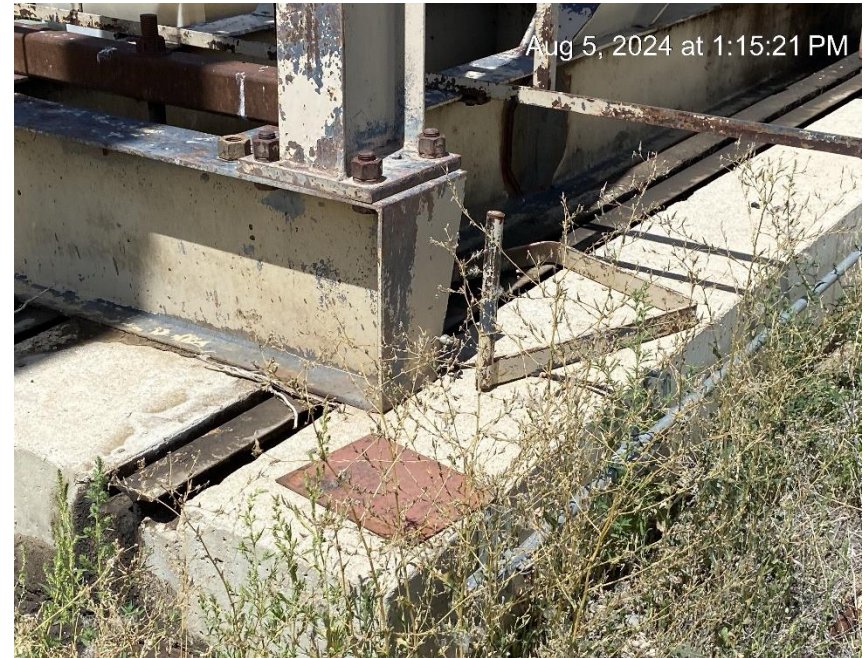
Debris

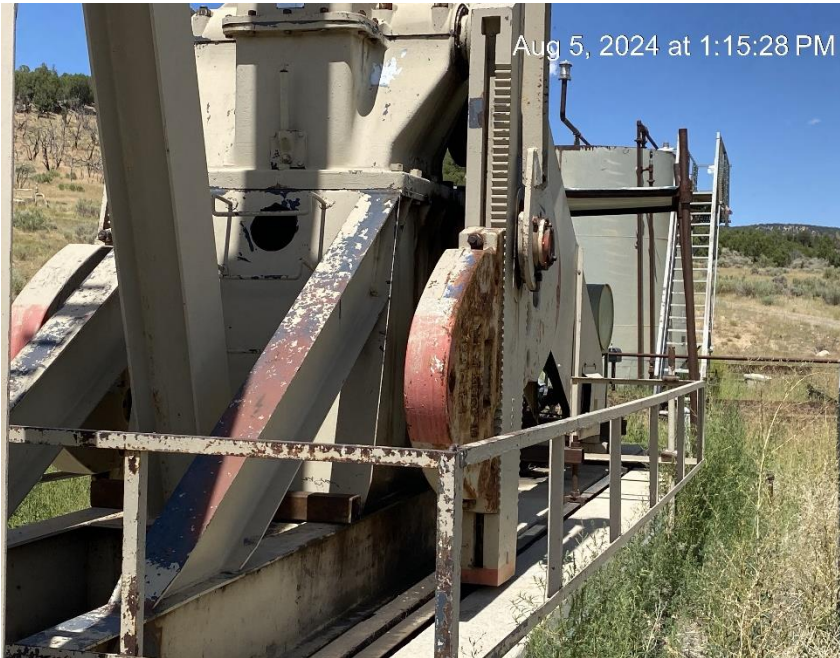
Equipment leak

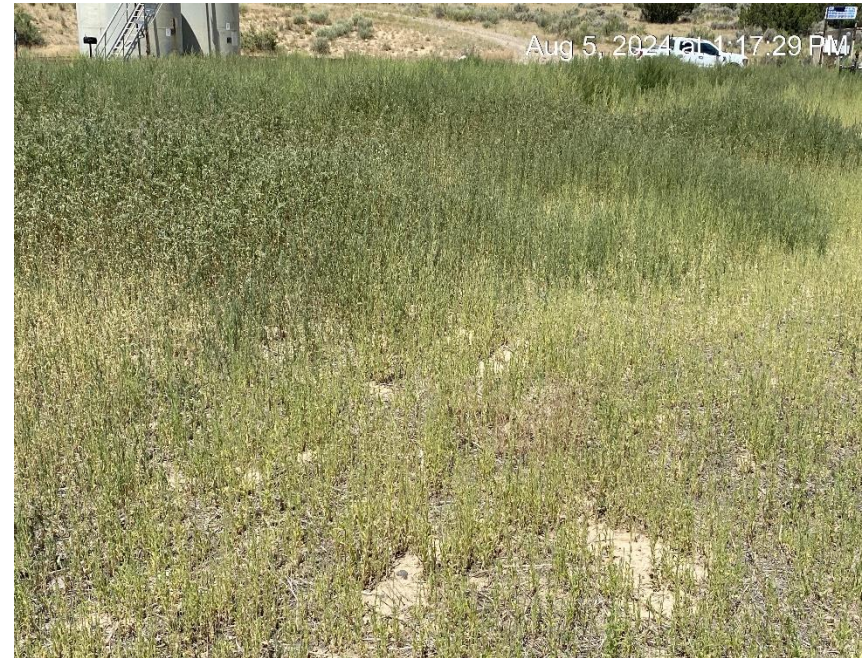
Weeds

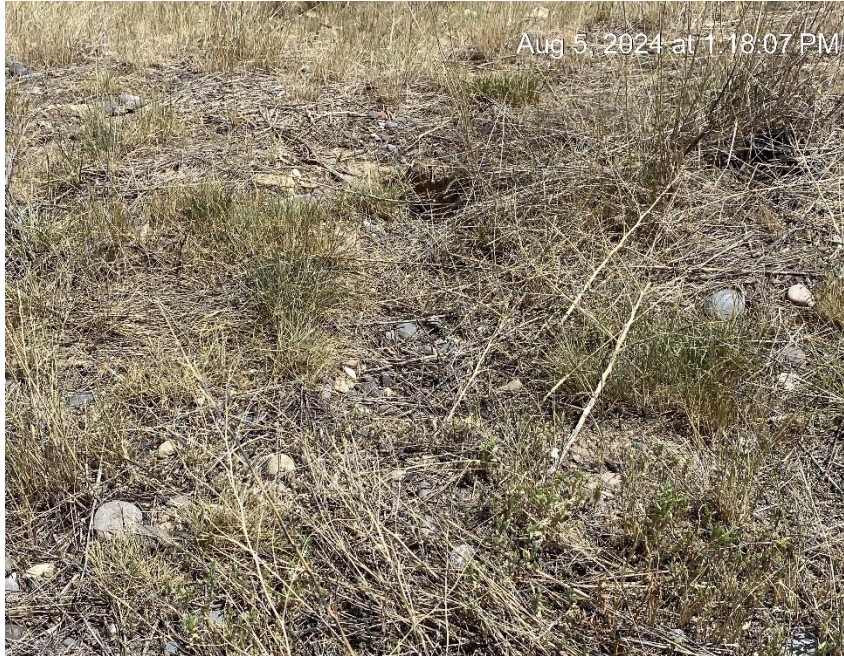
Erosion and sediment migration

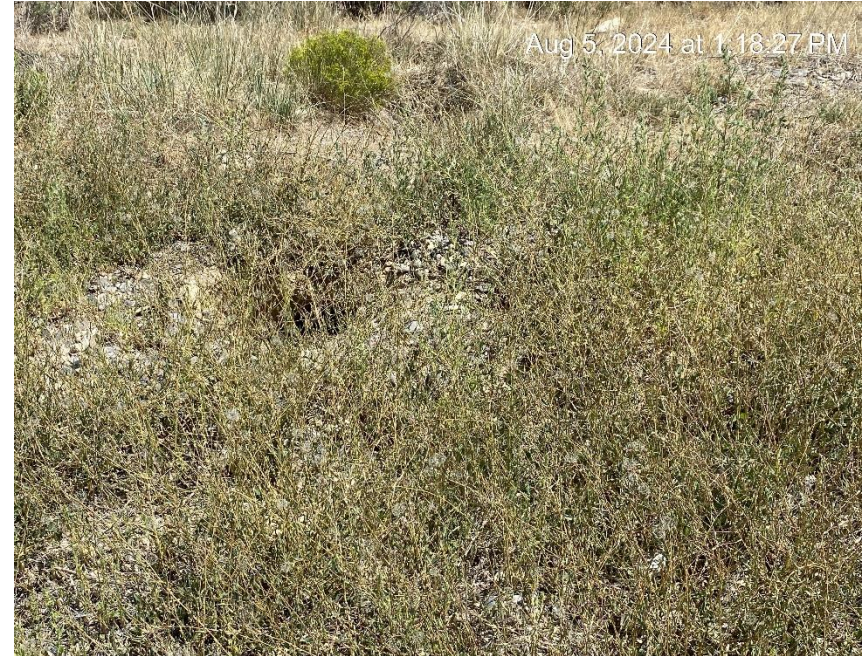
Erosion and sediment migration

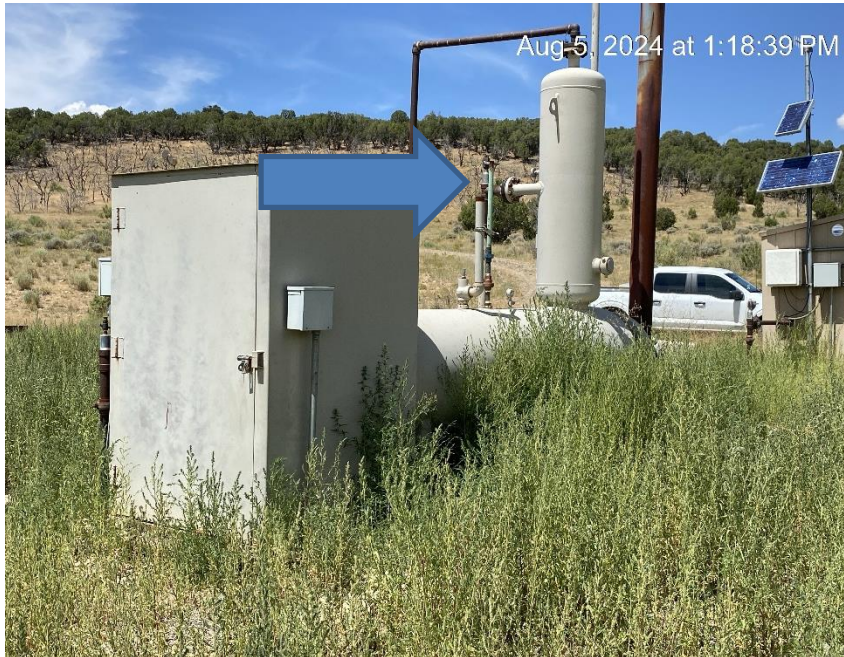
Weeds. Relief risers missing caps

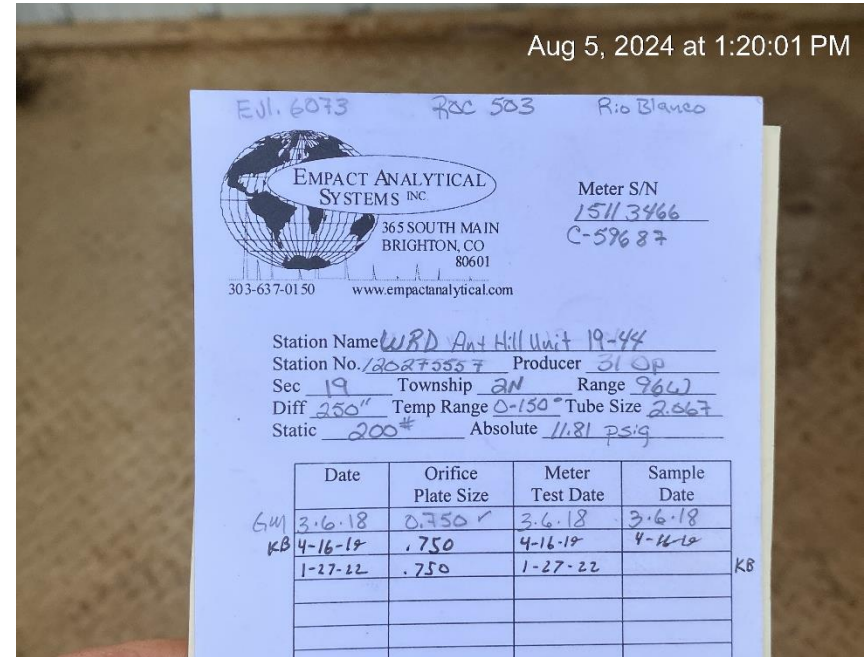
Calibration overdue.
