Inspection Photos

API: 043-06231

Operator: AUSCO PETROLEUM INC

Inspection Date: 8/5/2024

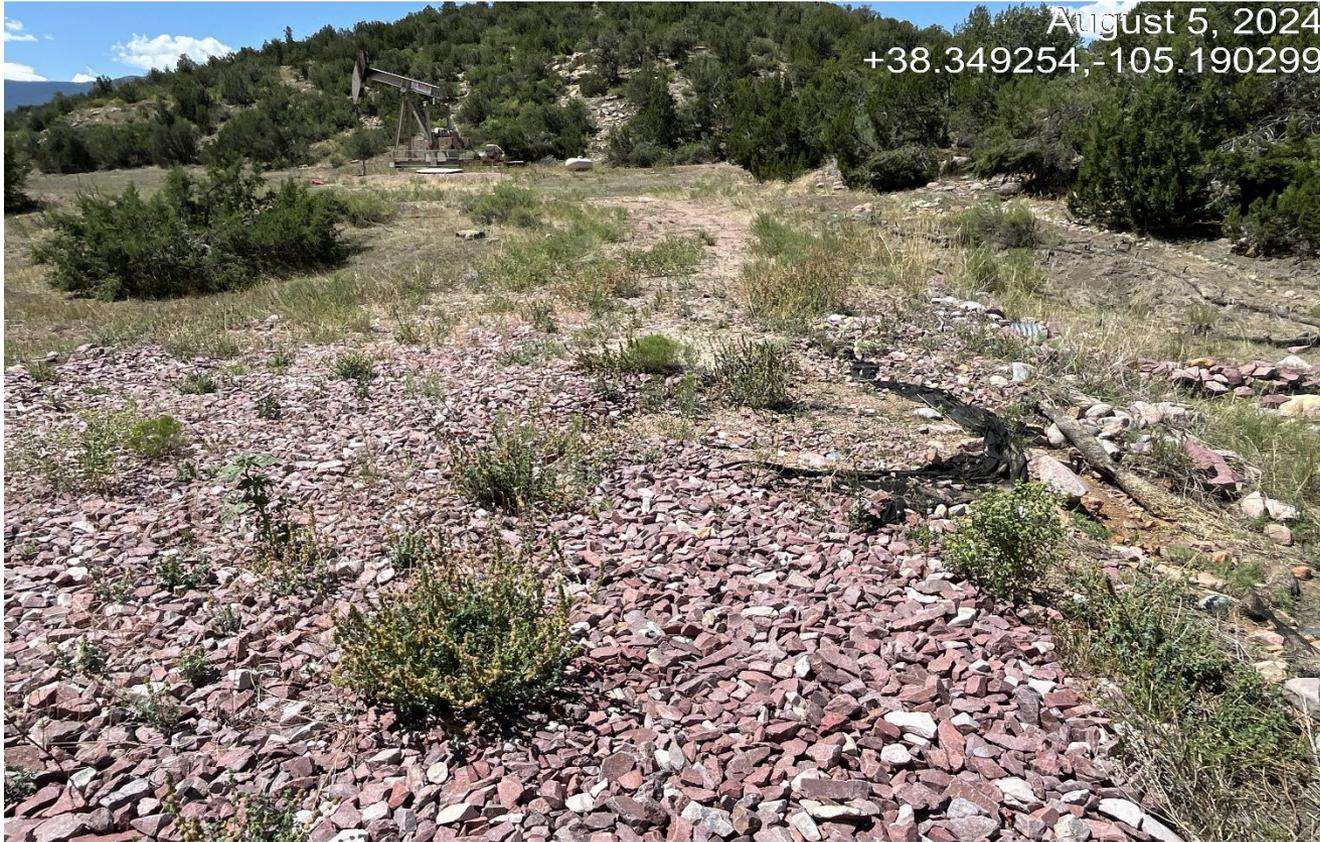
Photo 1. Facing toward the drainage crossing which has been washed out and has not been repaired. Previous corrective action was not completed.

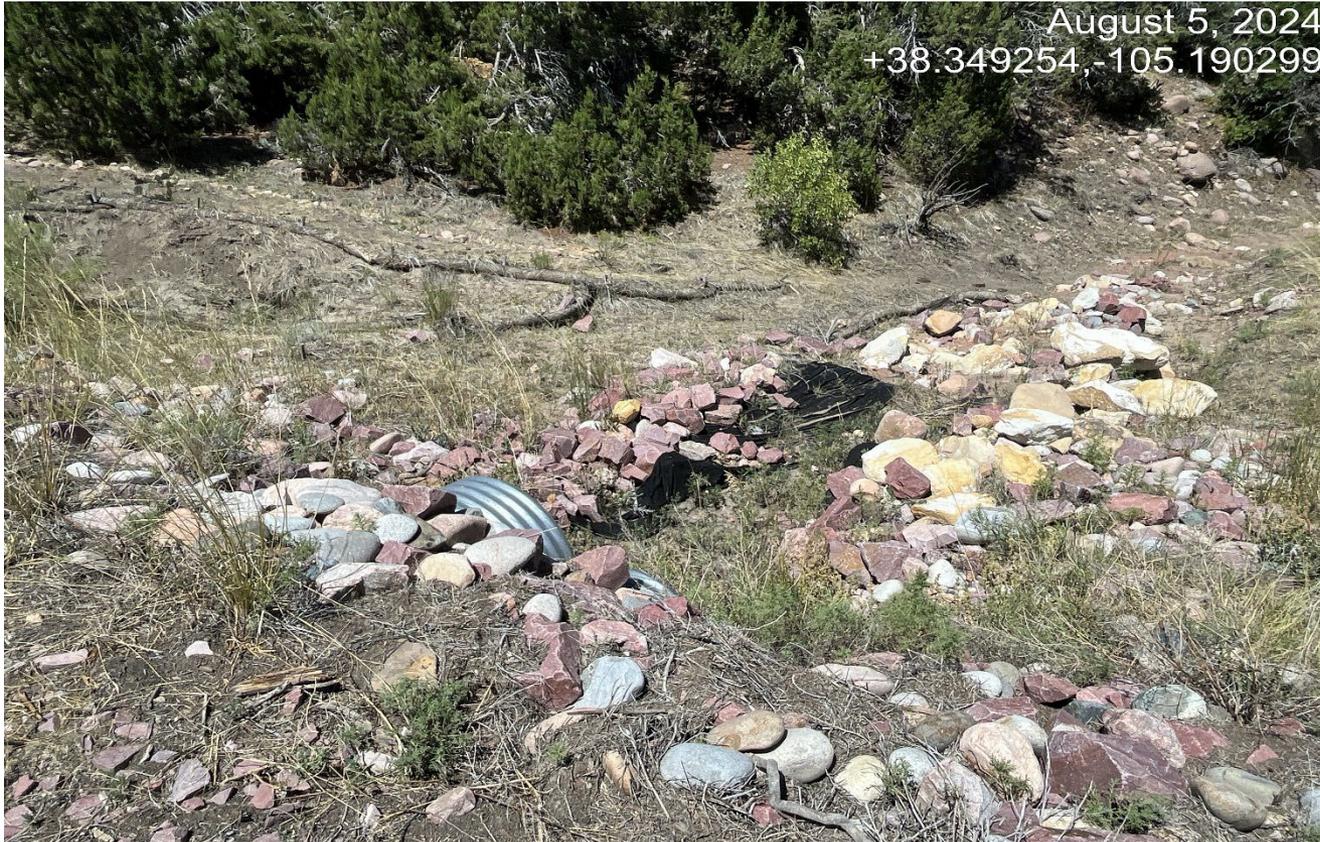
Photo 2. View of culvert outlet shows displaced rock. Outlet protection will need to be reinstated. Previous corrective action was not completed.

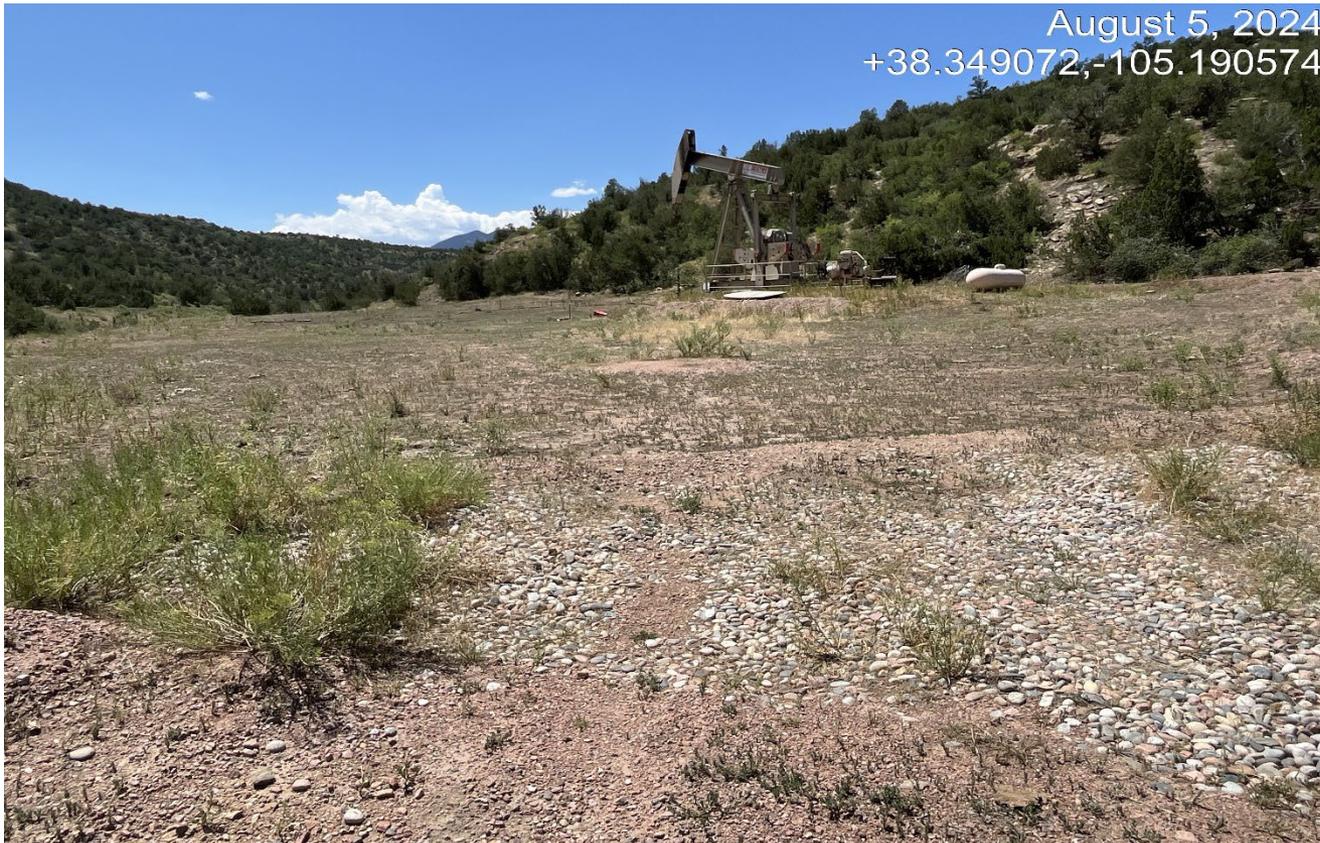
Photo 3. Facing southwest toward the wellsite. There are undesirable weeds around the equipment that need to be controlled. The pupjack is unused equipment that needs to be removed.

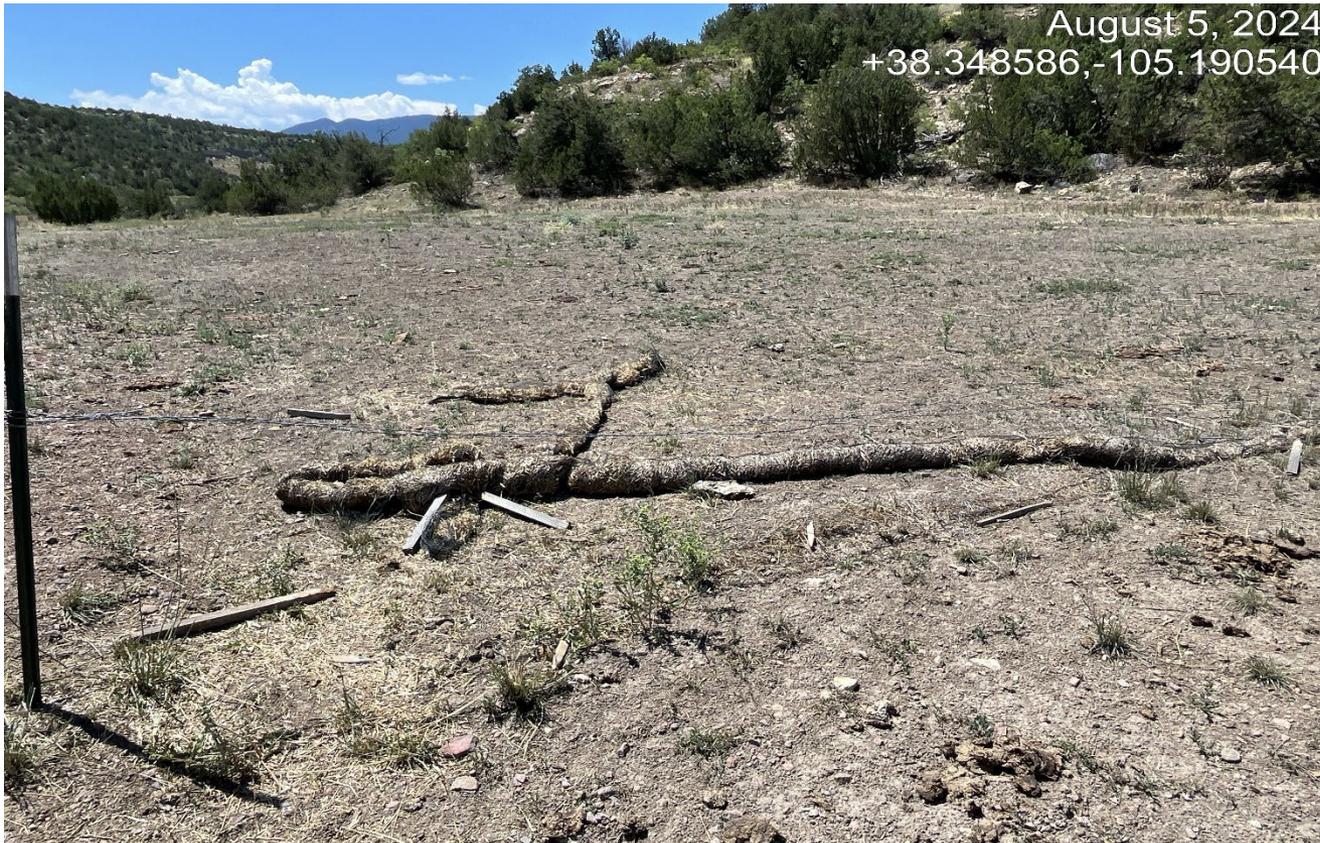
Photo 4. Facing southwest toward the interim reclamation area. The perennial vegetation has not established and the straw wattle is displaced. Previous corrective action was not completed.

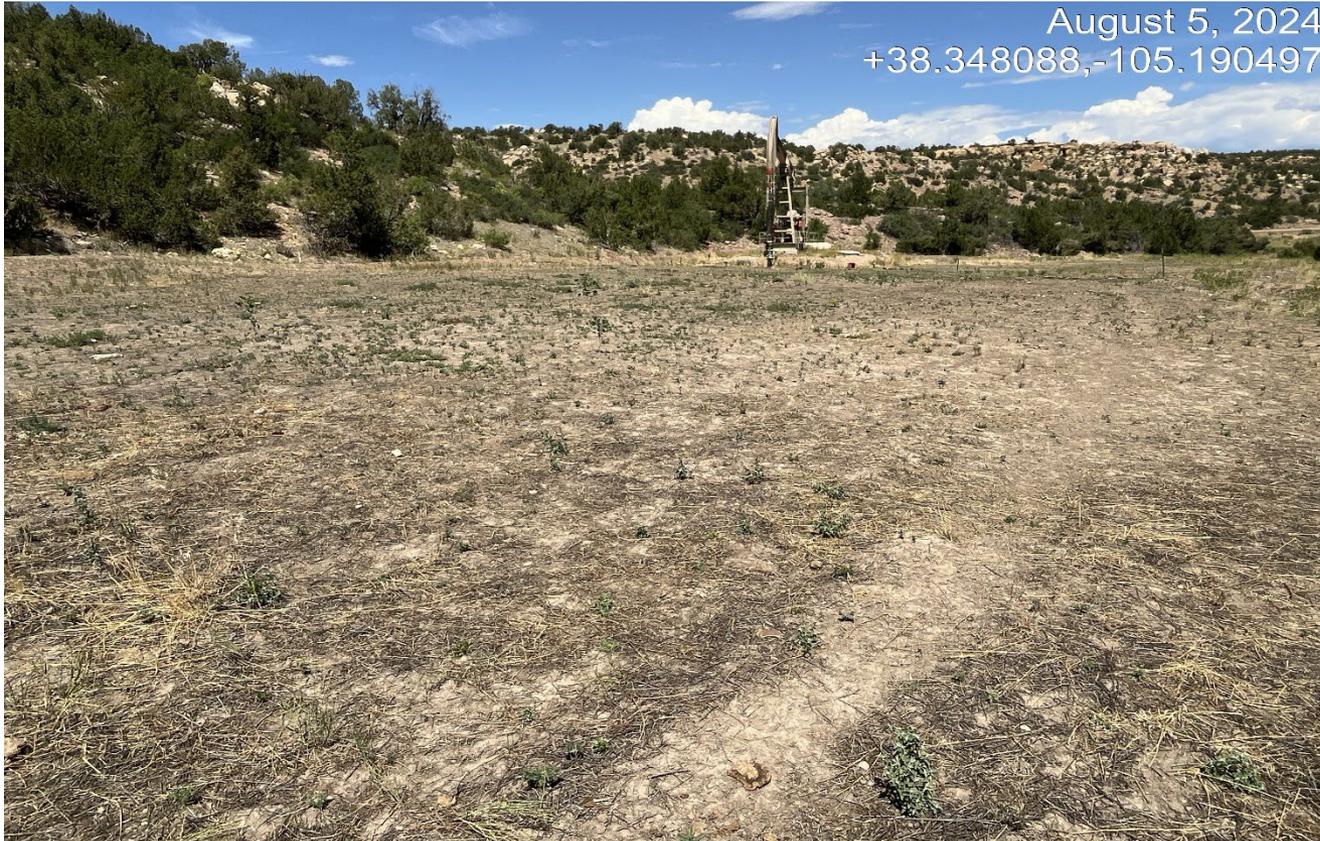
Photo 5. Facing northwest toward the interim reclamation area. The perennial vegetation has not established. This area will need weed control and reseeding. Previous corrective action was not completed.

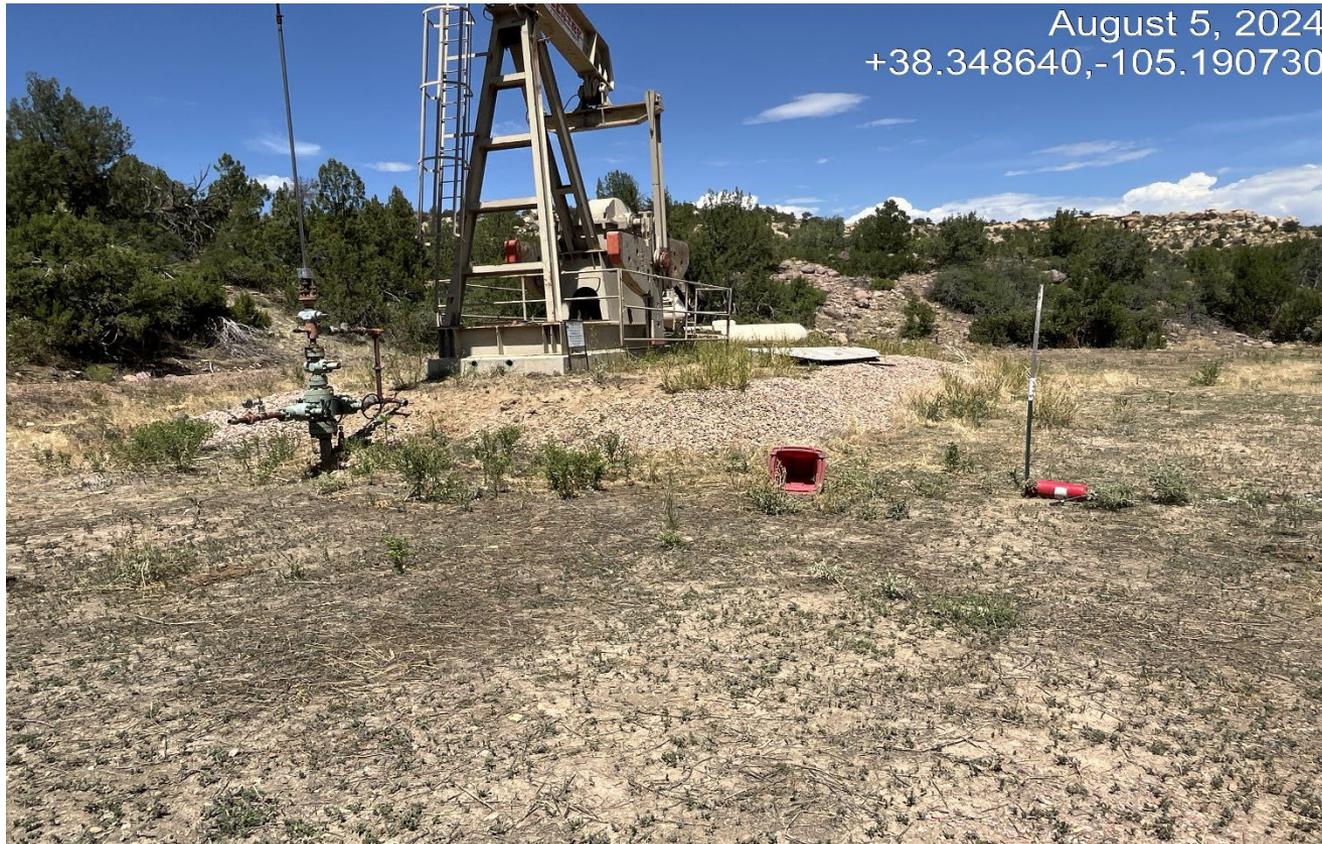
Photo 7. Facing toward the pumpjack. The pumpjack is unused and needs to be removed. The fire extinguisher has fallen over.
