# Inspection Photos

API: 043-06219

Operator: AUSCO PETROLEUM INC

Inspection Date: 8/5/2024

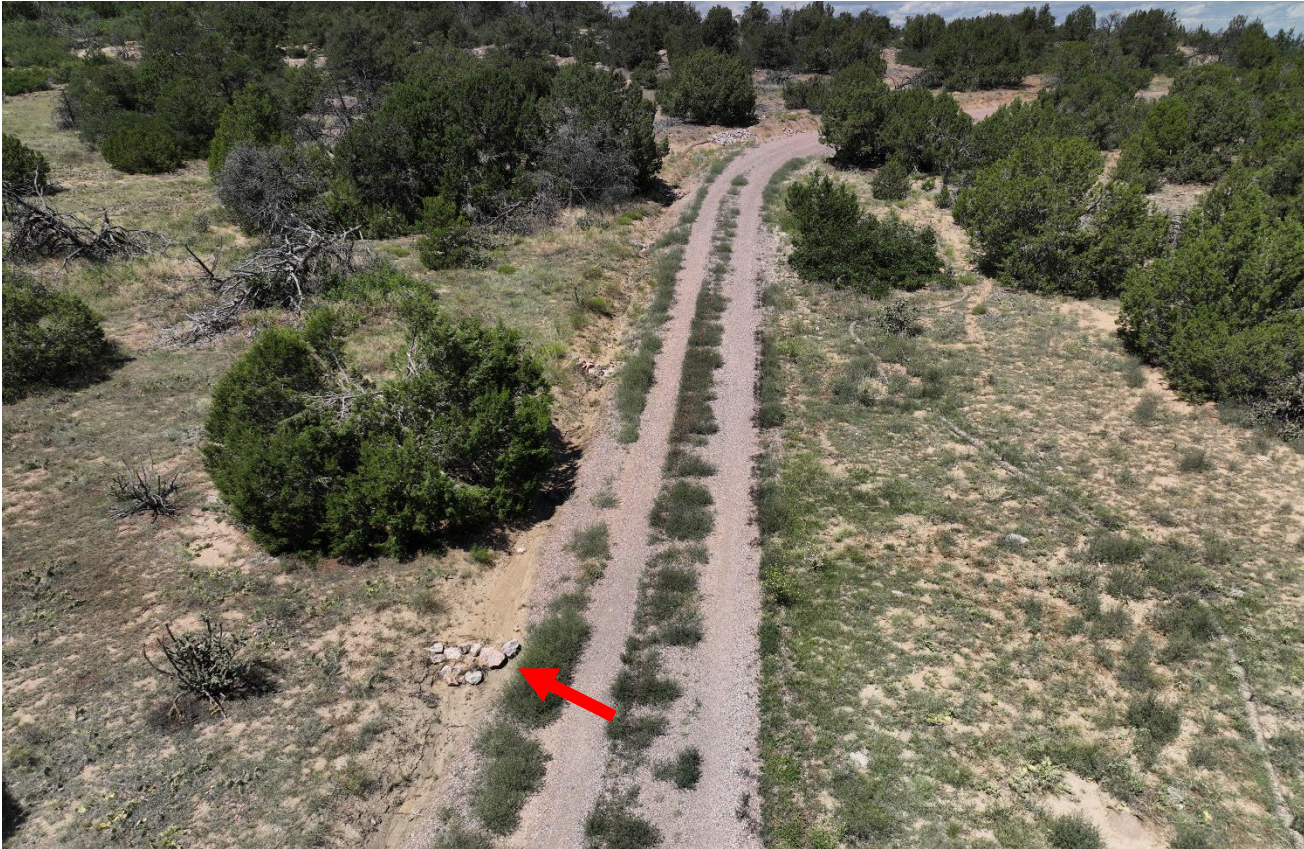
**Photo 1.** Drone aerial photo facing northwest along the access road. There are some check dams where stormwater is going around the check dam. BMP maintenance is needed. Previous corrective action was not completed.

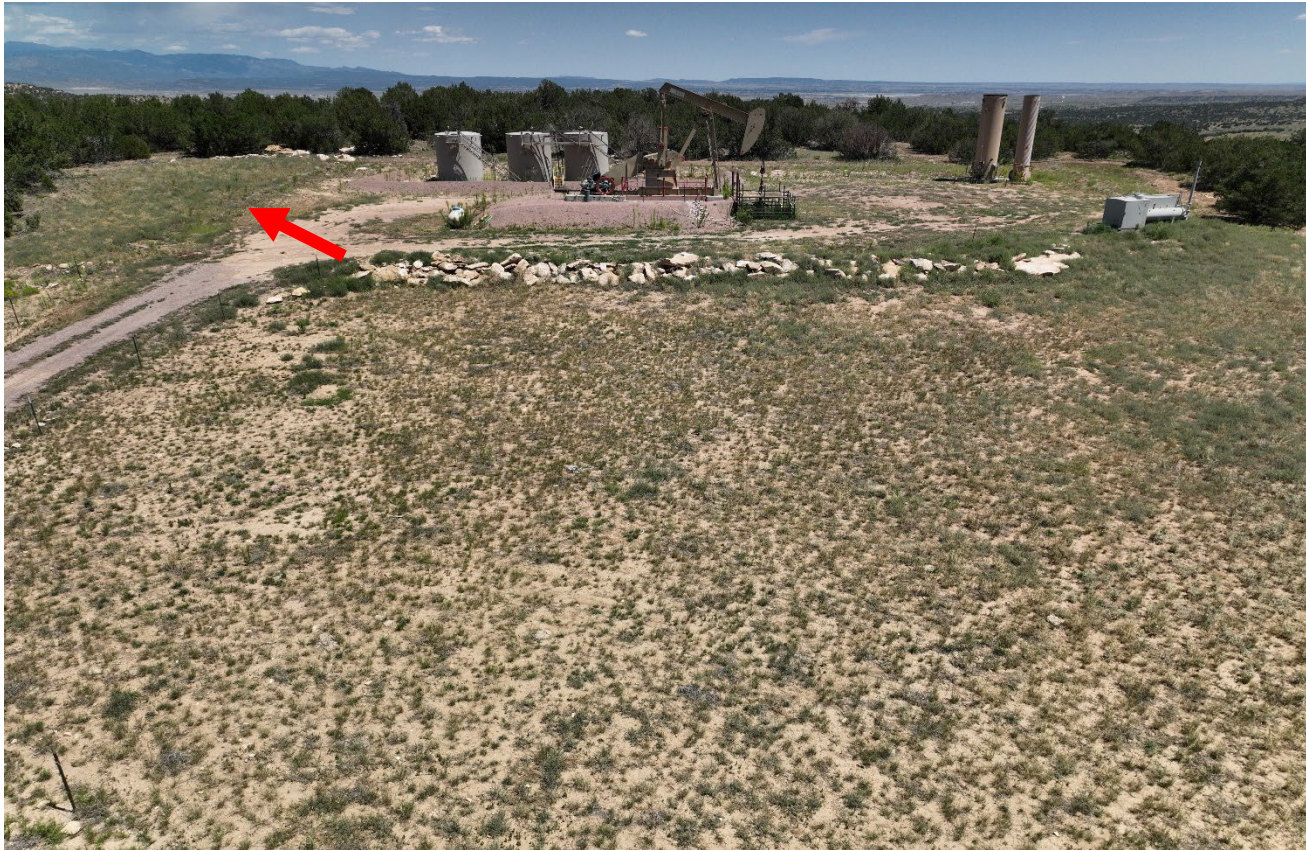
**Photo 3.** Drone aerial photo facing north toward the wellsite location. The degraded wattles still remain in the upper left at red arrow.

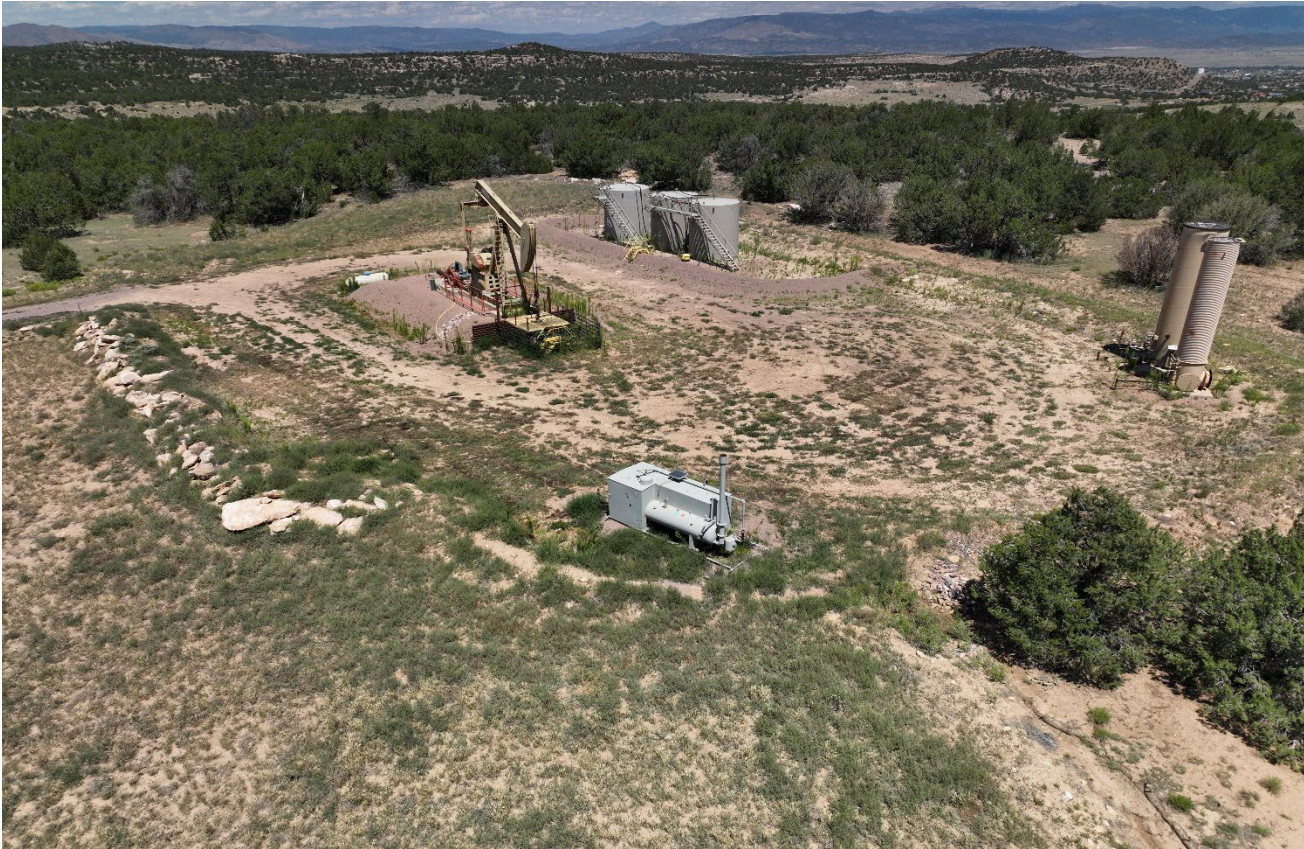
**Photo 4.** Facing northwest. This well has been inactive for a long period of time. Equipment is unused and needs to be removed. There are weeds growing around the equipment which is a fire hazard.

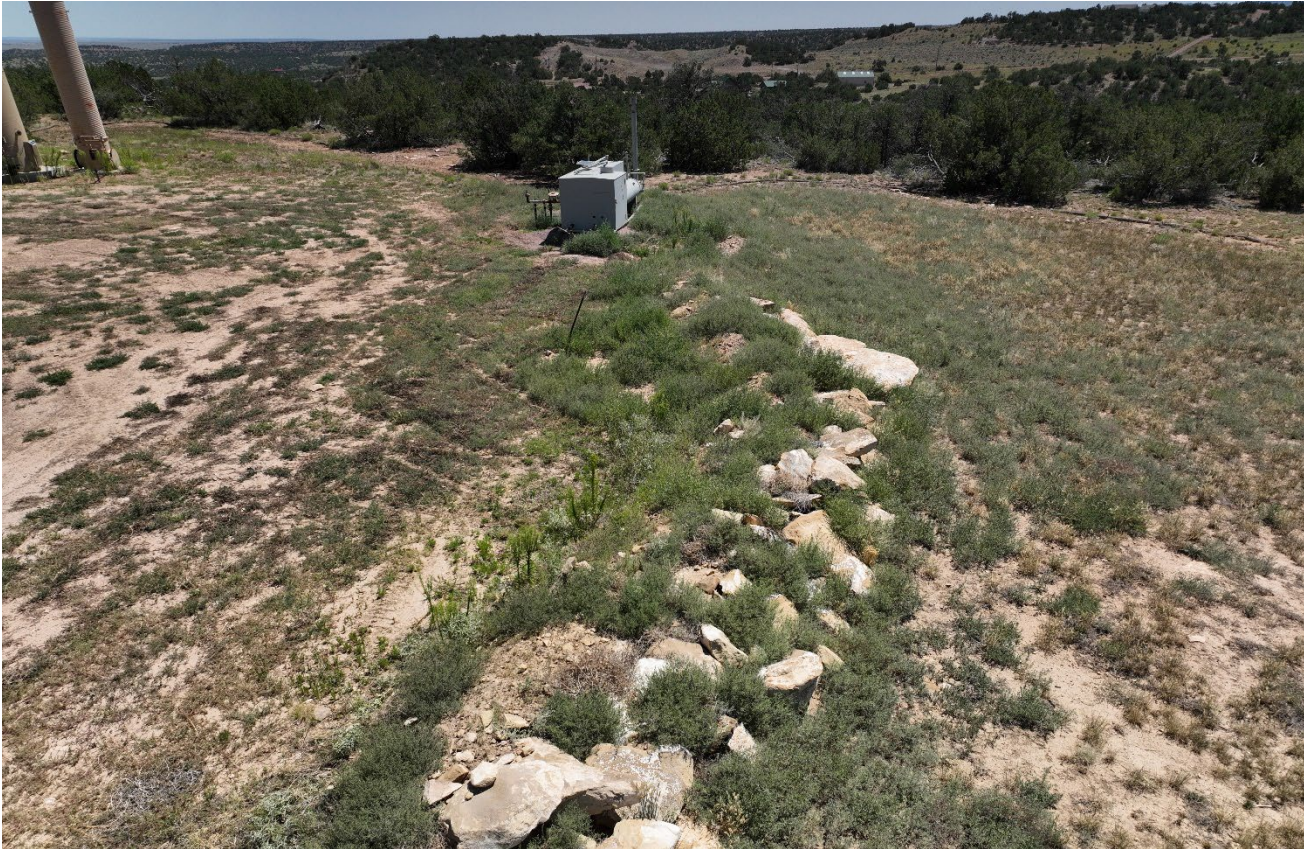
**Photo 5.** Facing east at the location. There is undesirable weeds, Russian thistle growing throughout this area by the equipment.
