# Inspection Photos

Loc: 424805

Operator: **JAVERNICK OIL**

Inspection Date: 8/5/2024

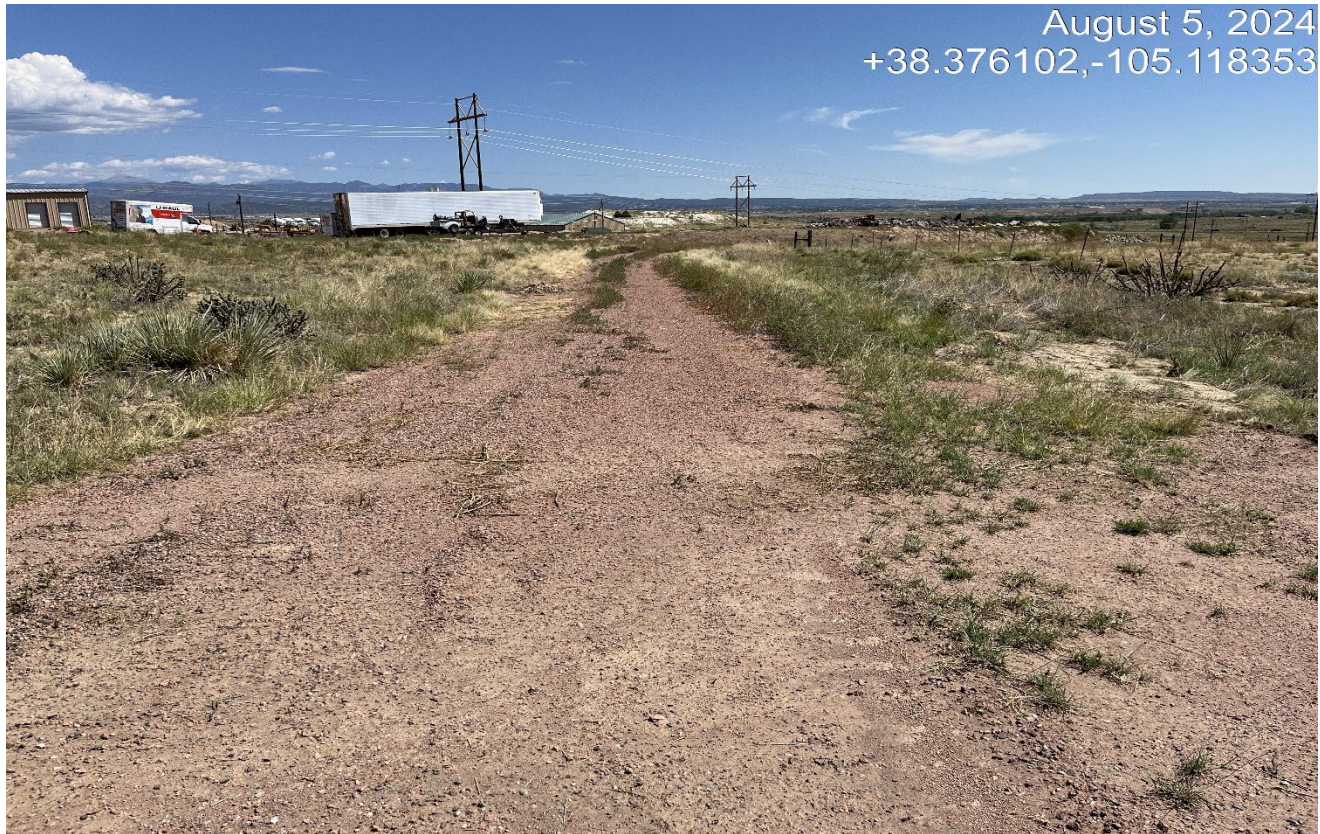
**Photo 1.** Facing northwest at the beginning of the access road. There are undesirable weeds along the access and the access road which has not been reclaimed.

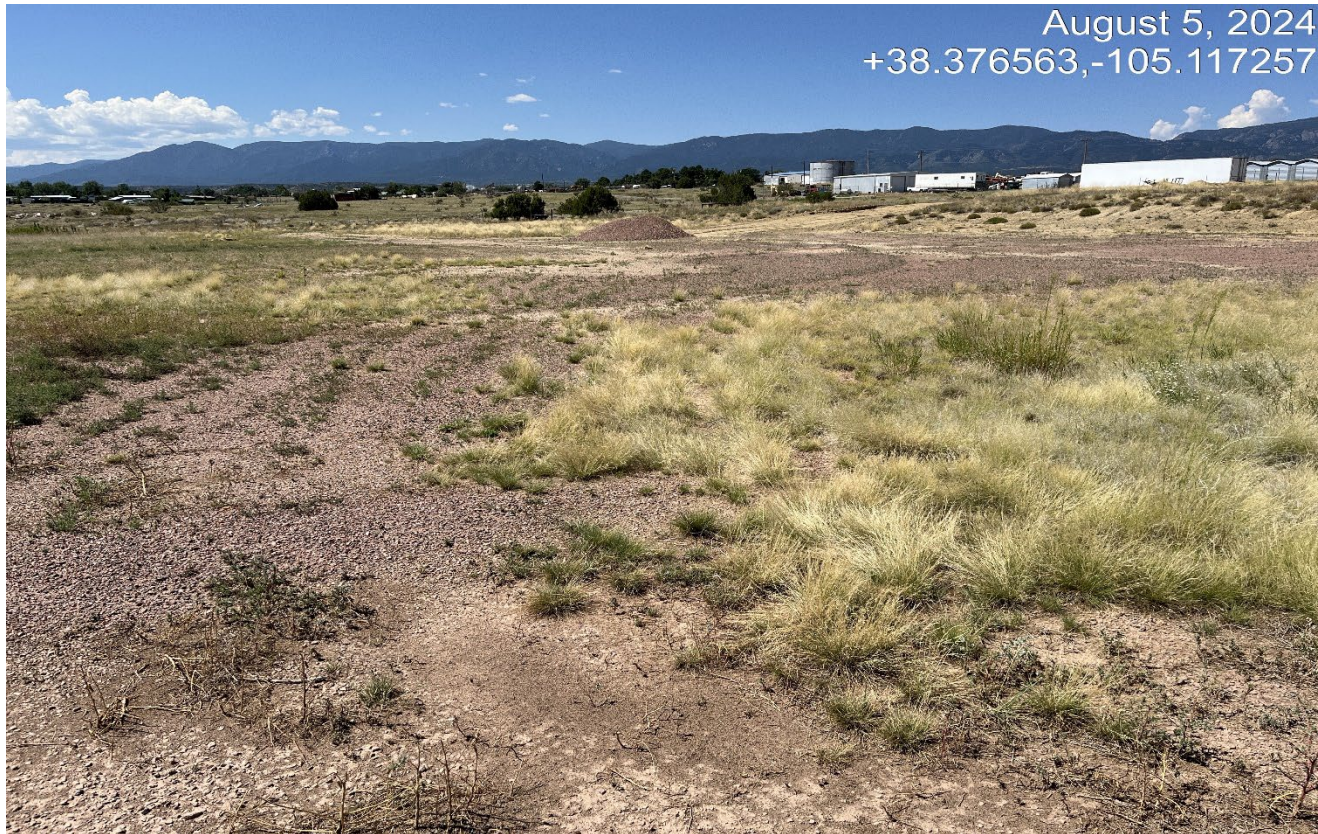
**Photo 2.** Facing south toward the location which has not been reclaimed per 1004 Rules.

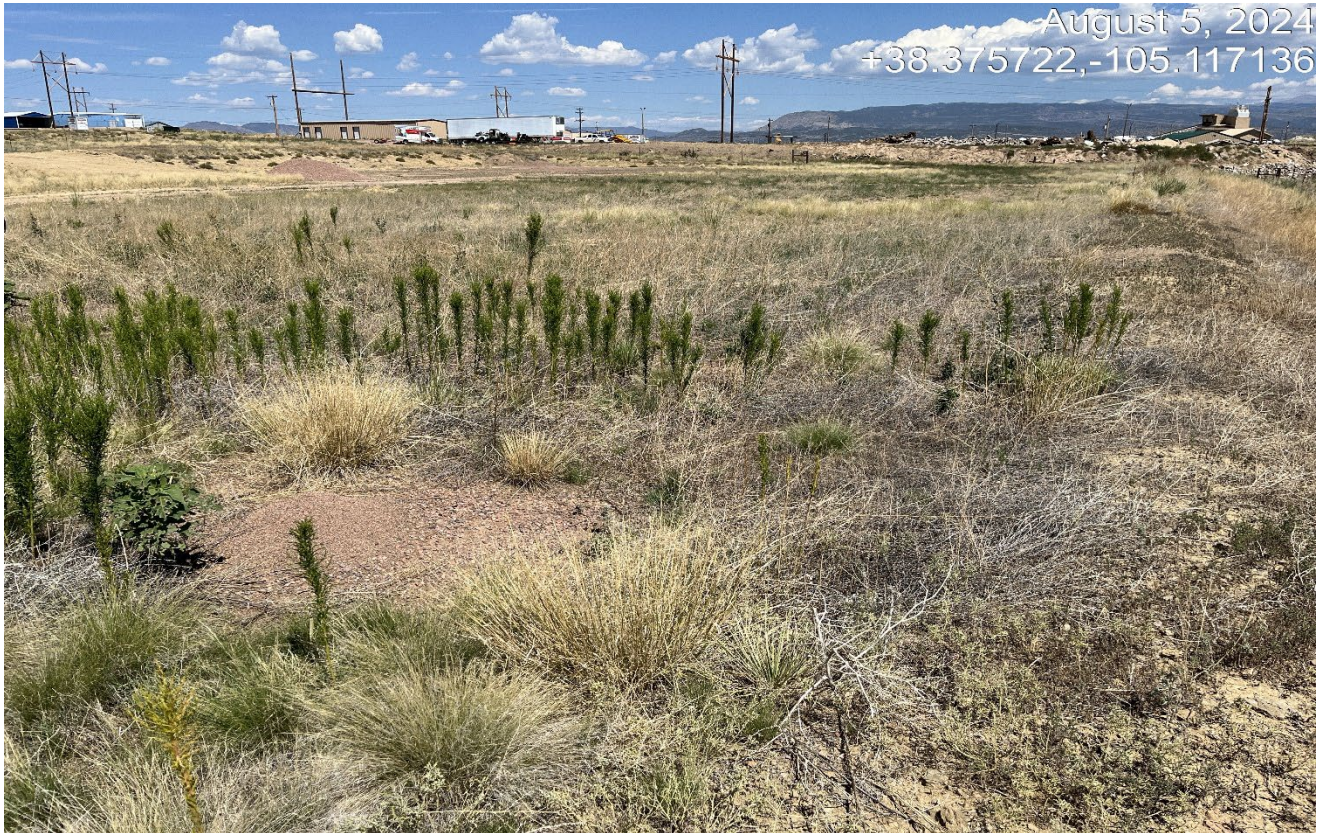
**Photo 3.** Facing northwest at the location. There are undesirable weeds throughout the location which is a fire hazard.

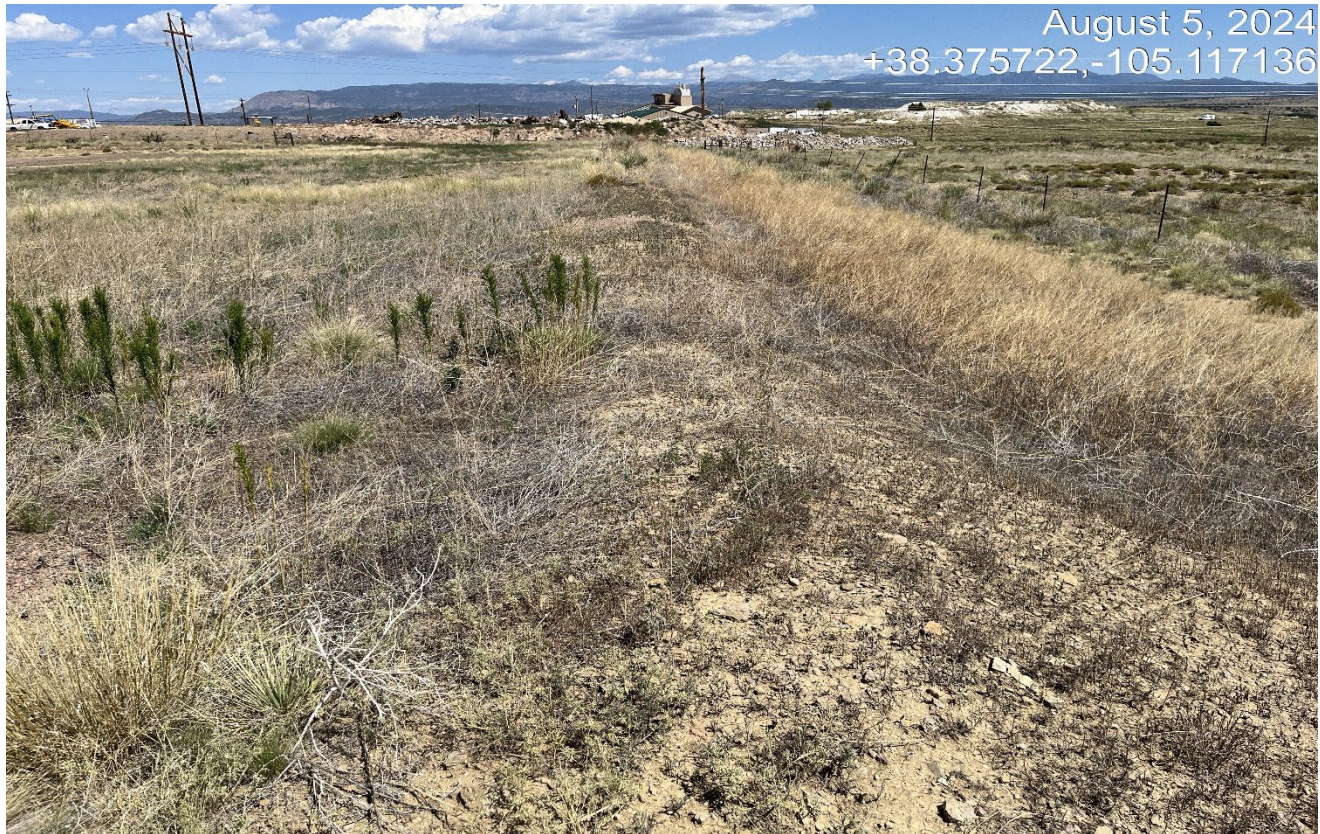
**Photo 4.** Southeast corner of the location facing north along the fill slope. There are undesirable growing along the fill slope that need to be controlled. The location has not been recontoured. Previous corrective action was not completed.

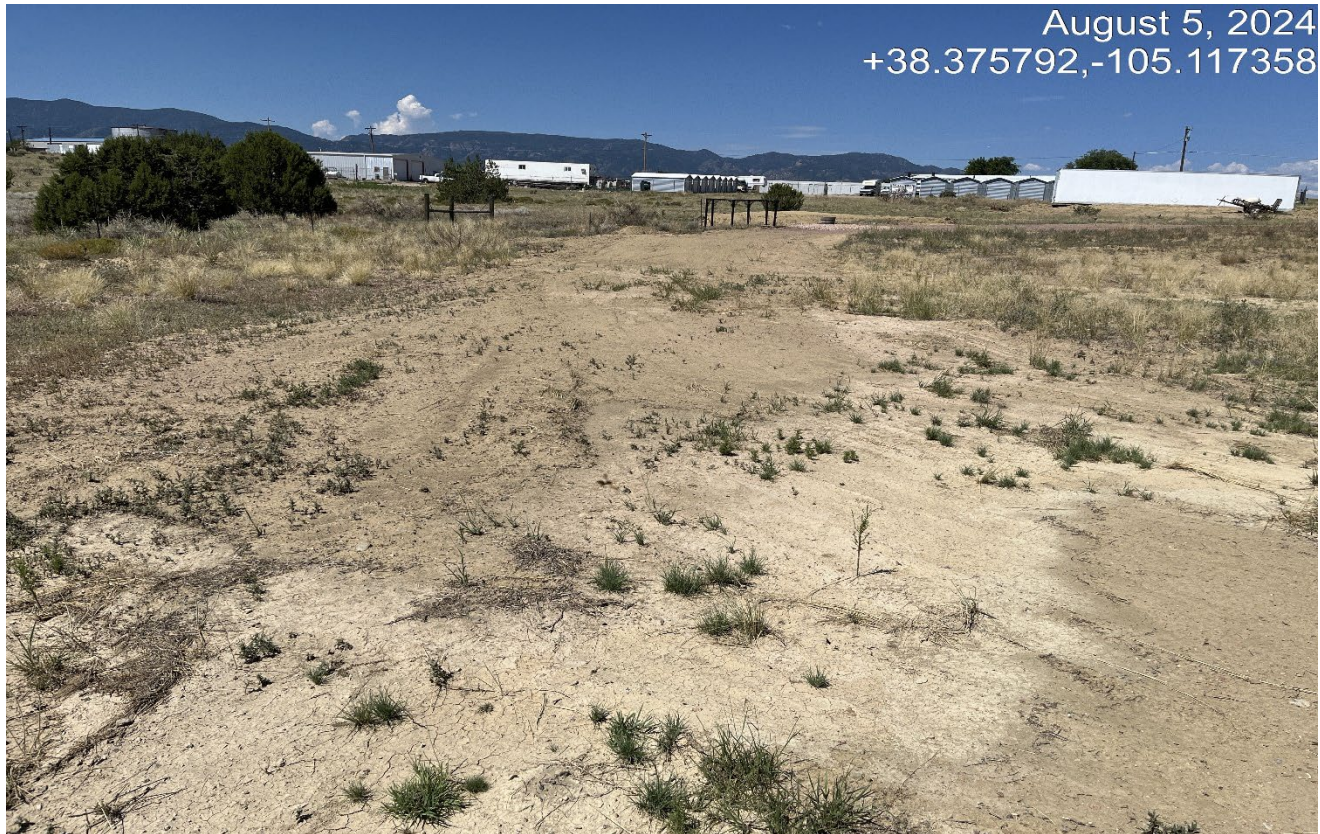
**Photo 5.** South side of the location facing west. There is new disturbance in this area.

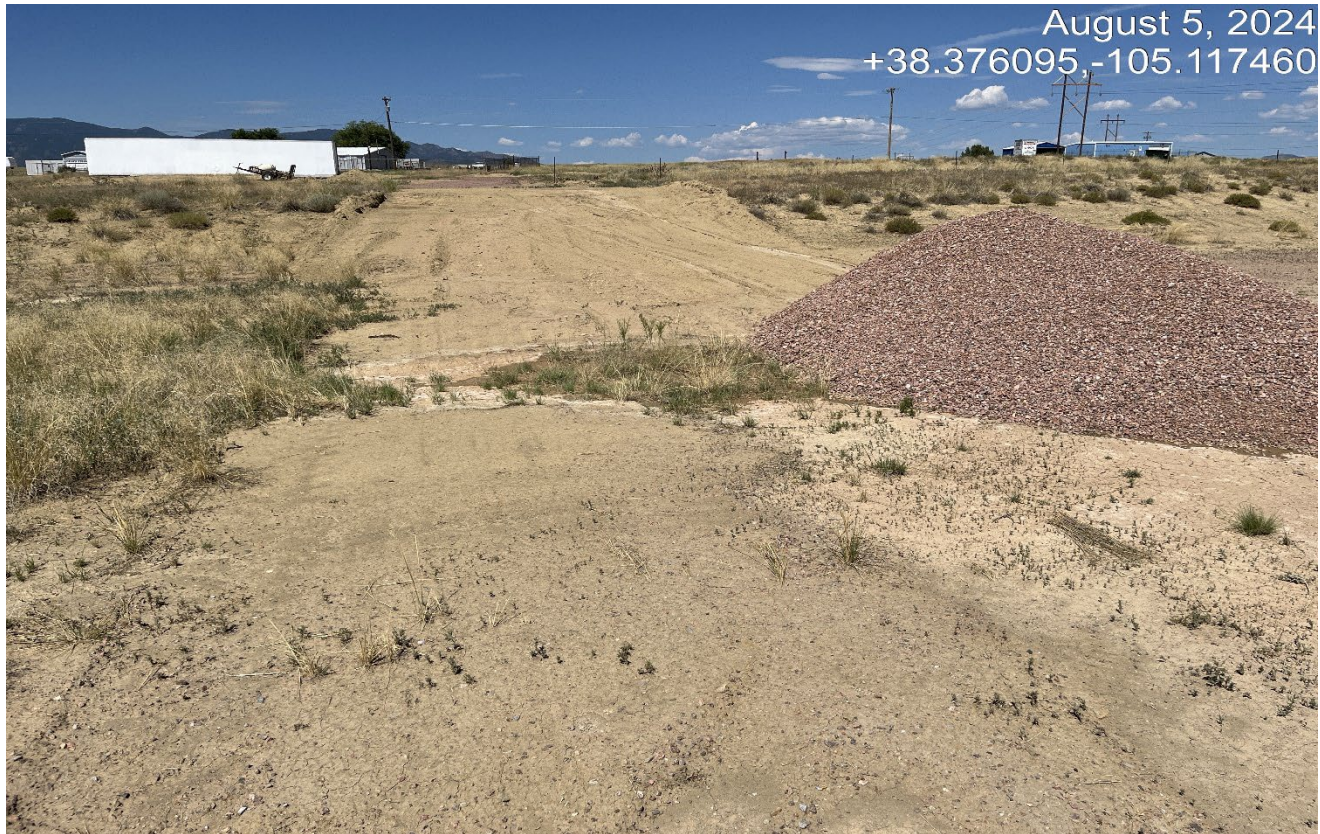
**Photo 6.** Facing west toward the cut slope which is not stabilized. There is new disturbance in this area.

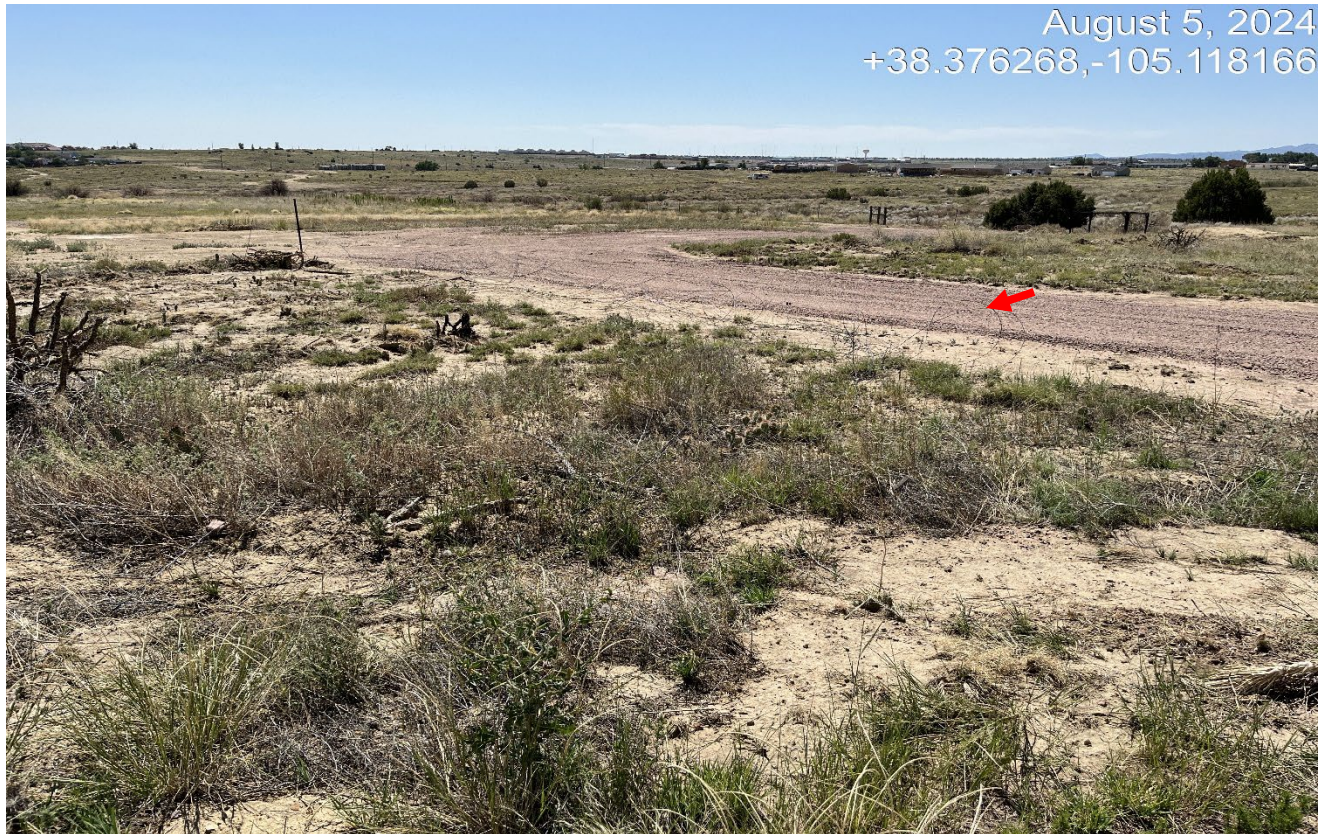
**Photo 7.** Facing southeast toward the location. The barbed wire fence is not maintained and wire is strung out at red arrow. Fence should be removed or repaired.
