Hilcorp Energy Company
Duncan Vanschaick-612N100W 29SWNW
Location ID: 333337

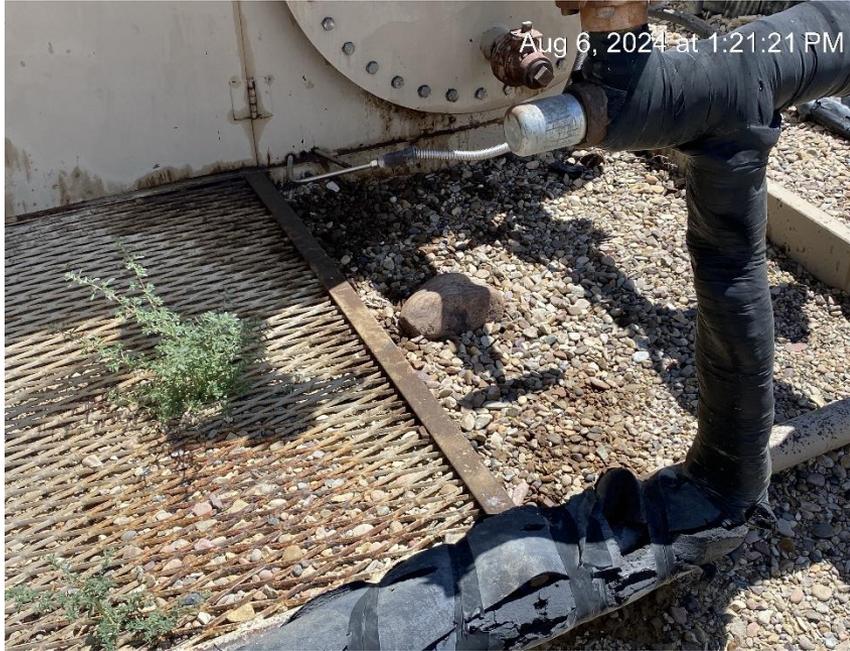
Stained soil

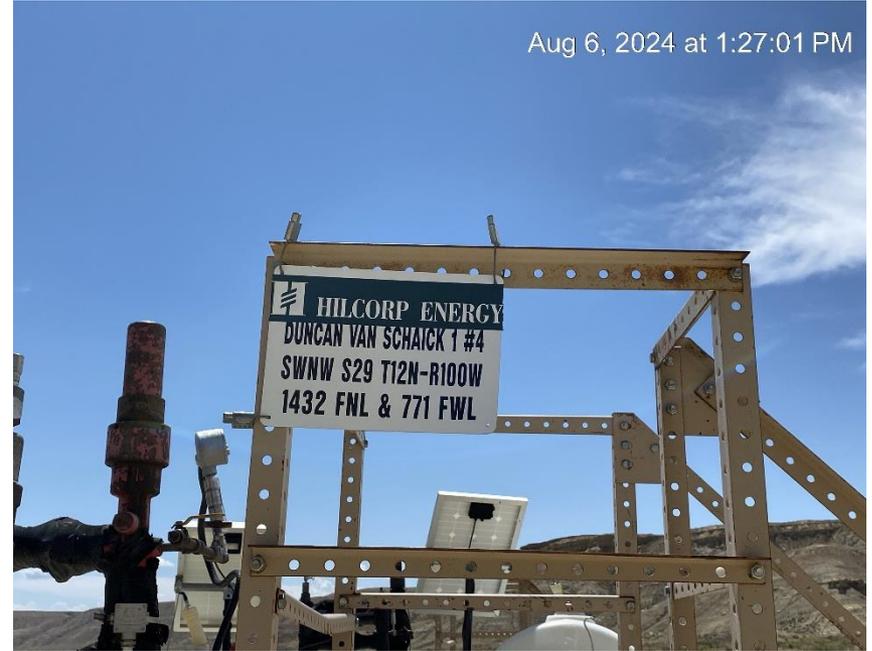
Additional information required when replaced

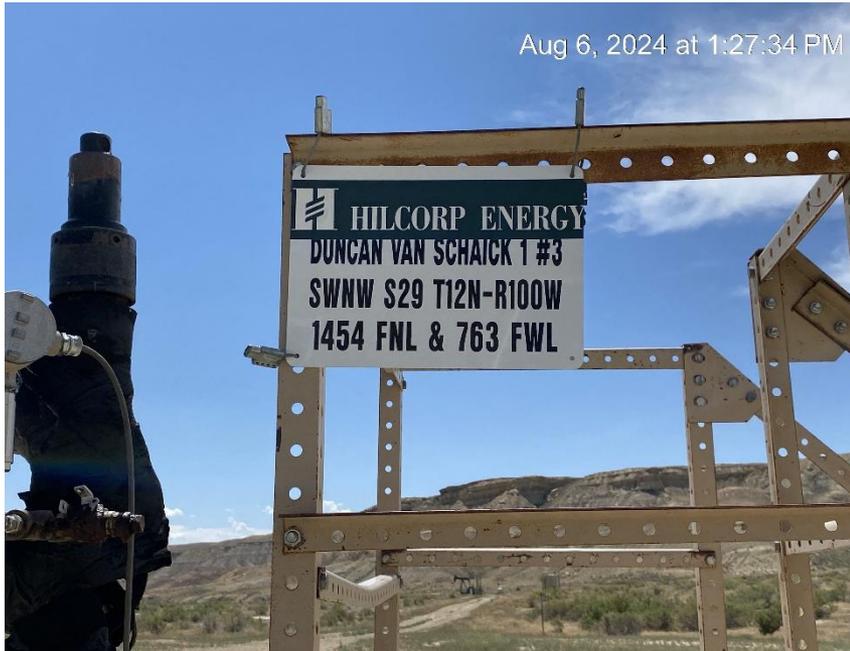
Additional information required when replaced

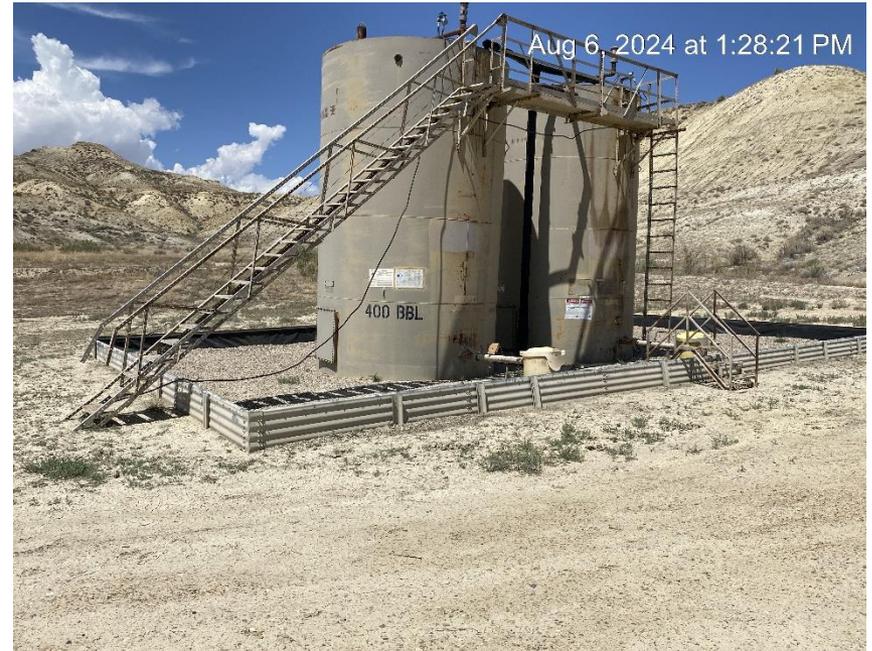
No tank battery sign

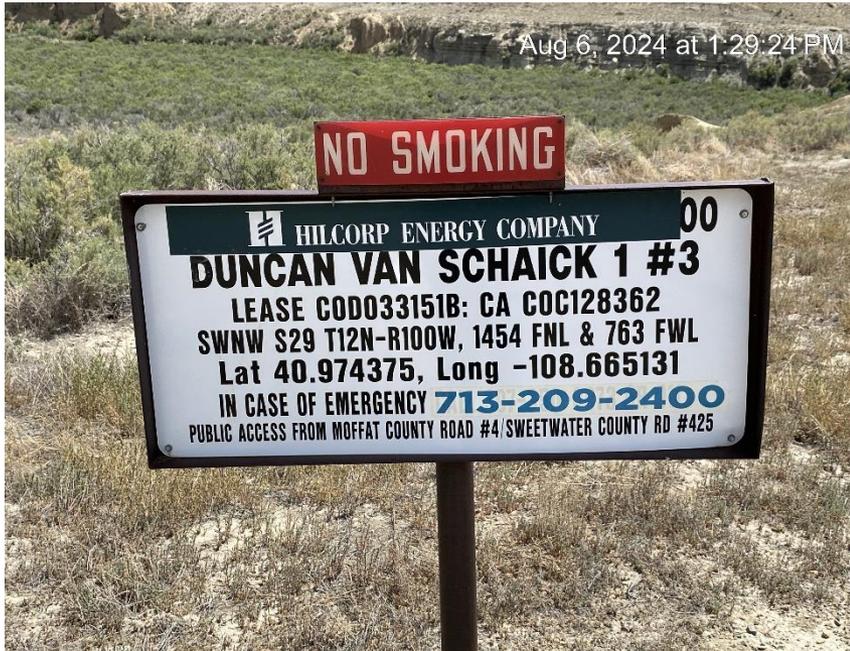
Additional information required when replaced

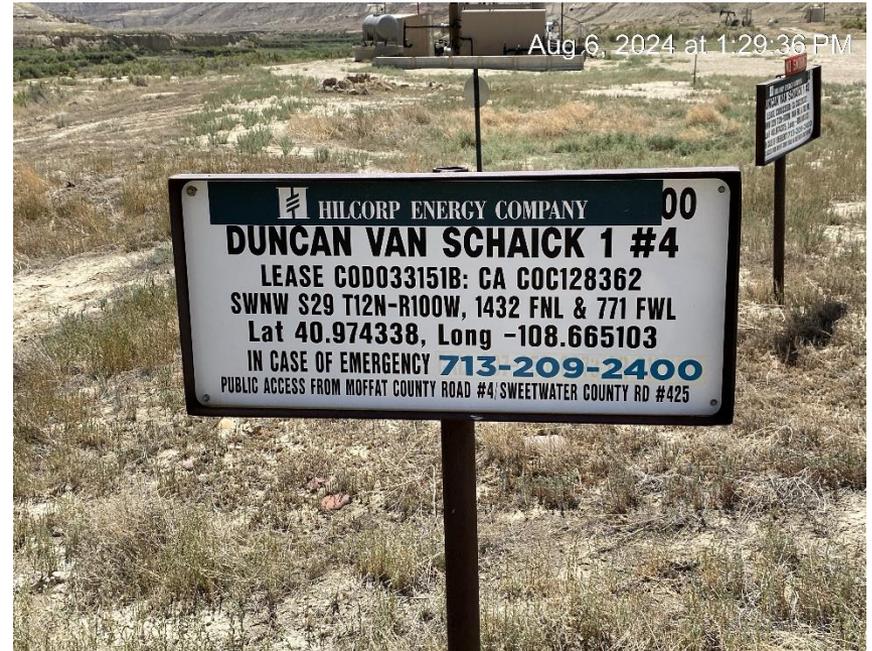
Additional information required when replaced

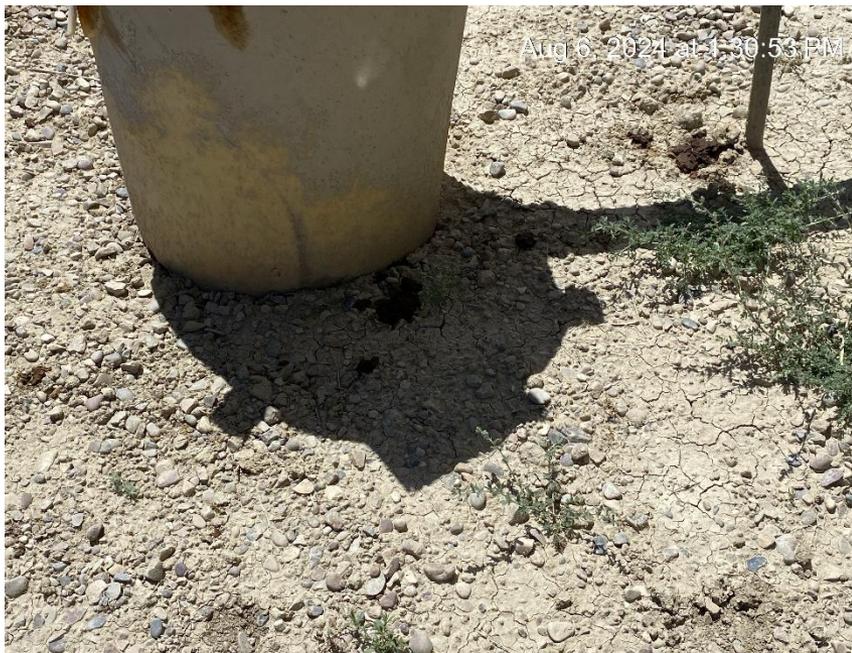
Oily waste

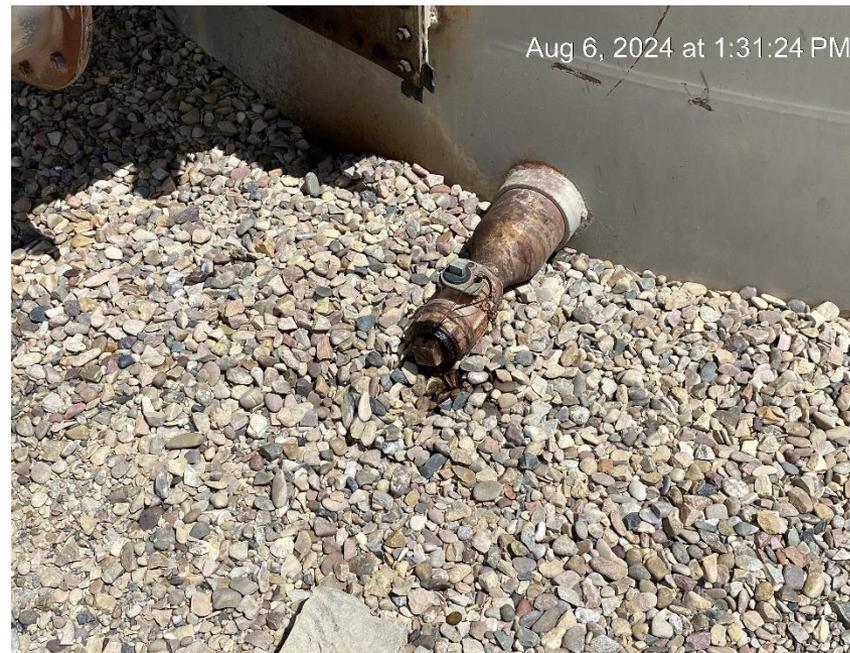
Leaking plug. Stained soil.

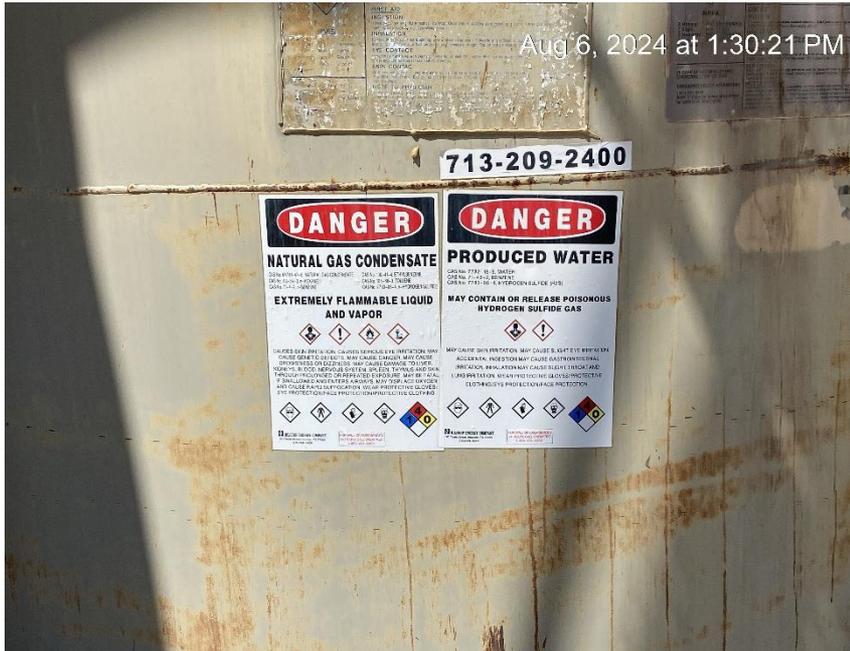
Missing required information

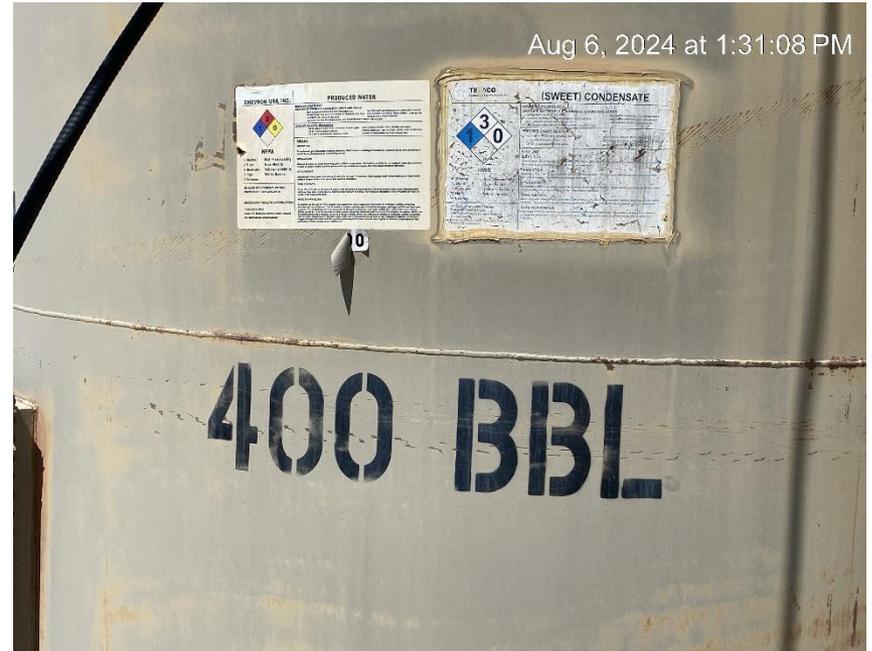
Missing required information
