Inspection Photos

Location: Caerus Piceance LLC Chevron/Texaco-66S97W/12SESE

Location ID: 335776

Date: 8/1/2024

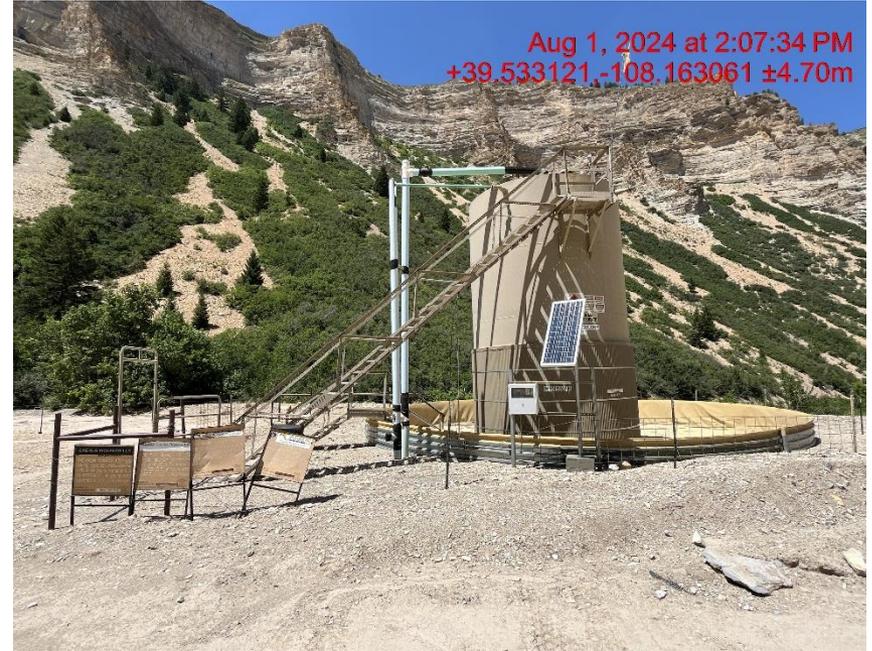
Tank battery/No tank battery sign - Photo #03952

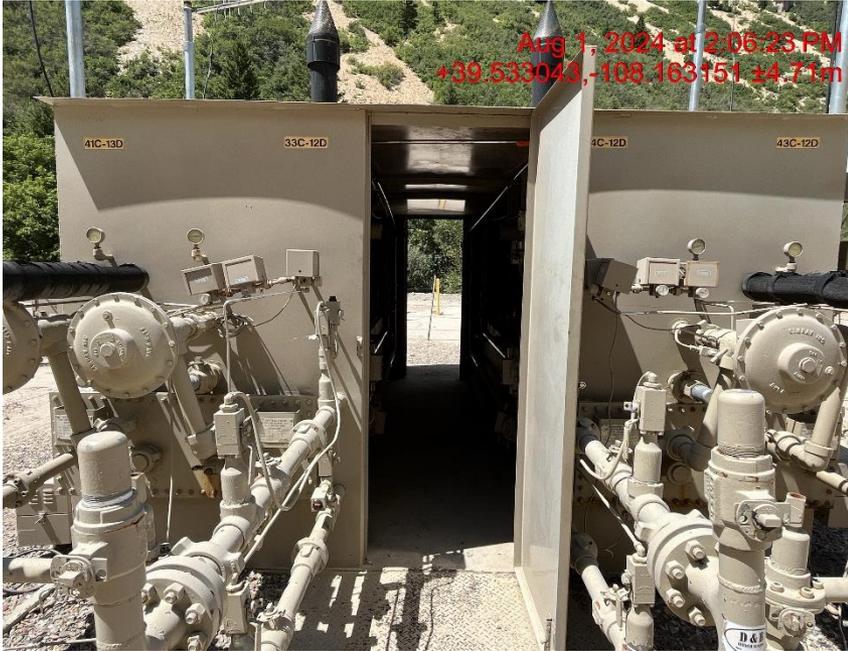
Open to wildlife/hazard - Photo #03951

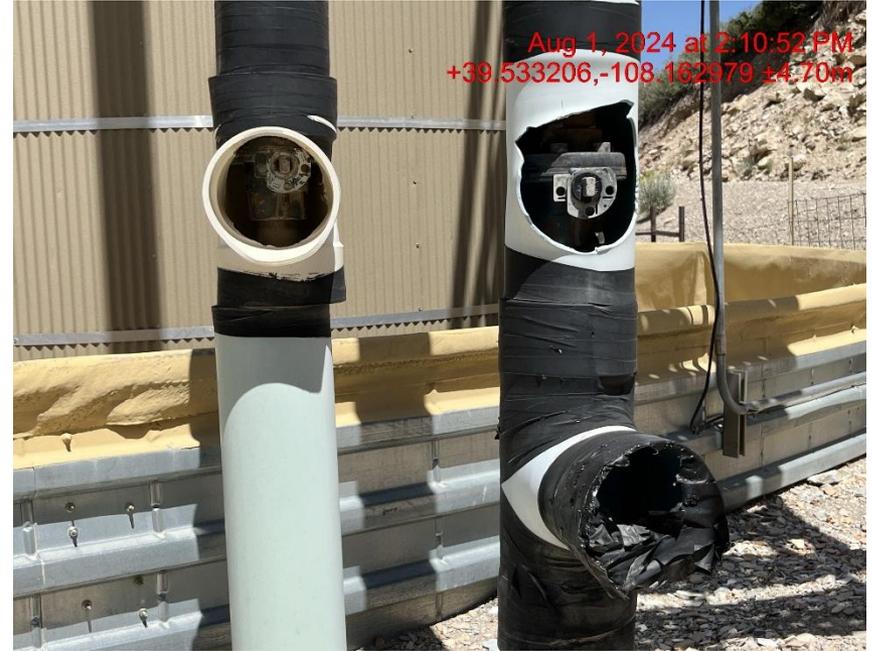
Open to wildlife/hazard - Photo #03956

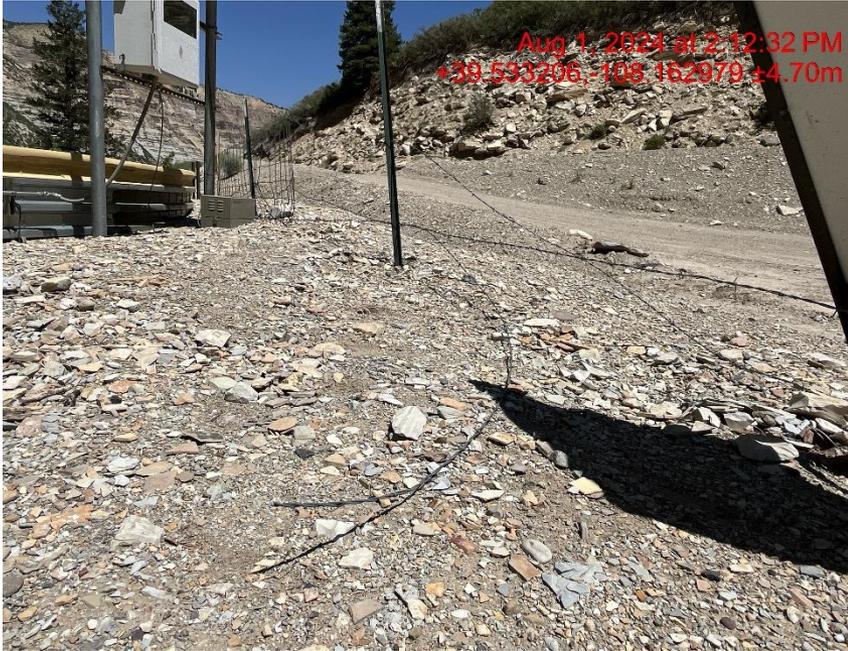
Loose barbed wire/wildlife hazard - Photo #03961

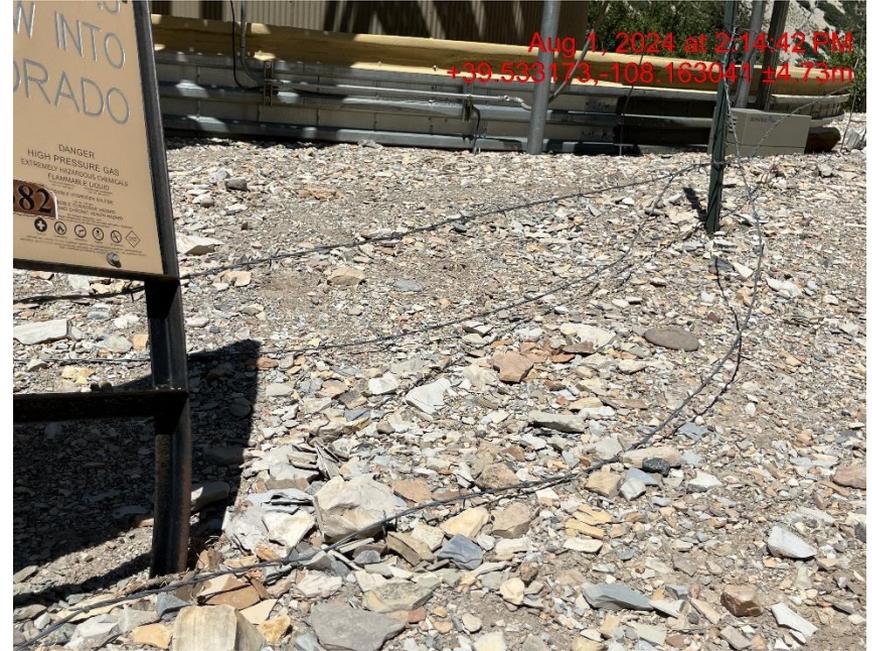
Loose barbed wire/wildlife hazard - Photo #03963

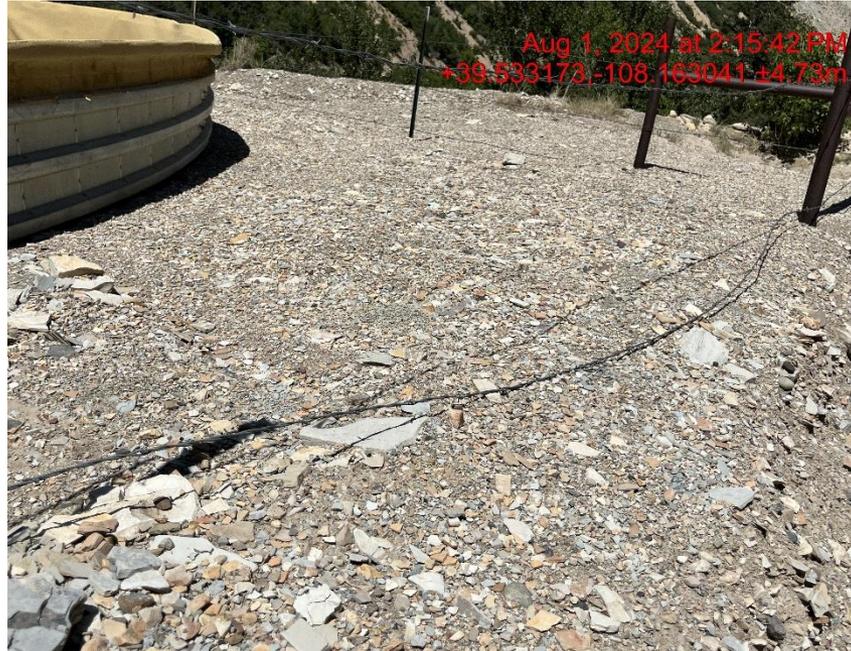
Loose barbed wire/wildlife hazard - Photo #03965
