Inspection Photos

Location Name: TEP Rocky Mountain LLC Mead RWF 43-23 Pad

Location # 419862

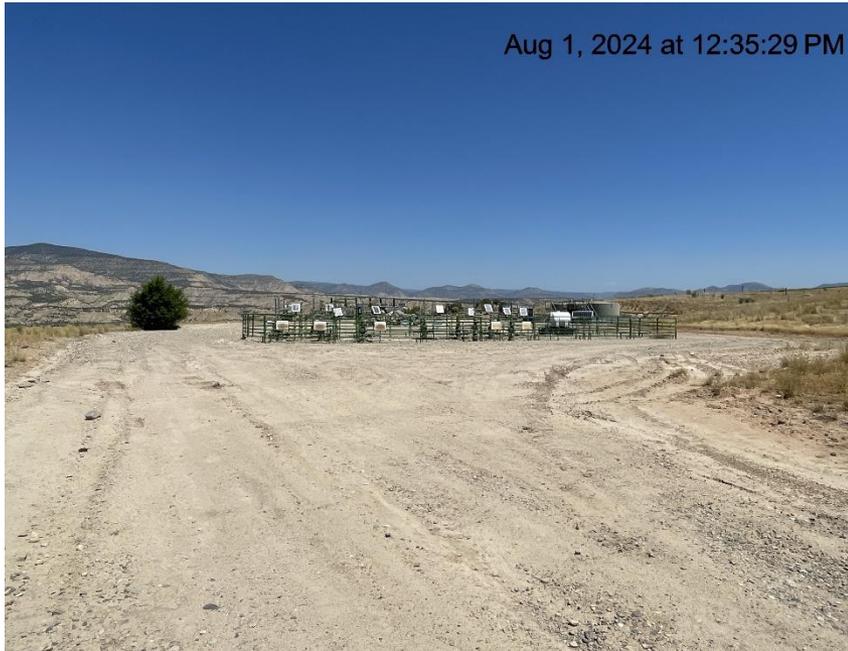
Photo # 4425 From entrance to location

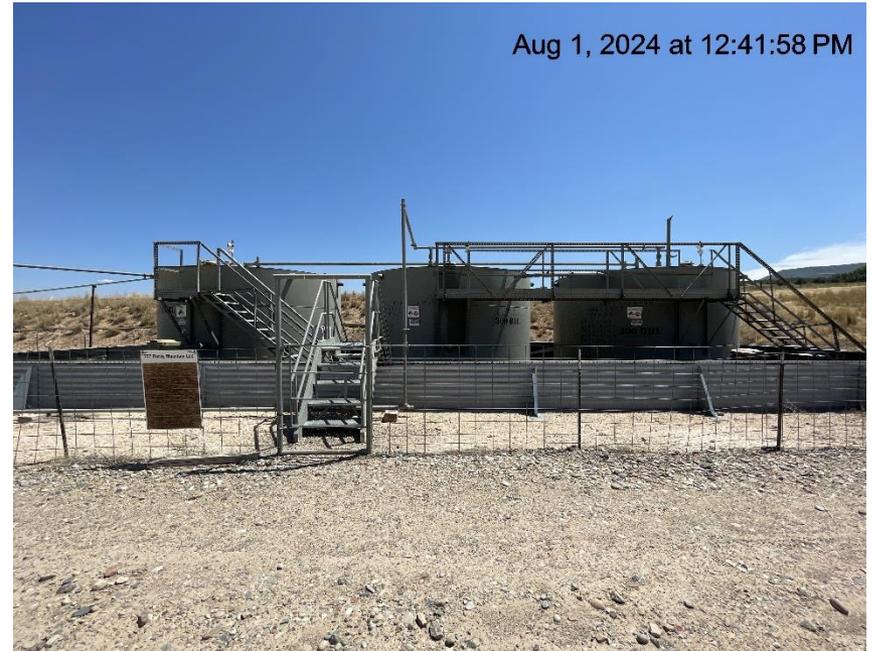
Photo # 4426 Location

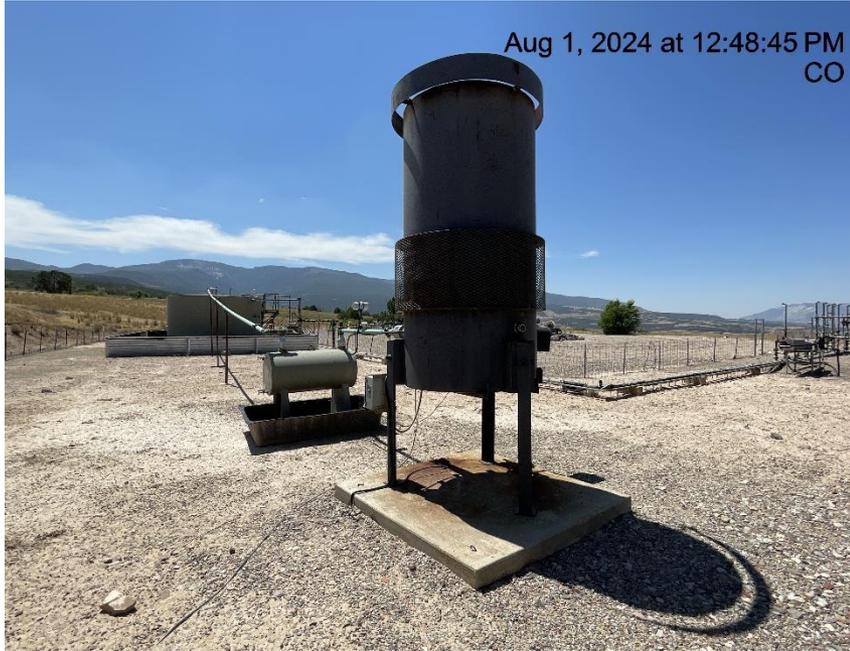
Photo # 4427 Location

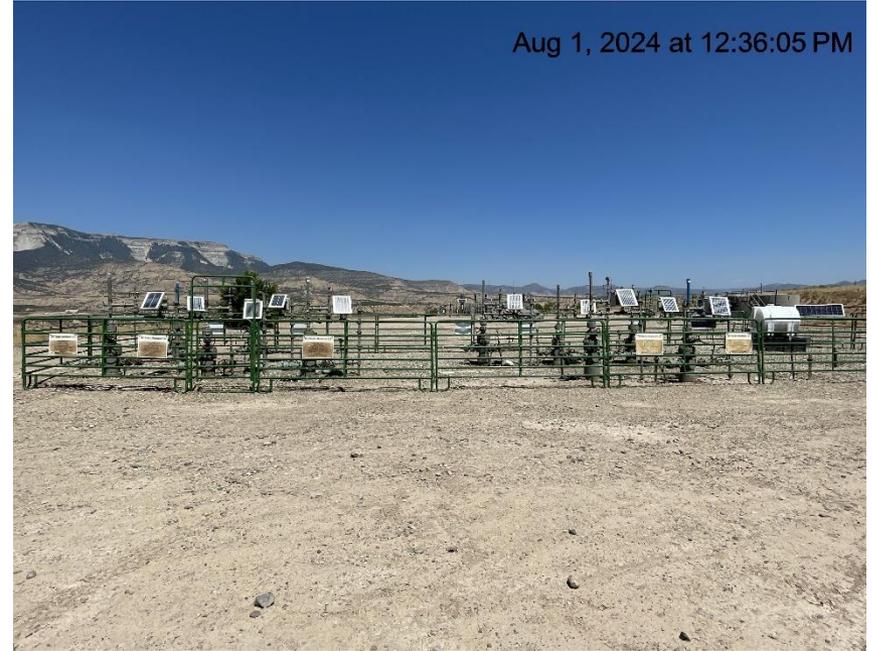
Photo # 4428 Location

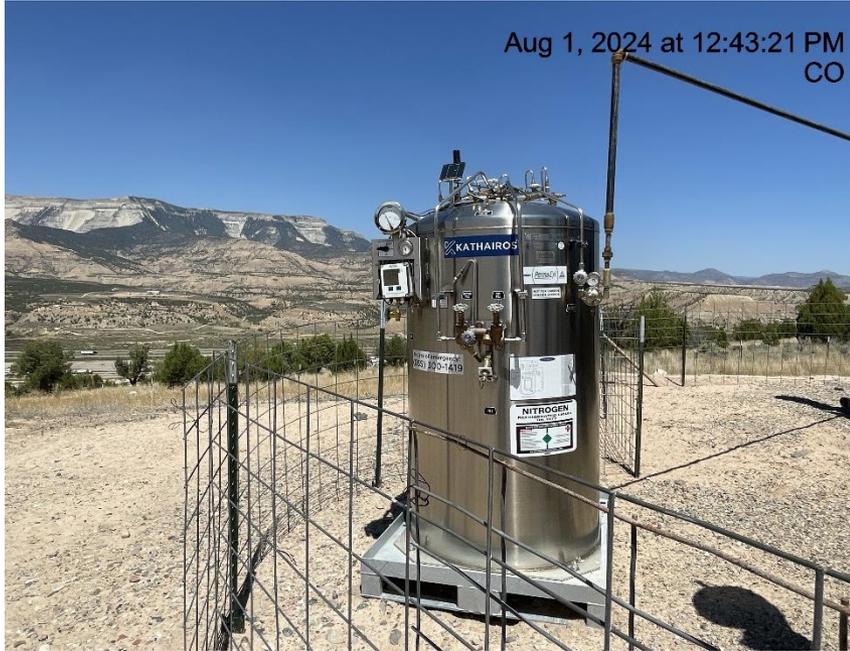
Photo # 4431 Location

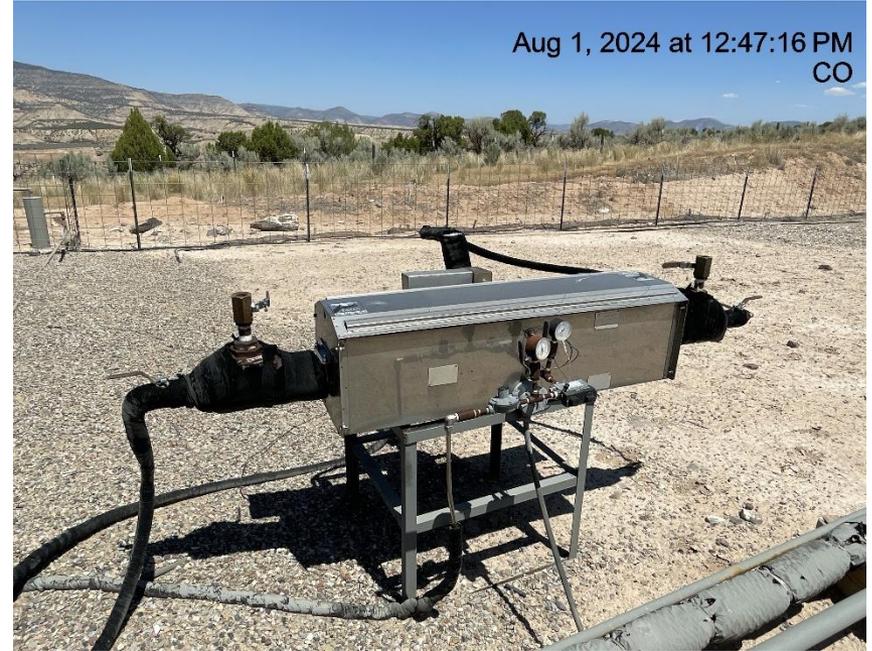
Photo # 4432 Location

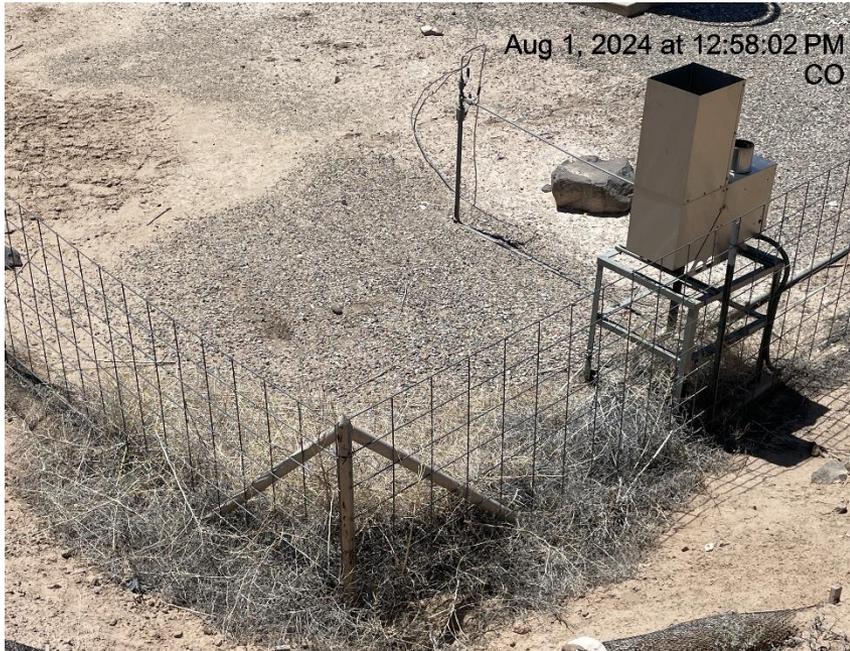
Photo # 4433 Dead weeds/debris near thermogen

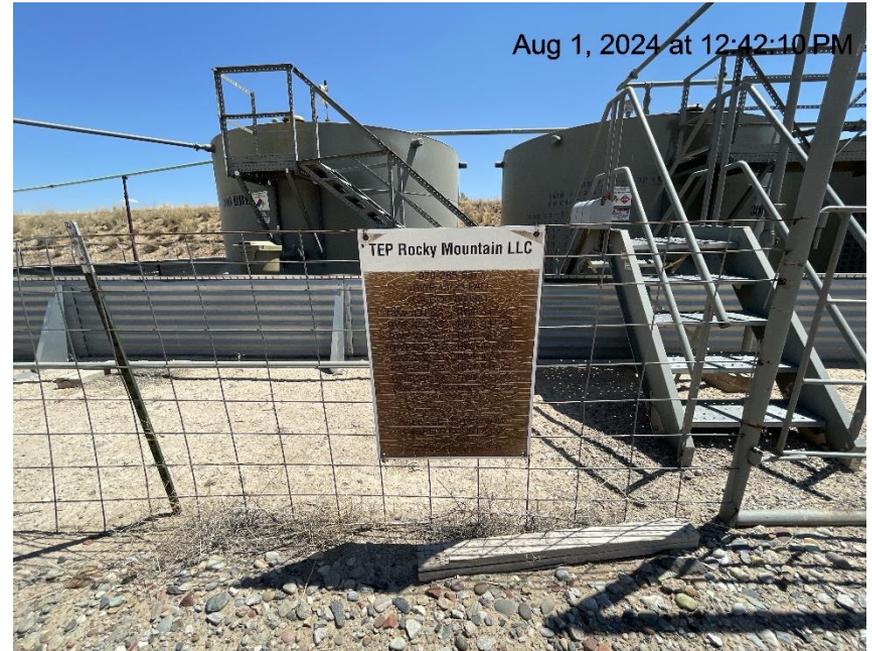
Photo # 4434 Battery sign weathered & cracking/becoming illegible/does not comply with CECMC rules

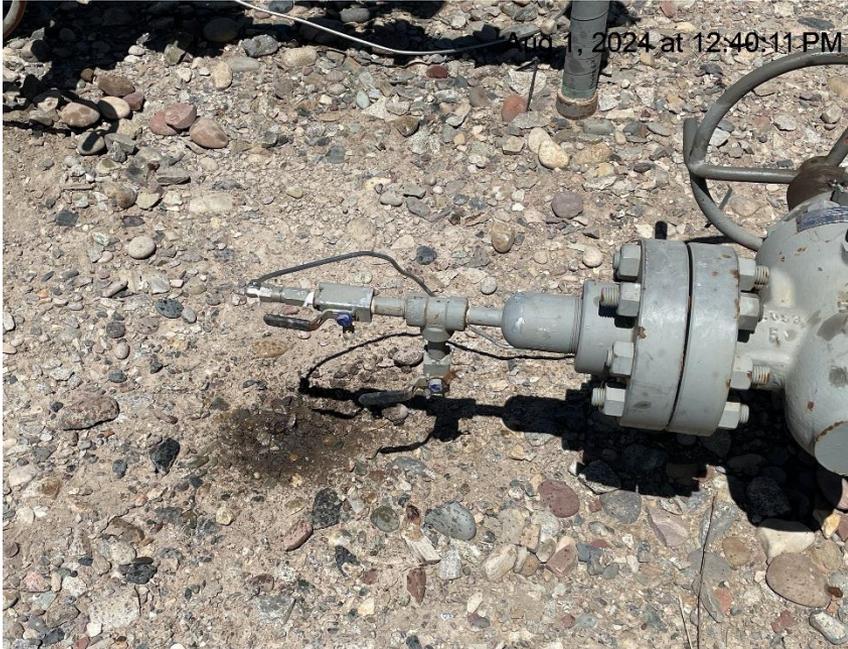
Photo # 4435 Staining near wellhead

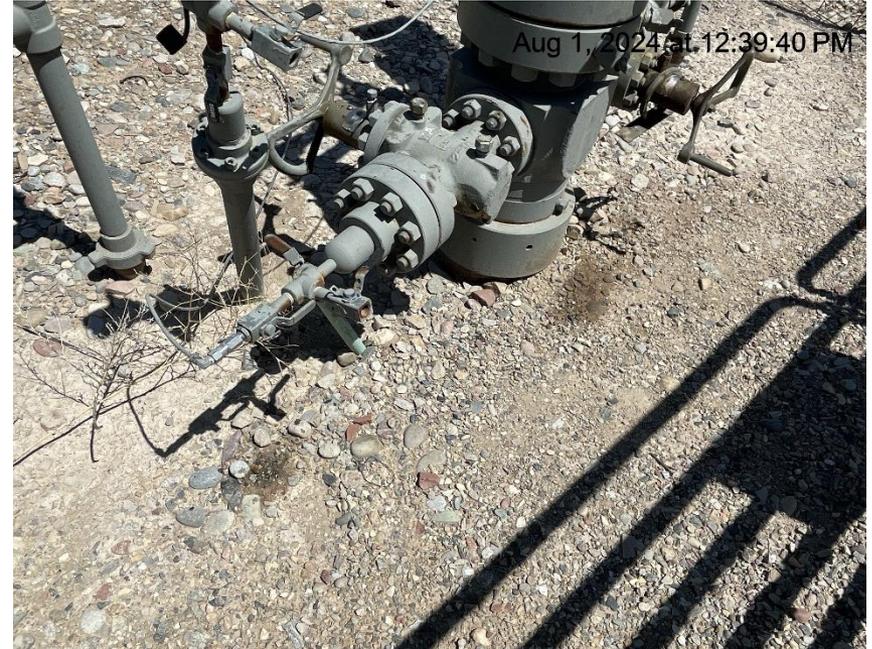
Photo # 4436 Staining near wellhead

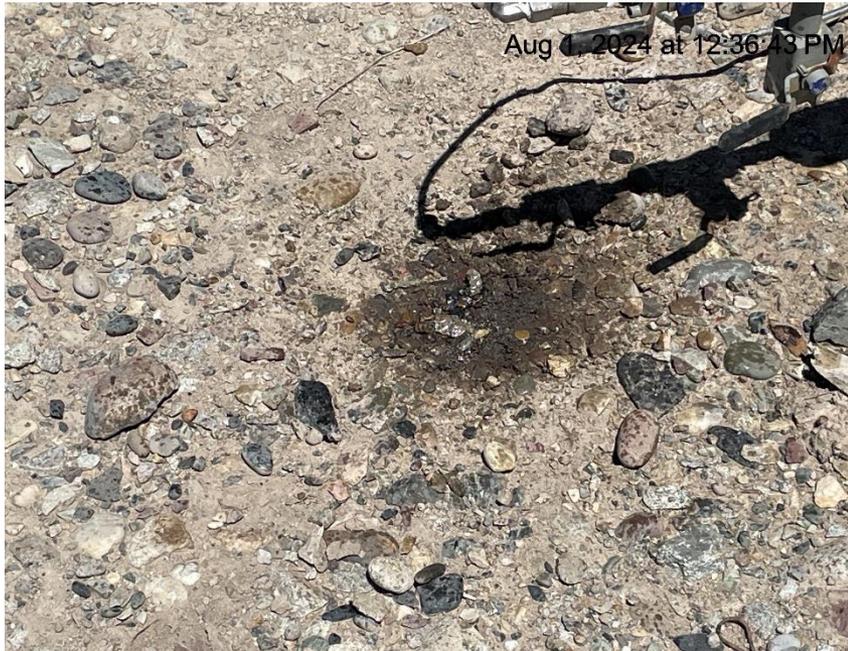
Photo # 4437 Staining near wellhead

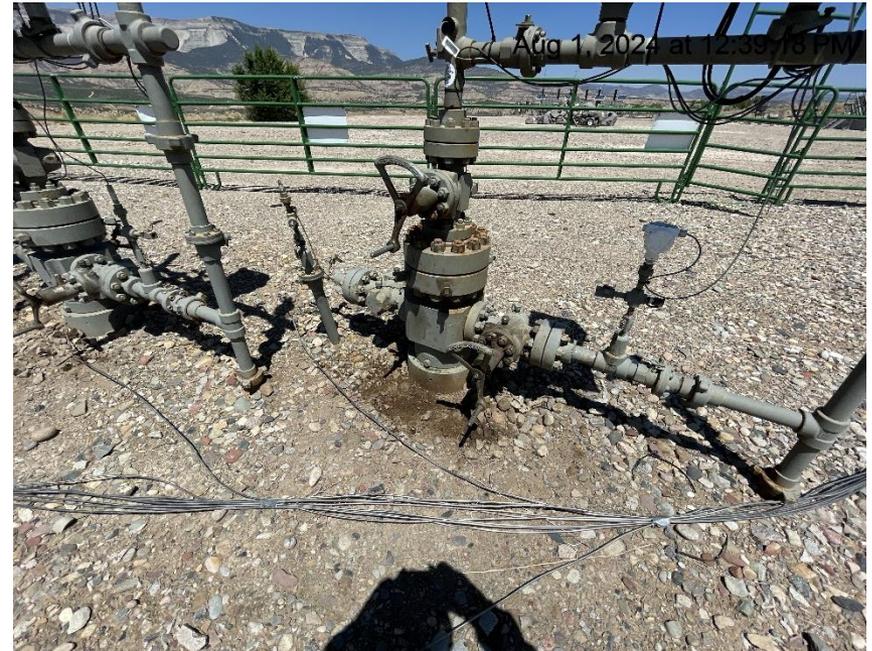
Photo # 4438 Staining near wellhead

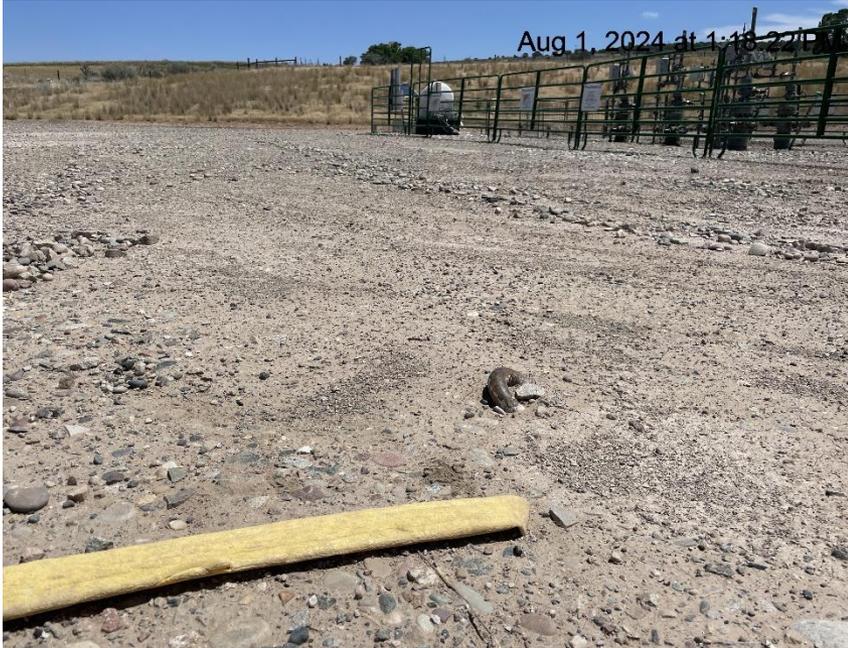
Photo # 4439 Improperly marked deadman

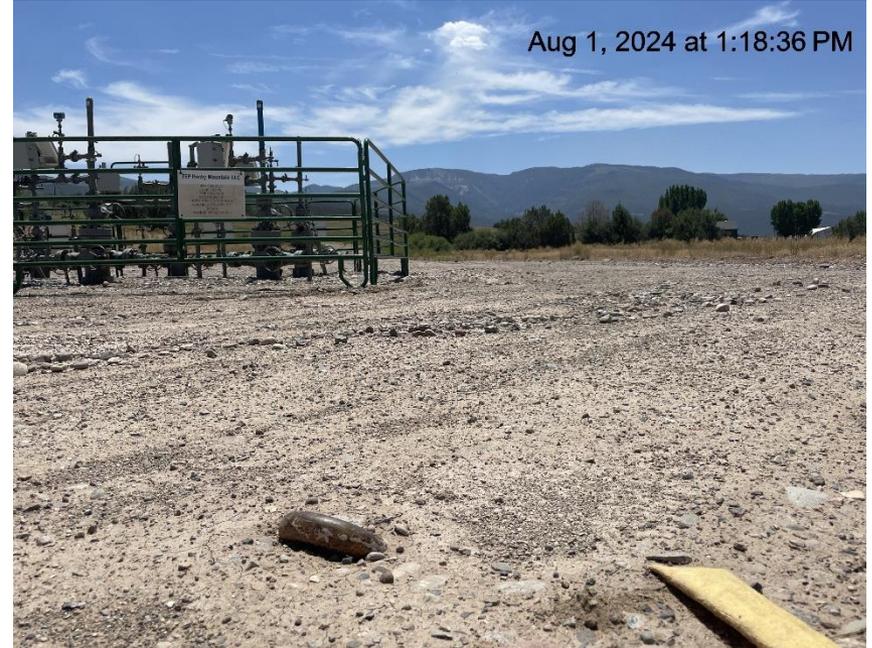
Photo # 4440 Same improperly marked deadman from a different angle
