CORRECTIVE ACTION REPSONSE

FACILITY NAME: SR 698-21-01

Corrective action narrative from the 27-1 pit inspection on 31 July 2024:

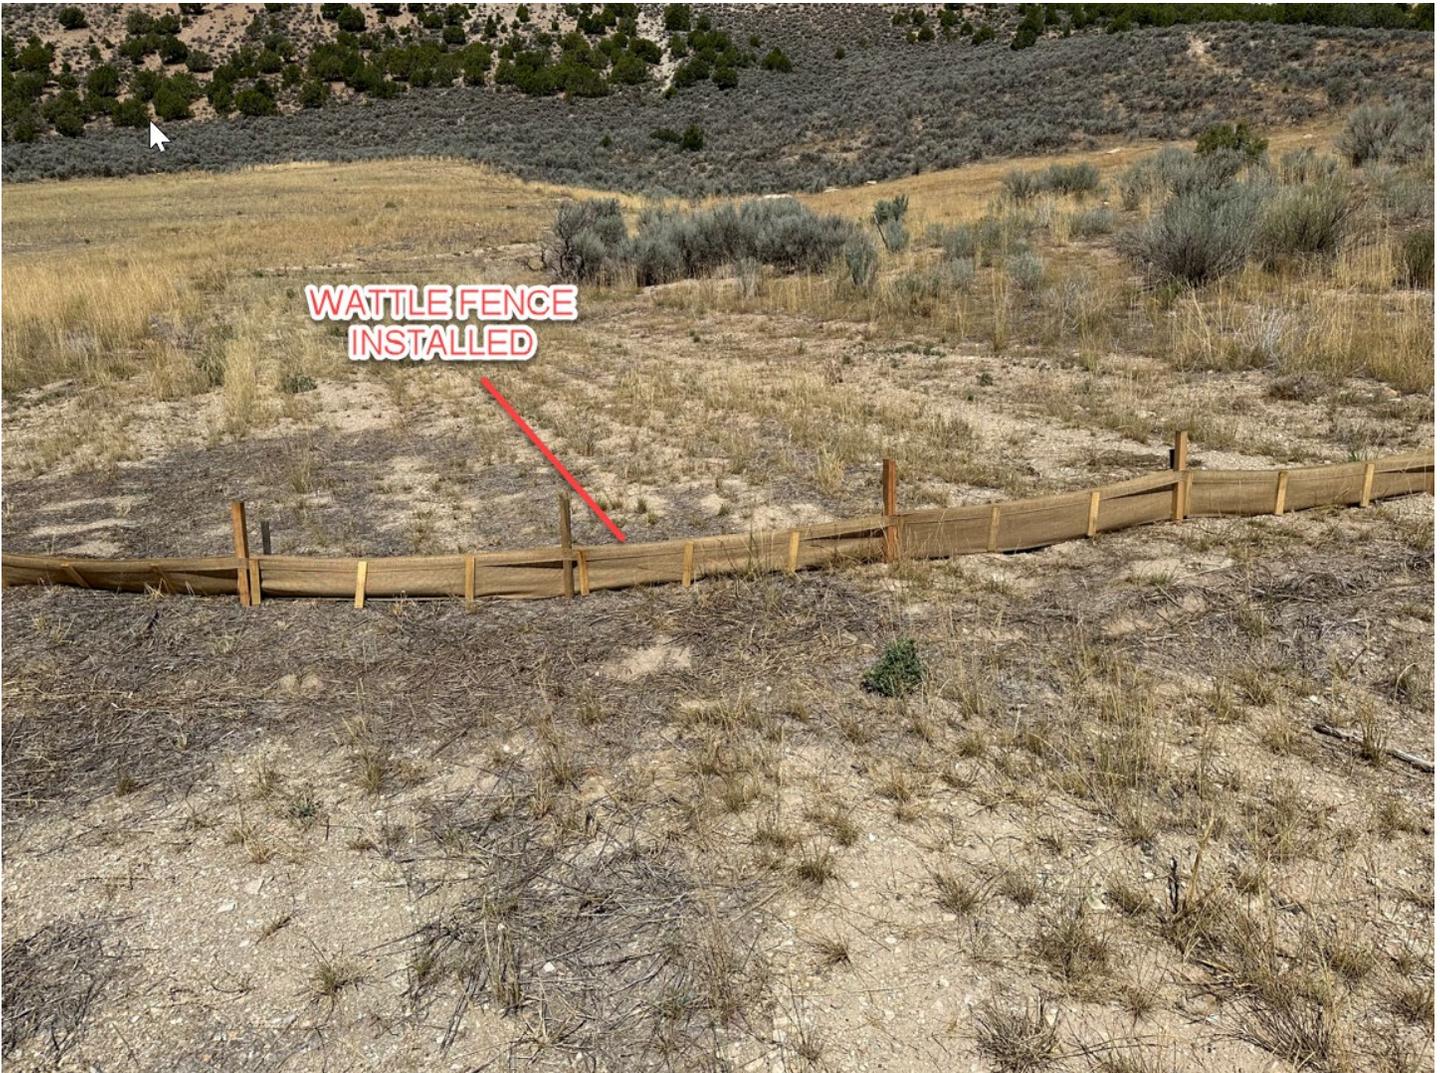
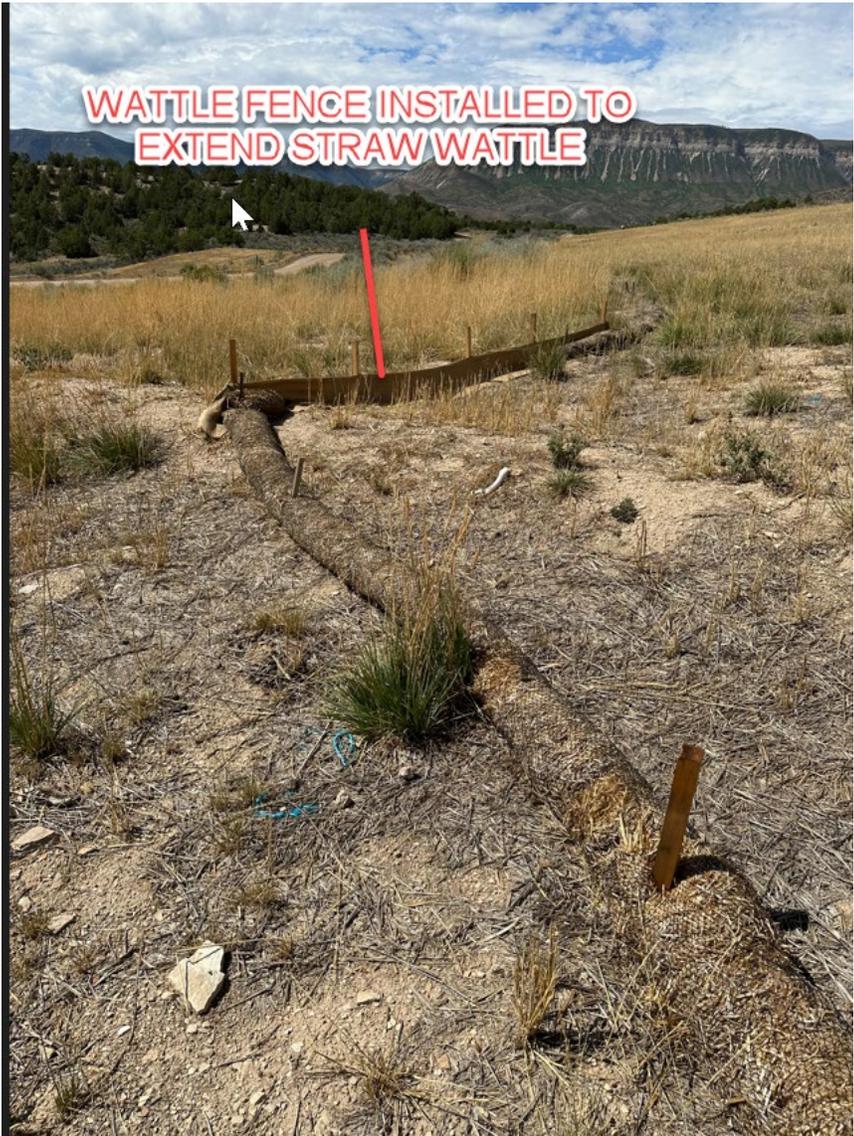
Operator has installed a slope drain from the access road; a section of the slope drain pipe has a crack/hole- hole will allow stormwater to divert into iintended areas of the reclamation where an engineered outlet has not been constructed. There are sections of erosion logs that are in disrepair; Erosion logs implemented appear to be constructed with non-biodegradable plastic. Silt Fence also observed to be in disrepair. BMPs that cannot be repaired will require proper disposal

New wattle fence has been installed and updated as needed. Wattle fence has been installed to reinforce existing straw wattles. The use of wattle fence was included in the Skinner Ridge 2023 SWAMP.

Wattles that are non-functional have been removed.

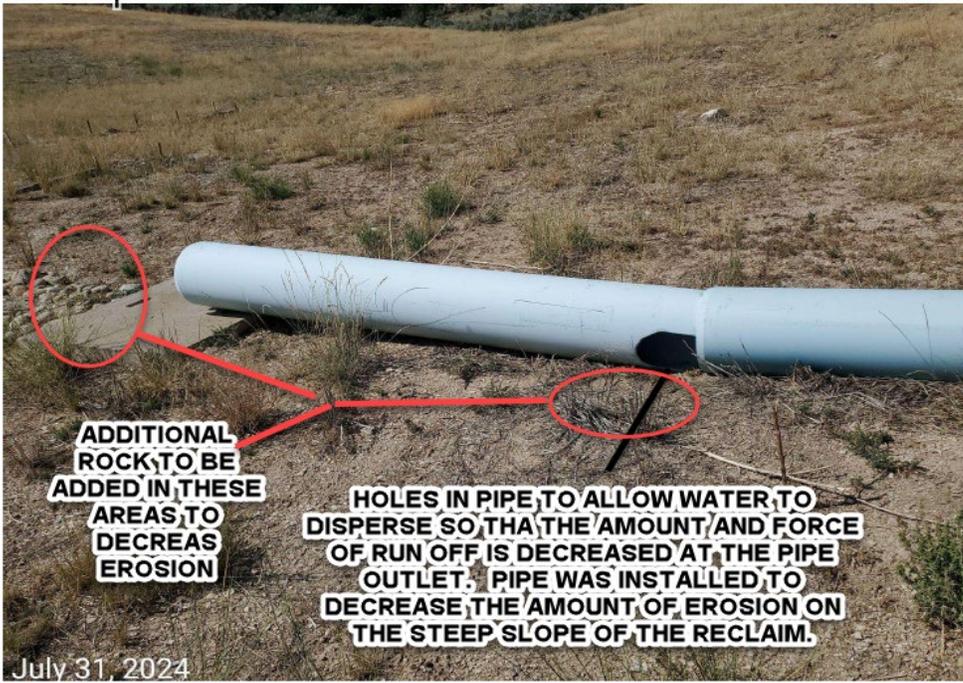
**HOLES IN PIPE TO ALLOW WATER TO
DISPERSE SO THAT THE AMOUNT AND FORCE
OF RUN OFF IS DECREASED AT THE PIPE
OUTLET. PIPE WAS INSTALLED TO
DECREASE THE AMOUNT OF EROSION ON
THE STEEP SLOPE OF THE RECLAIM.**

Rock apron has been installed at openings on pipe drain from culvert. The holes or openings on the pipe are there to decrease the amount of run off at the end of the pipe. The holes are to reduce the amount of and force of water at the outlet of the pipe. The holes also allow for distribution of run off and reduces the amount of run off at the pipe outlet.

**ADDITIONAL
ROCK TO BE
ADDED IN THESE
AREAS TO
DECREASE
EROSION**
