Impetro Resources, LLC

ANN ALLISON-63S54W/22NWNW Location ID 316957

Photo Log

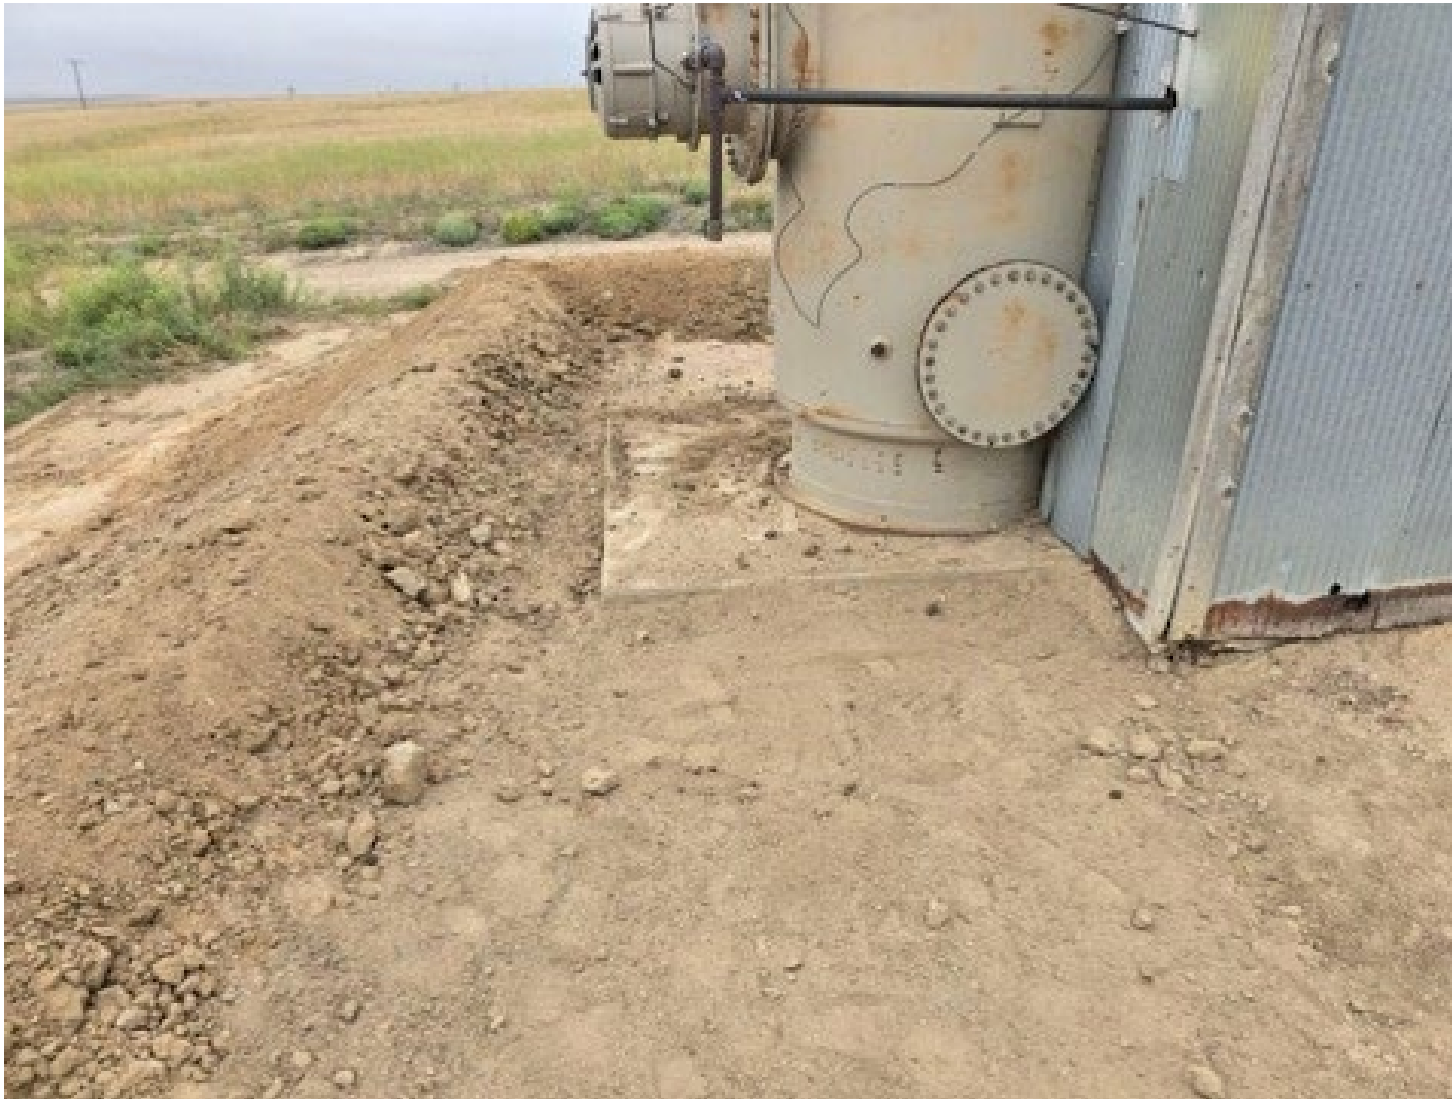
Oil-stained soil has been disposed of

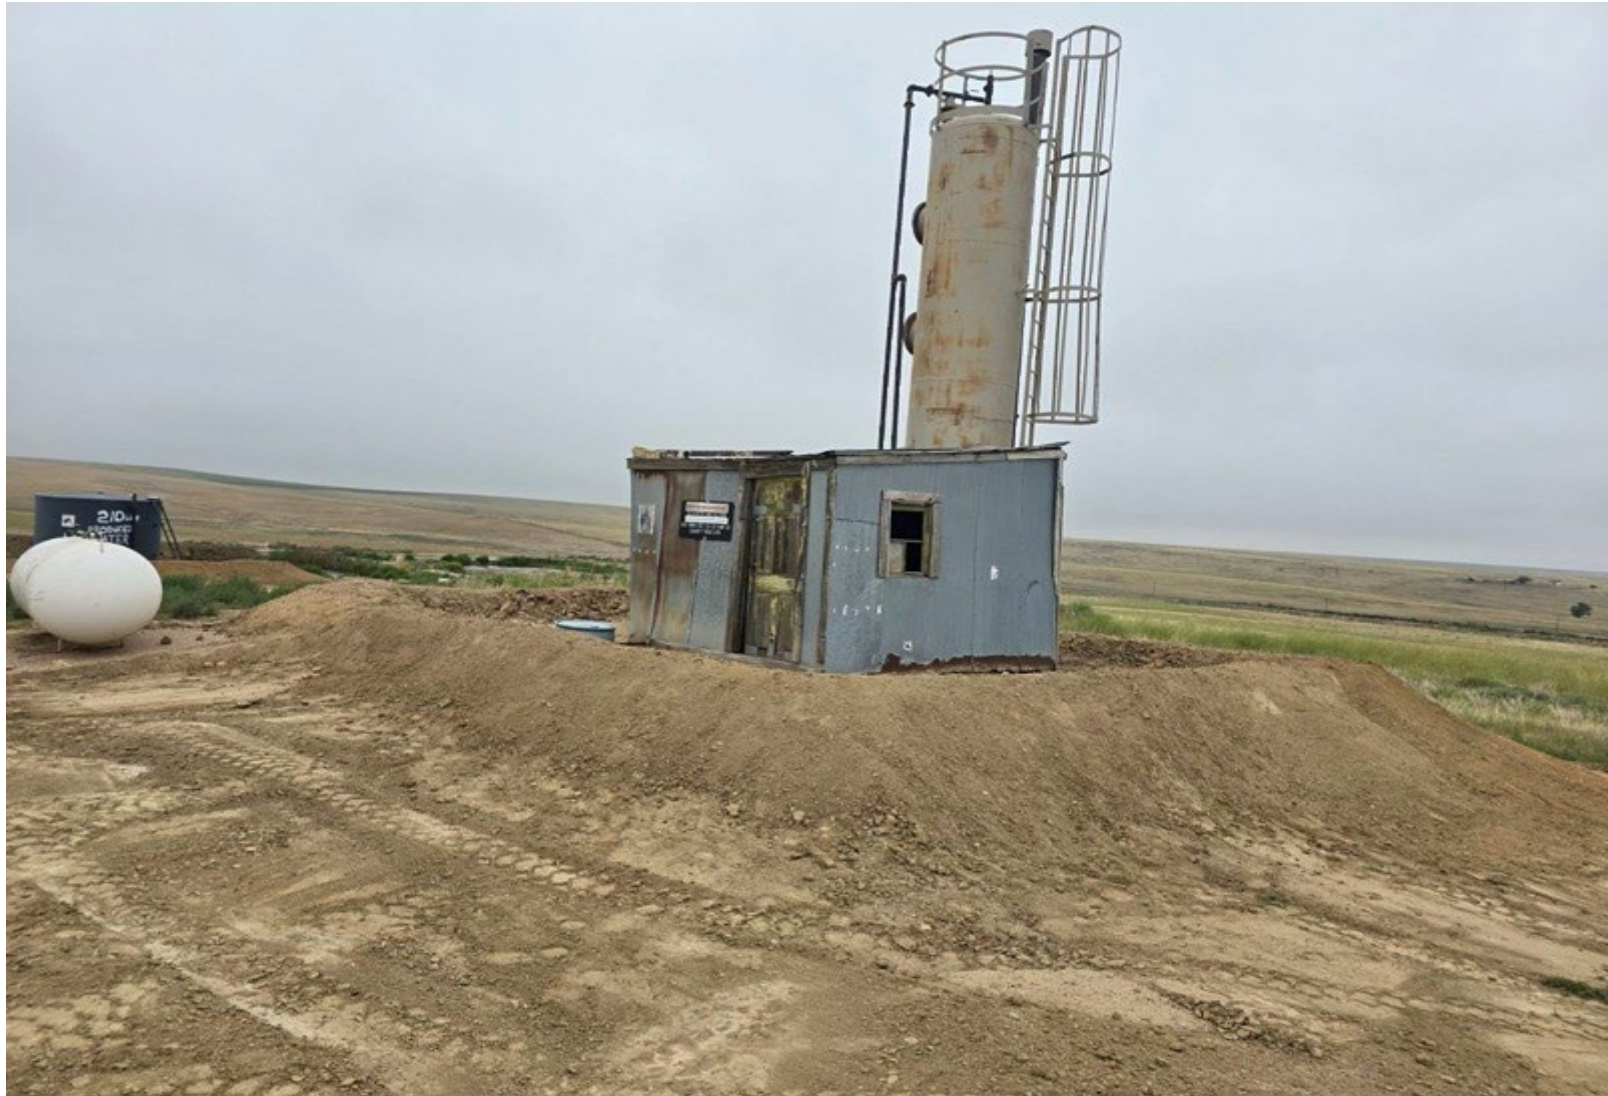
Repaired Berm around tank

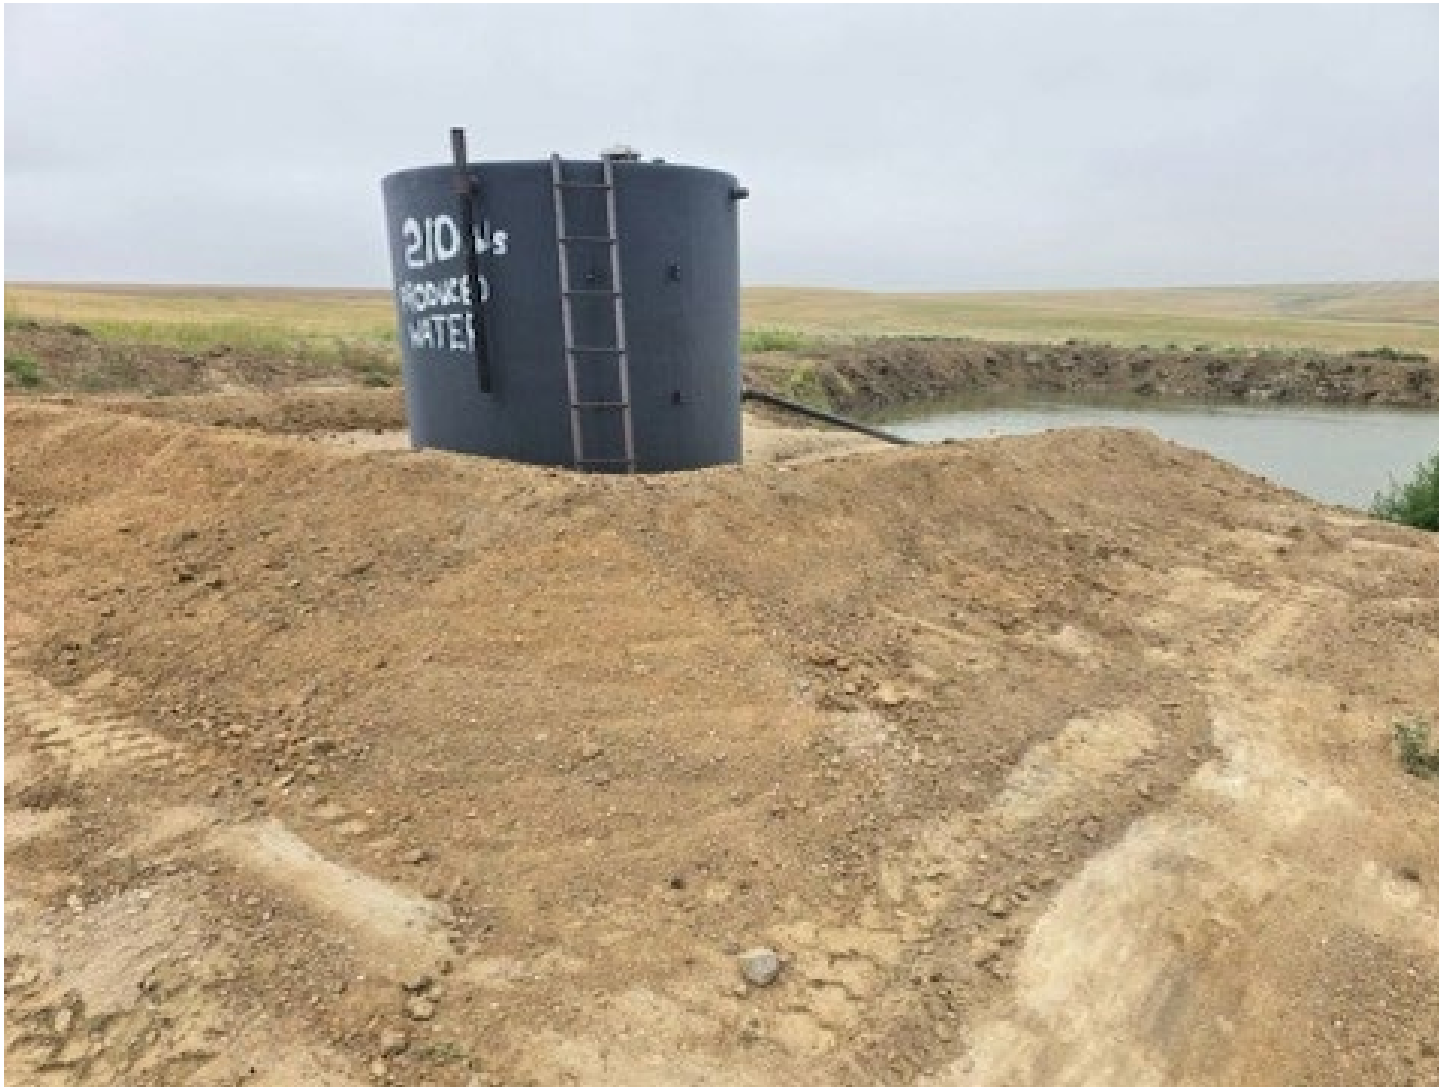
Repaired Berm around tank

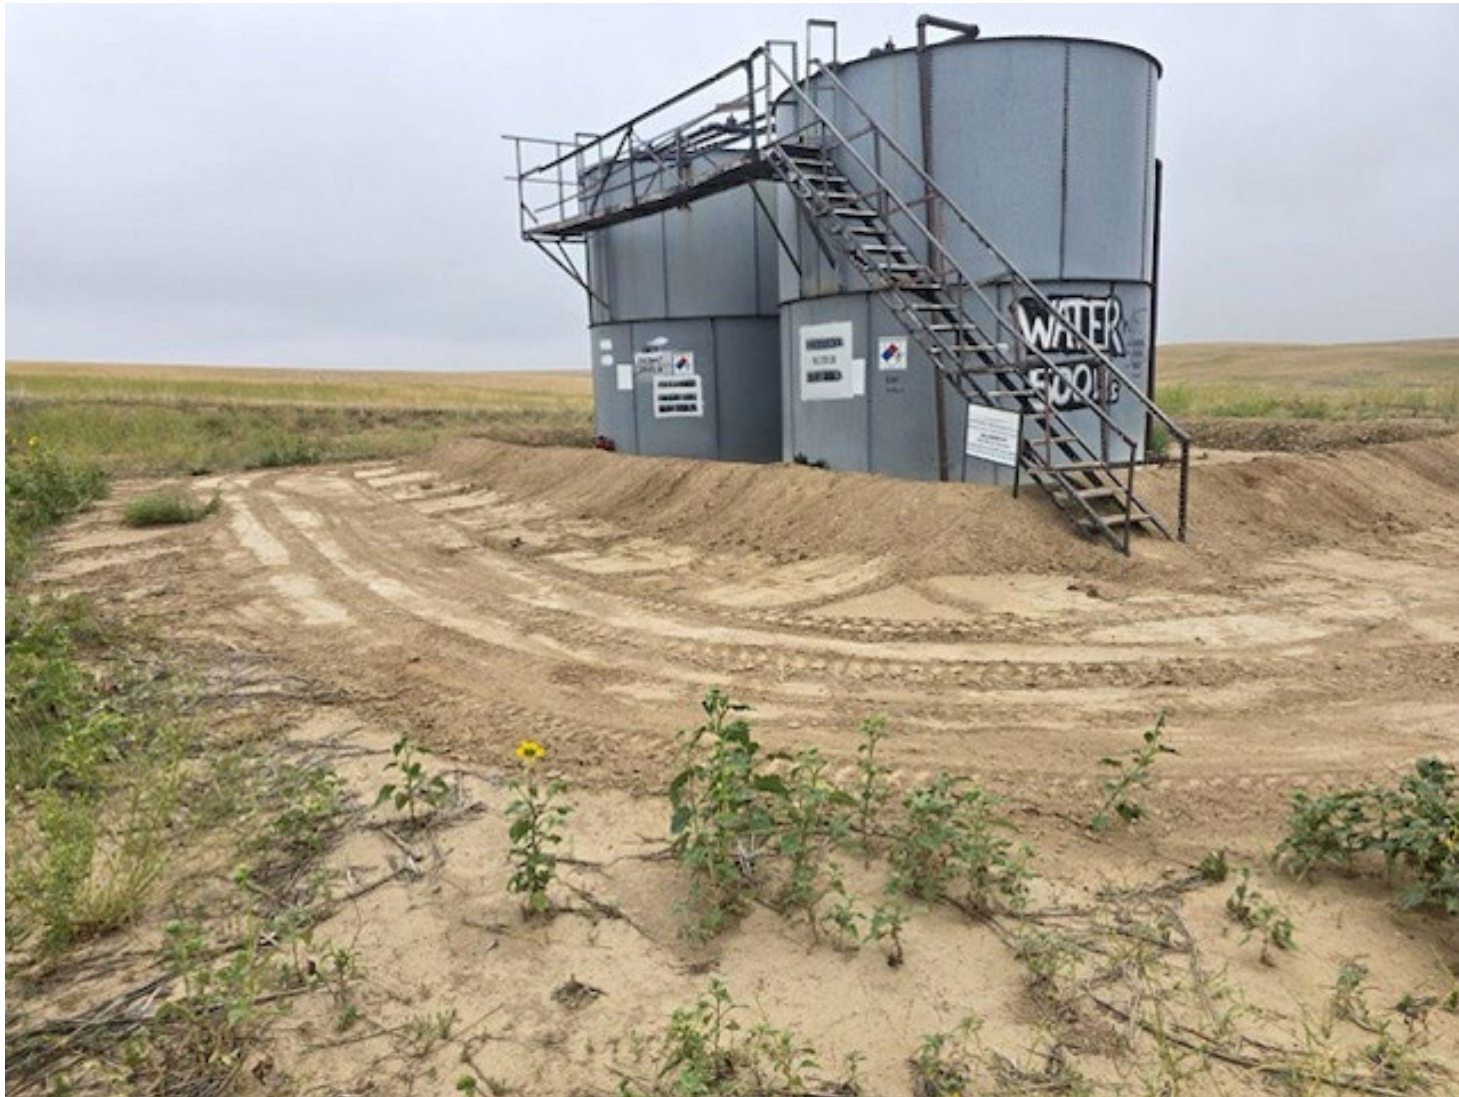
Repaired Berm around tank
