# Inspection Photos

**Operator:** TEP ROCKY MOUNTAIN LLC #96850

**Location ID:** 335636

**Inspection Doc:** 696206134

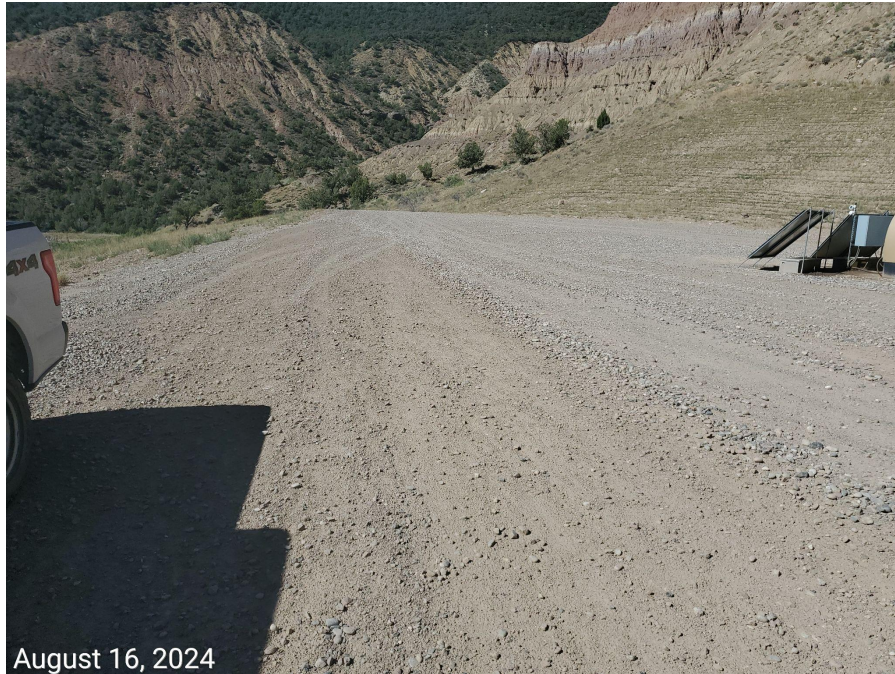
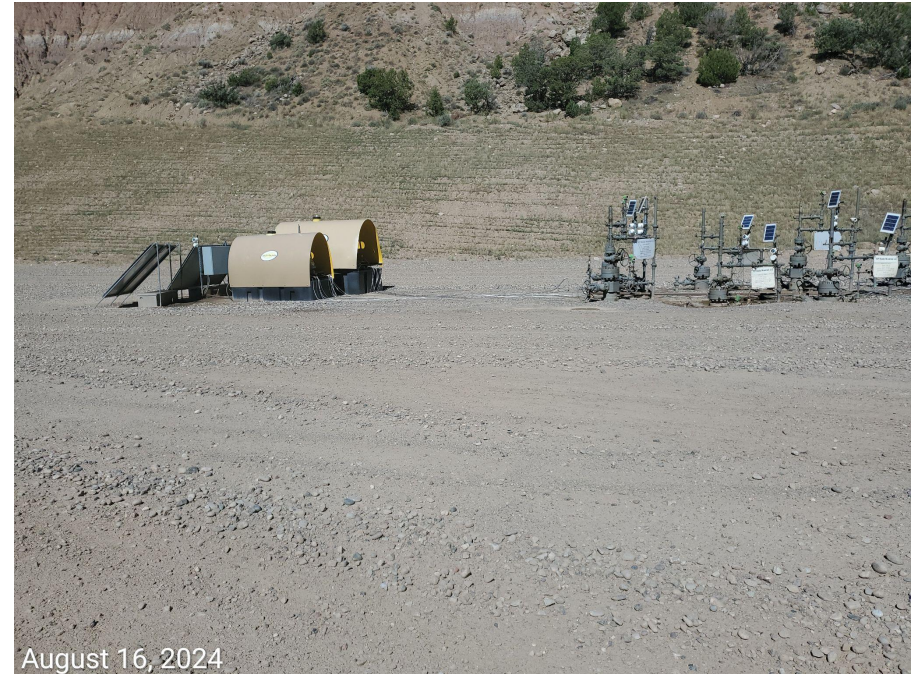
**Photo 1:** Photos 1-2 taken from the east end of the working pad surface. Photos provide an overview of the Location from south, southwest, northwest to north.

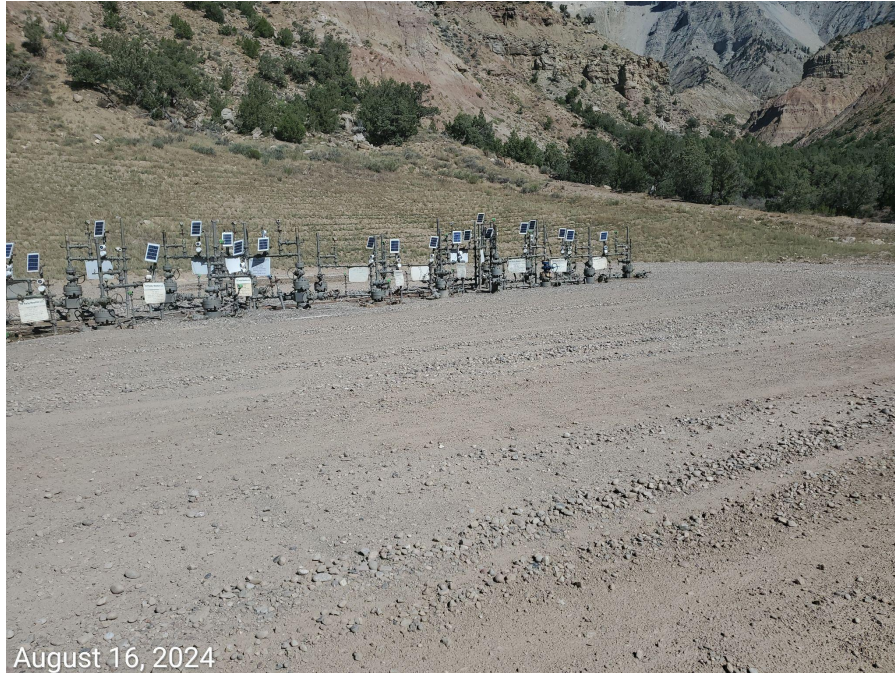
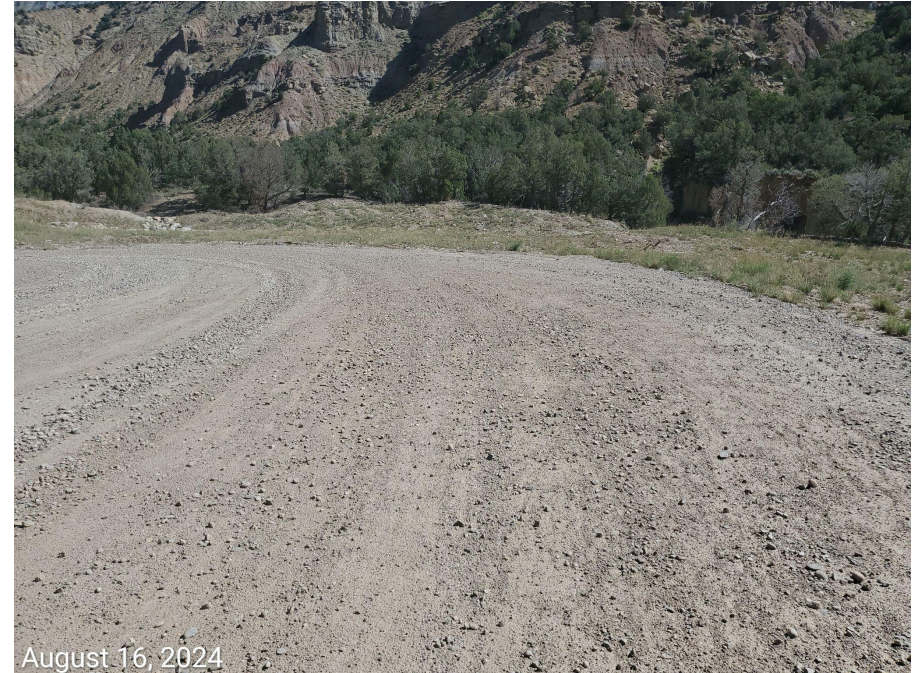
**Photo 2:** See comments under photo 1.

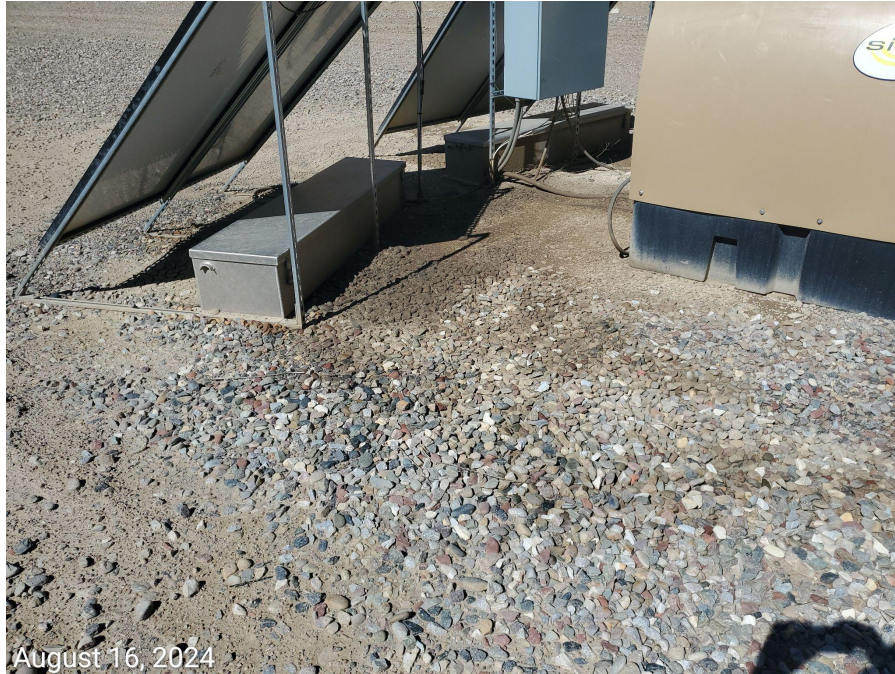
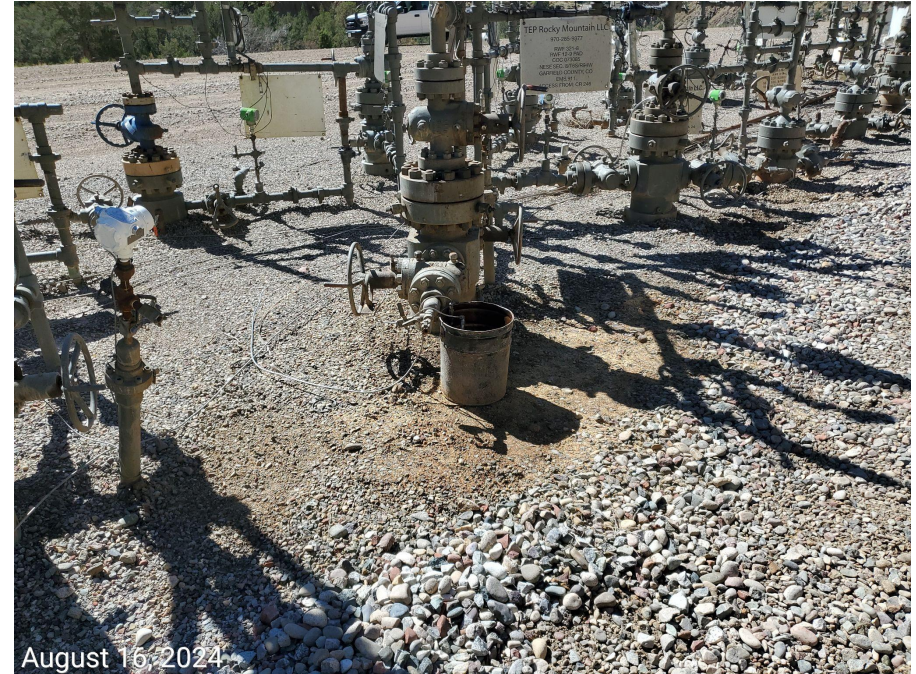
**Photo 3:** Photos 3-4 examples showing stained soils observed around the wells and methanol tanks.

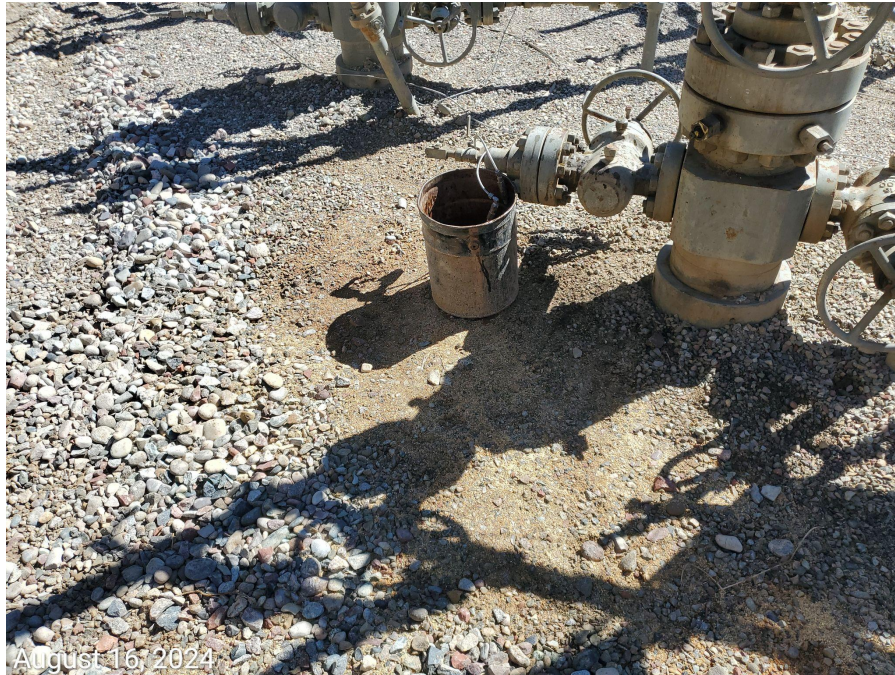
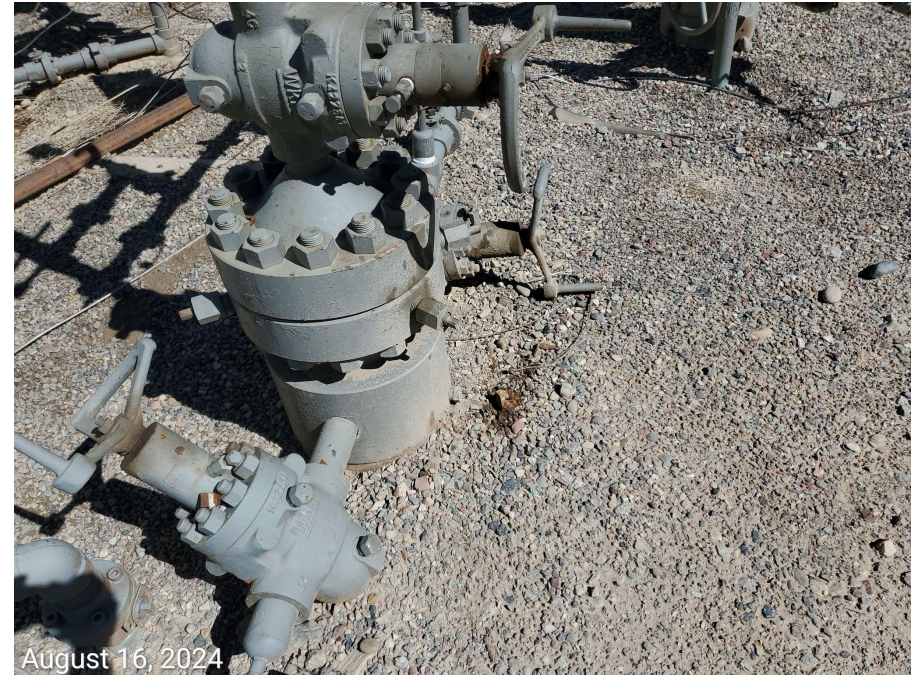
**Photo 4:** See comments under photo 3.

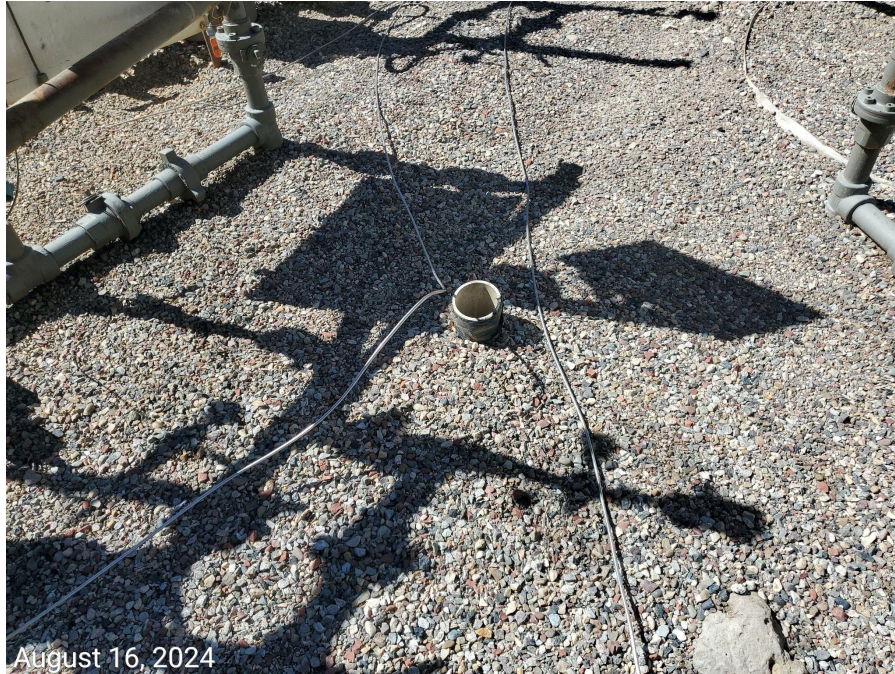
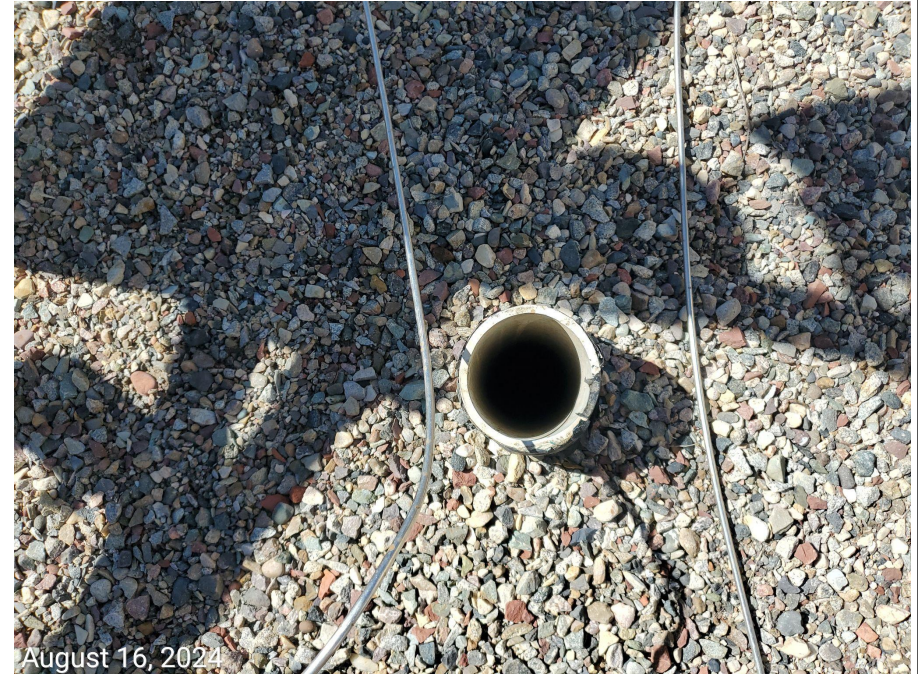
**Photo 5:** Photo shows open pipe observed along the north end of the well strings. This is a wildlife entrapment concern.

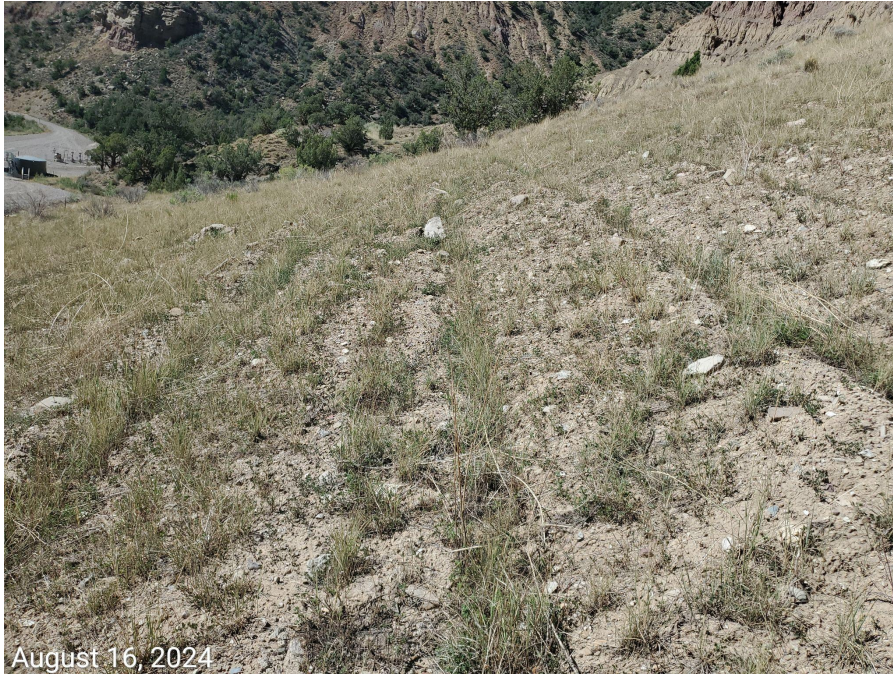
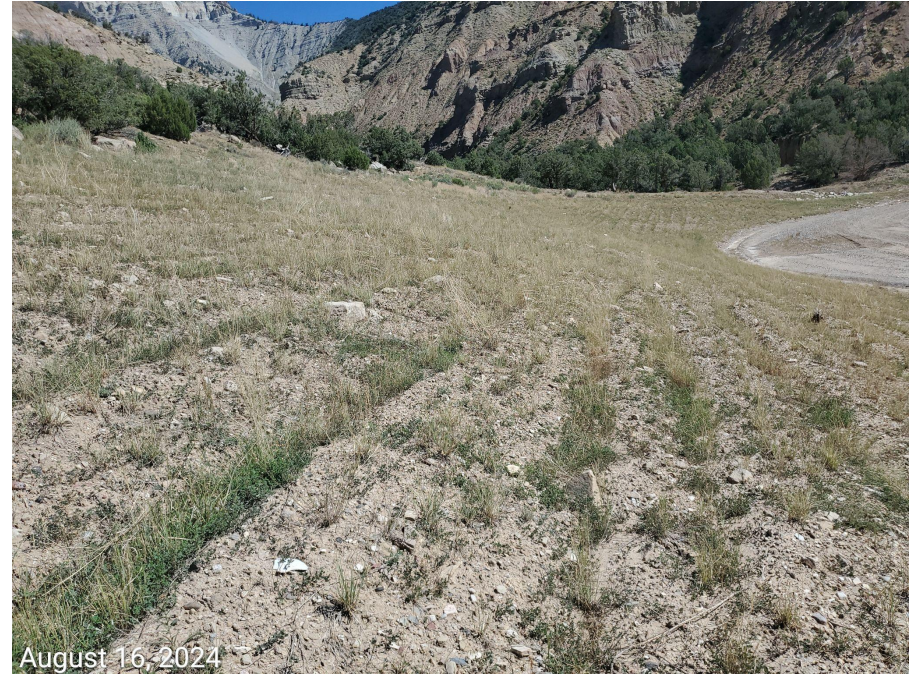
**Photo 6:** Photos taken from the interim areas on the west end of the Location, facing south and north. Reclamation within these areas appears to be progressing towards 1003 Standards.

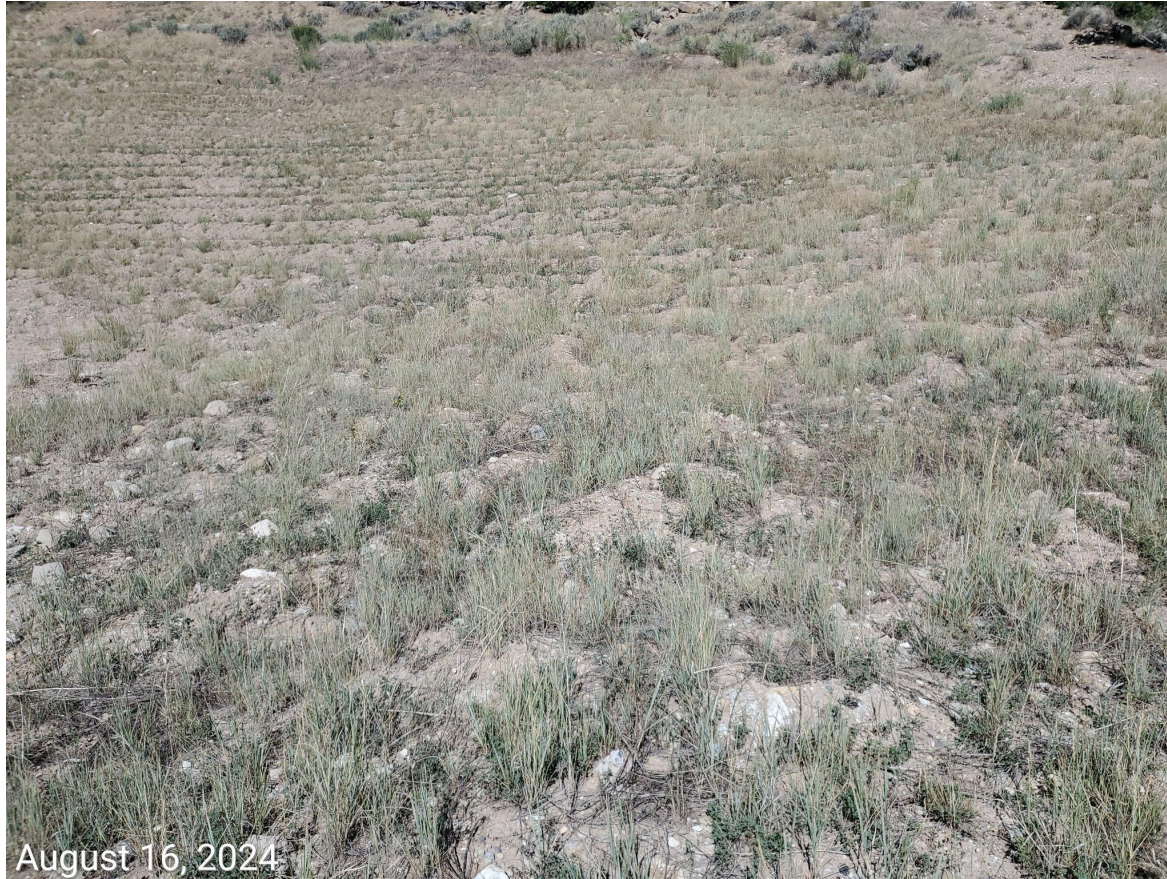
**Photo 7:** Photo taken from the interim areas on the north end of the Location, facing west. Reclamation within these areas appears to be progressing towards 1003 Standards.

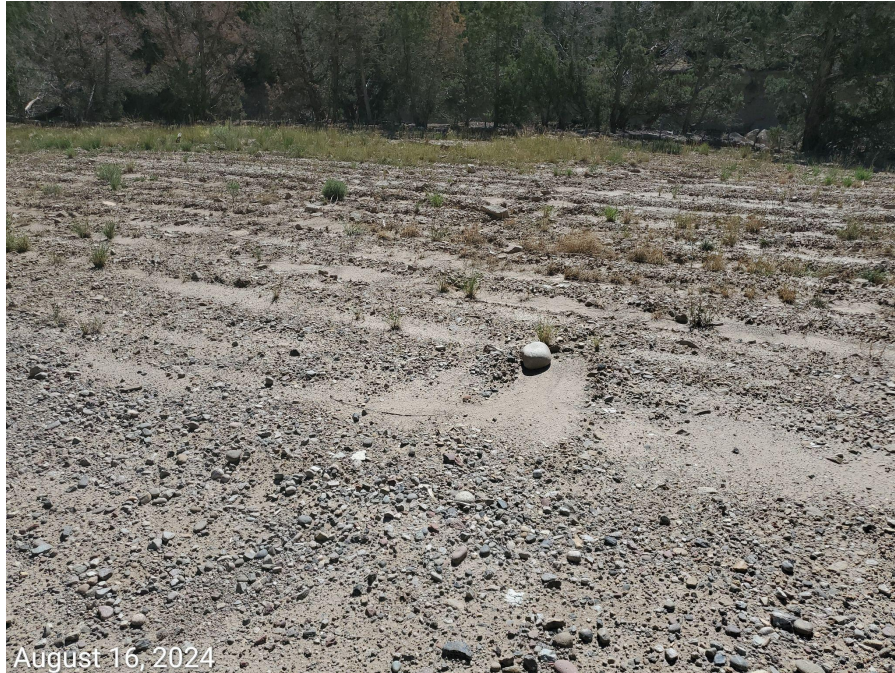
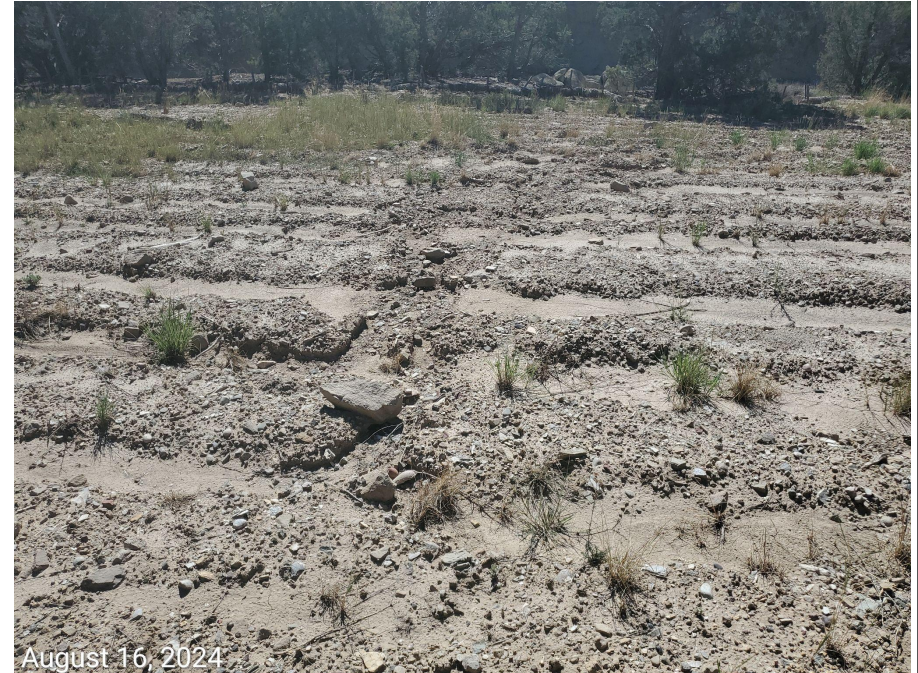
**Photo 8:** Photos 8-9 taken from the interim areas on the east end of the Location. Photos examples showing stormwater runoff from the pad is resulting in degradation and sediment deposition within the interim areas; resulting in impacts to the reclamation as desirable perennial germination and establishment was not observed, or not uniform, within these areas.

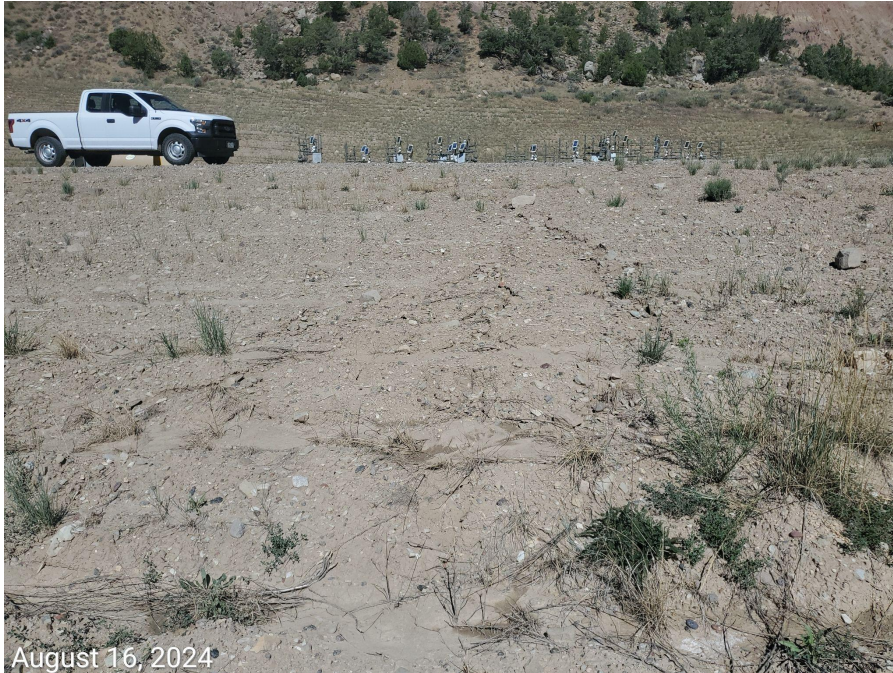
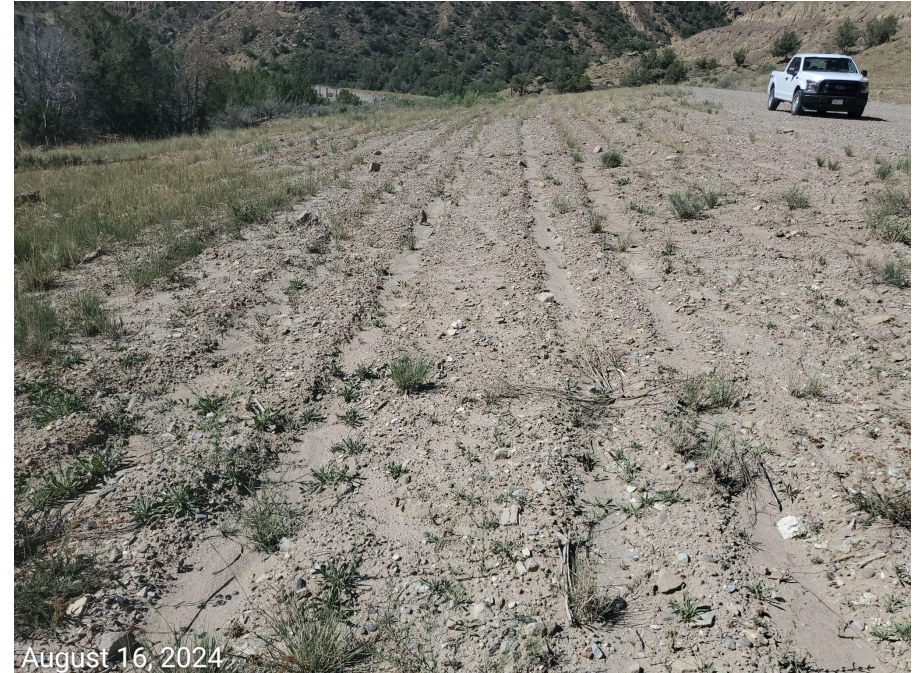
**Photo 9:** See comments under photo 8.

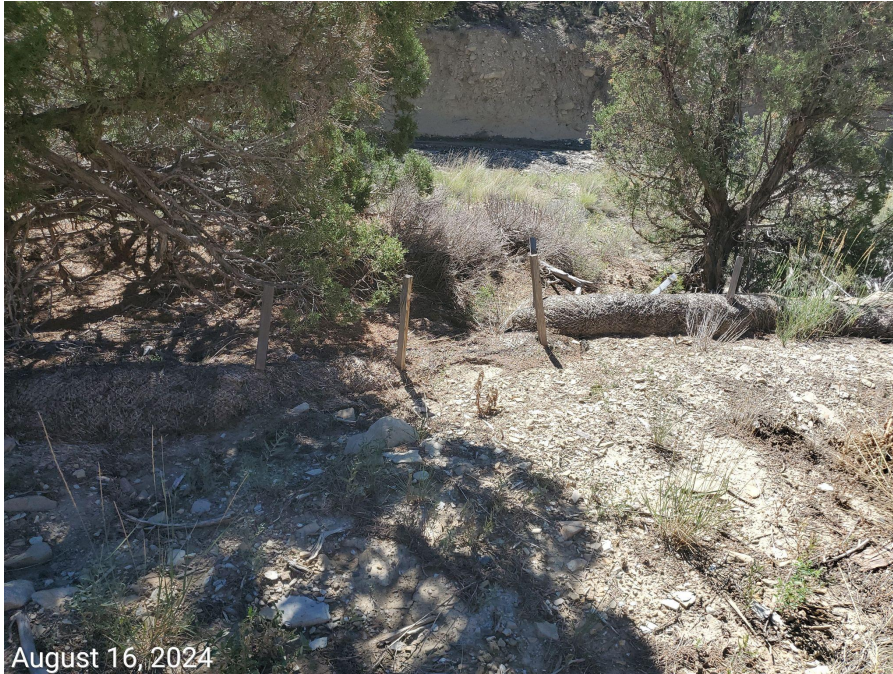
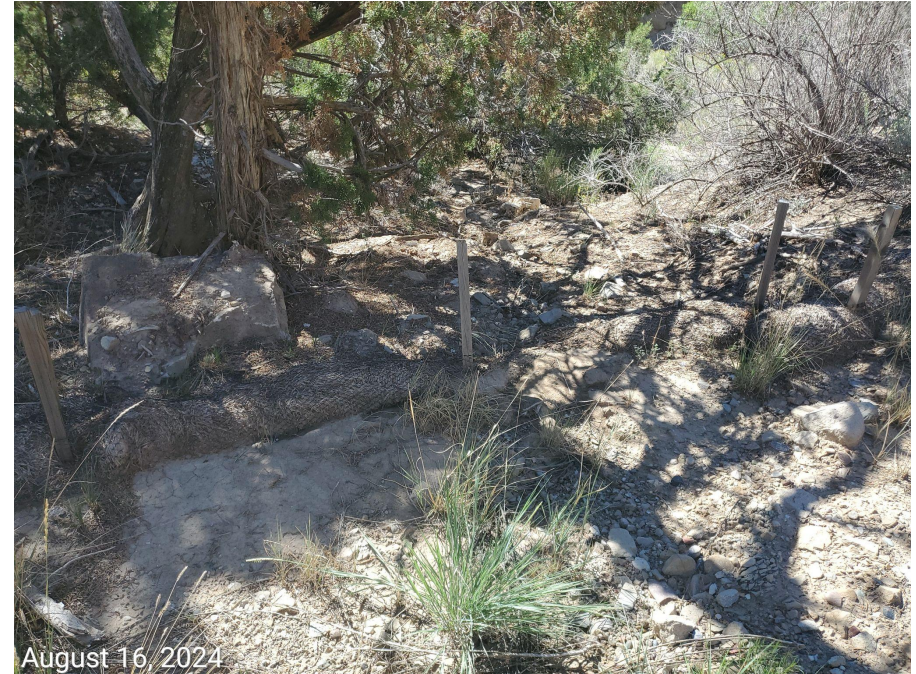
**Photo 10:** Photos taken from the eastern perimeter of the Location. Photos examples showing BMPs have not been maintained, resulting in off-site sediment transport.
