DOCUMENT NUMBER: 699700390  
FACILITY ID: 228882  
API NUMBER: 103-05874  
FACILITY NAME: WILSON CREEK MORRISON UNIT 20

CORRECTIVE ACTION NARRATIVE FROM ECMC INSPECTION REPORT DATED 24 JULY 2023

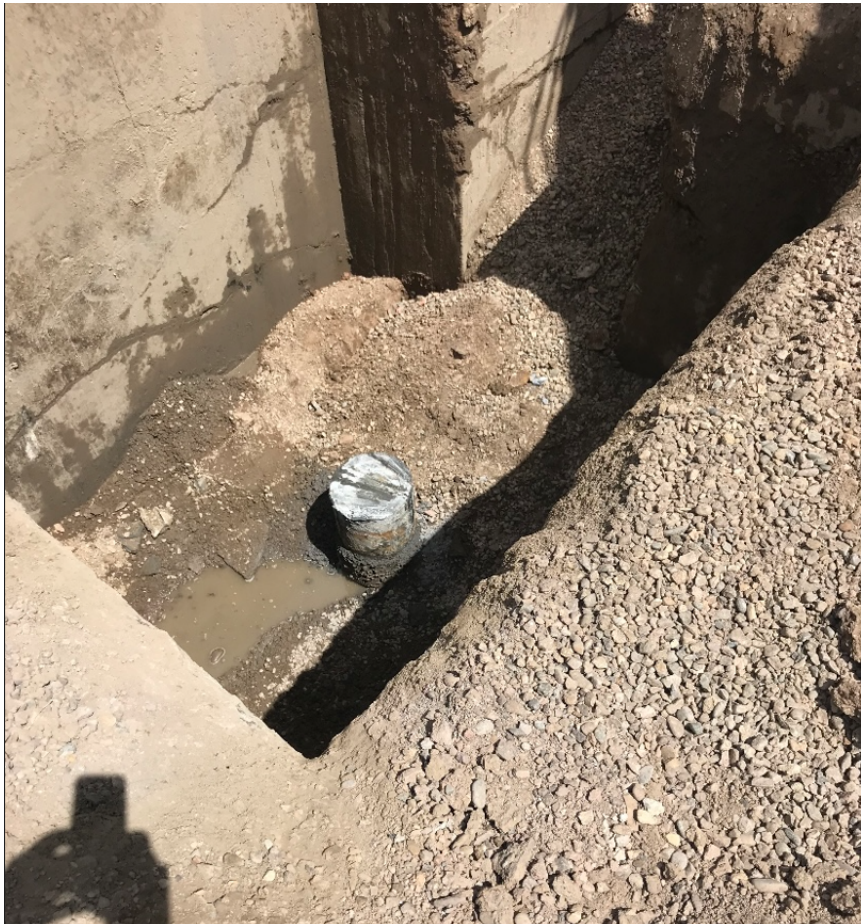
**Comment:** Potentially impacted material adjacent to the wellhead.

This picture shows the excavated wellhead is plugged and cutoff and the well cellar is intact.

RESPONSE TO CA 1: On 07/18/2024 Wilson Creek Well #20 wellhead was dug out by shovel to allow access to the wellhead bolts in preparation for plugging operations. On 07/30/2024 the P&A rig moved onto location to begin plugging the well. The Unit 20 plugging was completed on 8/9/2024 and cut/cap operations were completed on 8/14/24. Once the cut and cap was completed the well cellar was backfilled with excavated material. Chevron plans to excavate this Site during the 2025 field season.

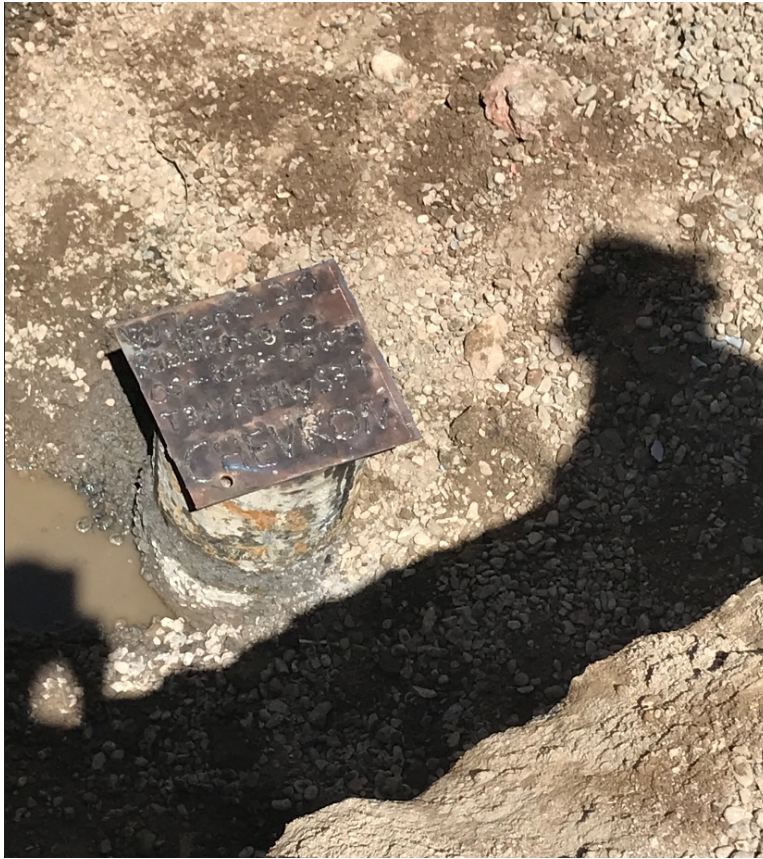
Wilson Creek 20 well is cut and capped

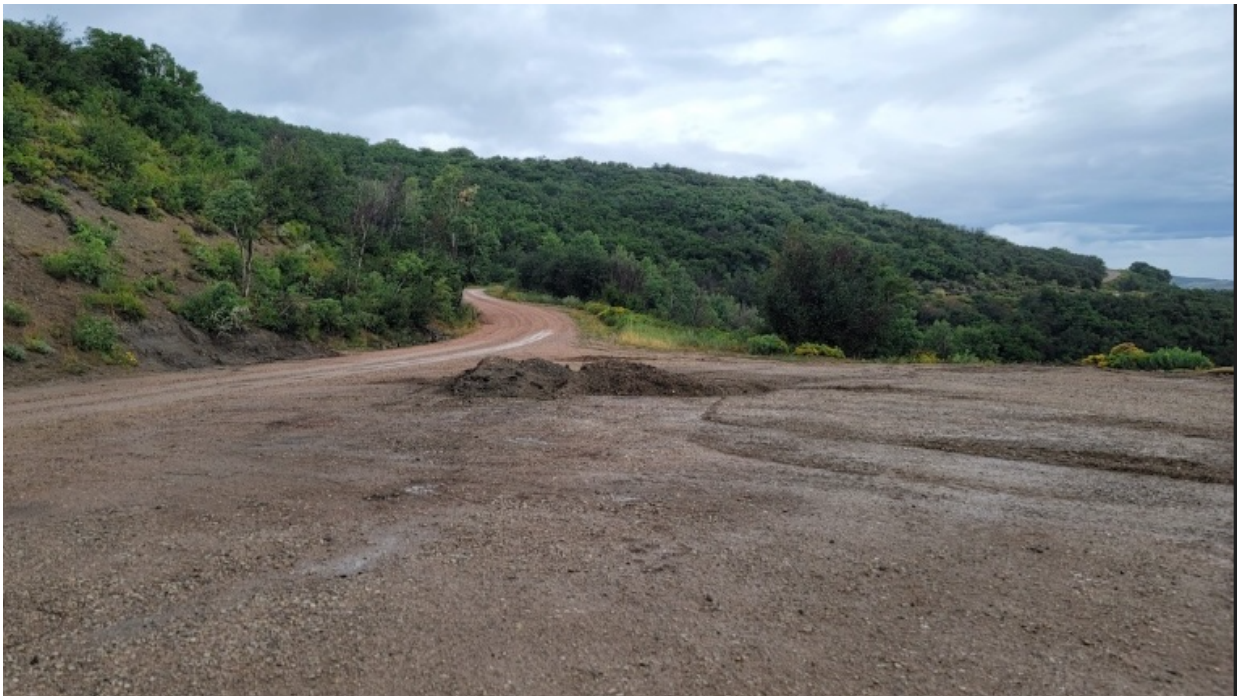
Wilson Creek 20 after cut and cap completion.

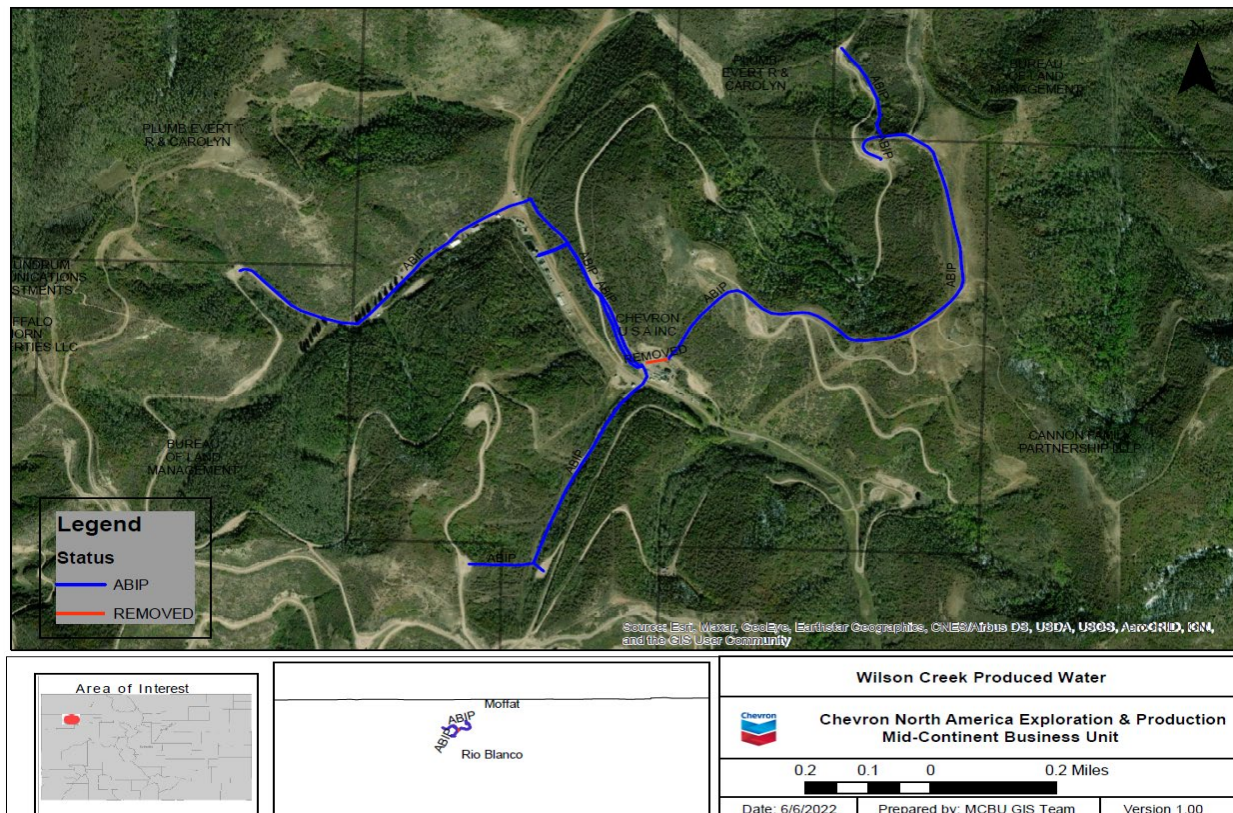
Comment: Unmarked riser adjacent to the wellhead.

**WILSON CREEK WELL 20  
CEMENT PLUG IN FLOWLINE**

RESPONSE TO CA 2: On 20 August 2024 the Wilson Creek Well 20 flow line was cut off 225 south of the Well 20 well head at GPS coordinates 40.188391/-107.920832 at a depth of 5 feet. The line was plugged with cement and the pipe was covered with dirt. See attached pictures.

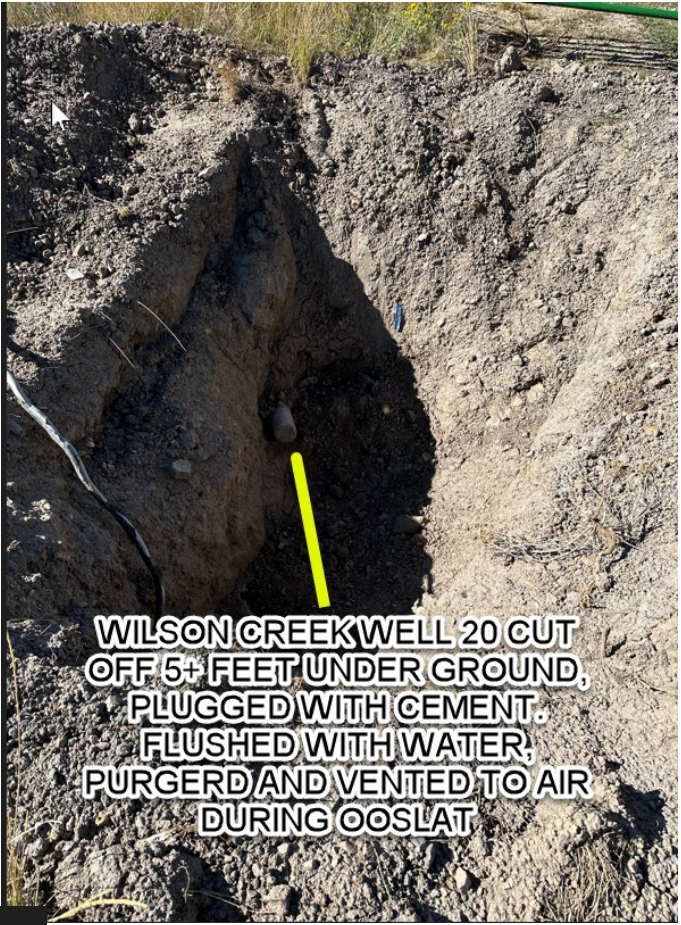
**WILSON CREEK WELL 20 CUT  
OFF 5+ FEET UNDER GROUND,  
PLUGGED WITH CEMENT.  
FLUSHED WITH WATER,  
PURGERD AND VENTED TO AIR  
DURING OOSLAT**

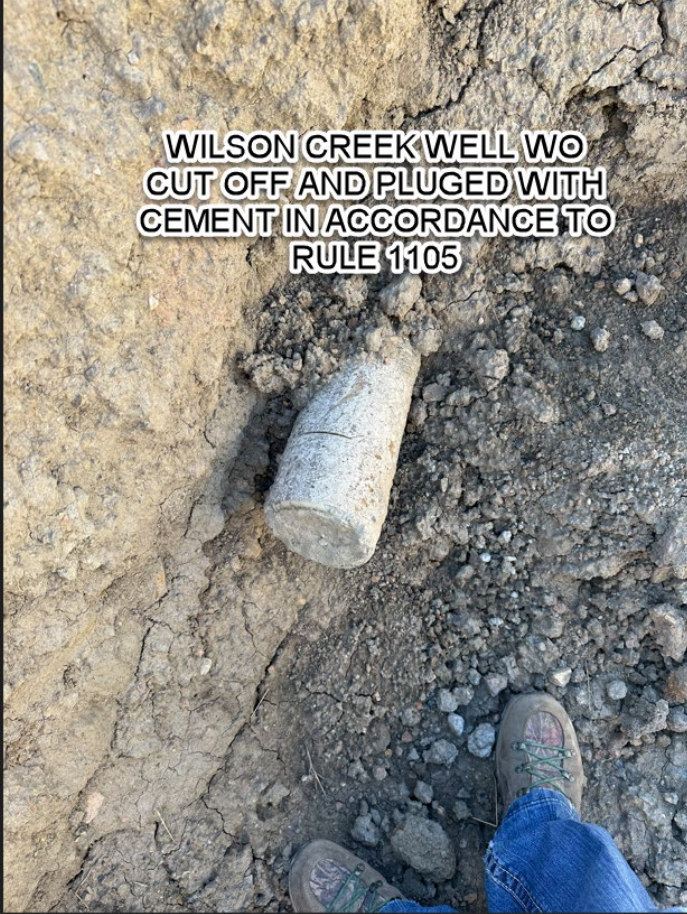
**WILSON CREEK WELL WO  
CUT OFF AND PLUGGED WITH  
CEMENT IN ACCORDANCE TO  
RULE 1105**
