Inspection Photos

Location Name: TEP ROCKY MOUNTAIN LLC CB-TG Land NW 11D-20-692 Pad

Location #: 418555

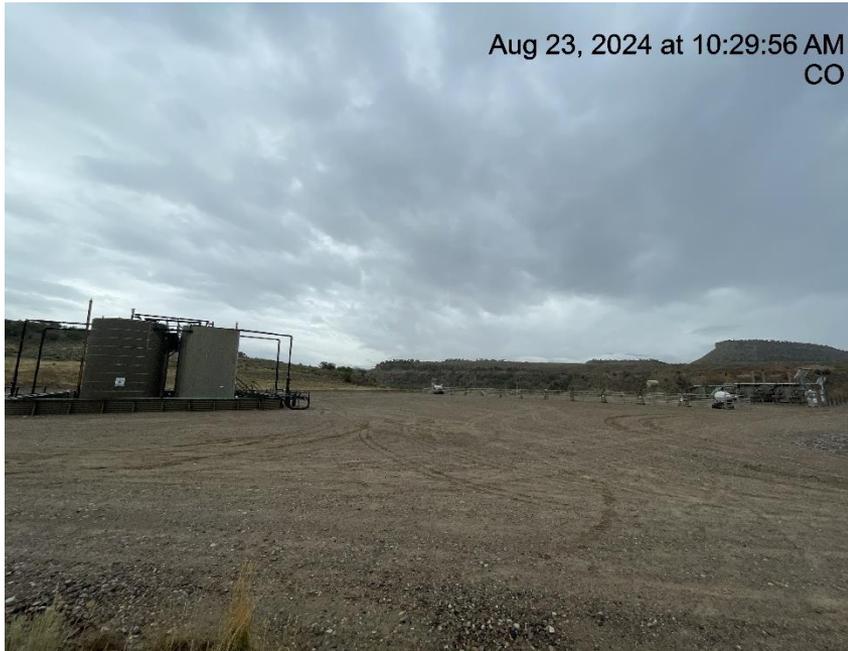
Photo # 6054 From entrance to location

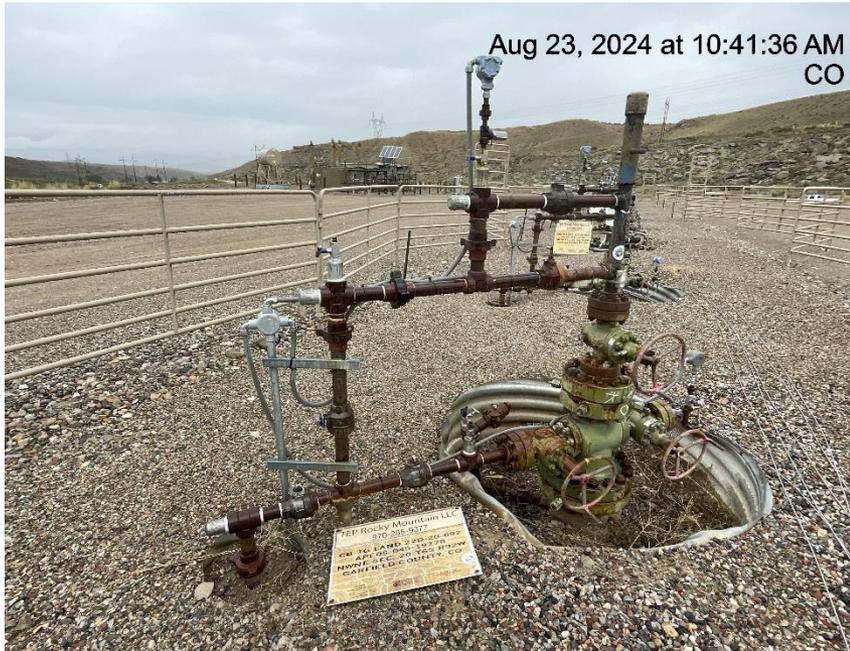
Photo # 6062 Wellhead sign laying on ground & not properly Posted/does not comply with CECMC signage rules

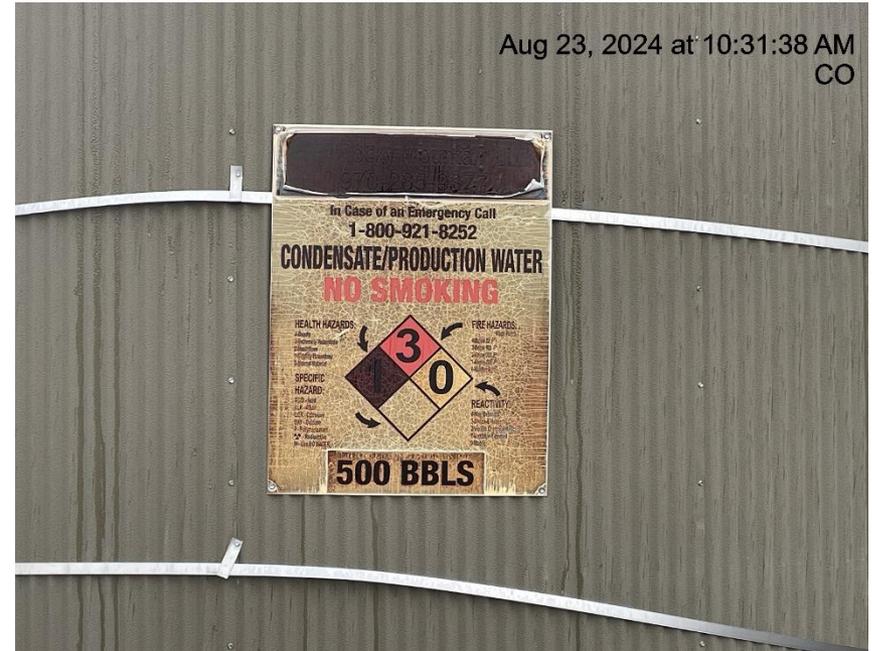
Photo # 6063 Tank label weathered & some required info is illegible/does not comply with CECMC labeling rules

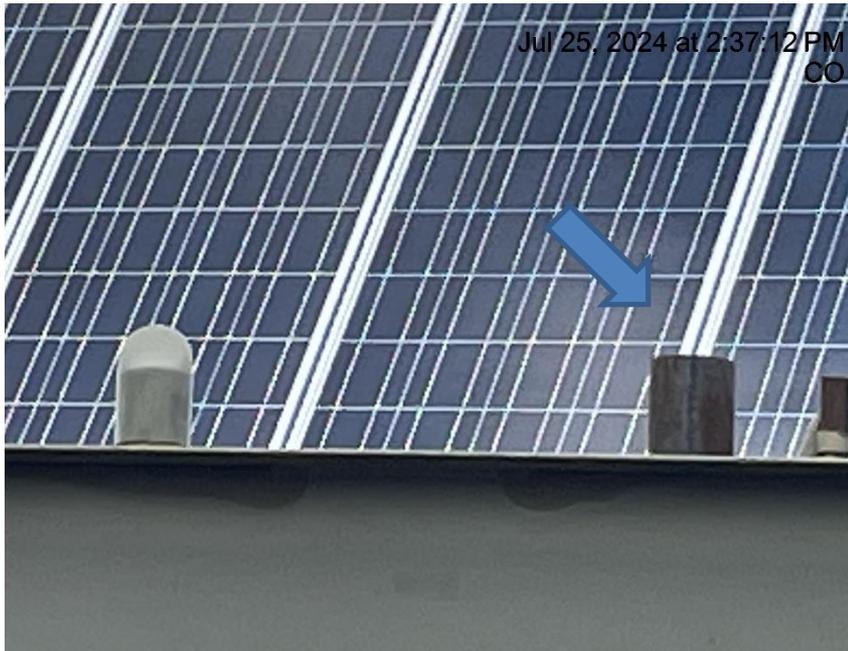
Photo # 3511 From inspection 708904231 conducted on 07/25/2024 PRV vent line on separator unit does not comply with CECMC pressure safety device rules

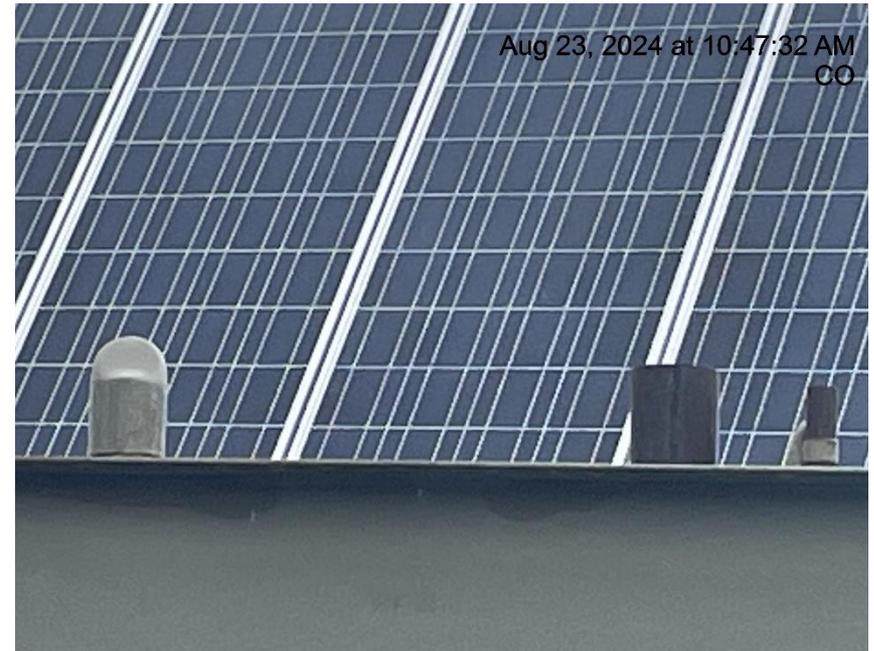
Photo # 6064 PRV vent line on separator unit does not comply with CECMC pressure safety device rules

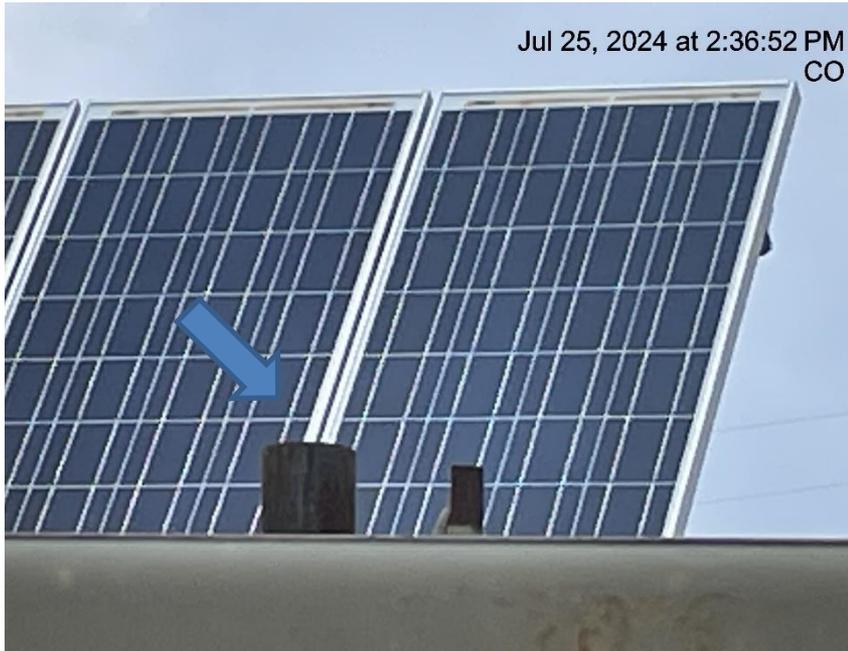
Photo # 3512 From inspection 708904231 conducted on 07/25/2024 PRV vent line on separator unit does not comply with CECMC pressure safety device rules
