Inspection Photos

Operator: Seeley Oil Company - 10506

Location ID: 322118

Inspection Photos
Location Name: Southeast Spargo 1
Location ID: 322118

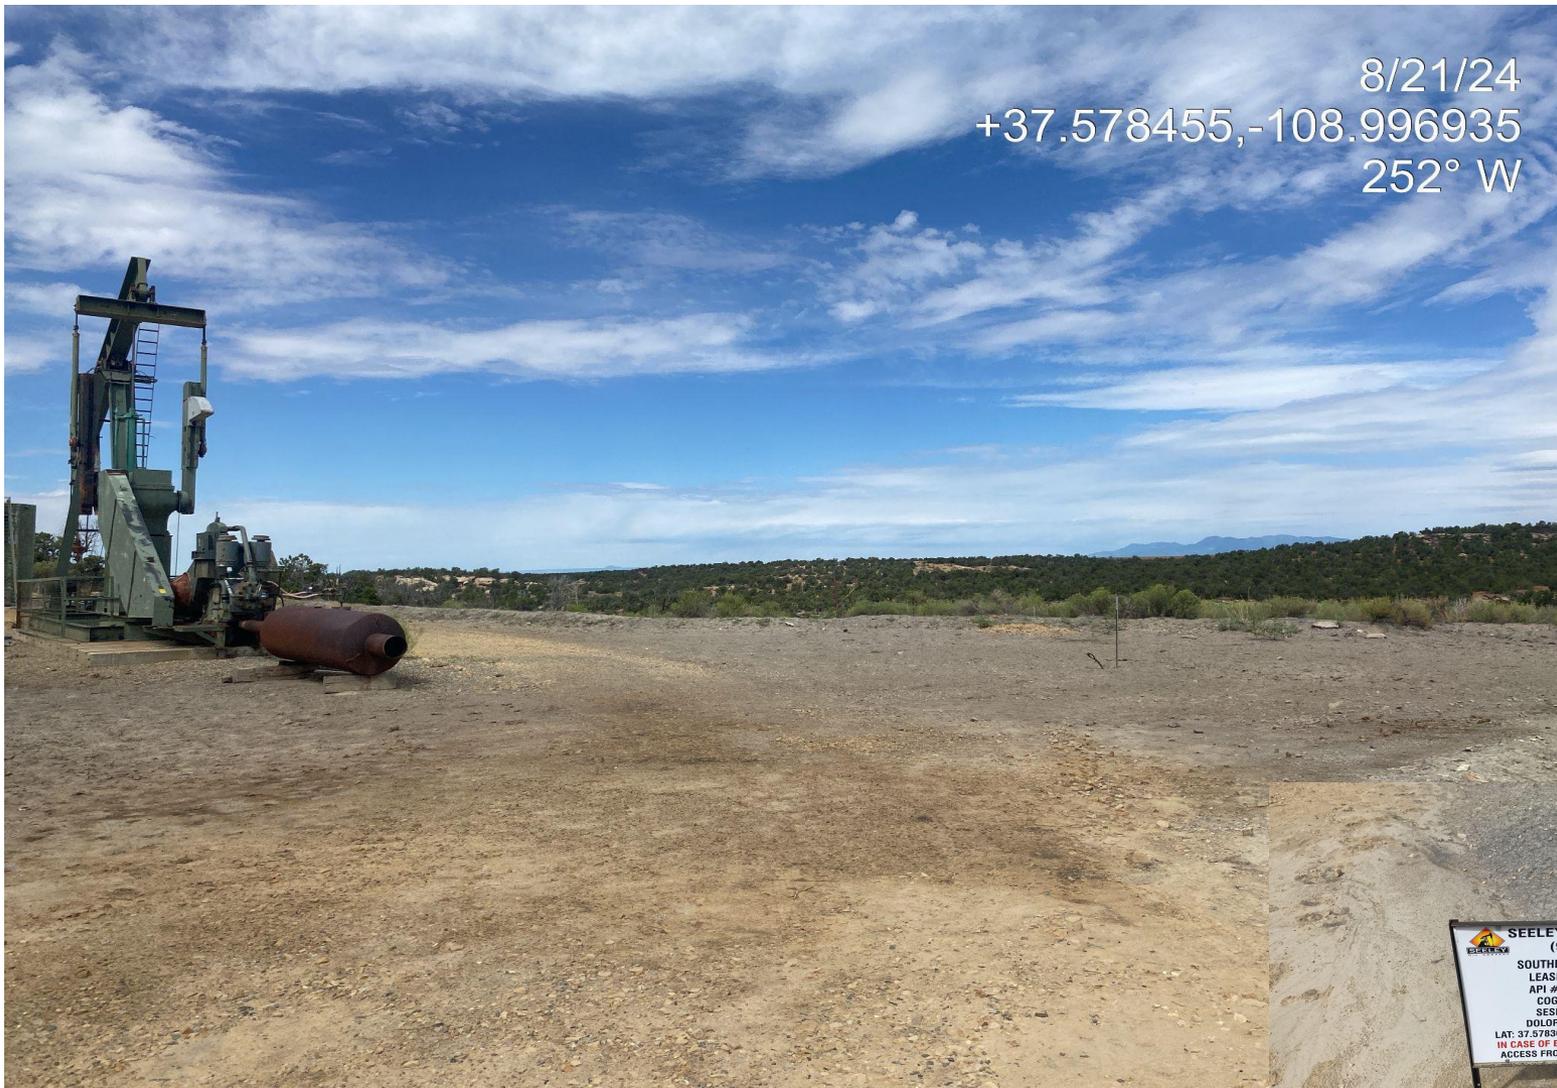
Photo 1. View of disturbance taken from the access point facing center.

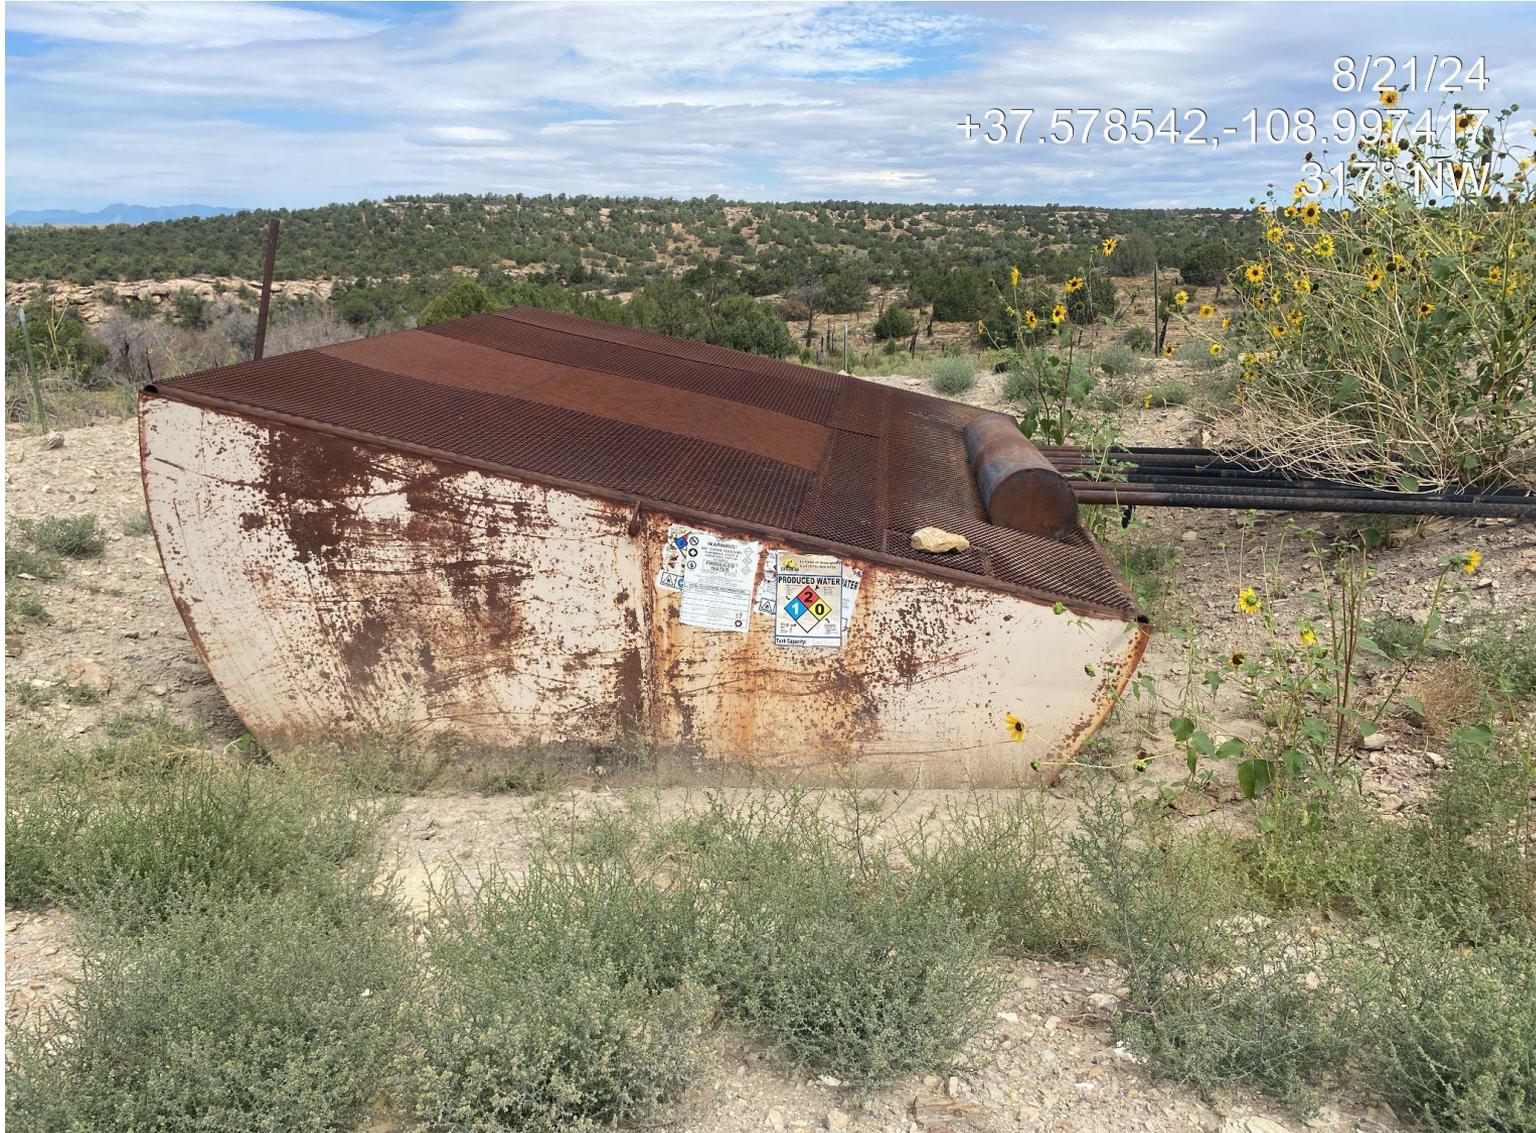
Photo 2. Produced water tank has been properly labeled with capacity.

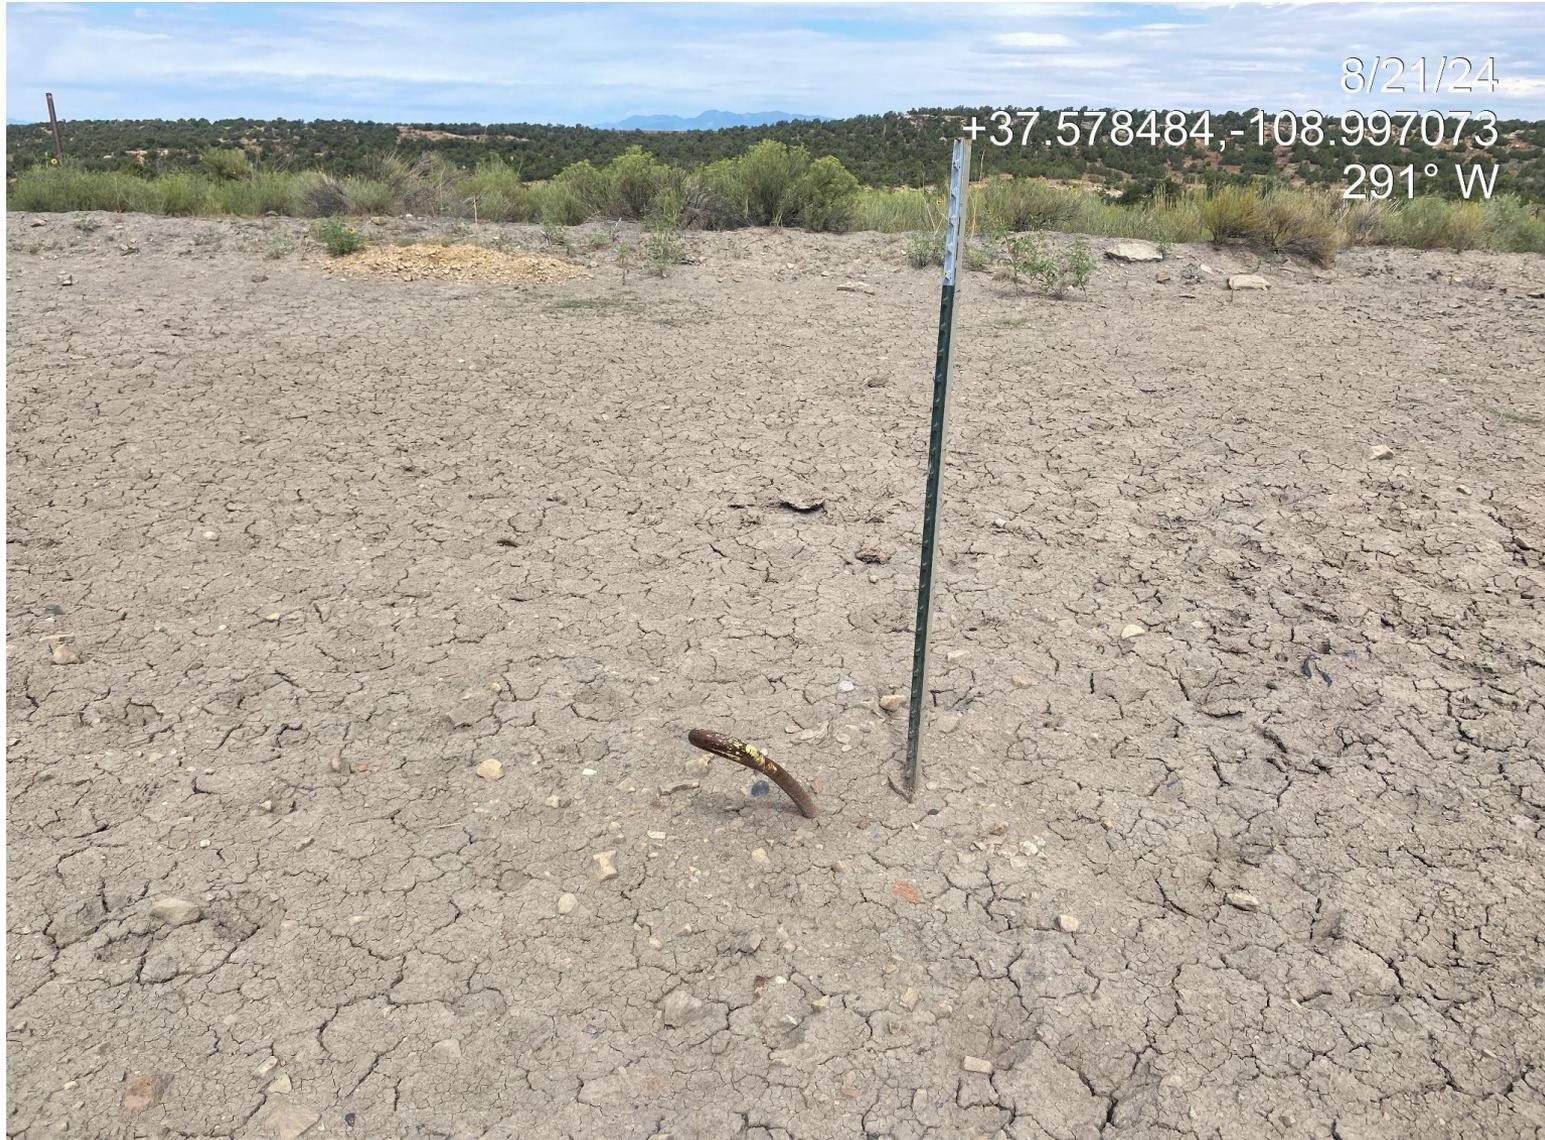
Photo 3. Guy line anchors on location have been properly marked.

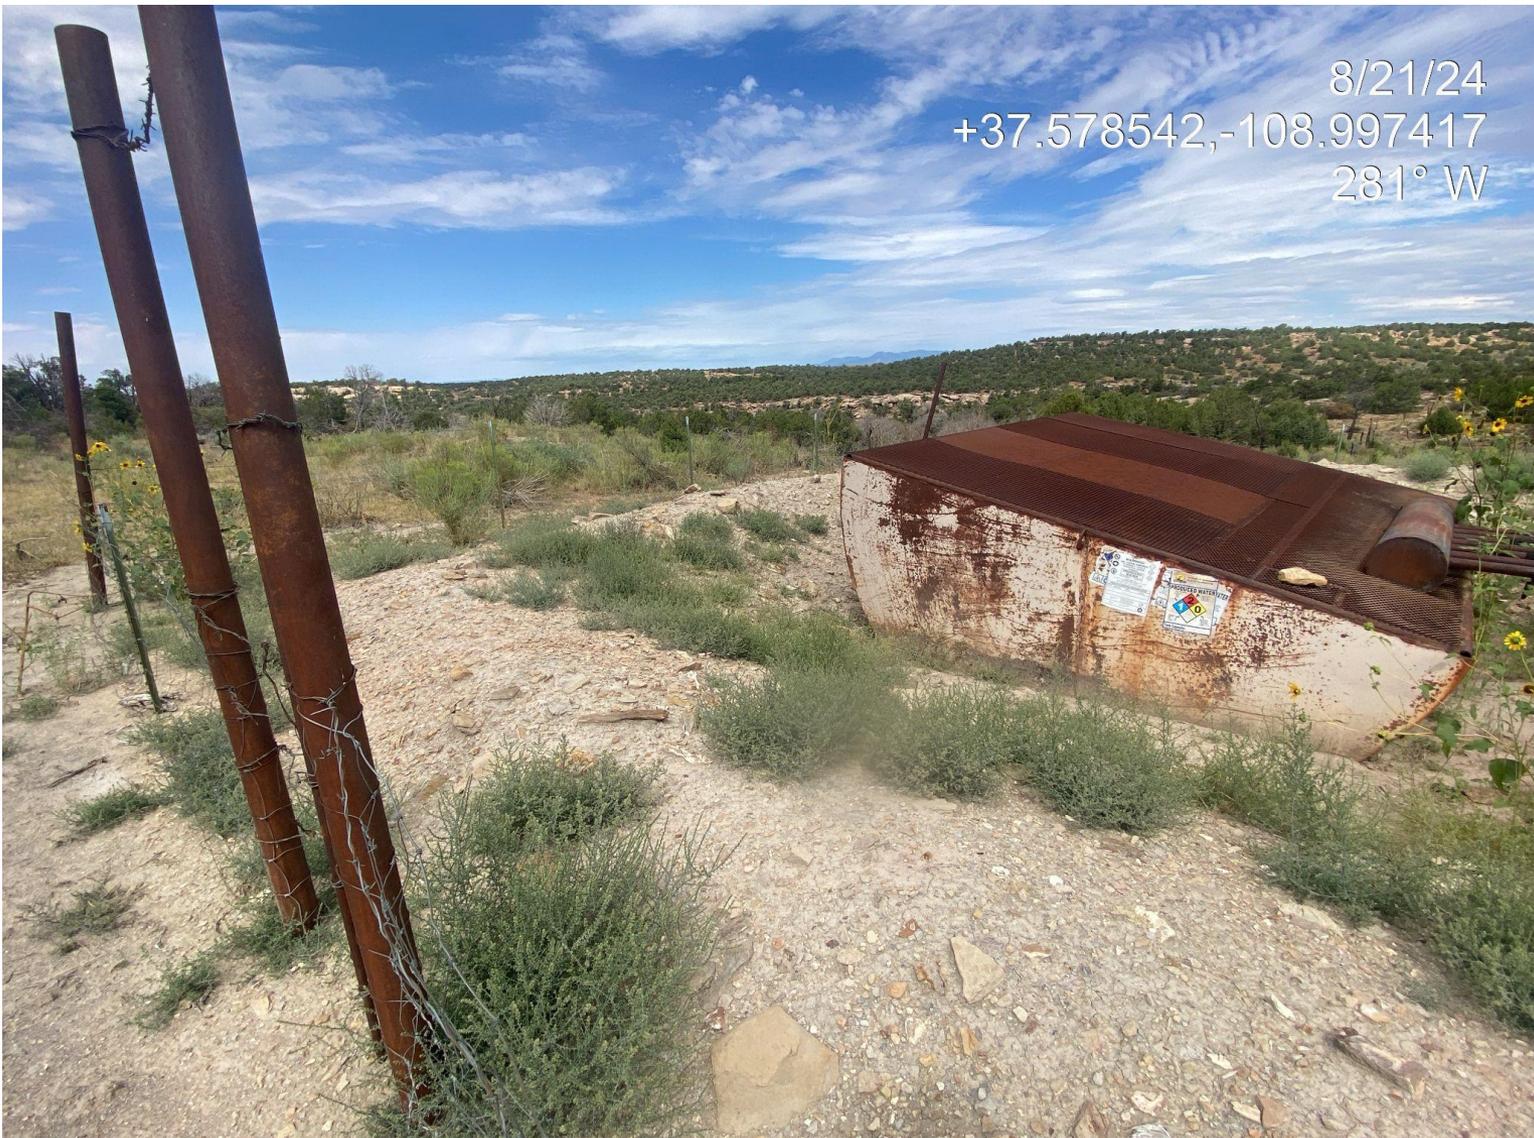
Photo 4. Weedy Russian thistle debris observed in a large patch at the produced water tank berm.

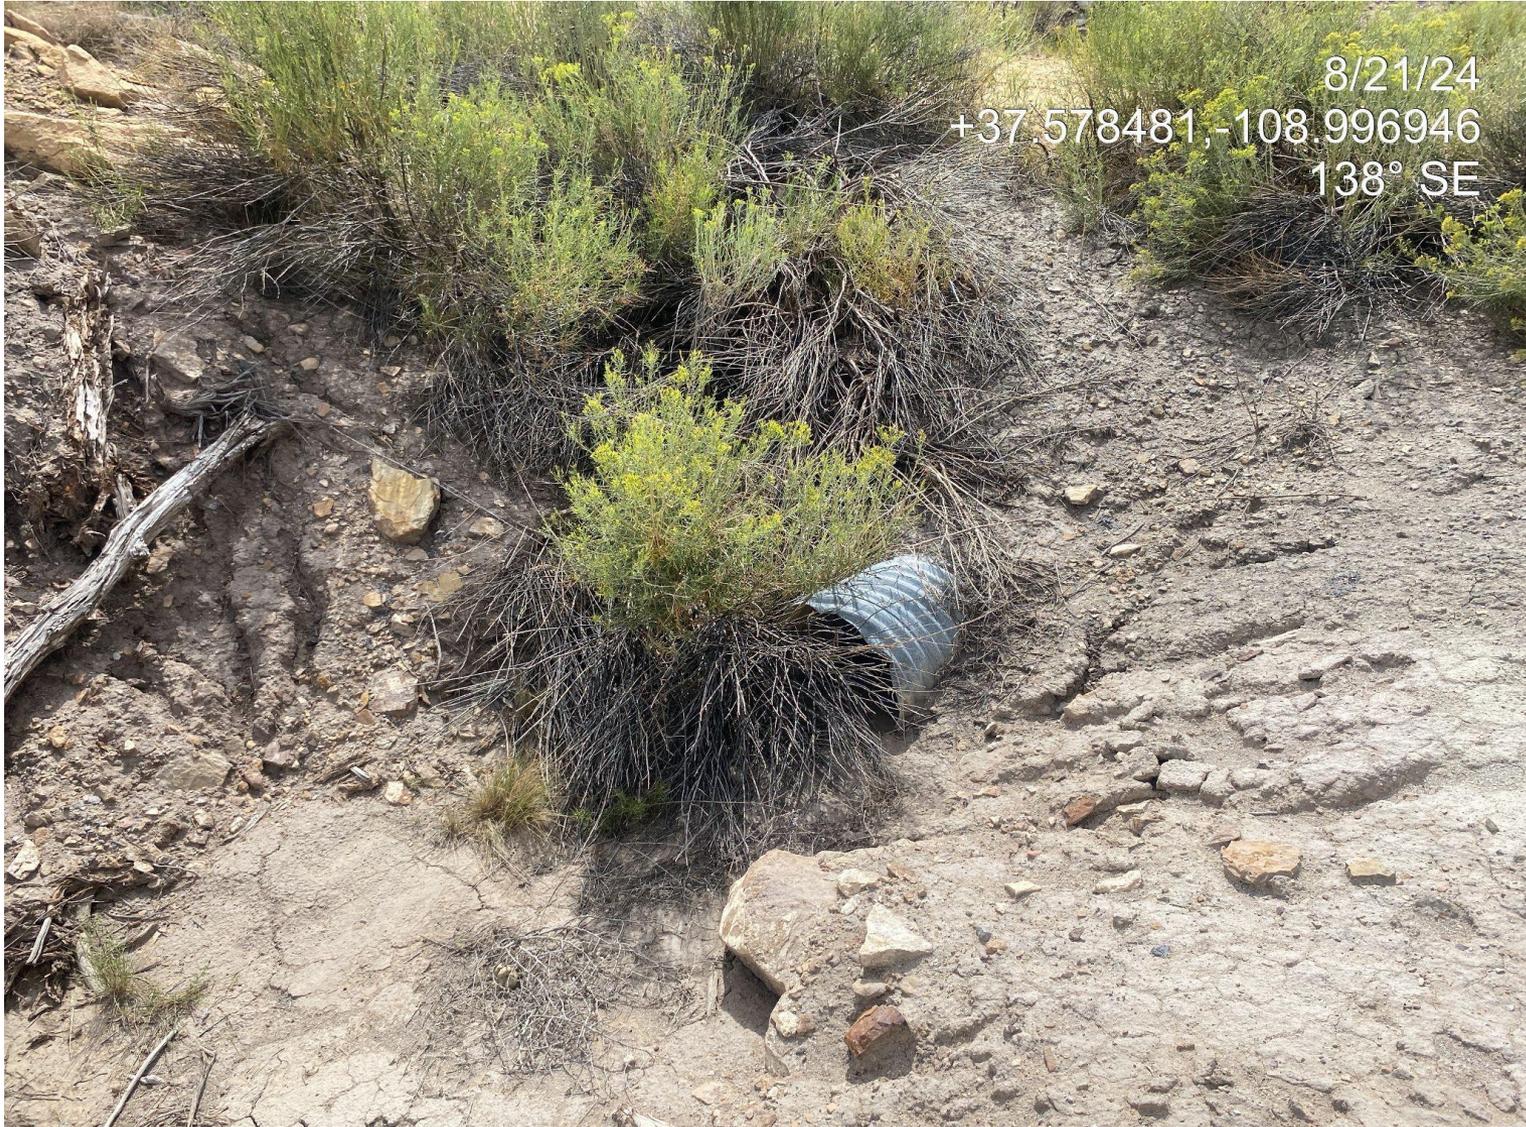
Photo 5. Culvert at access point is starting to fill with sediment, future maintenance is advised.

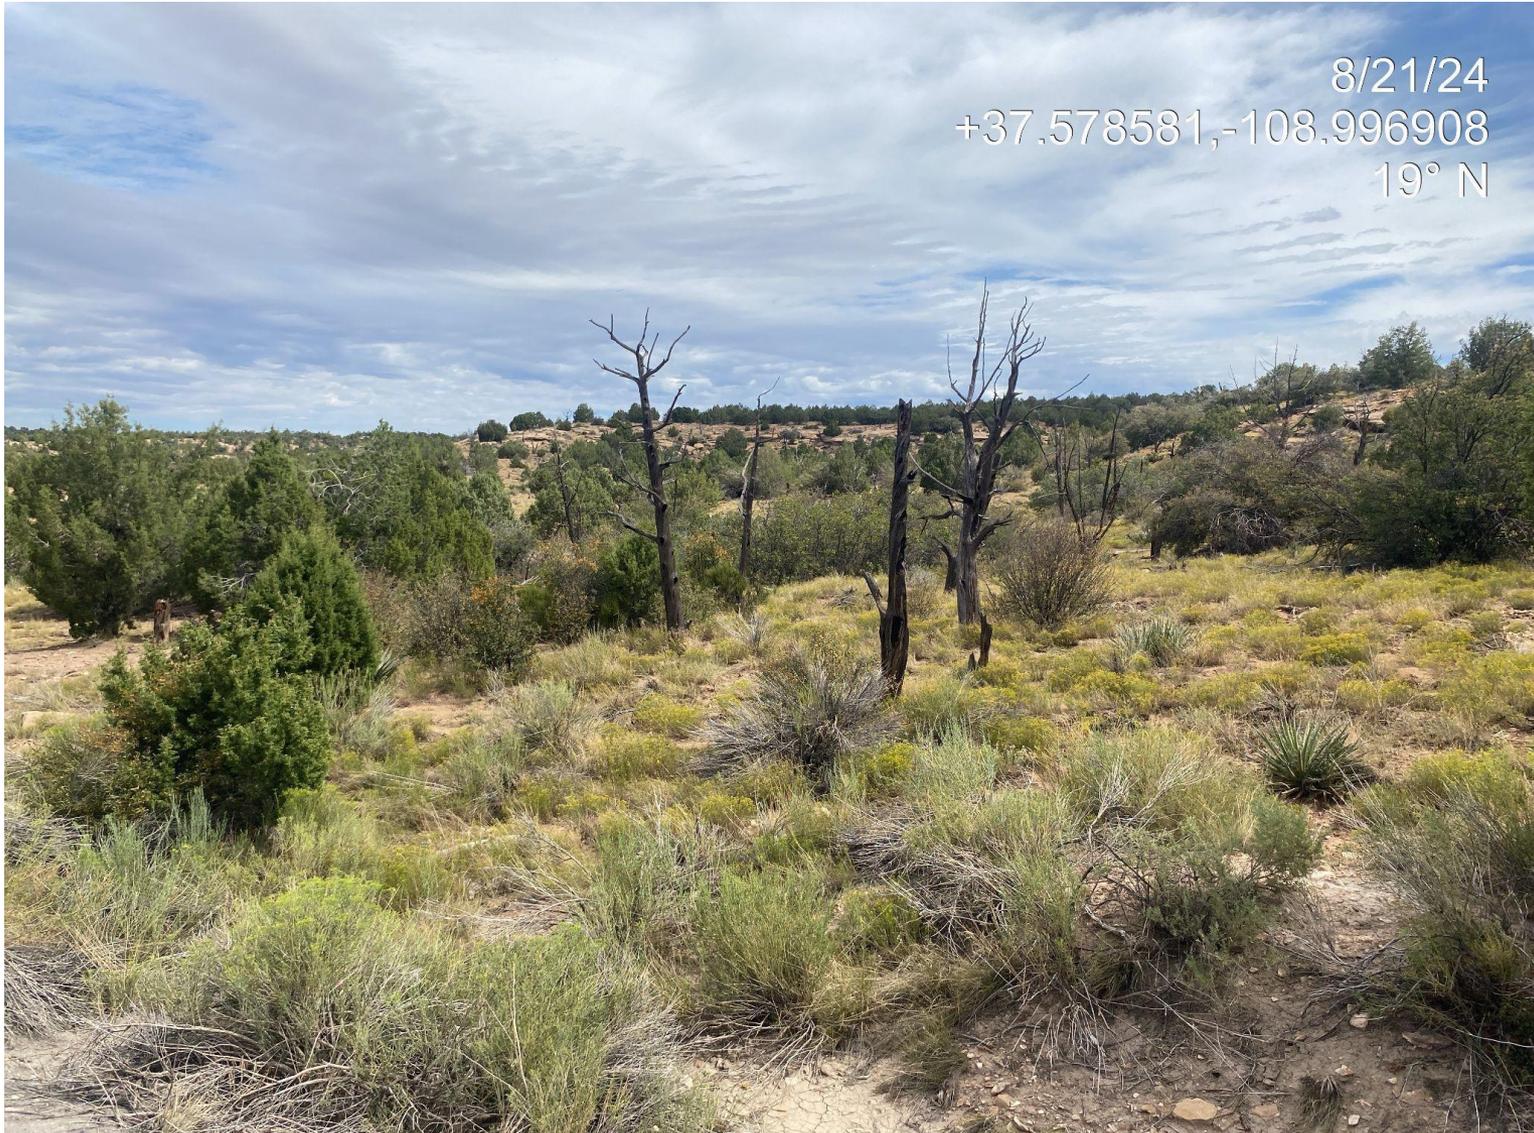
Photo 6. Reference area comprised of Brome snakeweed, Rabbirbrush, Juniper and Serviceberry.
