# Inspection Photos

Loc: 485654

Operator: BNL (ENTERPRISE) INC

Inspection Date: 8/26/2024

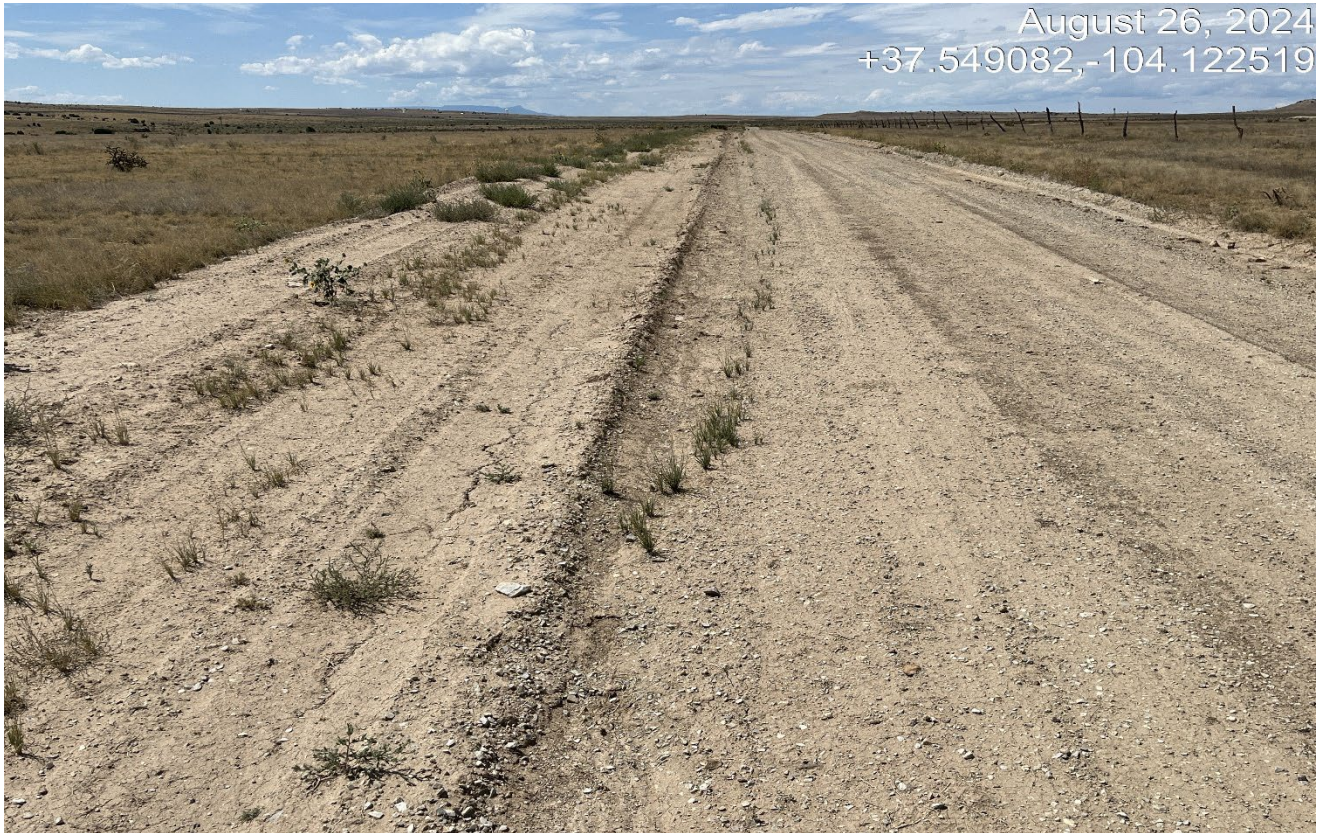
**Photo 1.** Facing south toward the access road. The sides of the road will need to be reclaimed. The road has been regraded and crowned since previous inspection.

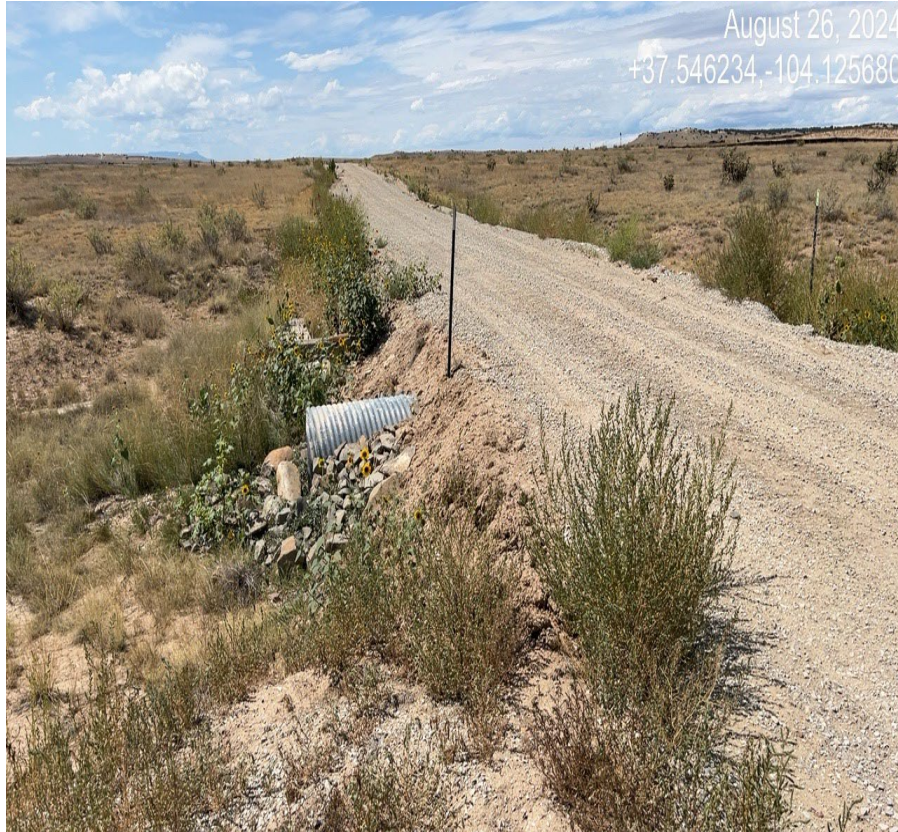
**Photo 2.** The culvert outlet has been repaired and outlet protection was installed, The loose soil along the embankment need to be stabilized..

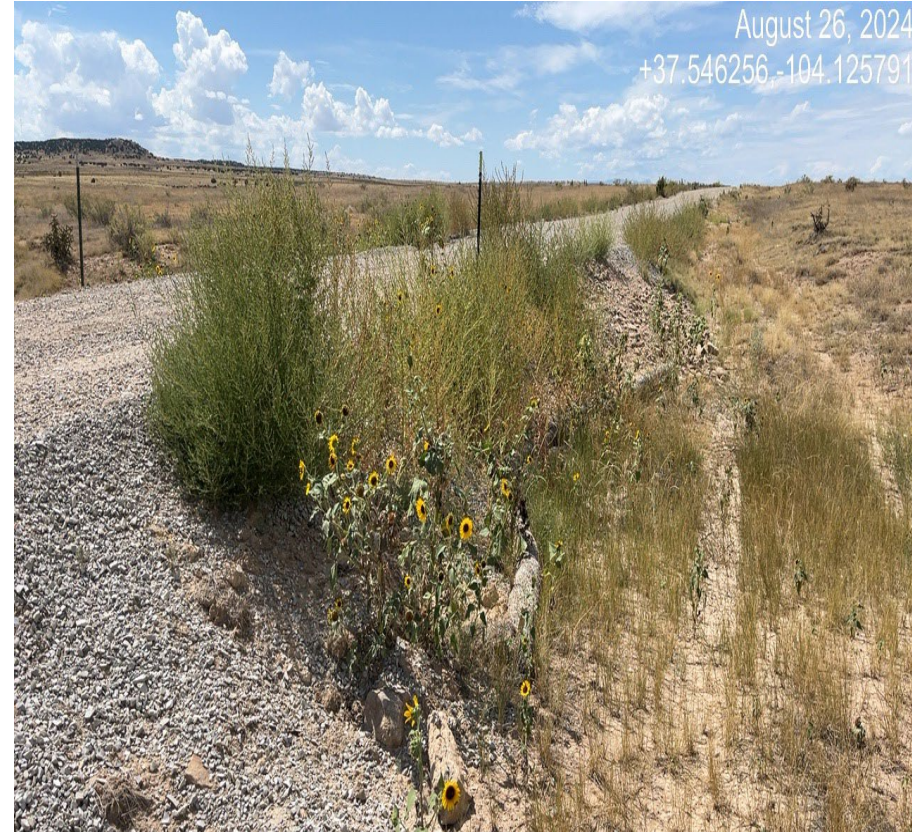
**Photo 3.** The embankment along the road side at the culvert is not stabilized and loose gravel is falling into the culvert.

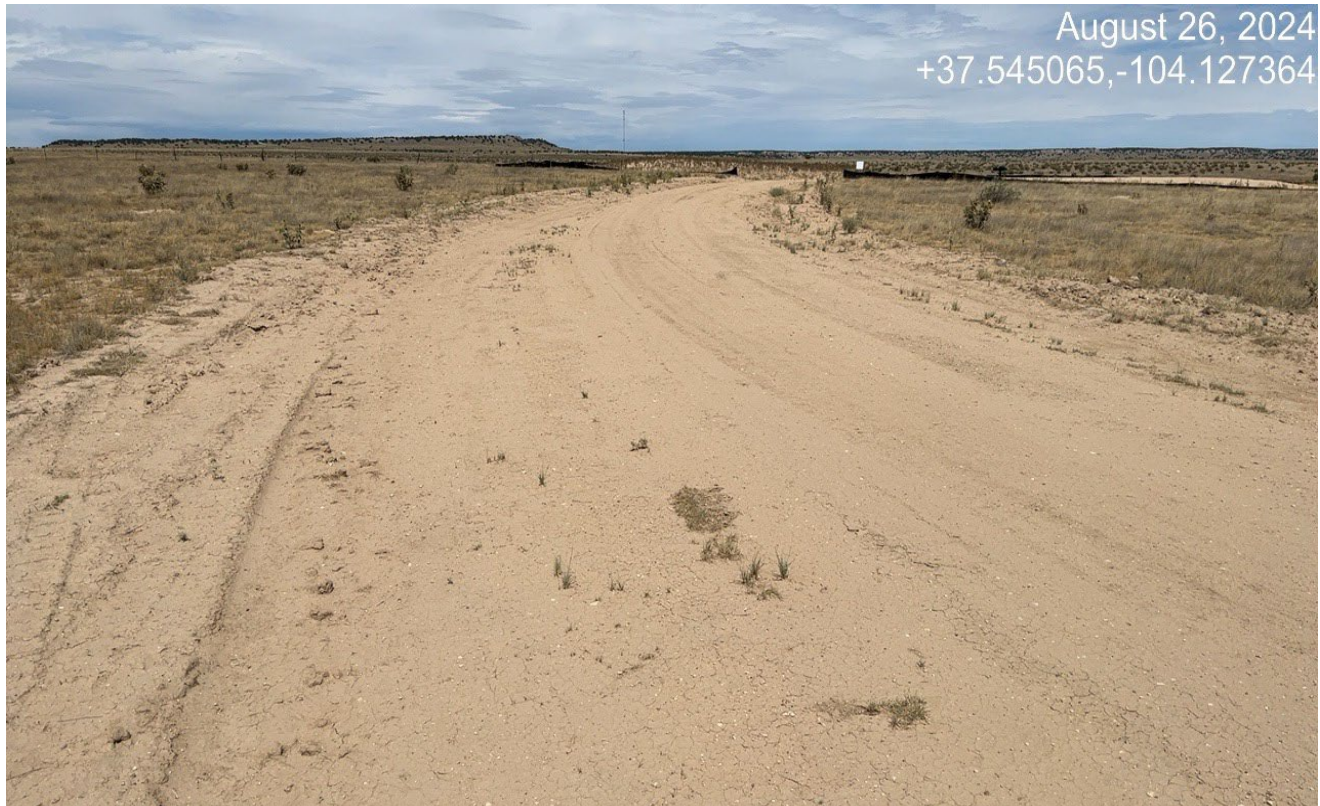
**Photo 3.** Facing northwest toward the access road. The side of the road needs to be seeded and stabilized. Previous corrective action was not completed.

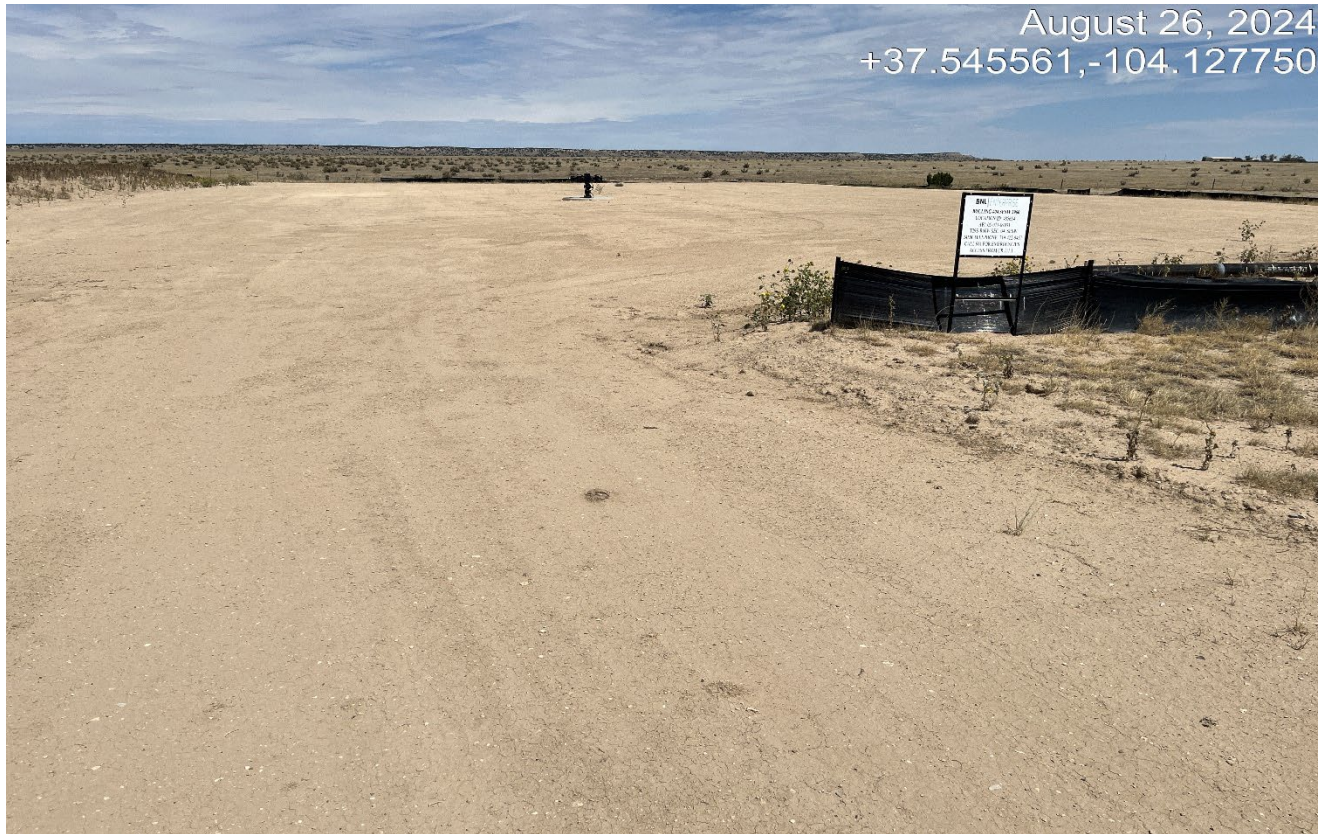
**Photo 4.** Facing west toward the location. Sign posted at entrance.

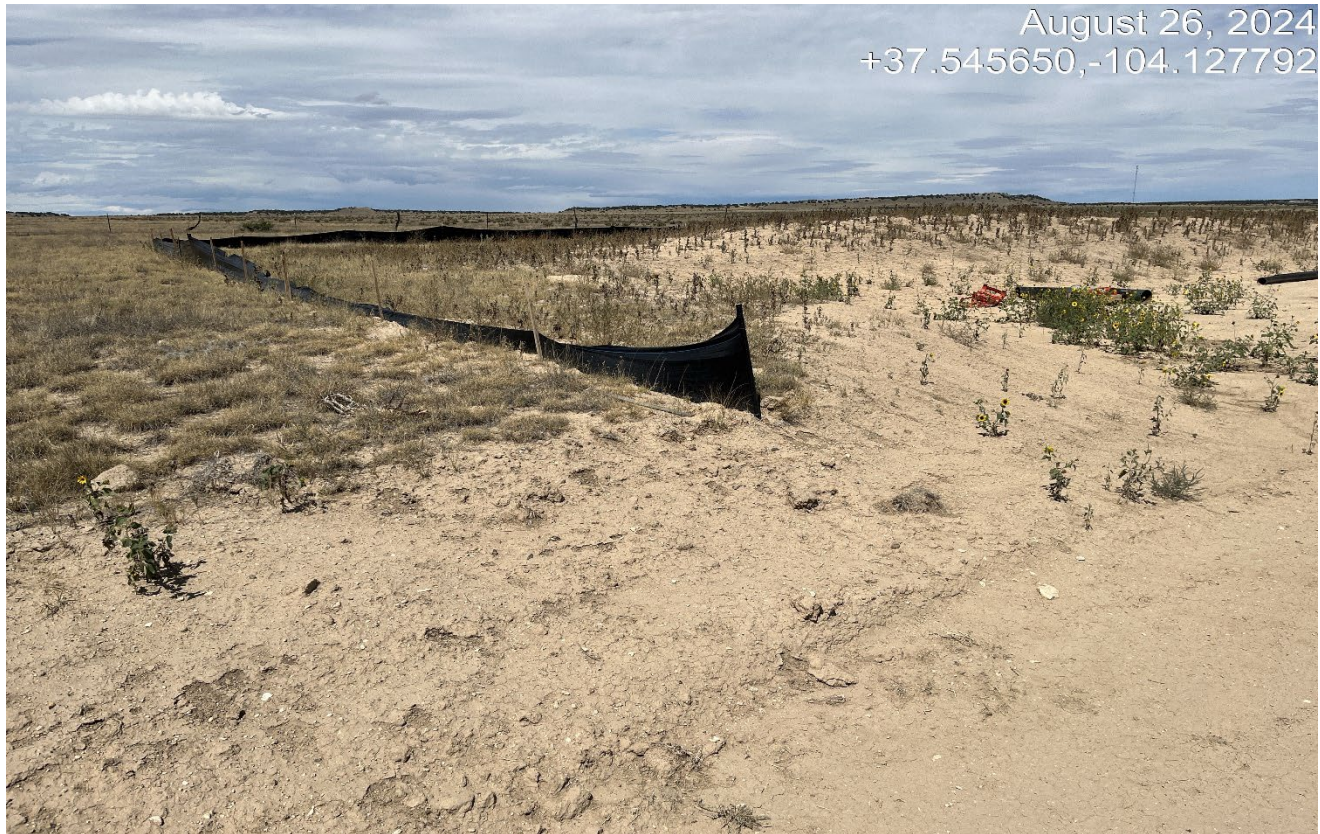
**Photo 5.** Facing southwest at the location. The silt fence is not maintained.

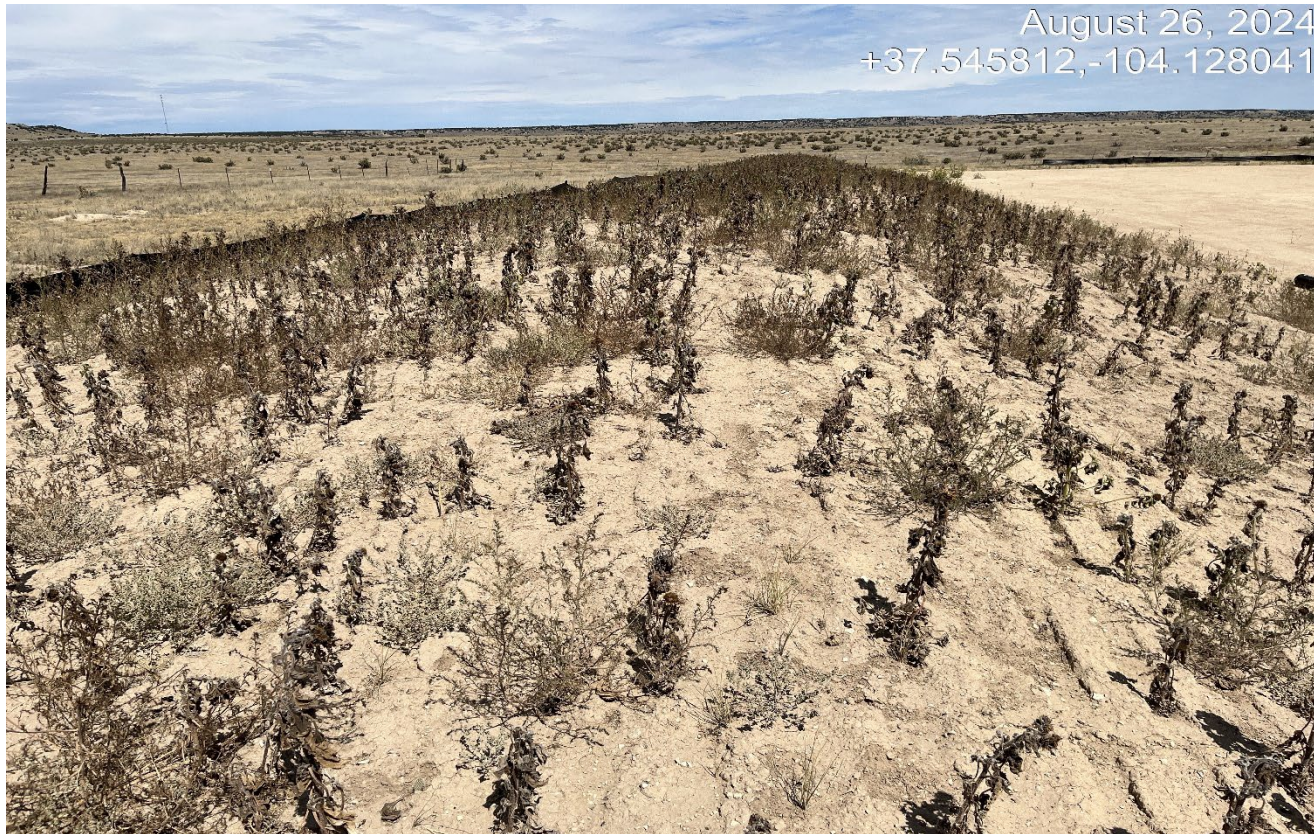
**Photo 6.** Facing toward the soil stock pile. The topsoil has not been seeded and stabilized and there are weeds established along the topsoil.

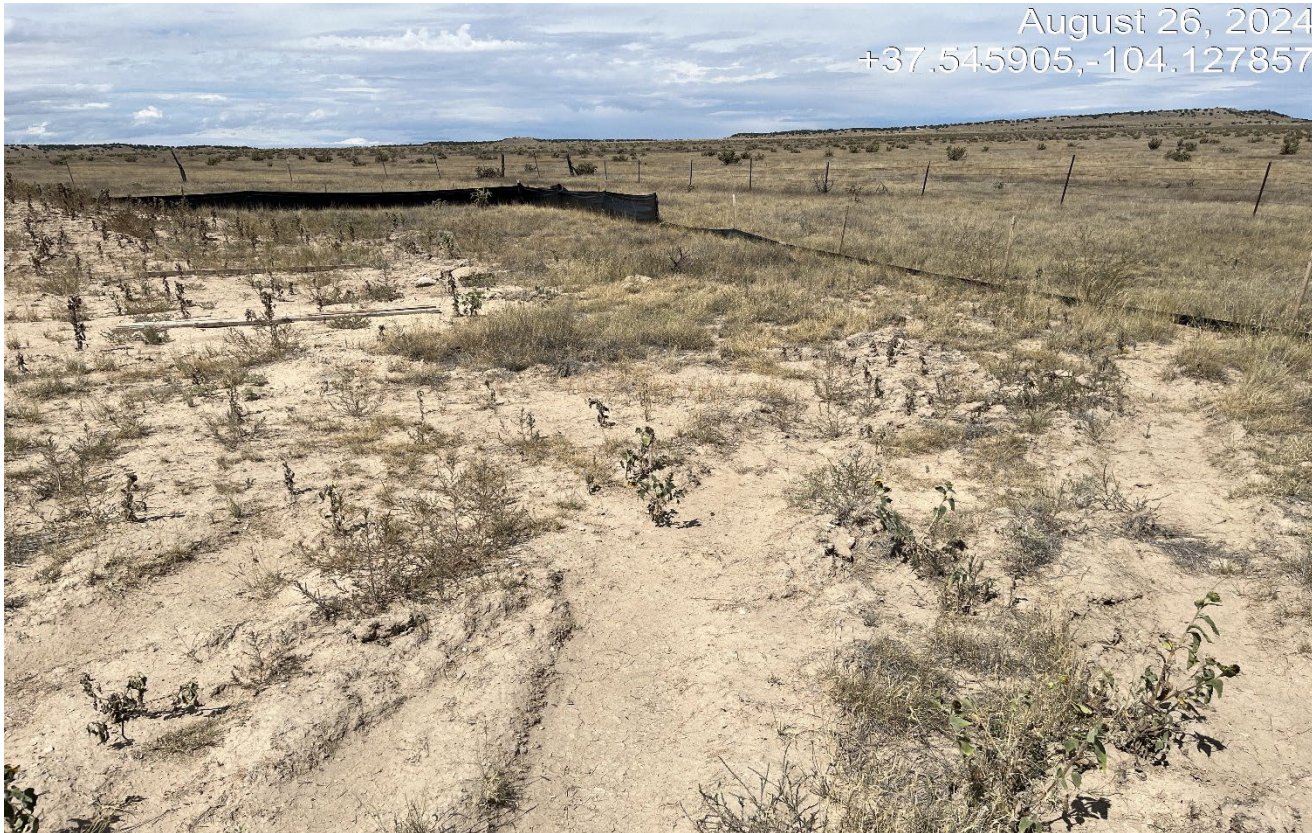
**Photo 7.** Facing toward the west corner of the location. The silt fence still remain down in this area.

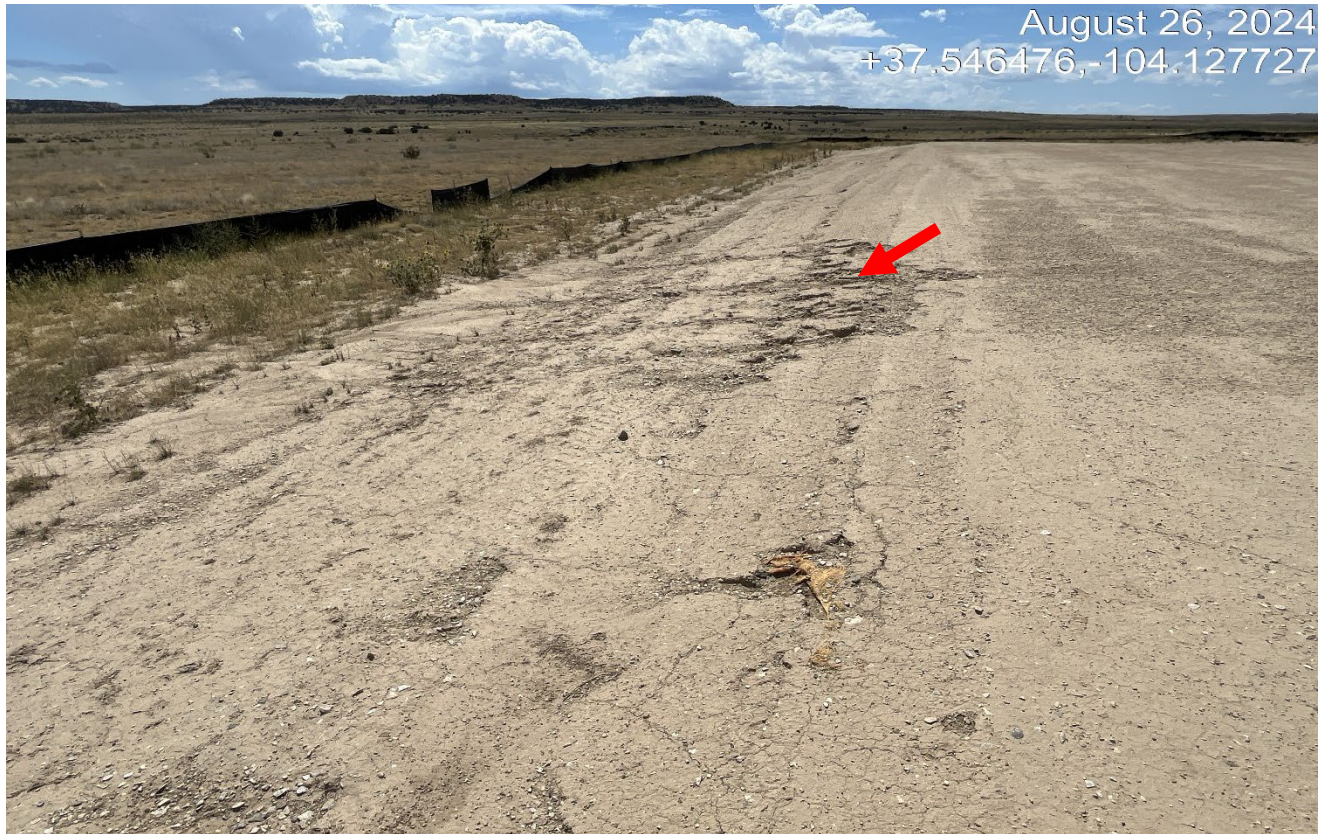
**Photo 8.** Facing southeast along the fill slope. There is erosion occurring shown at red arrow.
