Operator: 8 North

Location Name: RANCH-611N61W 18NWNW

Loc ID: 317622

Inspection: 684905110

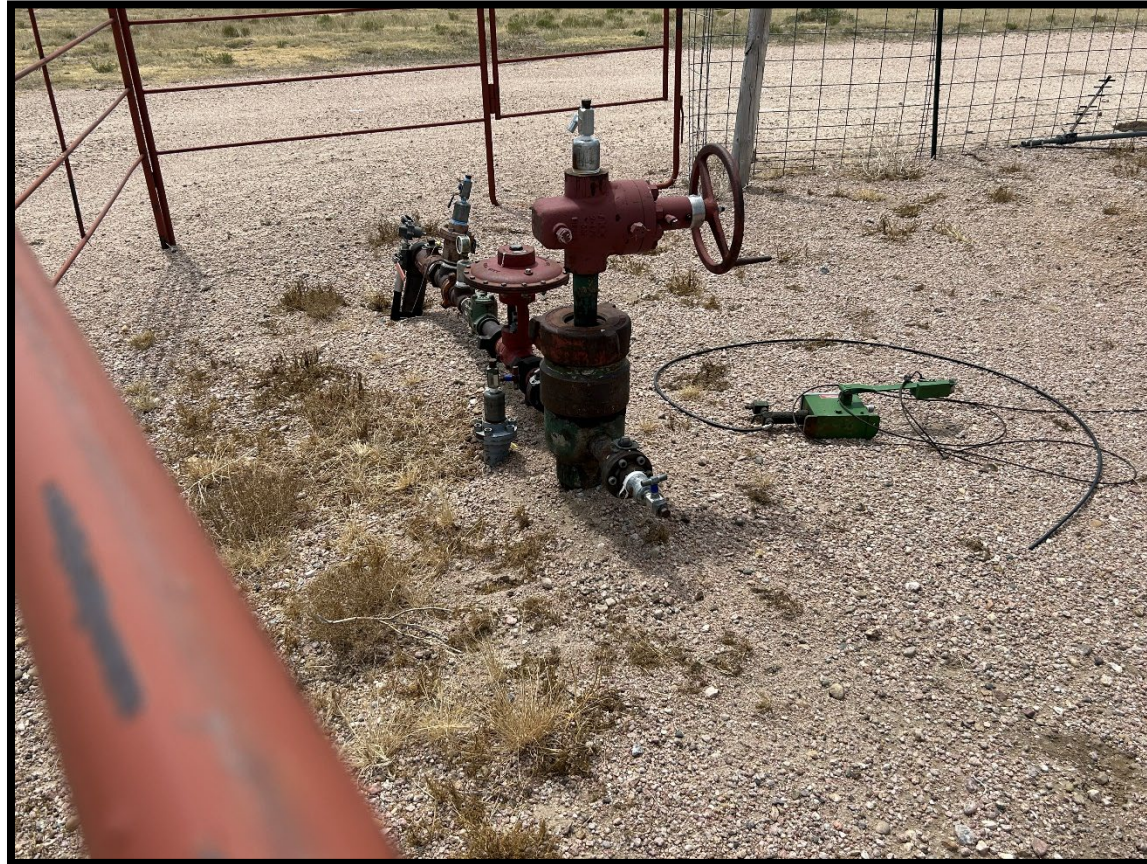
CA: Stained soil at engine, exhaust: Comply with rule 603.f

CA Resolution: Operator has provided photo evidence to show that the stained soil has been appropriately removed/cleared and mechanical issues leading to the leak have also been addressed to comply with the 600 and 900 series.
