# Interim Reclamation and Stormwater Inspection

Date: 8/21/24

Operator: Crestone Peak Resources Operating LLC -  
10633

Inspection Photos  
Location Name: Bear 3-65 22-23  
Location ID: 449179

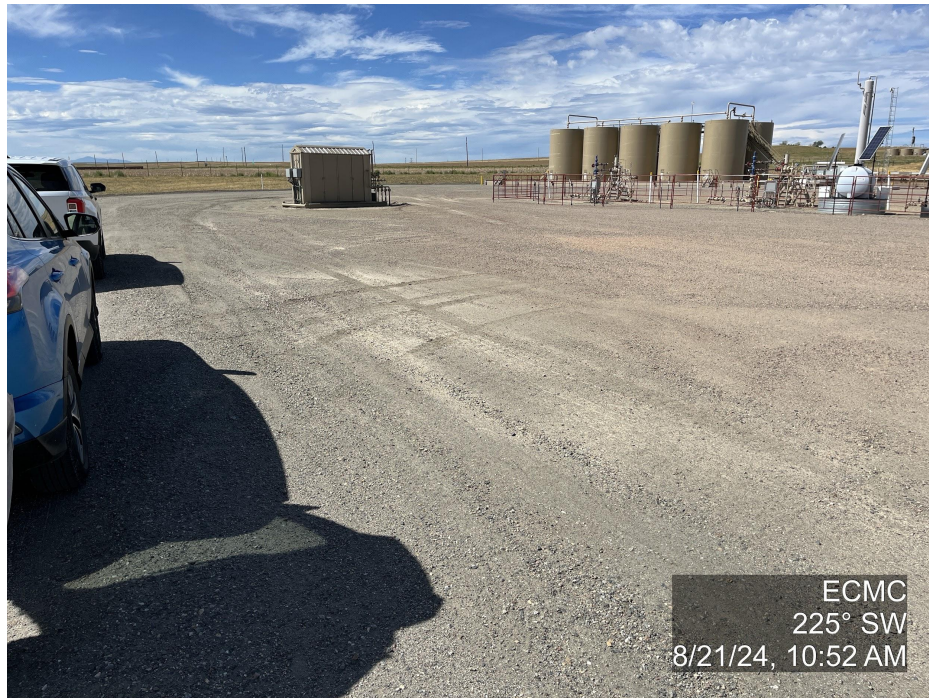
**Photo 1.** The photo was taken at the well location facing Southwest. The photo illustrates an overview of the well location.

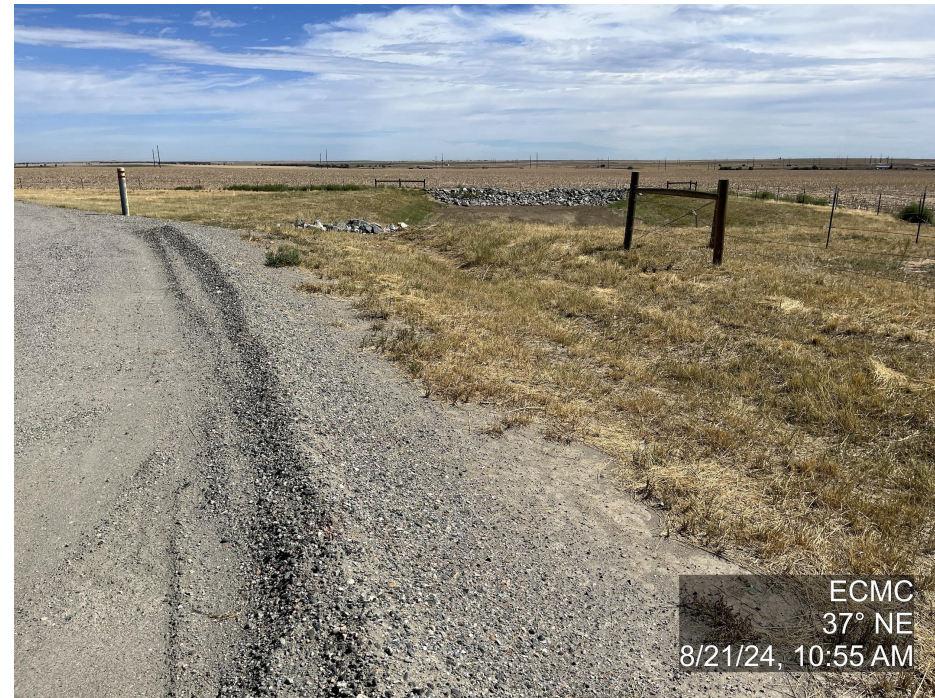
**Photo 2.** The photo was taken at the well location facing Northeast. The photo illustrates interim areas are vegetated and being managed with evidence of mowing as well as the location sediment trap.

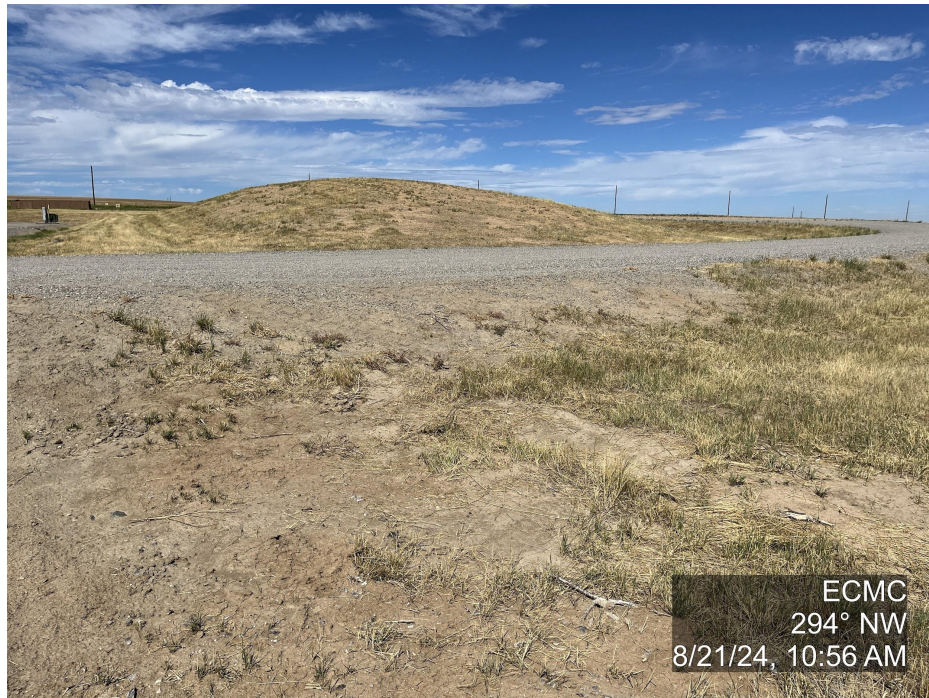
**Photo 3.** The photo was taken at the well location facing Northwest. The photo illustrates the entrance and topsoil stockpile. The stockpile at the time of inspection was vegetated and mowed.

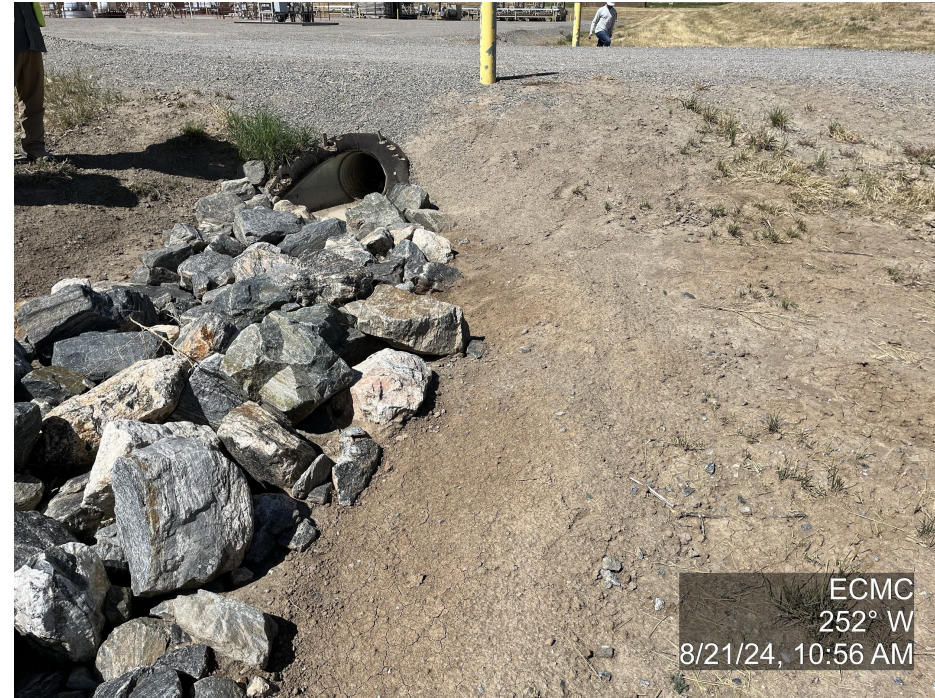
**Photo 4.** The photo was taken at the well location facing West. The photo illustrates the stabilized culvert at the entrance to well location.

Note - Wattle around outlet needs replaced.

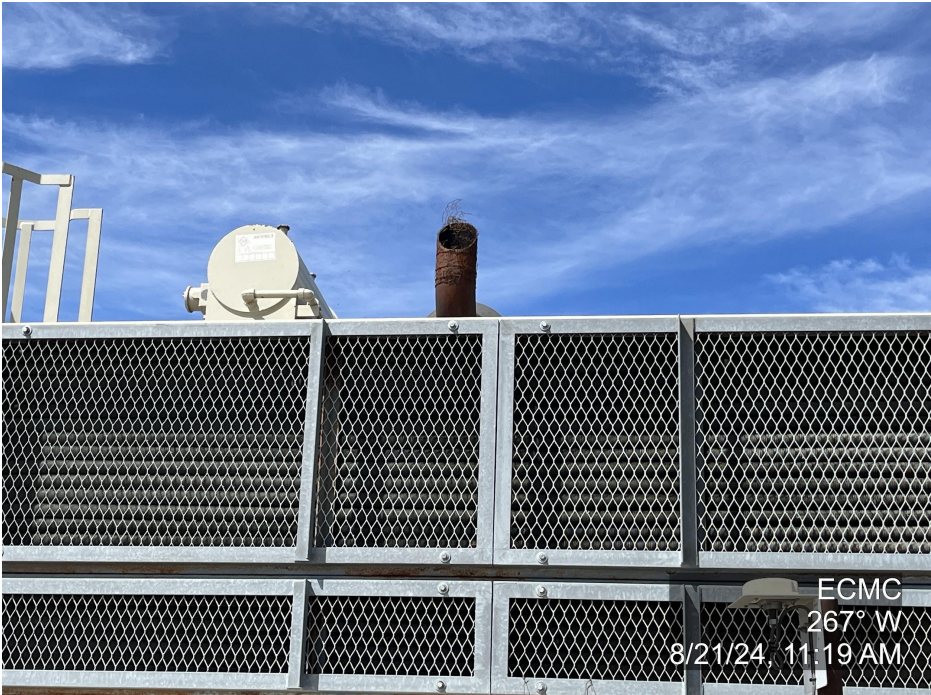
**Photo 6.** The photo was taken at the well location facing West. The photo illustrates wildlife screen on exhaust pipe needs replaced.

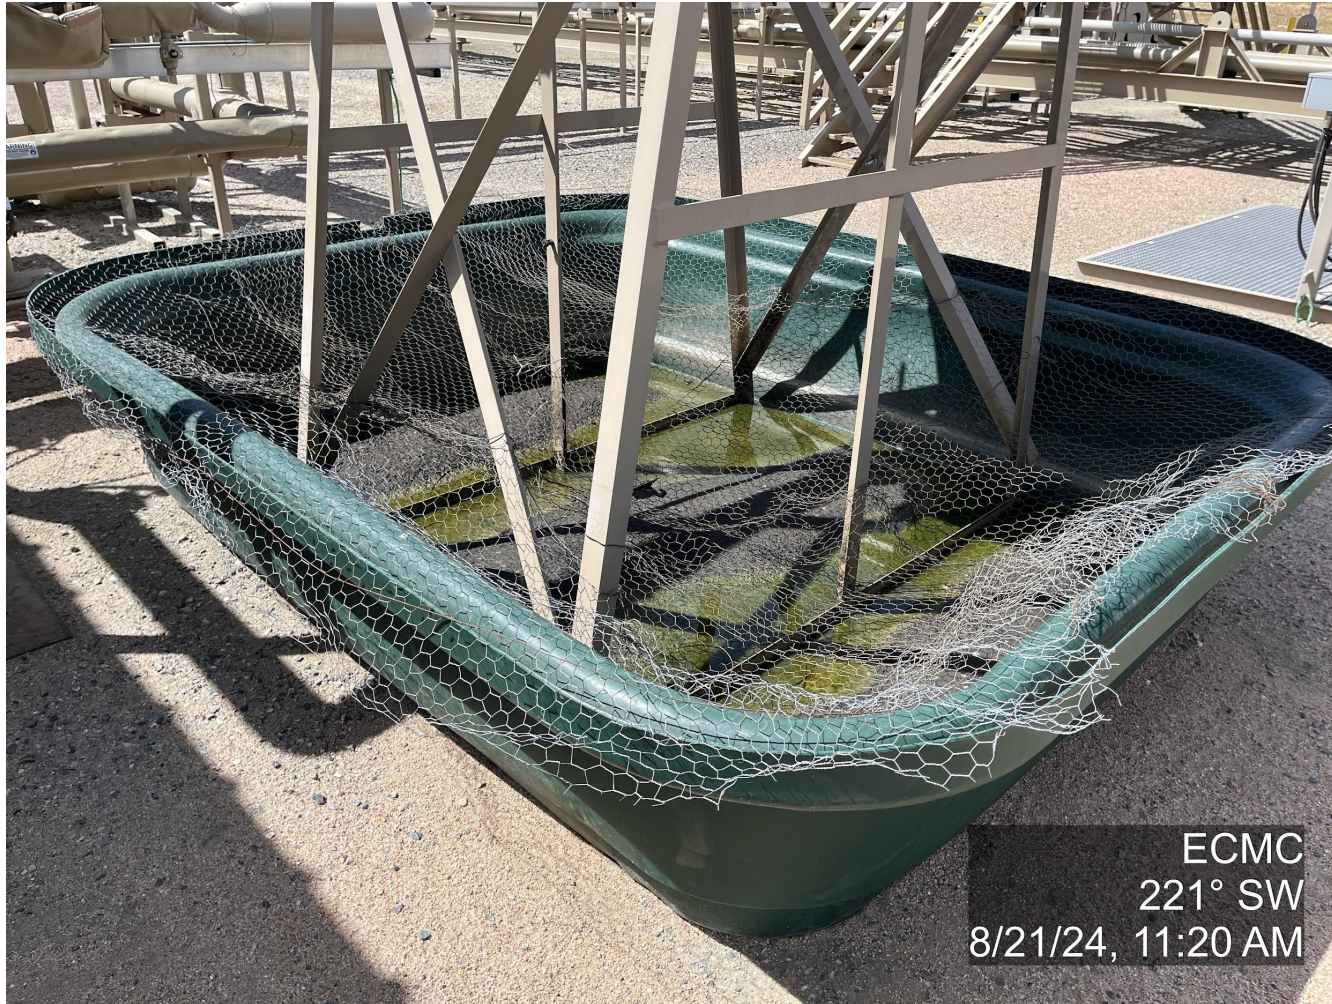
**Photo 7.** The photo was taken at the well location facing Southwest. The photo illustrates wildlife protections on secondary containment are not secured.

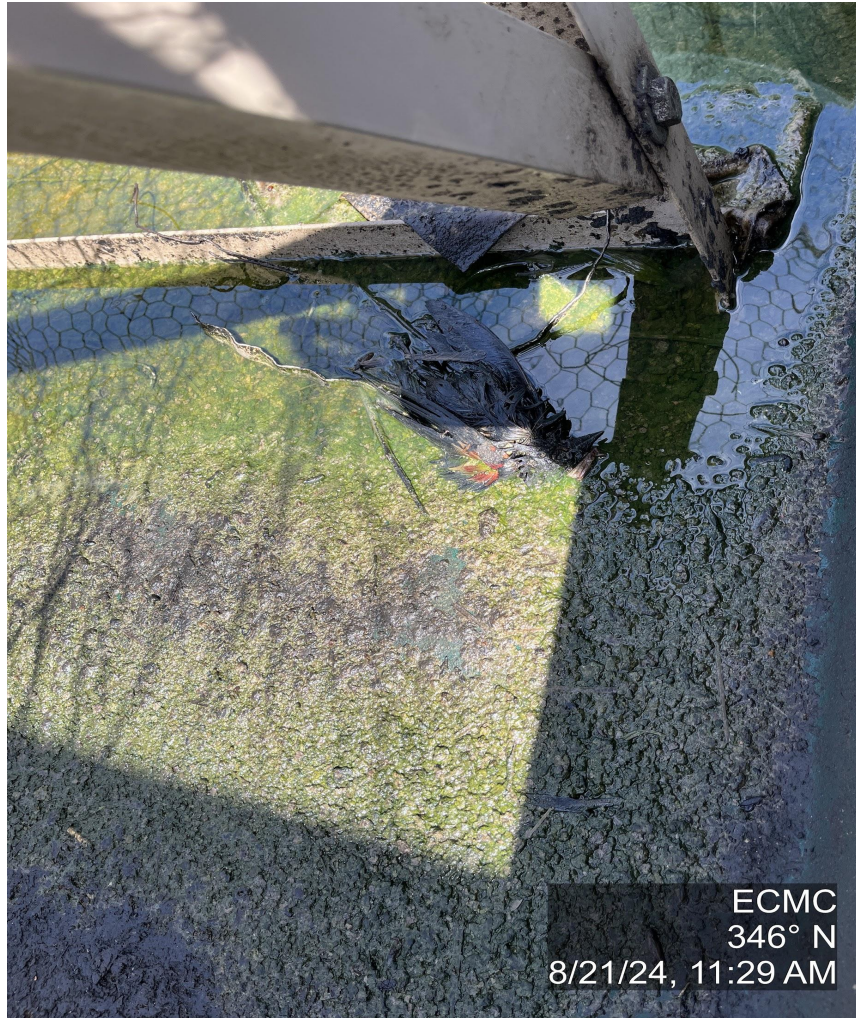
**Photo 8.** The photo was taken at the well location facing South. The photo illustrates that there has been a wildlife mortality (appeared to be a Red-winged blackbird) inside secondary containment due to wildlife protections not being secured.

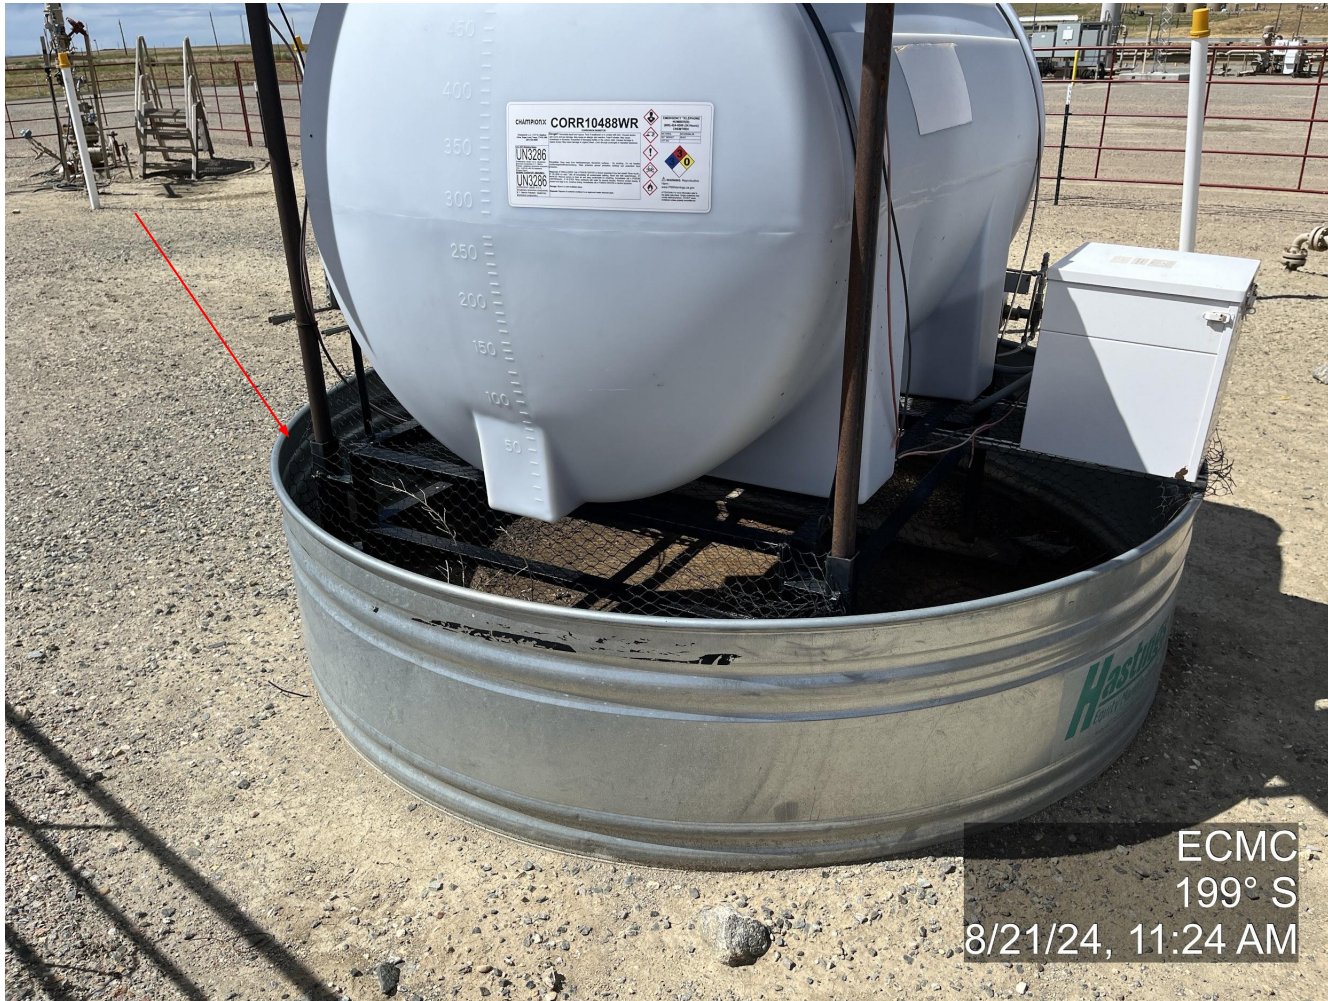
**Photo 9.** The photo was taken at the well location facing South. The photo illustrates the netting around the secondary containment of a tank has not been installed correctly, not extending over the edge of the tank, and could lead to more wildlife mortality.
