Inspection Photos

Location Name: CAERUS PICEANCE LLC COUEY 18-10 (J18) Pad

Location #: 334865

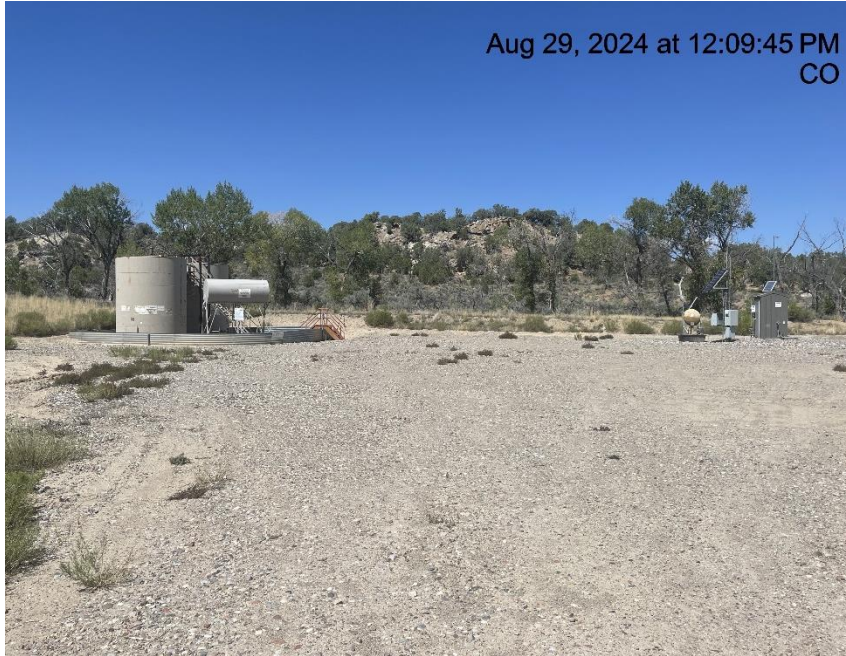
Photo # 7478 From Entrance to location

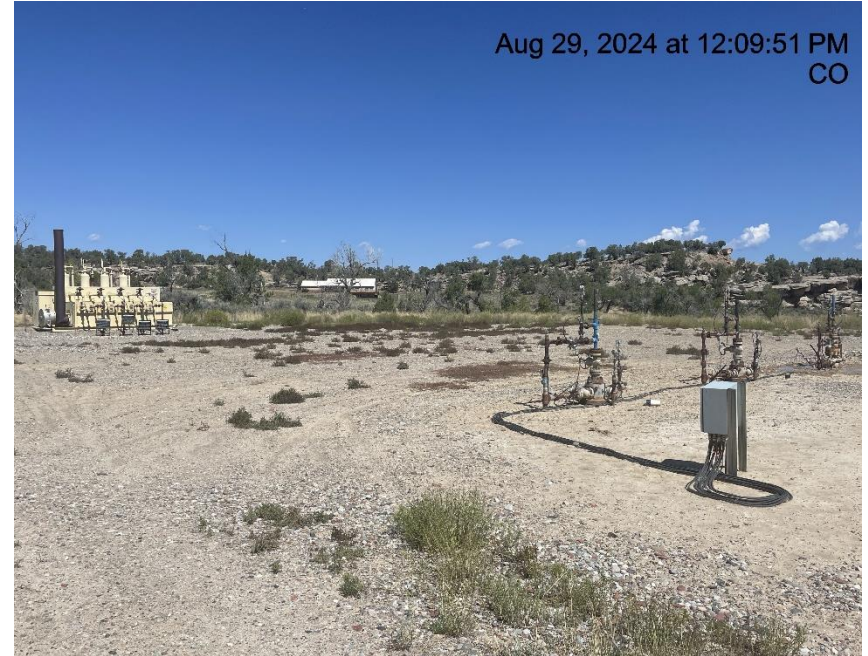
Photo # 7479 From Entrance to location

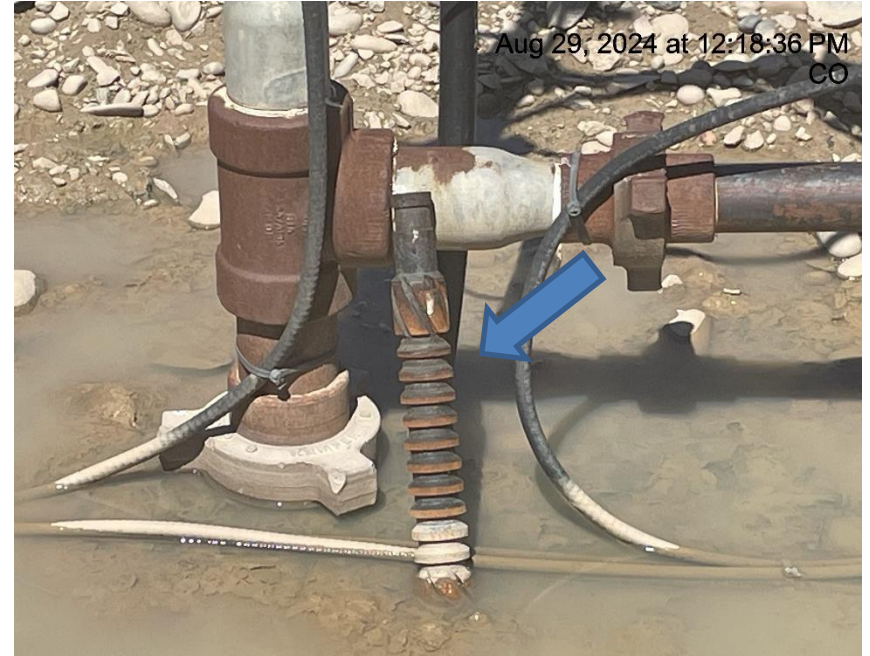
Photo # 7485 Debris

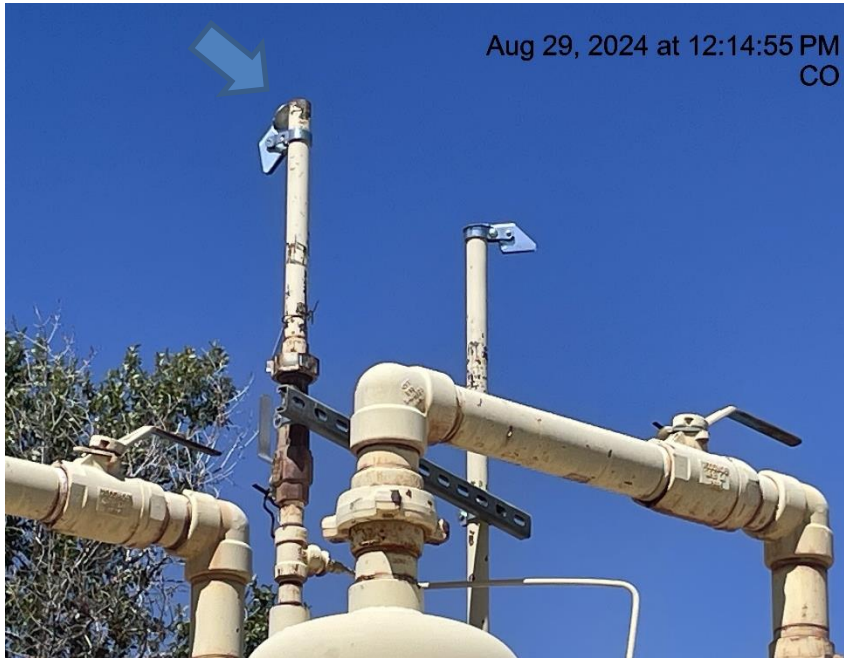
Photo # 7486 Rupture disc vent line does not comply with CECMC pressure safety device rules

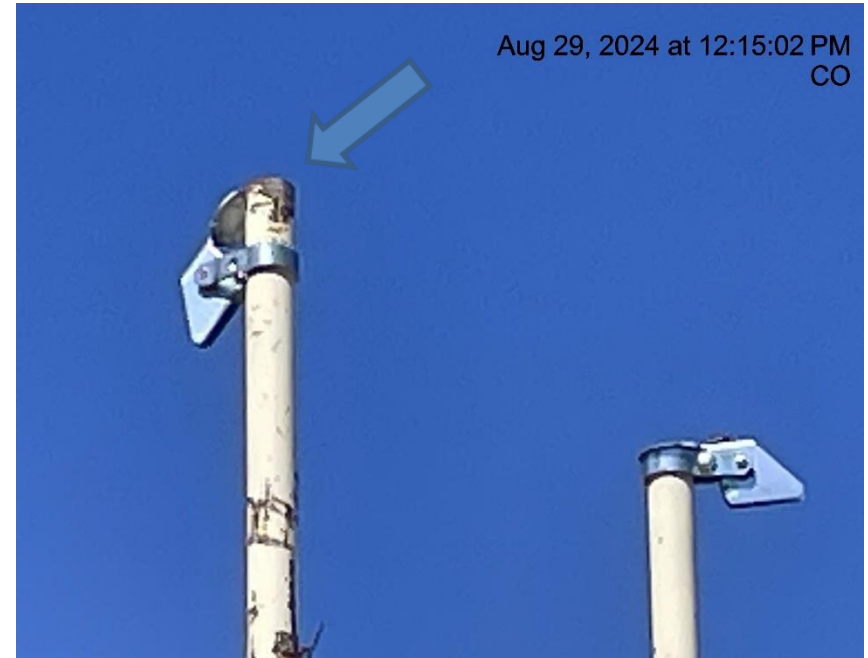
Photo # 7487 Rupture disc vent line does not comply with CECMC pressure safety device rules
