Inspection Photos

Location Name: CAERUS PICEANCE LLC Shideler Fee 31-13C (O31E) Pad

Location #: 334156

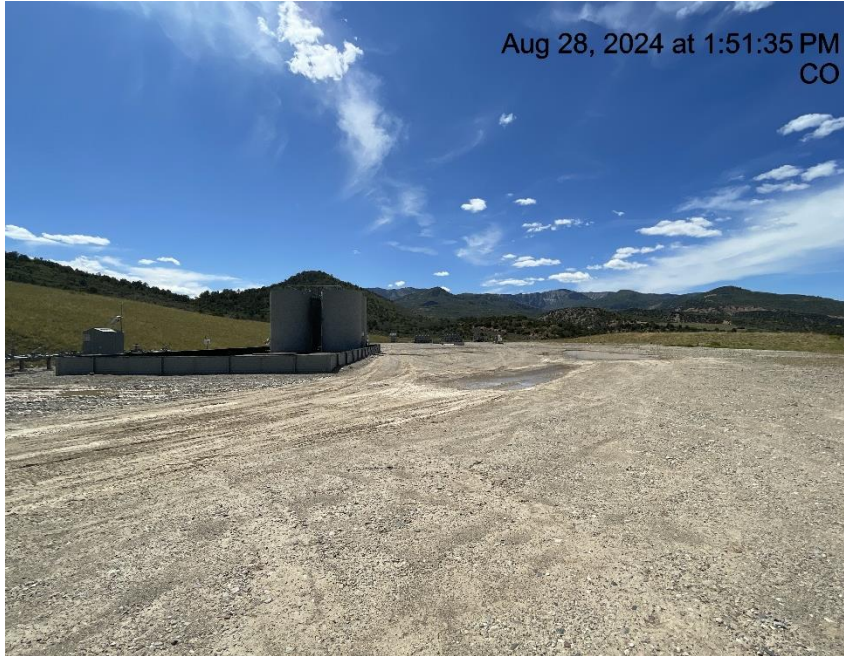
Photo # 7021 From Entrance to location

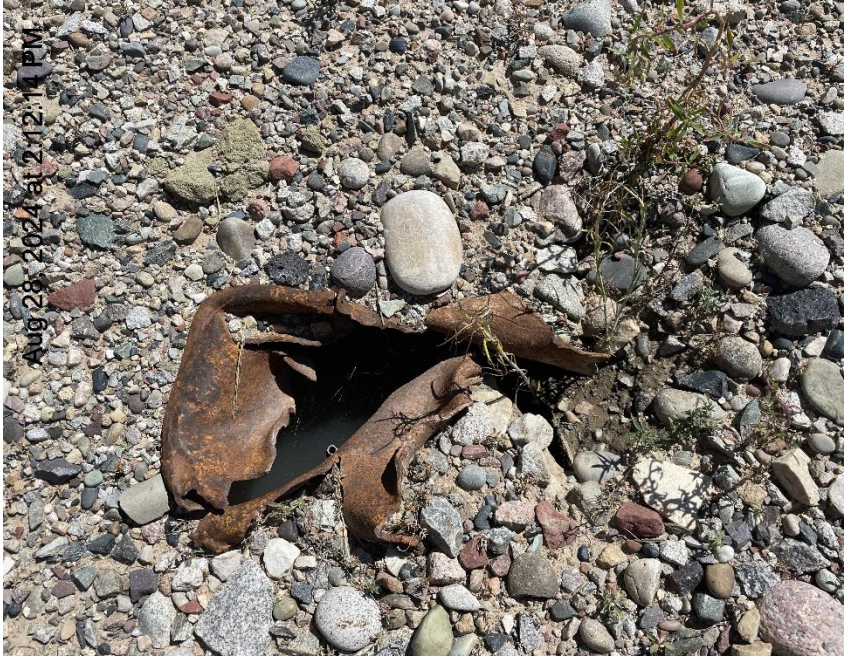
Photo # 7031 Open pipe/wildlife hazard

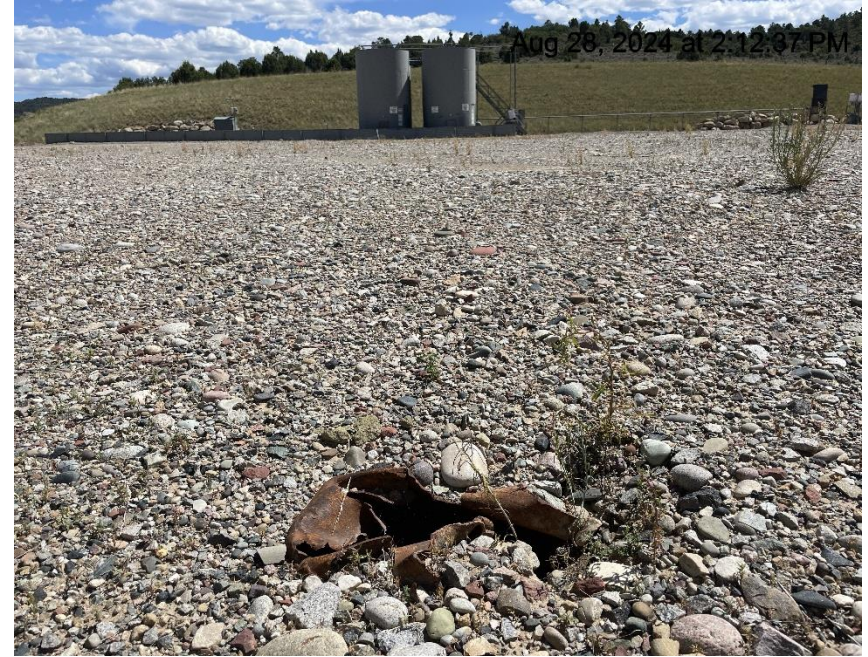
Photo # 7032 Open pipe/wildlife hazard

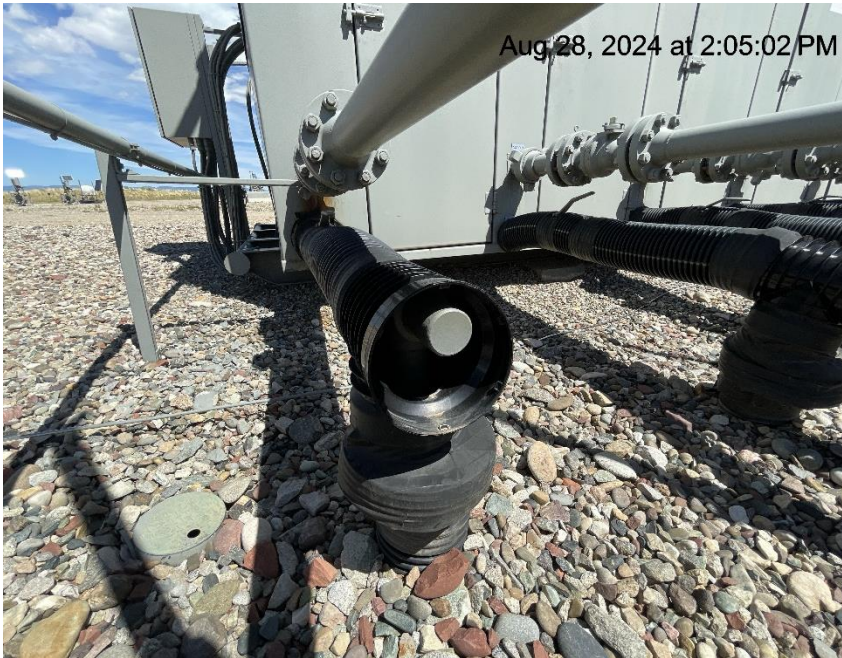
Photo # 7033 Flowline heating insulation open ended/open to entry by wildlife/wildlife hazard

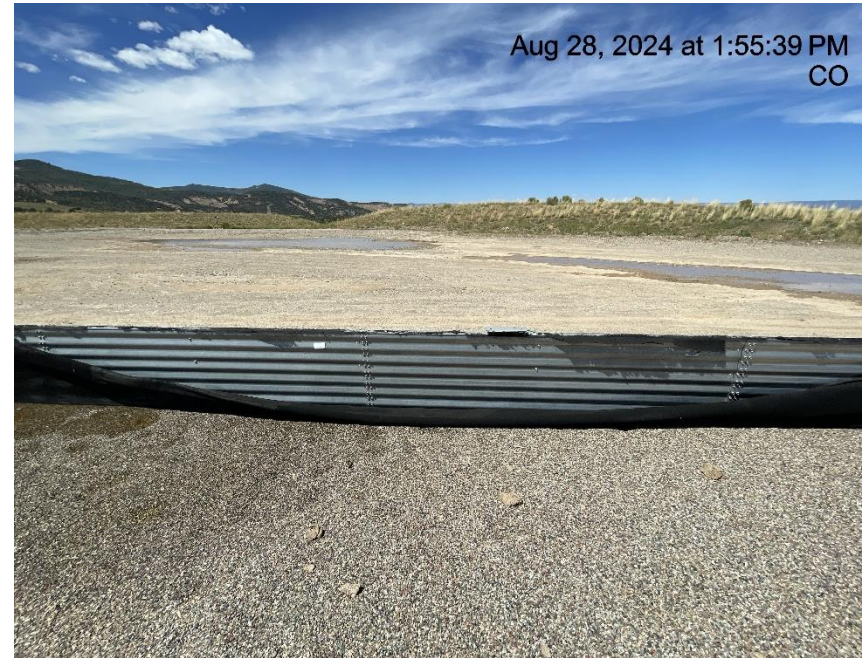
Photo # 7034 Secondary containment liner needs maintenance

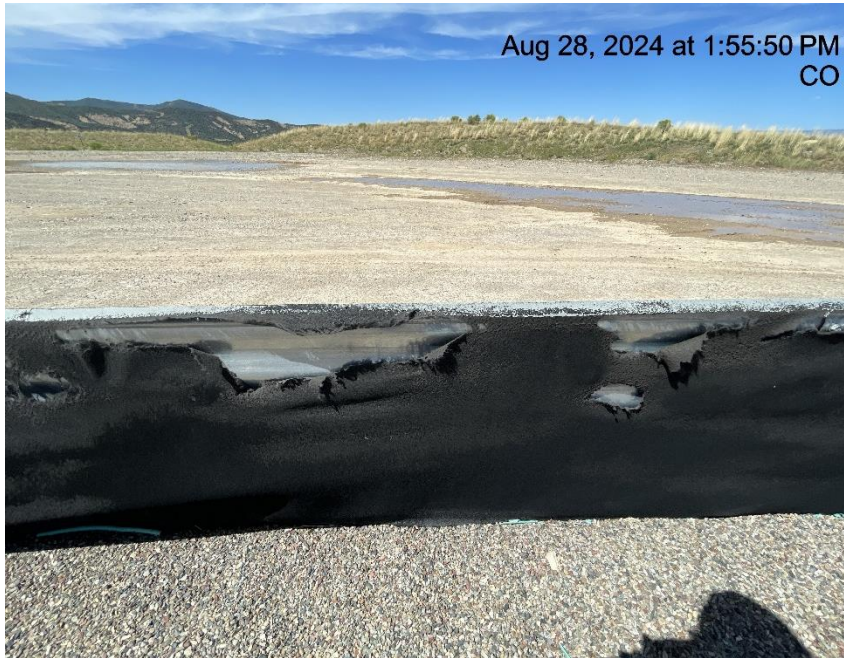
Photo # 7035 Secondary containment liner needs maintenance

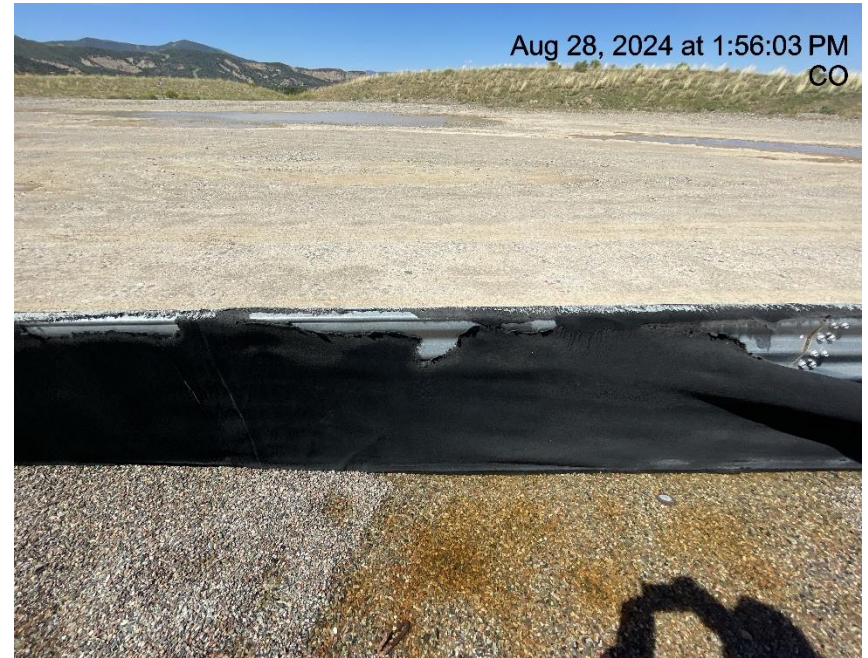
Photo # 7036 Secondary containment liner needs maintenance

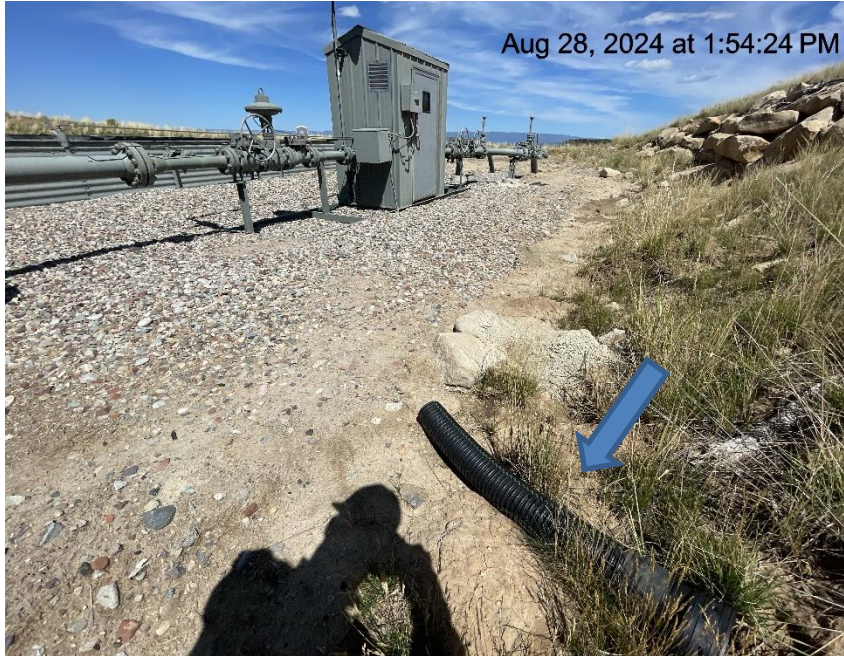
Photo # 7037 Debris
