Inspection Photos

Location Name: TEP ROCKY MOUNTAIN LLC QUARTER CIRCLE 43-33H Pad

Location ID: 334690

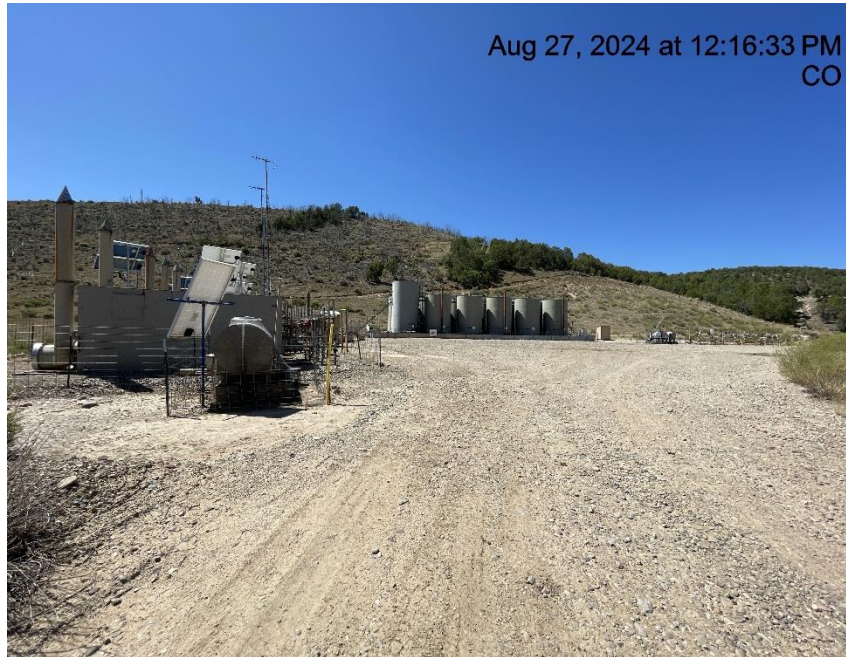
Photo # 6748 From entrance to location

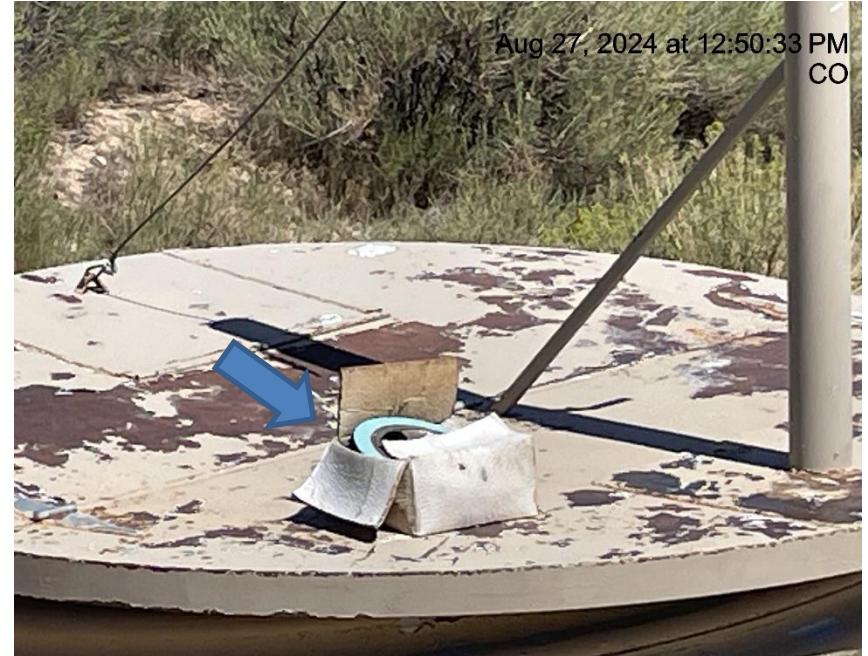
Photo # 6759 Debris

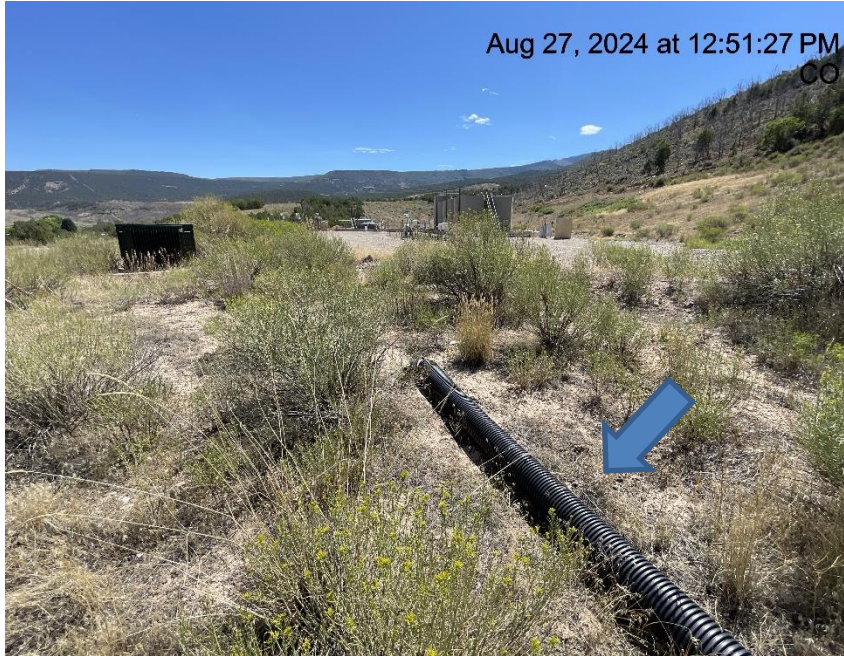
Photo # 6760 Debris

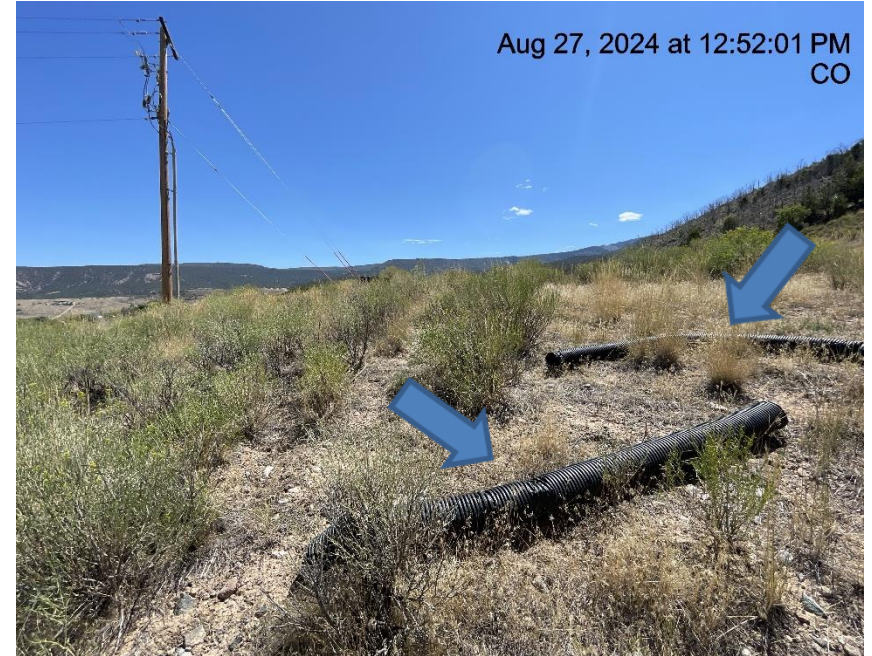
Photo # 6761 Debris

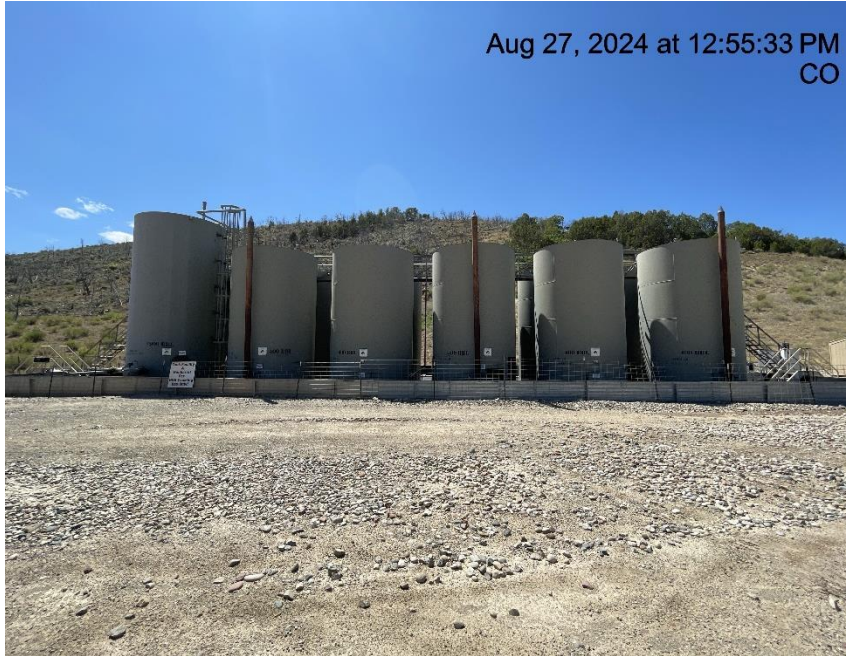
Photo # 6762 Tank battery lacks required signage

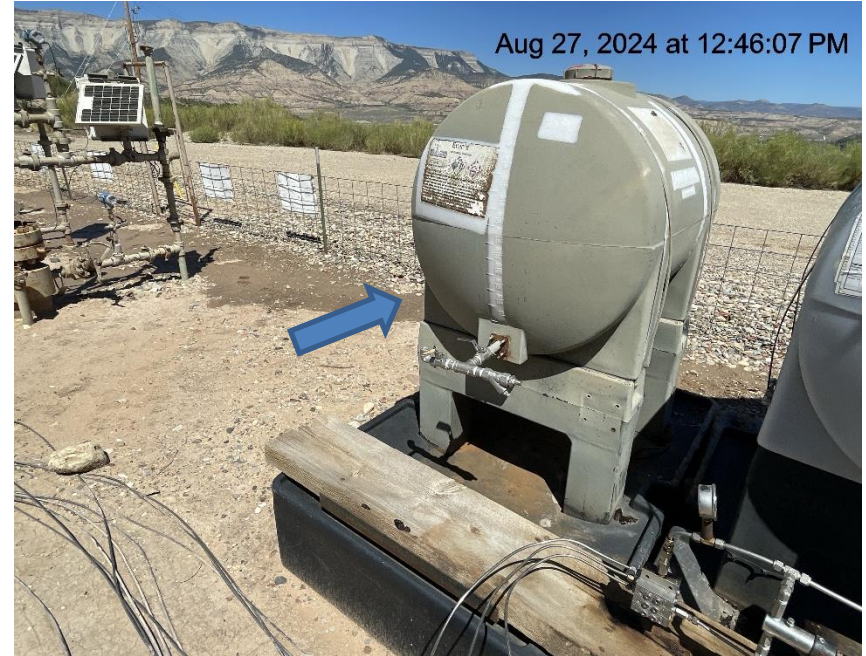
Photo # 6763 Unused equipment on location (labels on unused chemical tank are also illegible)

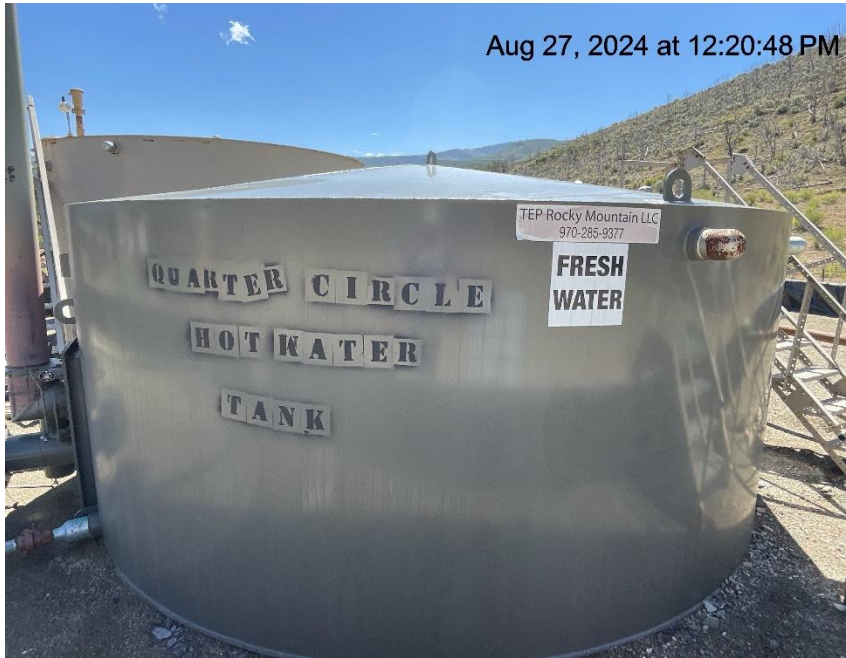
Photo # 6764 Tank lacks capacity

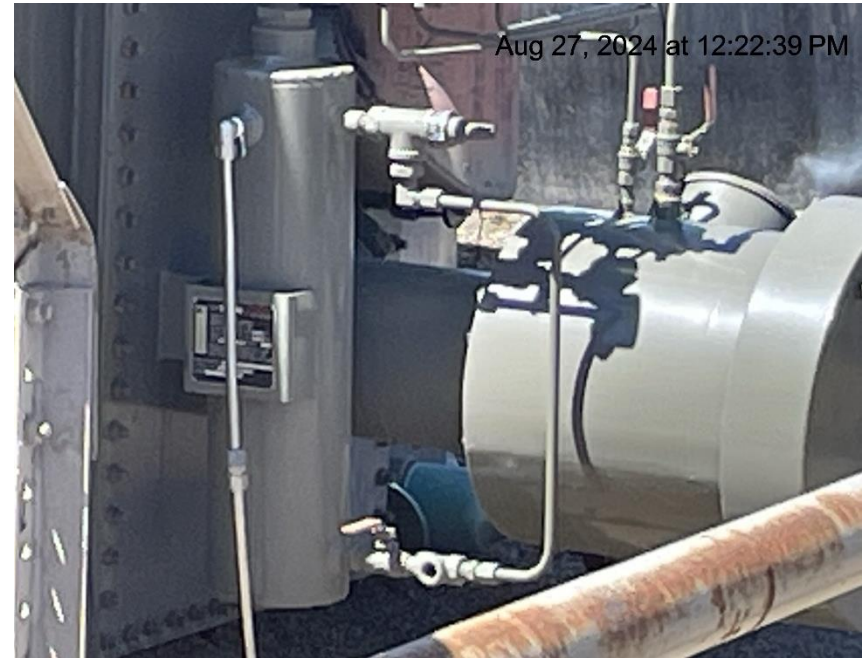
Photo # 6765 Multiple PRV vent lines do not comply with CECMC pressure safety device rules

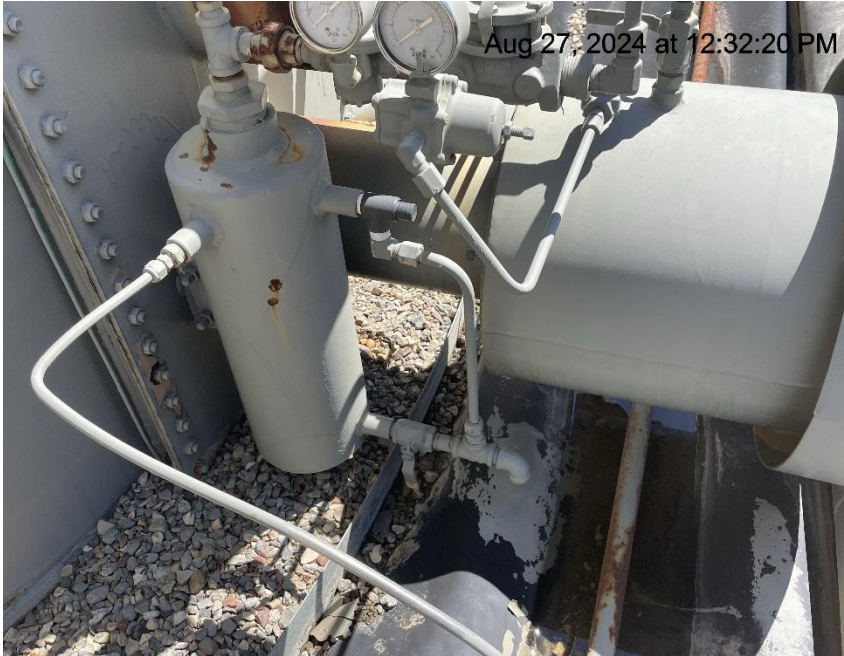
Photo # 6766 Multiple PRV vent lines do not comply with CECMC pressure safety device rules
