# Inspection Photos

**Operator:** SWN PRODUCTION COMPANY LLC

**Location ID:** 313149

**Inspection Doc:** 696206163

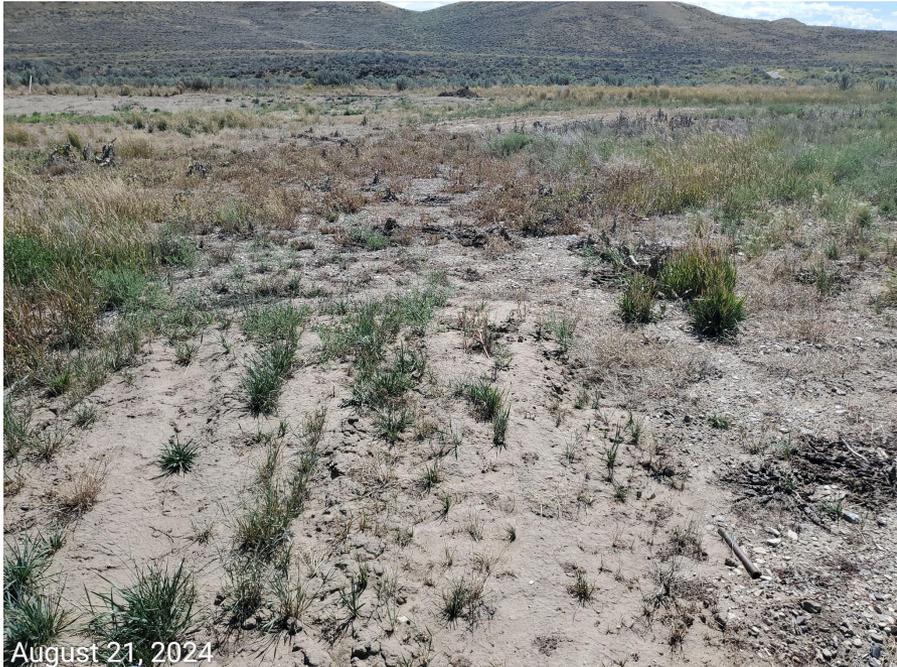
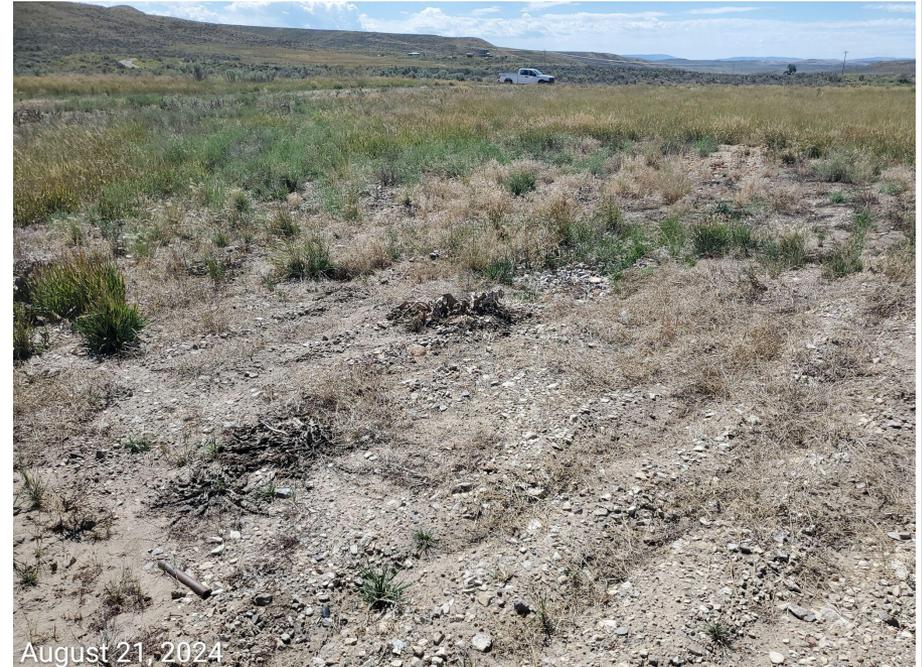
**Photo 1:** Photos 1-2 taken from the north end of the well site Location. Photos provide an overview from east, southeast, southwest to west. Photos shows Location has not been reclaimed in accordance with 1004 Requirements. Location is predominantly bare, or vegetated by undesirable plant species.

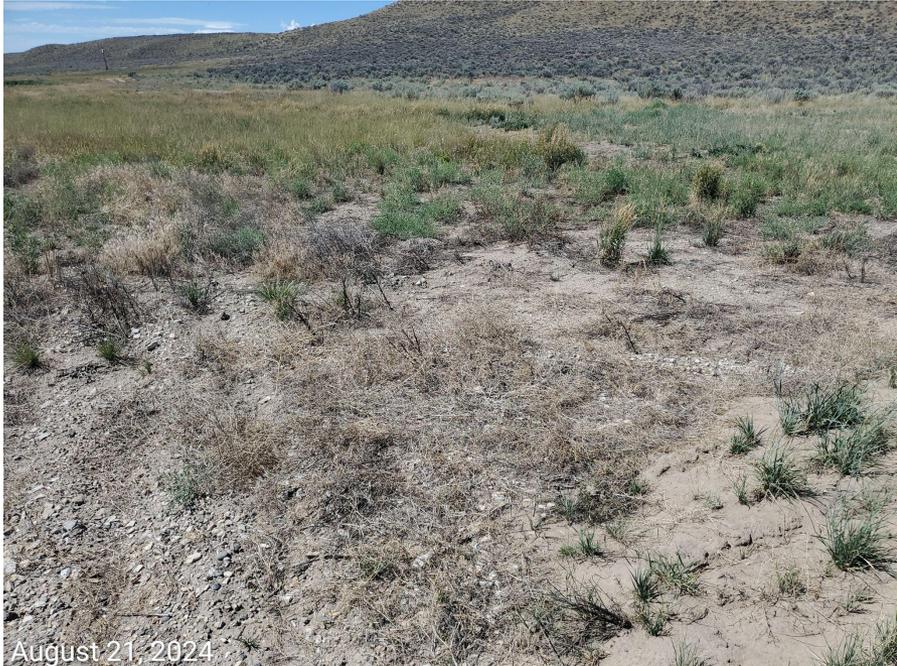
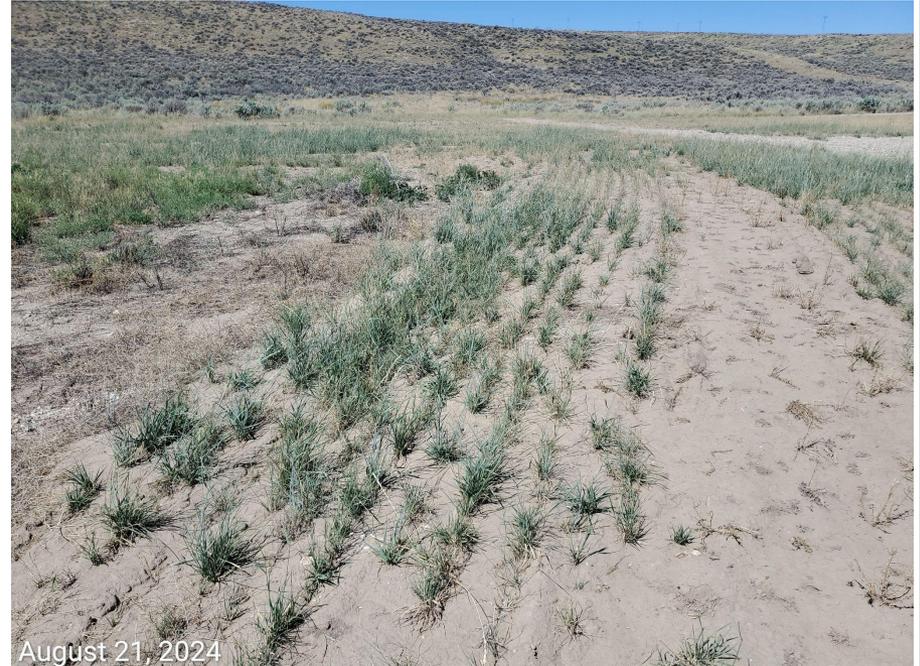
**Photo 2:** See comments under photo 1.

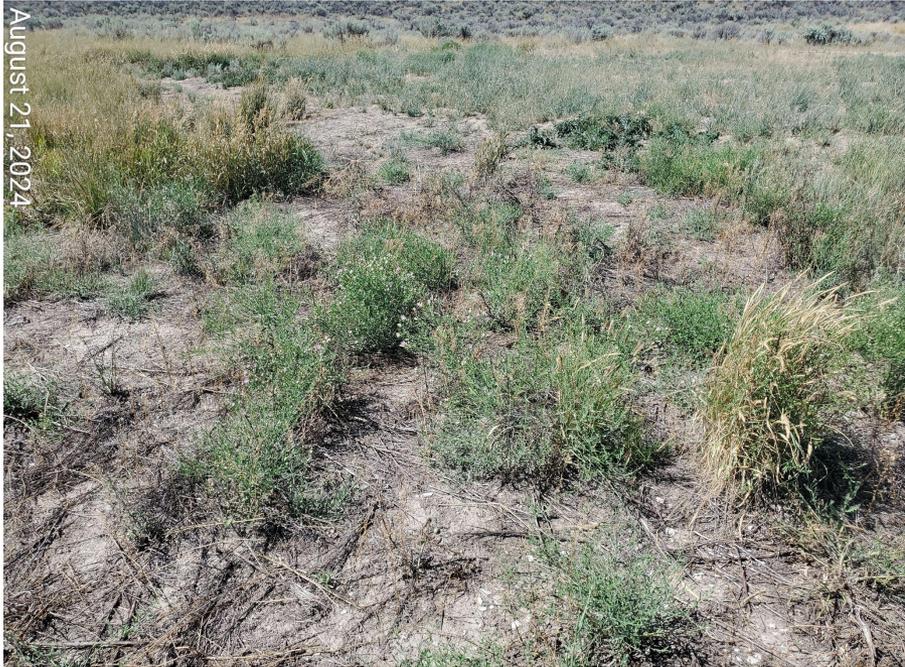
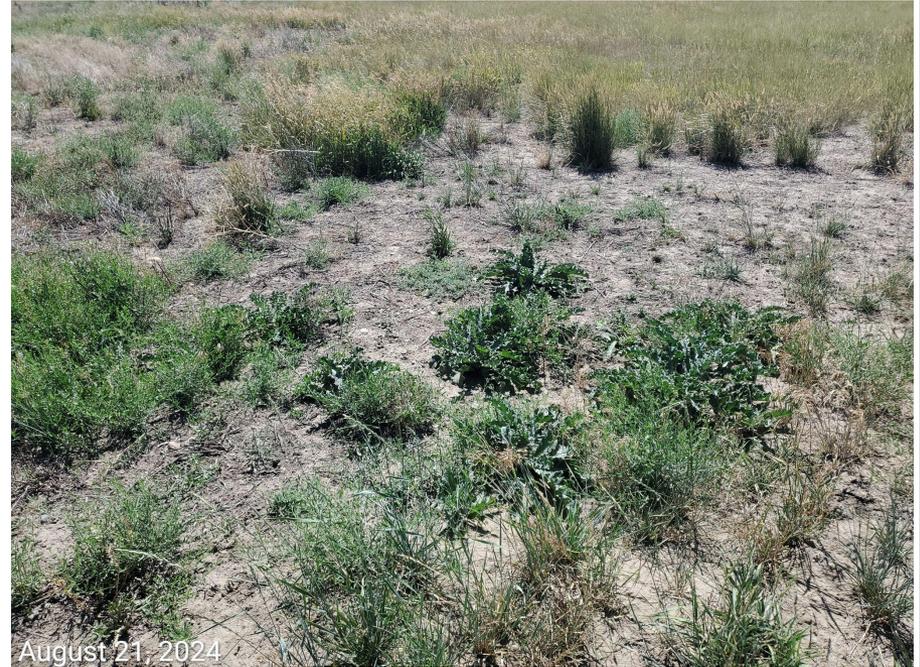
**Photo 3:** Photos taken from the well site Location. Photos examples showing Noxious weeds (Scotch thistle, Knapweed) observed established throughout the Location.

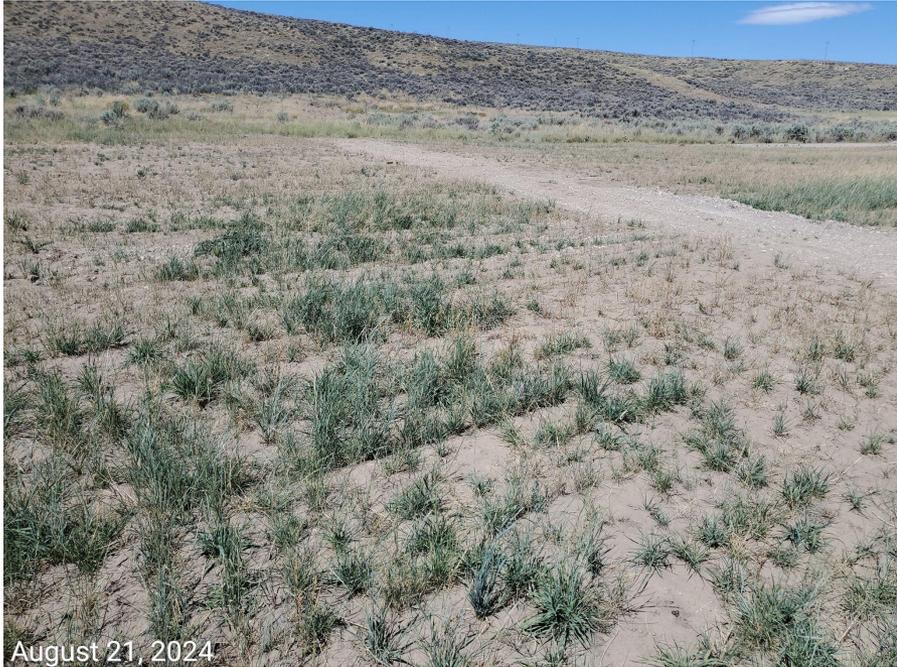
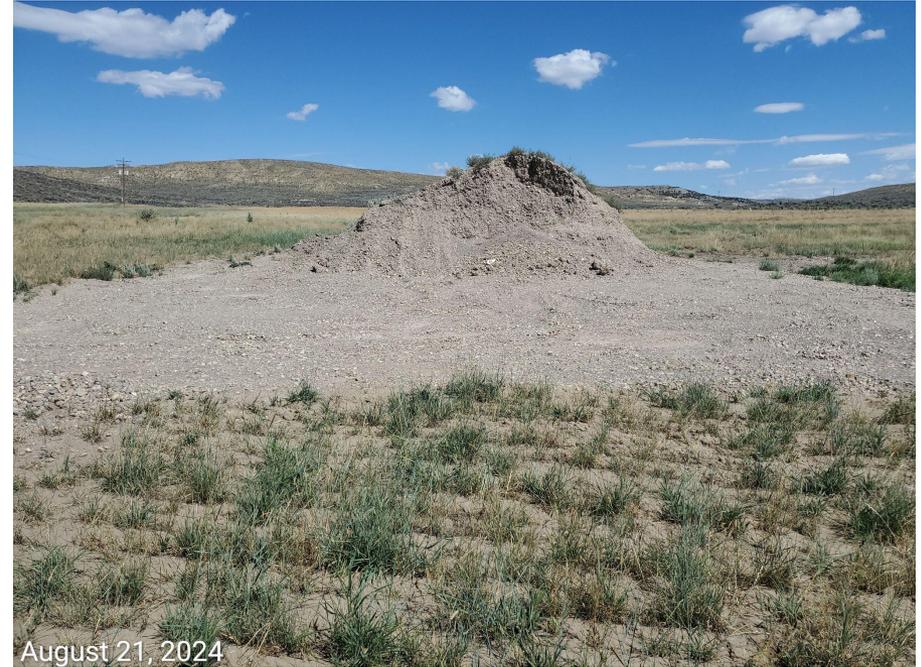
**Photo 4:** Photos taken from the northwest end of the well site Location, facing northwest and north. Photo shows areas that have not been reclaimed, including an access road, and an areas being used to store stockpiled soils/gravel material.

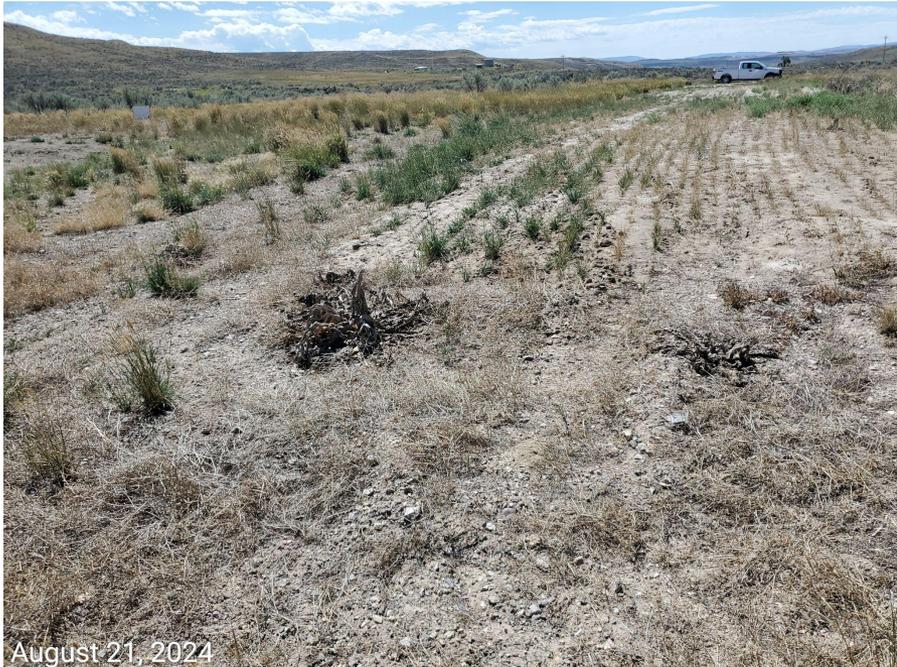
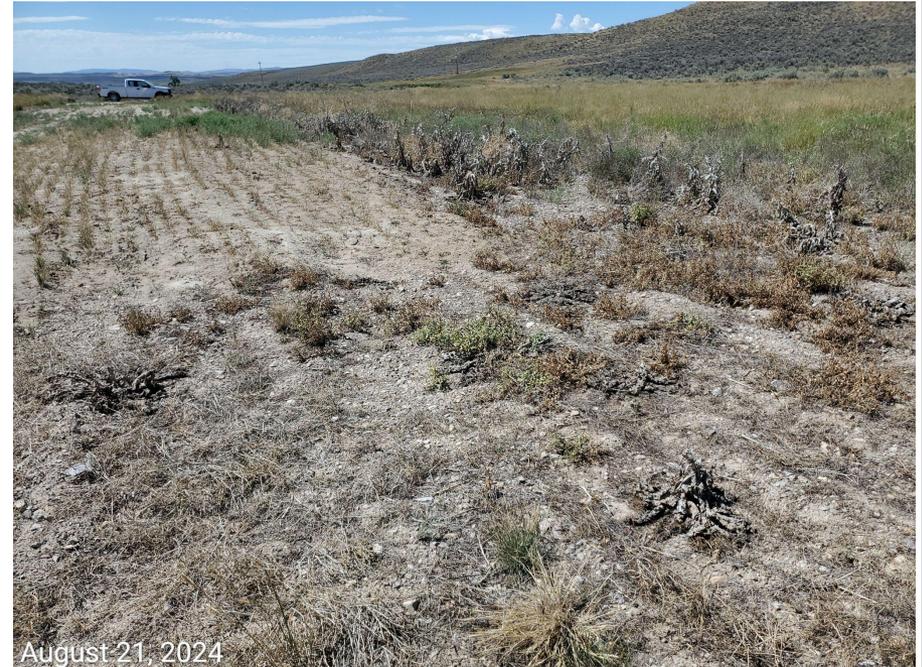
**Photo 5:** Photos taken from the southeast end of the well site Location, facing south. Access road has not been reclaimed in accordance with 1004 Rules. Operator appears to have pushed/dumped soil over this area of the access road without conducting gravel removal and compaction alleviation activities.

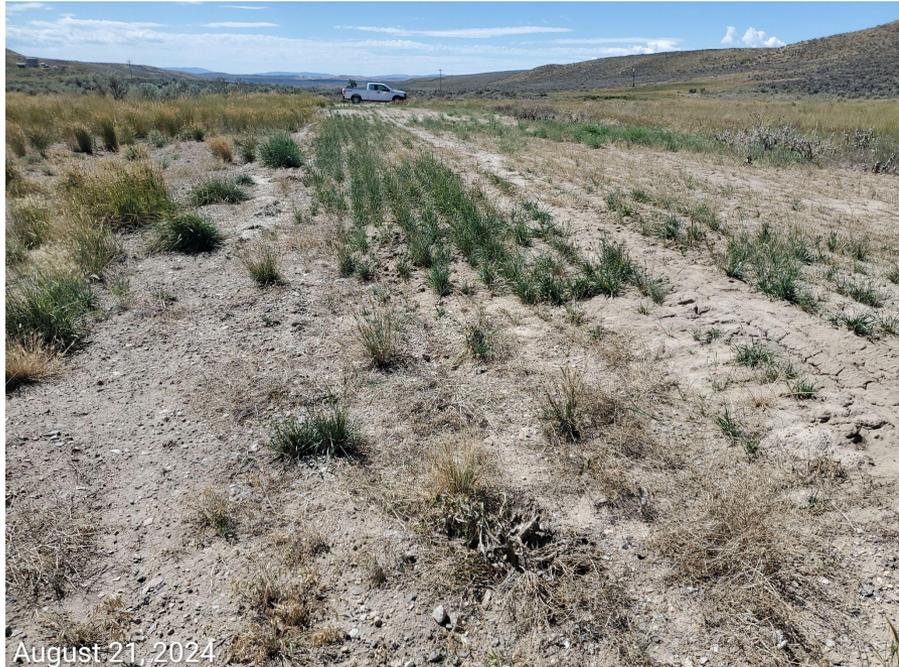
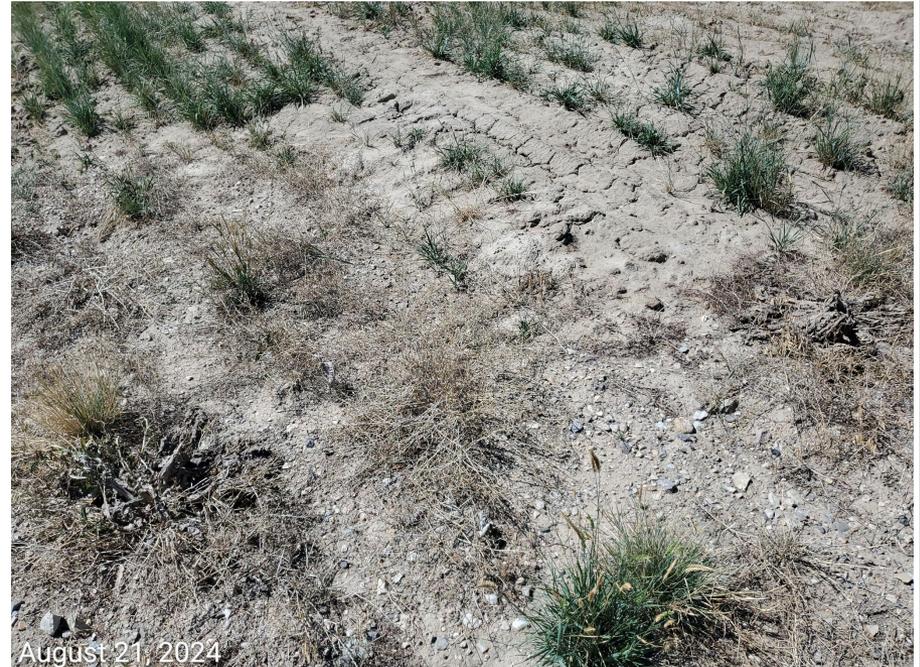
**Photo 6:** See comments under photo 5.

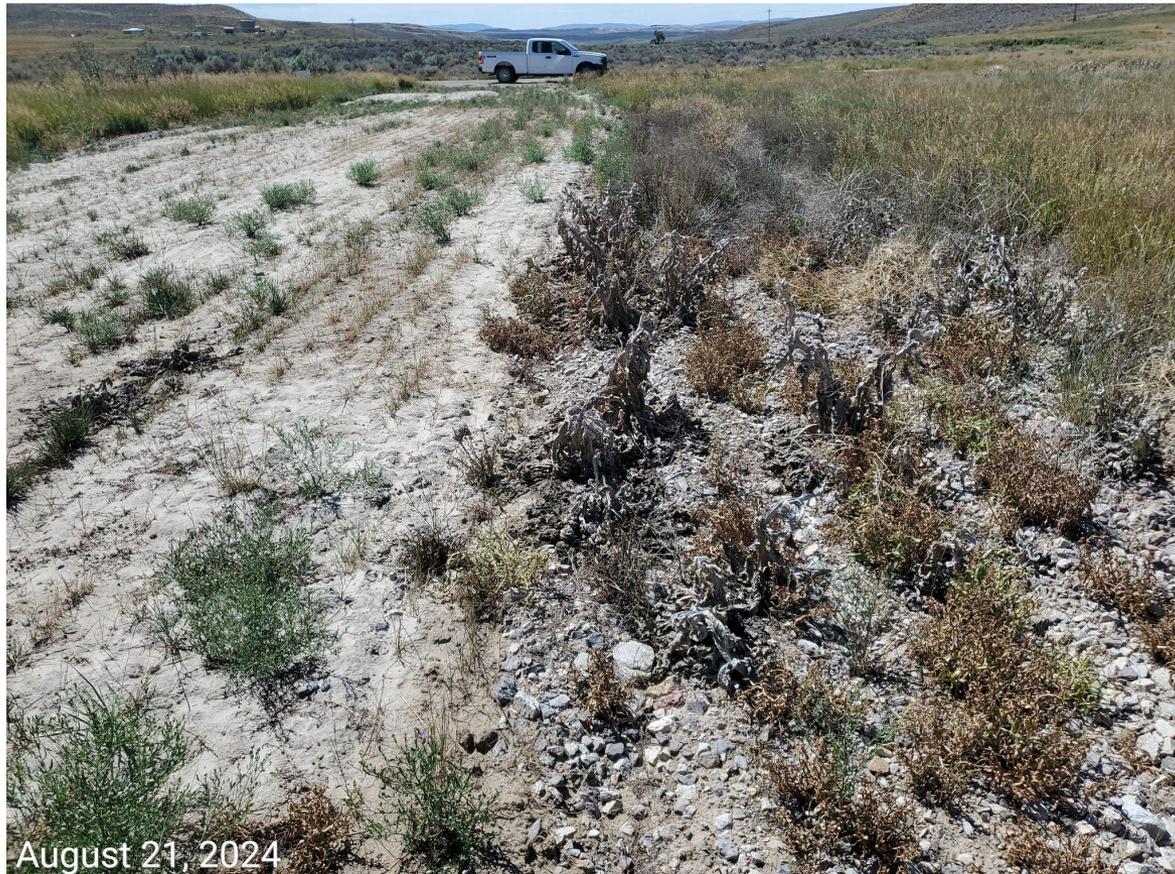
**Photo 7:** See comments under photo 5.

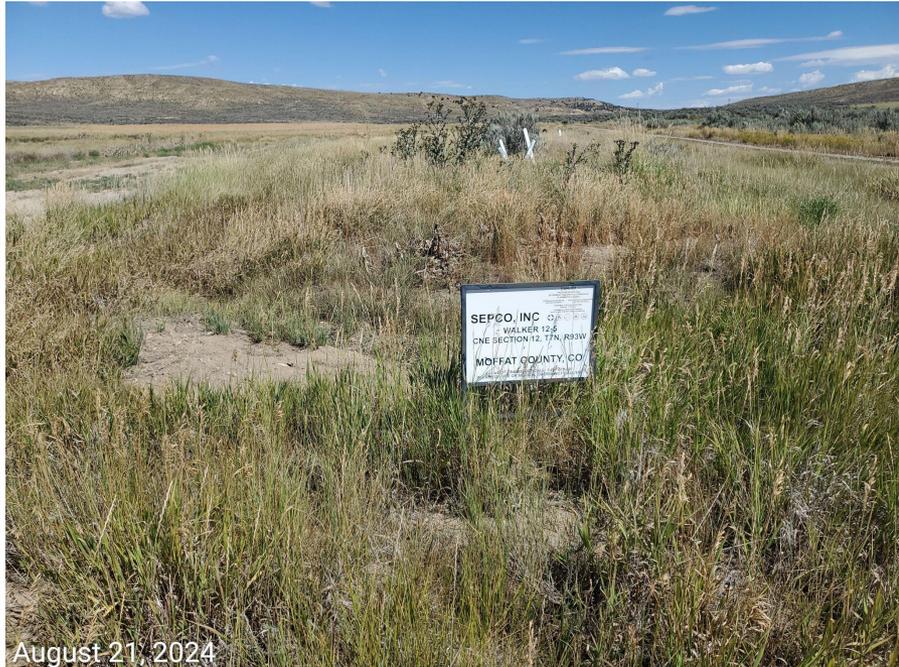
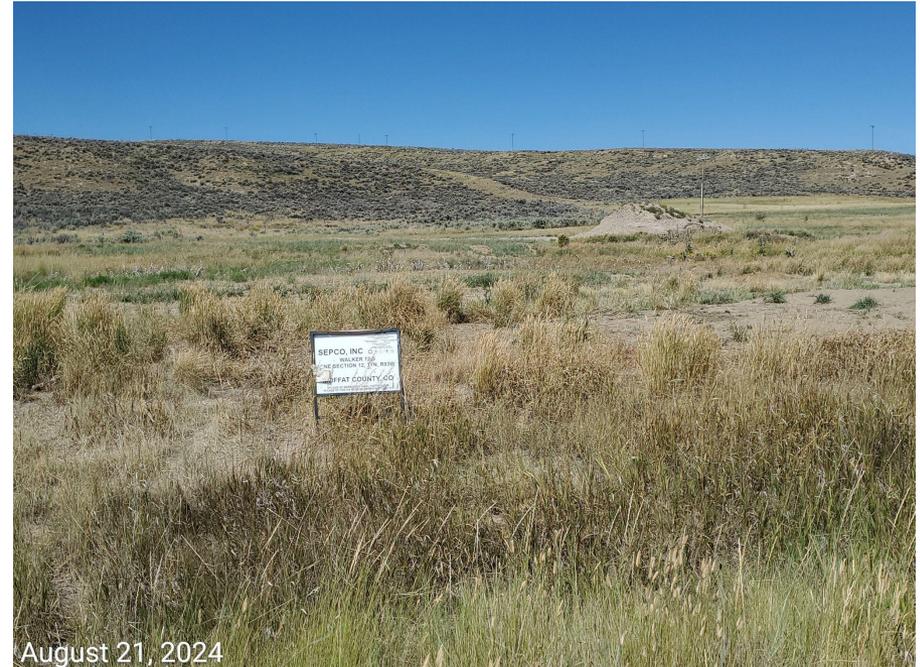
**Photo 8:** Photo left taken from the southeast end of the Location, facing north. Photo right taken from the east end of the Location, facing west. Photos show signage remaining with incorrect Operator information posted.

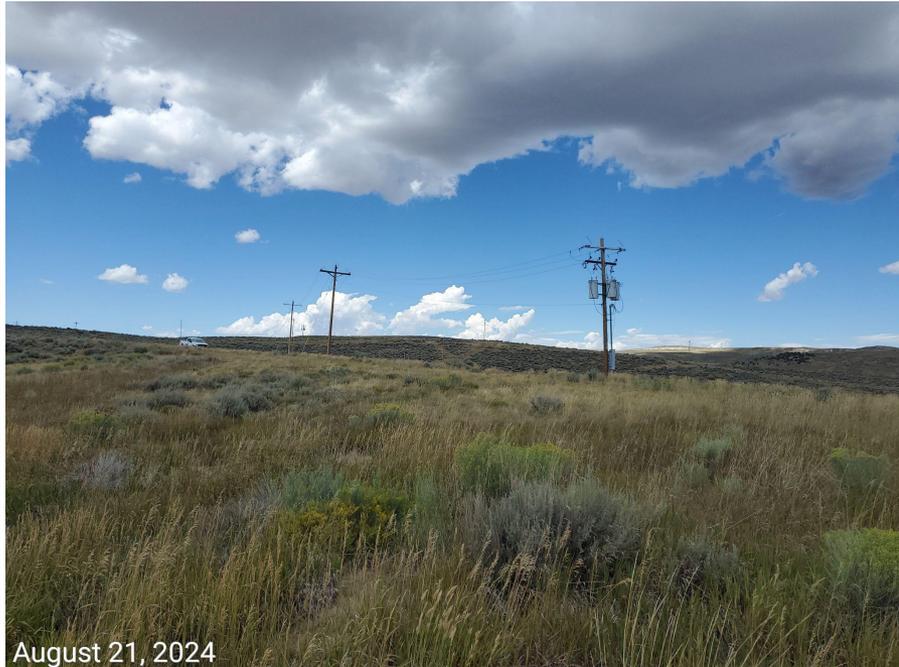
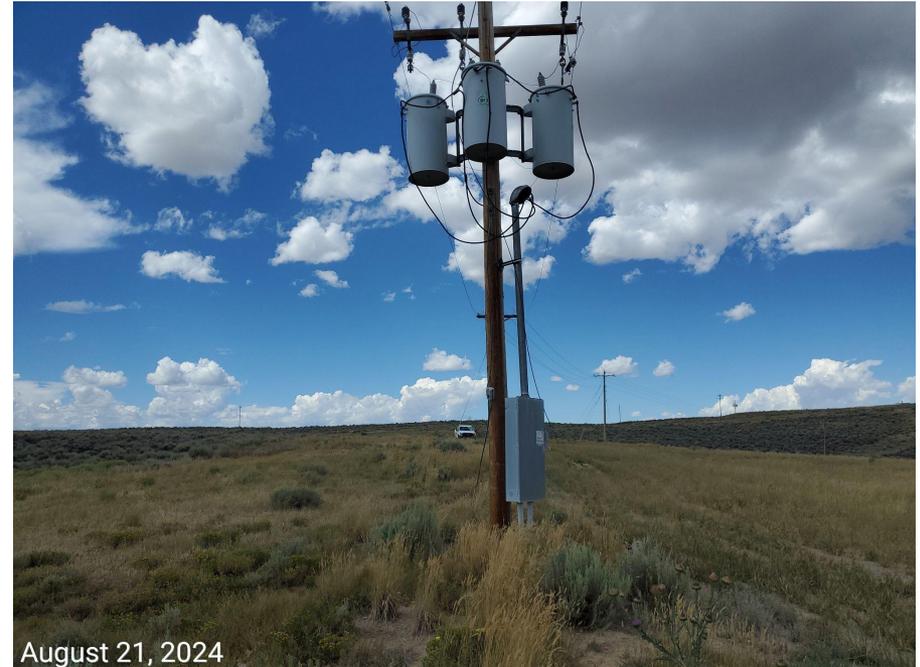
**Photo 11:** Photos taken from the south end of the Pit Facility Location. Photos show utility equipment on and leading to location has not been removed.

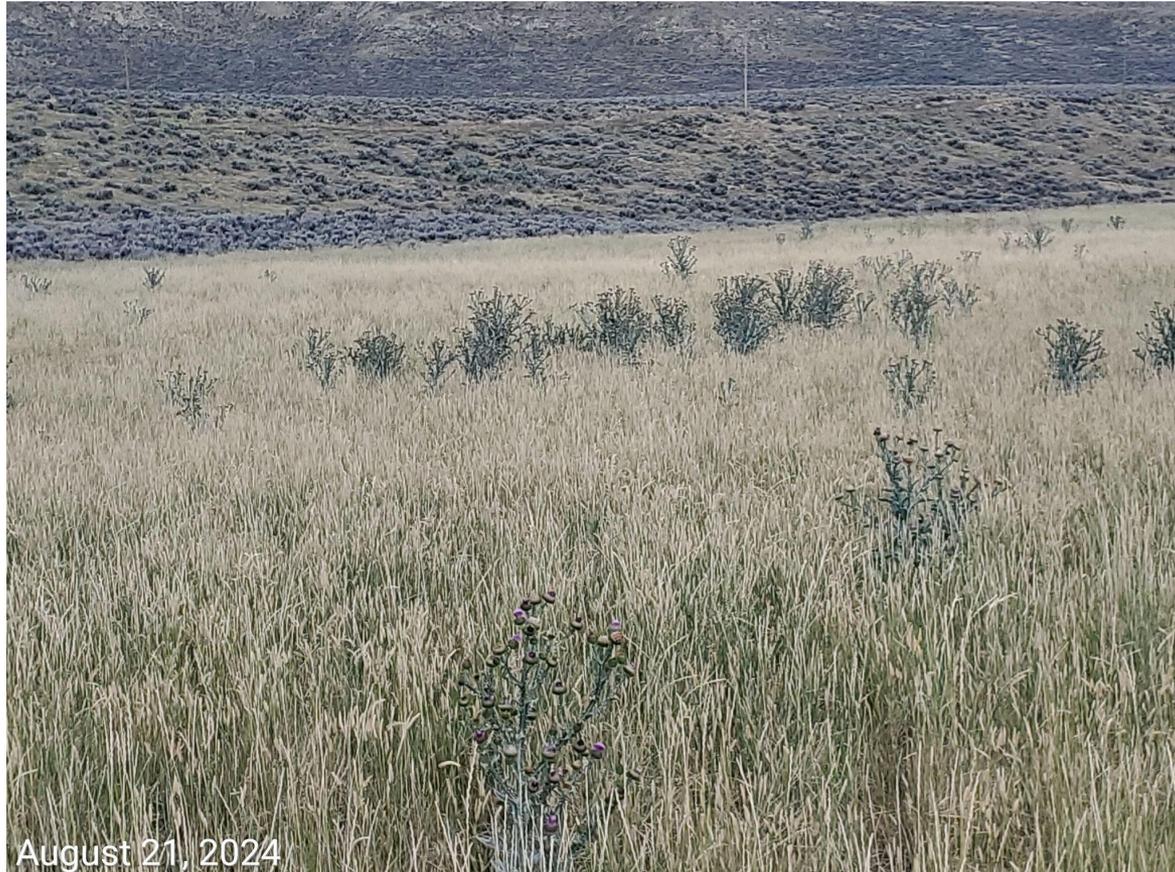
**Photo 12:** Photos examples showing Noxious weed establishment (Scotch thistle) observed throughout the Pit Facility Location.

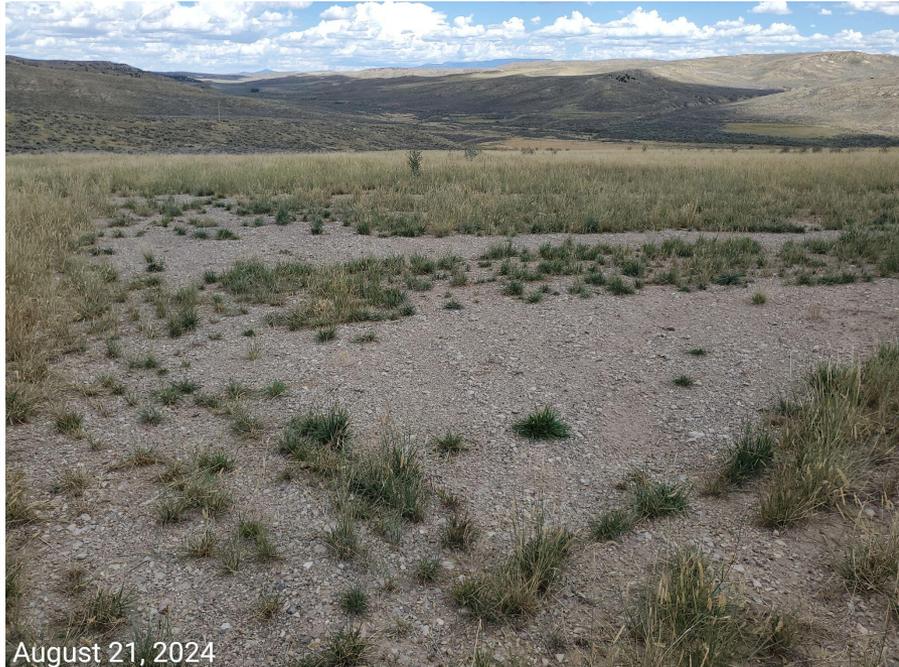
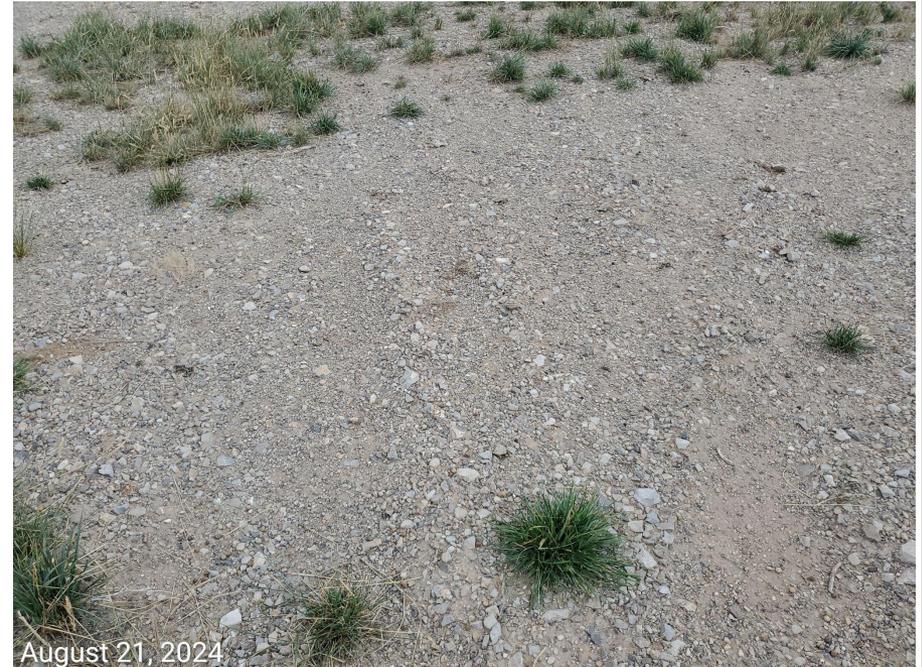
**Photo 13:** Photo taken from the west end of the Pit Facility Location. Photo example showing areas of the Location that have not been reclaimed in accordance with 1004 Rules and requirements.

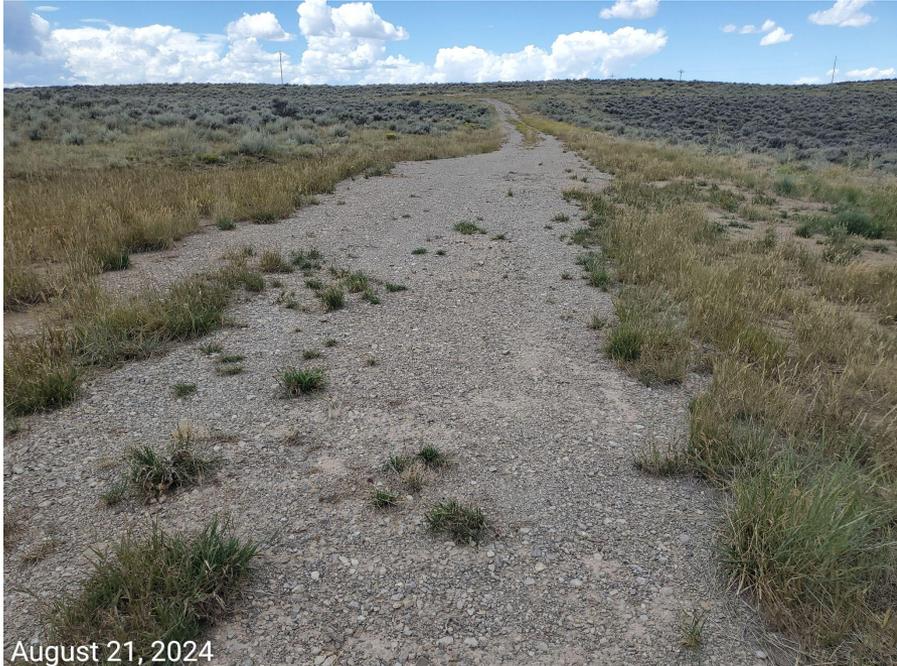
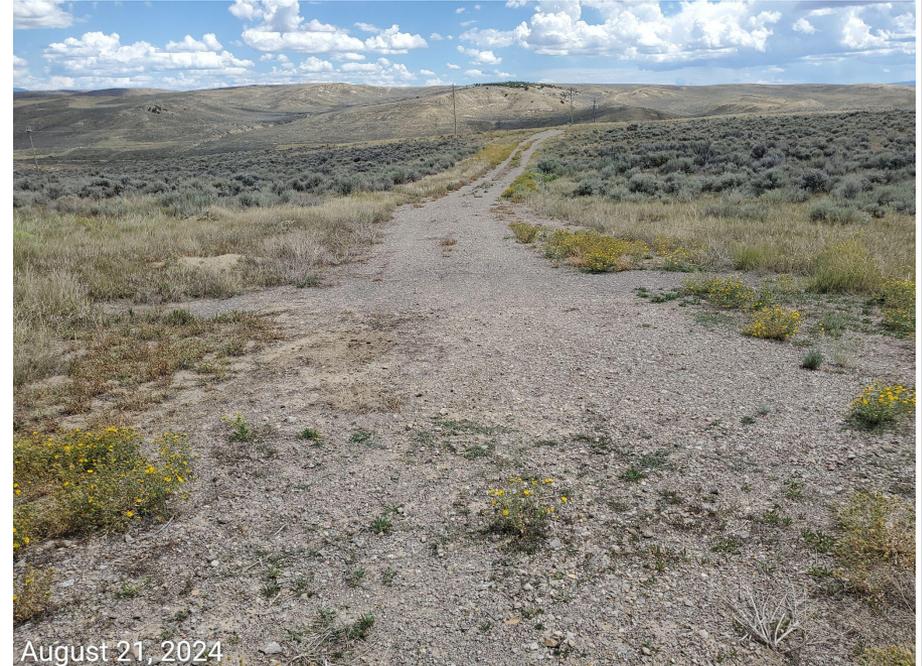
**Photo 14:** Photo left taken from the west end of the Pit facility Location, facing west. Photo right taken from the access road entrance leading to the Location, facing east. Photos show access road to the Pit Facility Location has not been reclaimed.
