**Operator: 8 North**

**Location Name: EVERITT-611N61W 14NWSW**

**Loc ID: 302935**

**Inspection: 696300869**

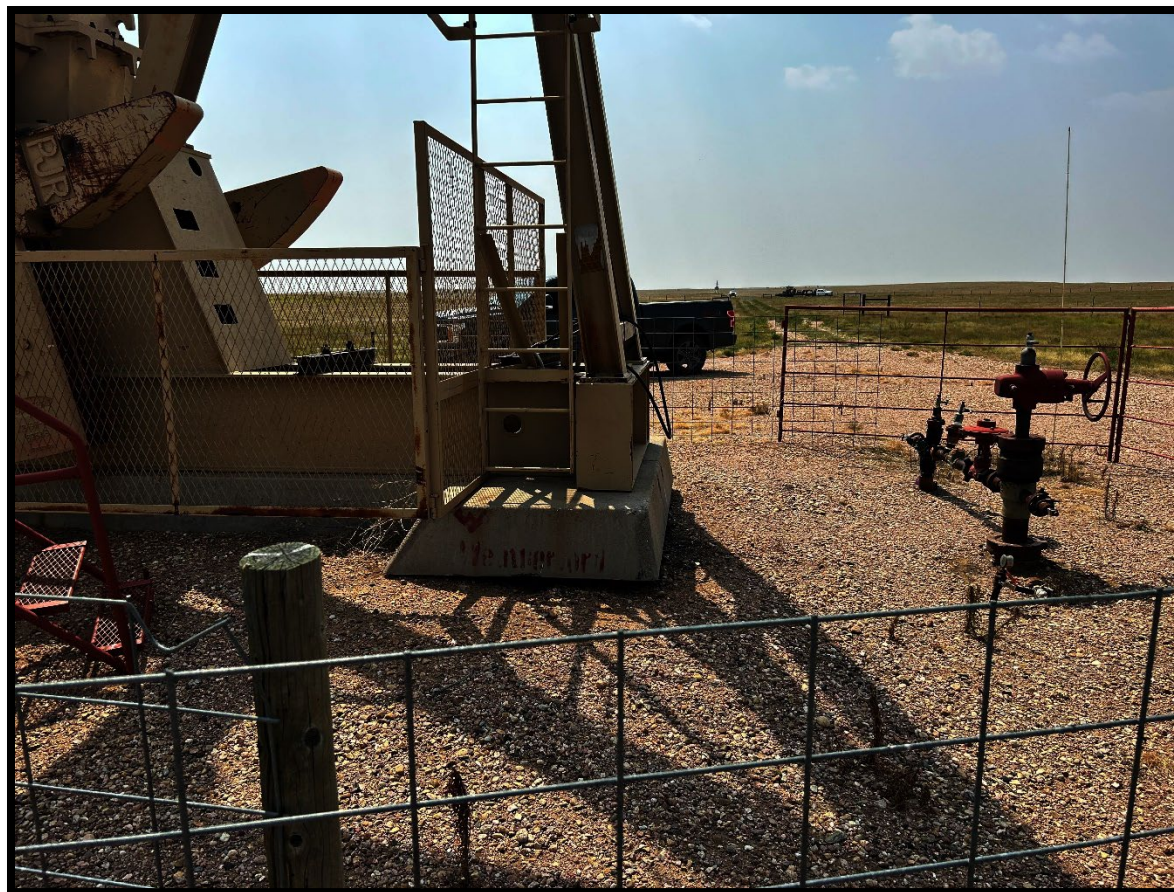
**CA:** Unused Wellhead Parts, see photo 4. Comply with Rule 603.f .

**CA Resolution:** Unused equipment has been removed from the location to comply with the 600 series.
