Inspection Photos
Location: Reynard 34-34
Location ID: 333697
API # 05-071-07092

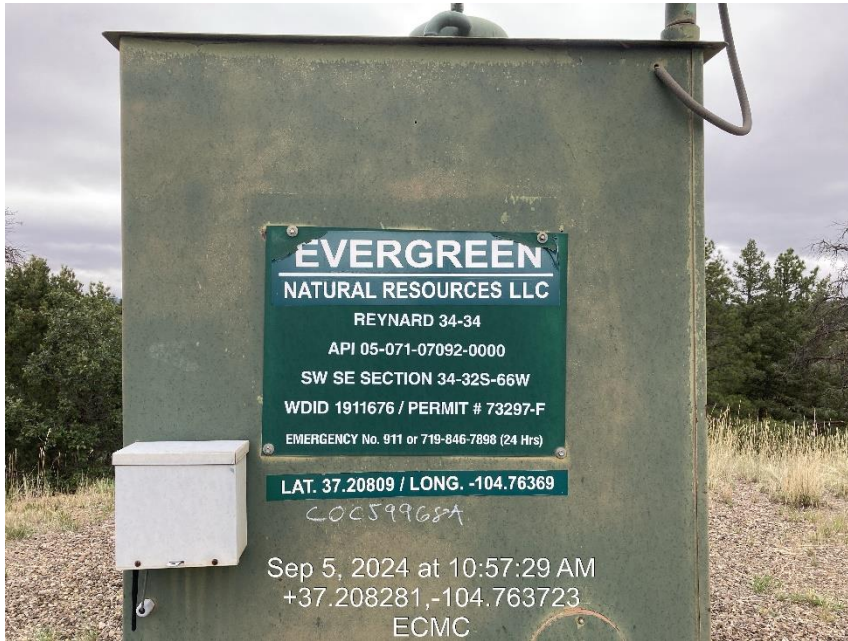
Photo 1 –Well placard on meter house.

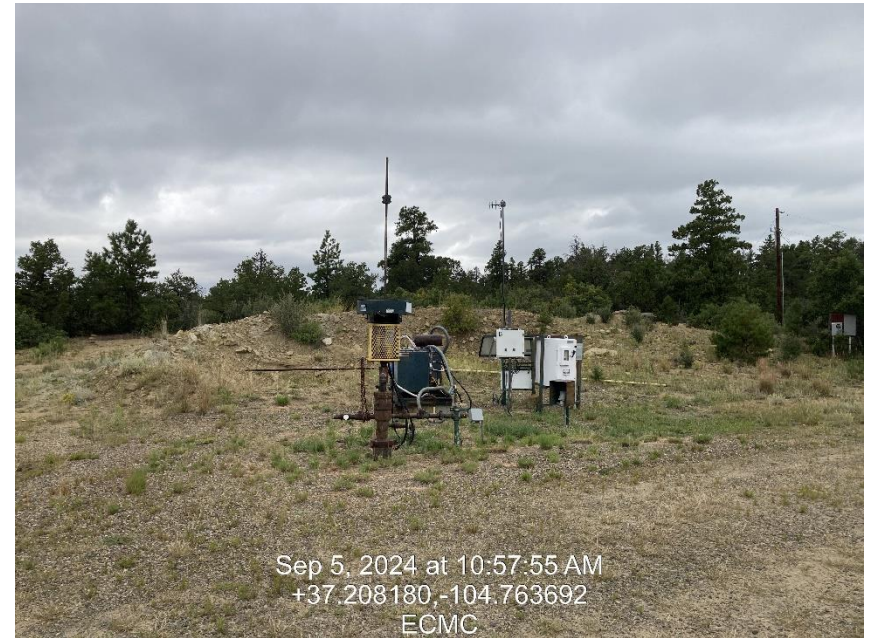
Photo 2 – Wellhead and equipment.

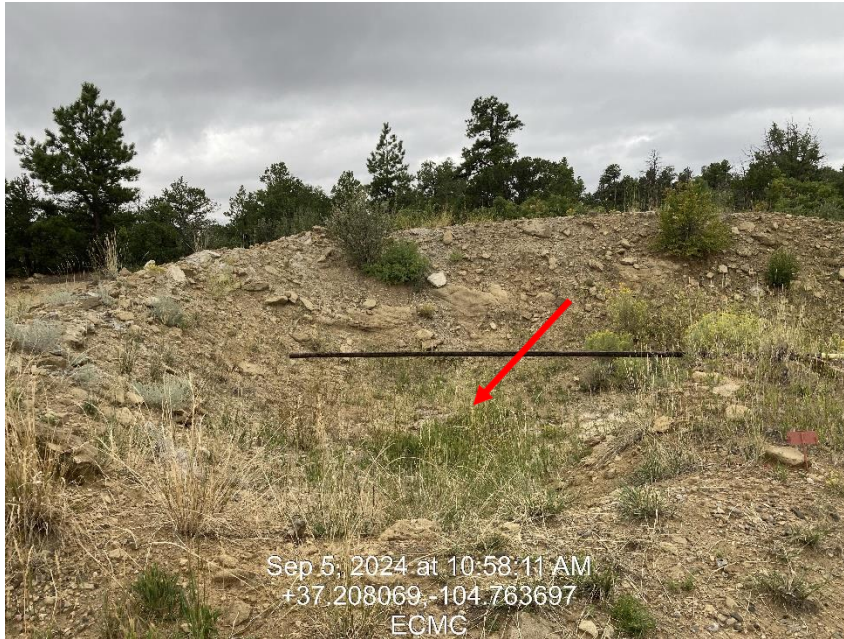
Photo 3 – Pit Facility ID 260821

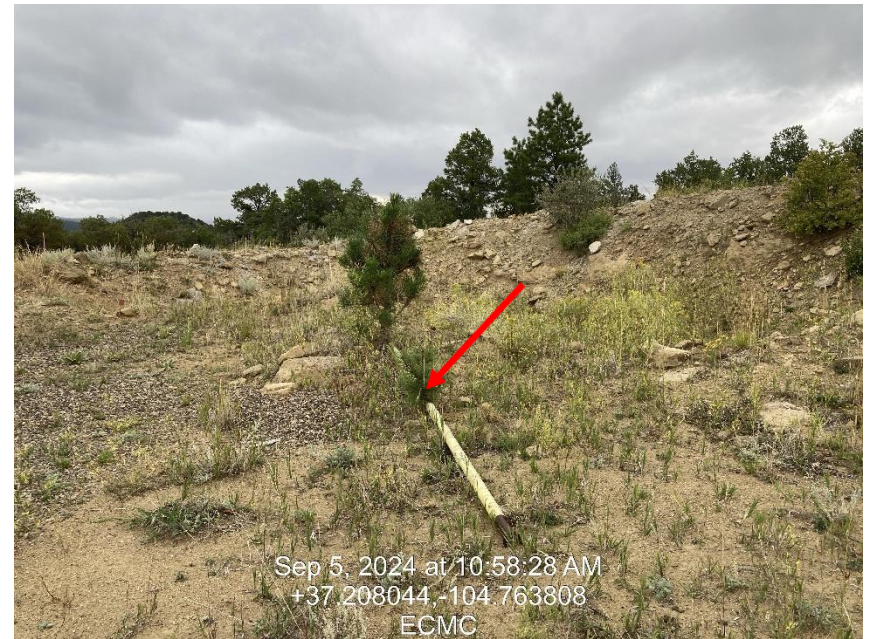
Photo 4 – Pit Flowline not in use.

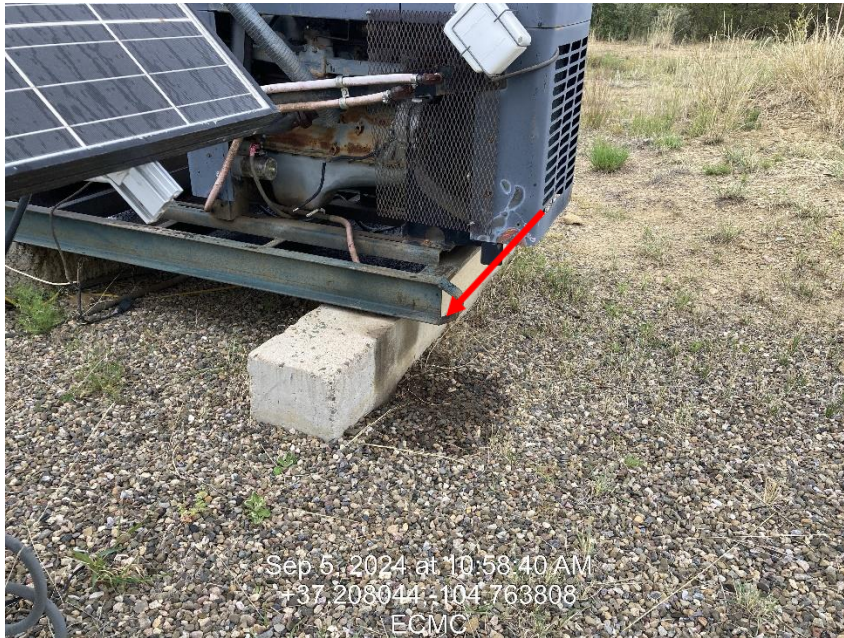
Photo 5 – Oil Stained soils at engine skid

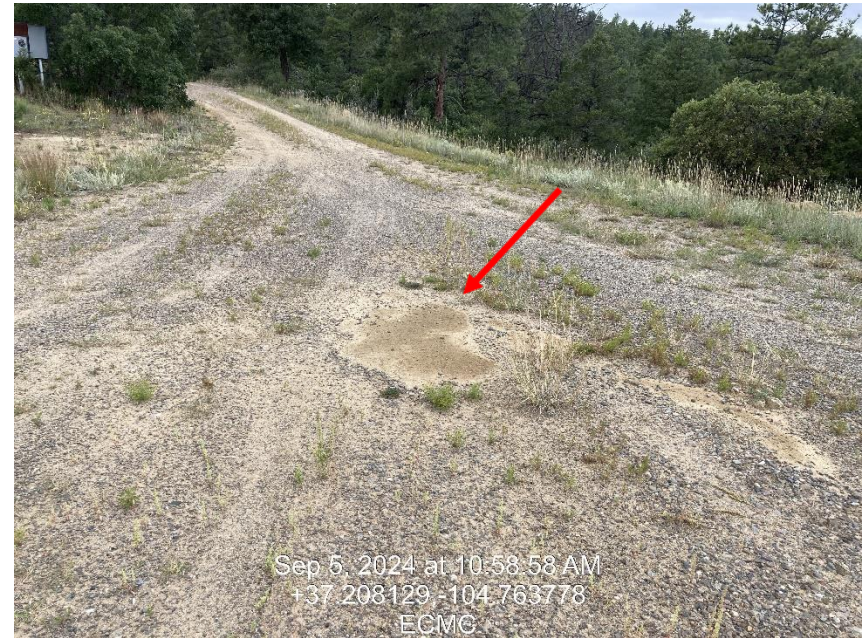
Photo 5 – Oil stained soils on well pad

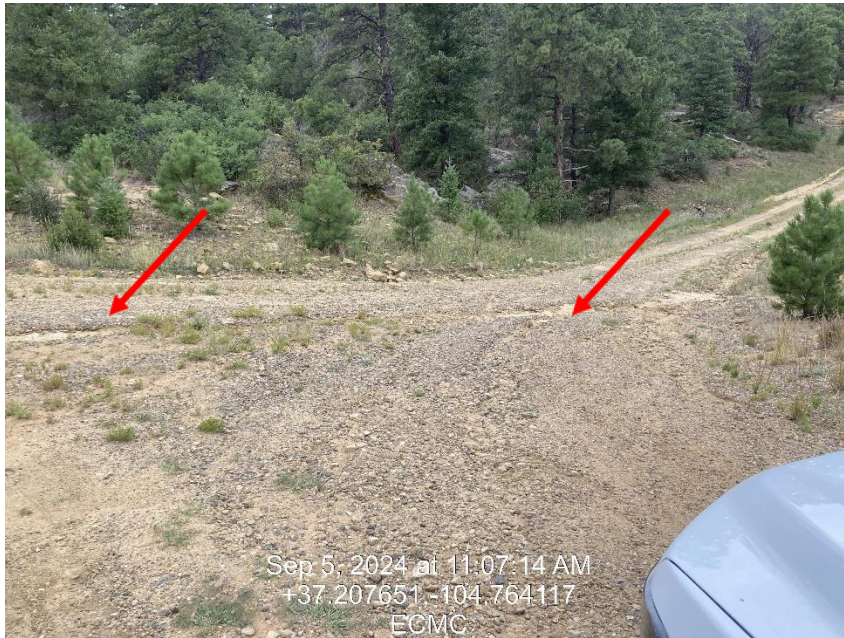
Photo 7 – Stormwater is causing erosion at road intersection
