Operator: 8 North

Location Name: DF RANCH-611N61W 2SWSW

Loc ID: 410183

Inspection: 696300965

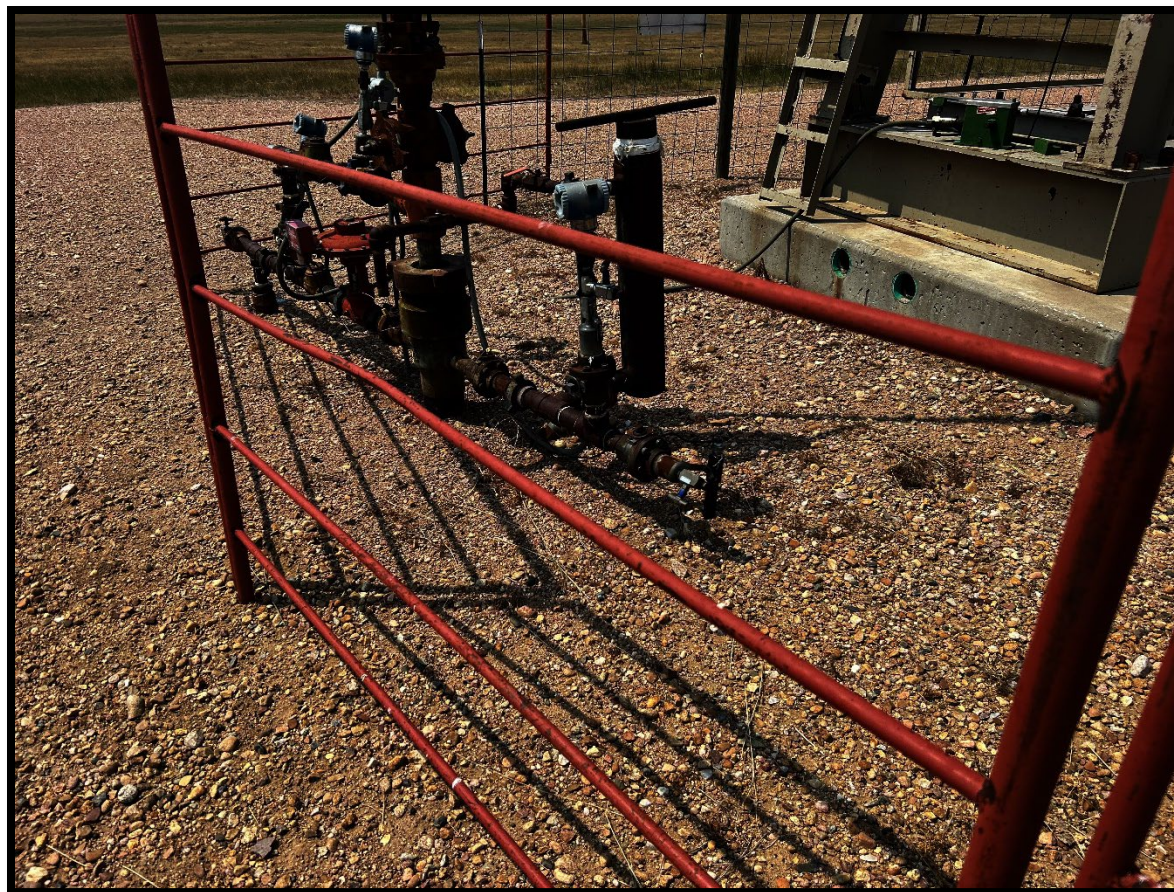
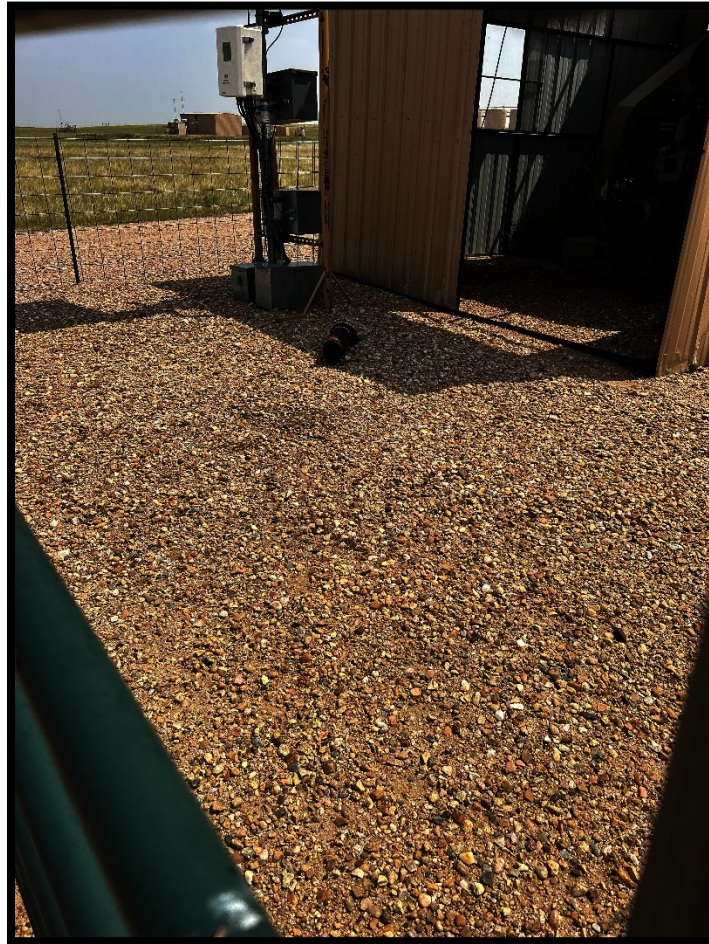
CA: Stained Soil at Exhaust and Wellhead, see photos 2 and 3. Properly treat or dispose of oily waste in accordance with 907.e

CA Resolution: Operator has provided photo evidence to show that the stained soil has been appropriately removed/cleared and mechanical issues leading to the leak have also been addressed.
