CORRECTIVE ACTION REPSONSE

DOCUMENT NUMBER: 713400261
FACILITY NAME: SKINNER RIDGE 36-BV
Location: CHEVRON USA INC SKR-65S98W/36NWSW
Location ID: 336048

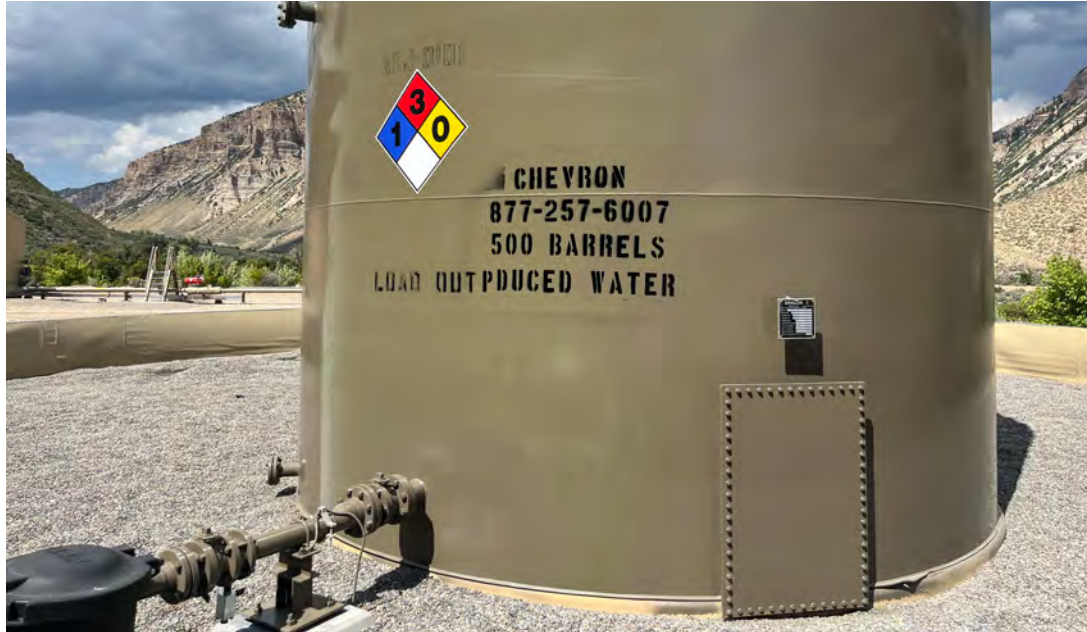
CORRECTIVE ACTION #1 COMMENT:

Tank missing labeling. Tank in tank battery is missing name of operator, operators emergency contact information, tank capacity and tank contents.

Labels have been added to tank - 09/04/2024

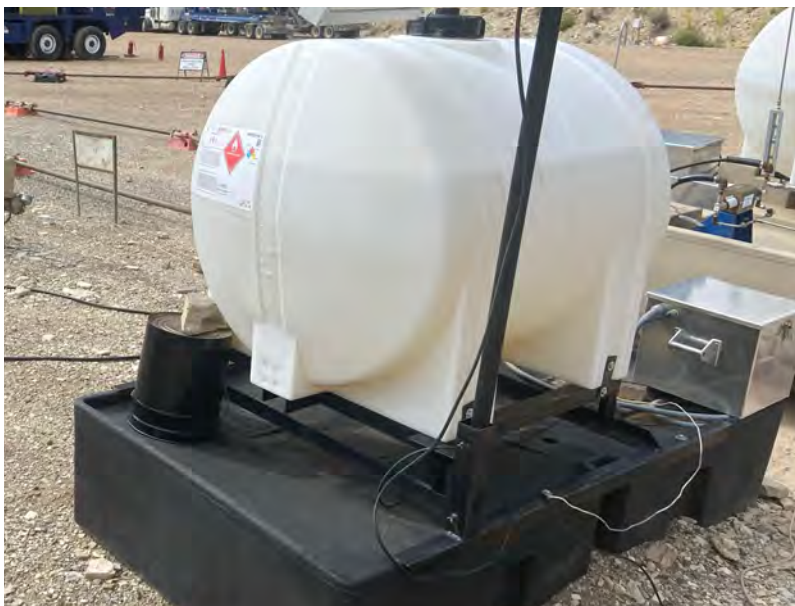
CORRECTIVE ACTION #2 COMMENT: Chemical tank has no labeling.

CORRECTIVE ACTION RESPONSE: Labels have been added to tank - 09/09/2024

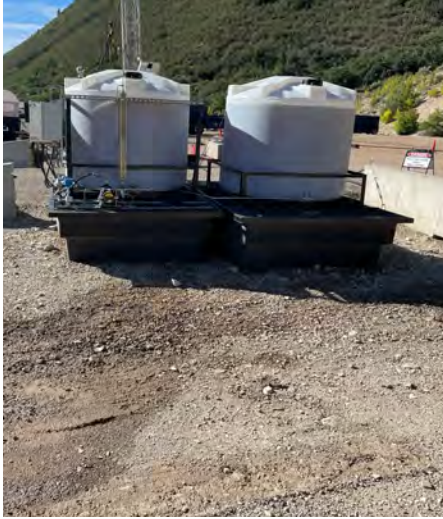
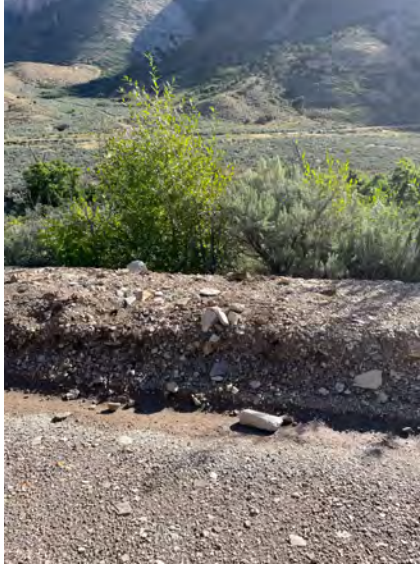
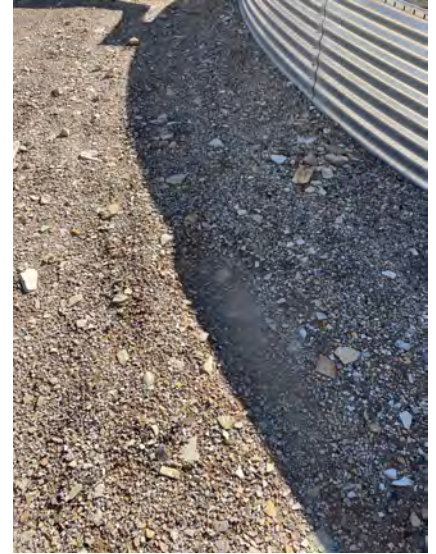
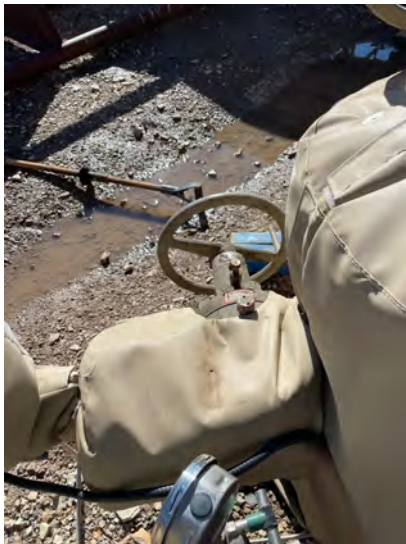
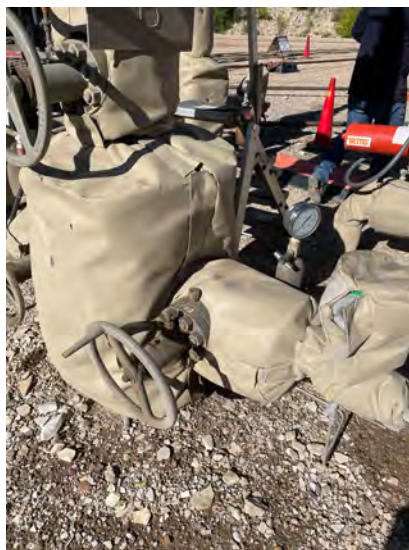
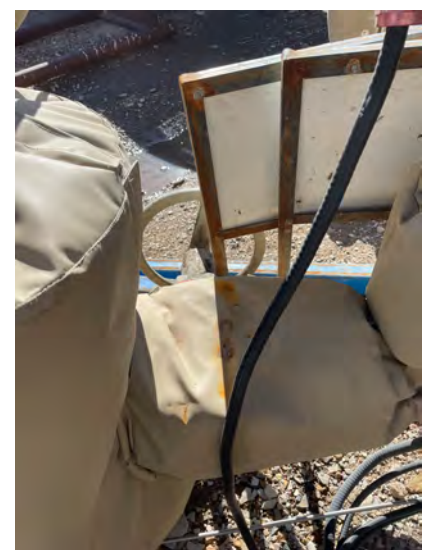
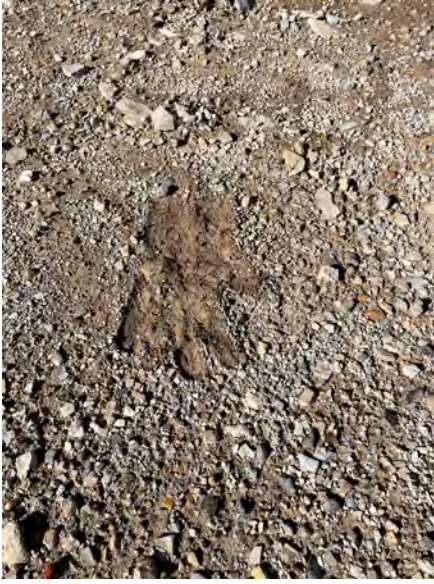
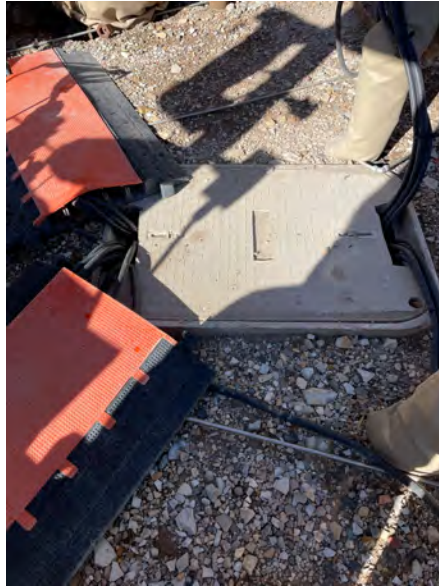
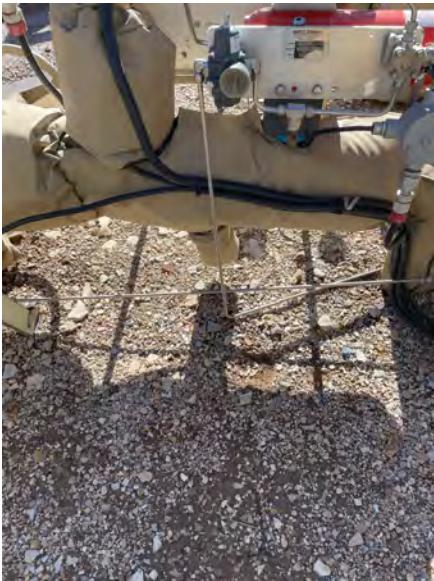
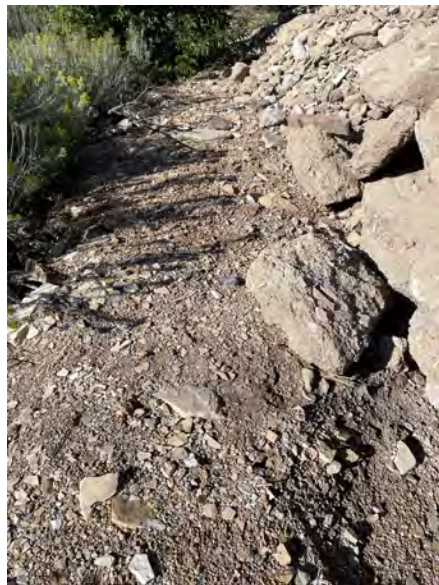
CORRECTIVE ACTION #3 COMMENT:
Multiple debris on location, refer to photos.

On the day of the receipt of this inspection report (28 August 2024) and corrective actions noted the Skinner Ridge Well Pad 36-BV was gone over by Chevron crews and all debris was removed from the pad and properly disposed of.

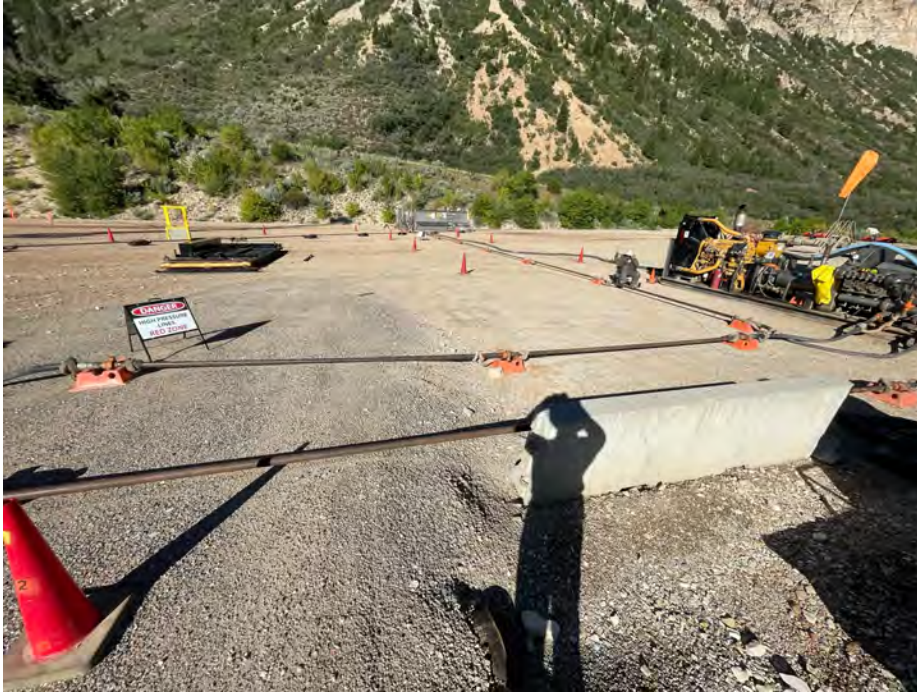
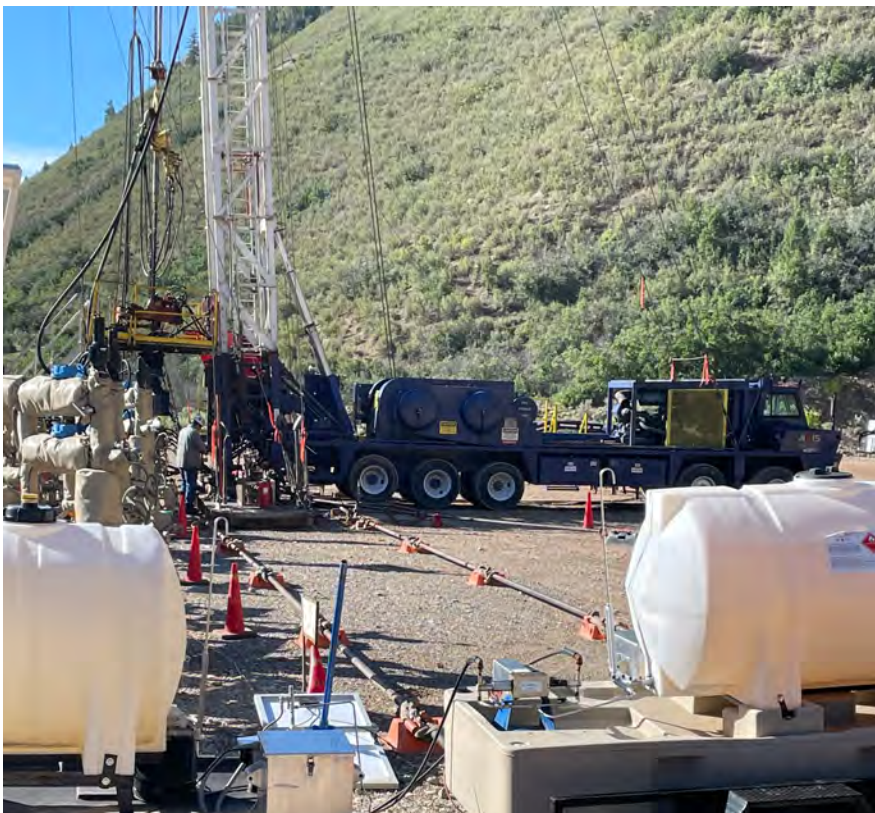
CORRECTIVE ACTION #4 COMMENT:

Multiple open ended piping/wildlife hazard/ available for entry by wildlife.

Piping was unhooked to allow P&A rig to move to next well in operation and then reconnected - 08/29/2024.

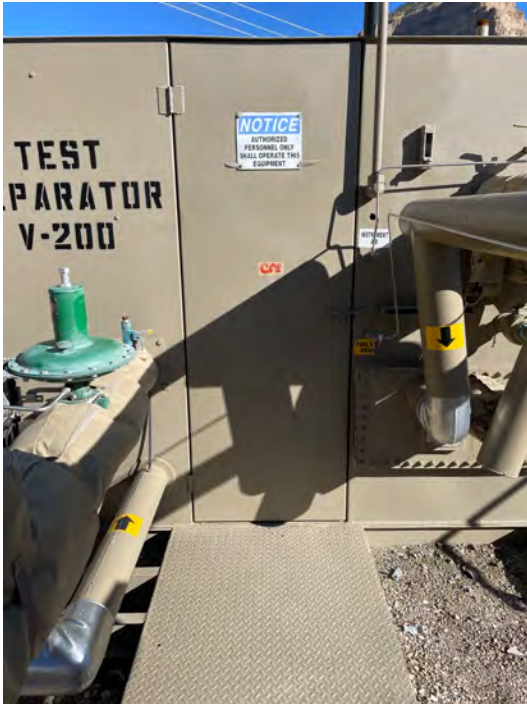
CORRECTIVE ACTION #5 COMMENT:
Separator doors open/wildlife hazard.

CORRECTIVE ACTION RESPONSE:
Separator doors have been closed - 08/28/2024.

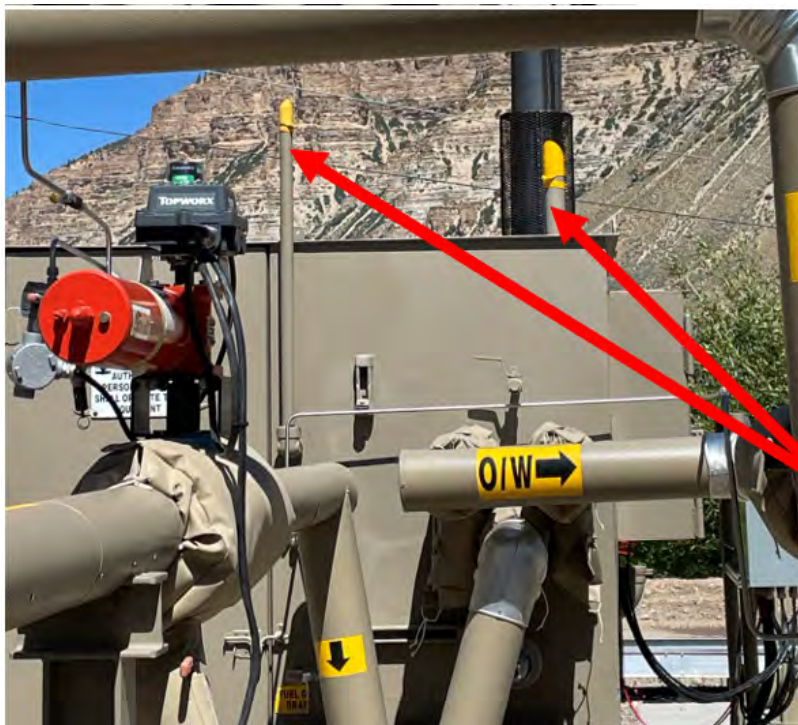
CORRECTIVE ACTION #6 COMMENT:
PRV does not comply with CECMC pressure safety device rules.

CORRECTIVE ACTION RESPONSE:
Both PRV lines were capped - 08/28/2024.

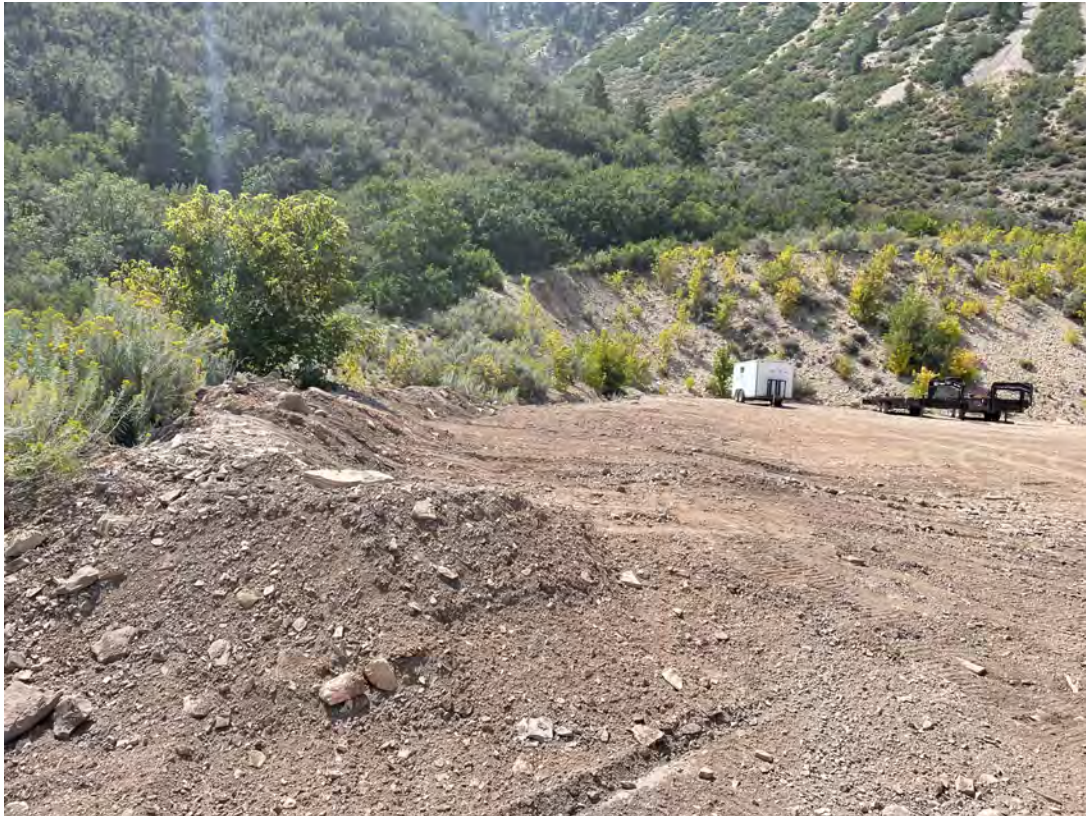
CORRECTIVE ACTION #7 COMMENT:
Stockpiled soils with no BMP's, refer to photos.

CORRECTIVE ACTION RESPONSE:
This stockpile was of clean dirt. It was removed and spread to fill low areas on location. -
09/05/2024
