## FIELD INSPECTION FORM

Loc ID 316821 Inspector Name: BROWNING, CHUCK On-Site Inspection ☐ 2A Doc Num: \_\_\_\_\_**Operator Information:**

Name of Operator: AMERICAN HELIUM OPERATING LLC

Facility ID	Type	Status	Status Date	Well Class	API Num	Facility Name	Insp Status
261300	WELL	TA	01/01/2017	GW	113-06088	FOSSIL FEDERAL 2-20	TA

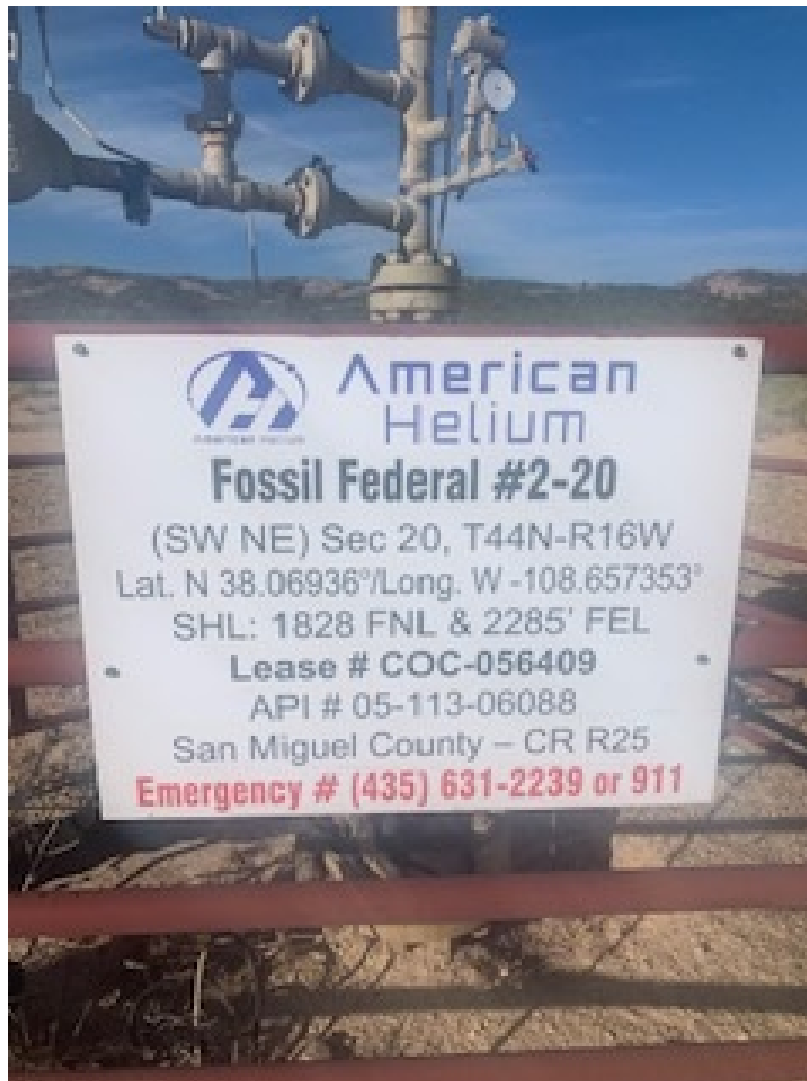
On 7-31-24, FF 2-20 signage was corrected. Please see attached photo.

<b>Signs/Marker:</b>			
Type	TANK LABELS/PLACARDS		
Comment:	Sign or label not posted or information inaccurate on tanks or containers or sign/label too small to read at distance or installed in place where not visible.		
Corrective Action:	Install sign to comply with Rule 605.h.	Date:	09/30/2024
Type	WELLHEAD		
Comment:			
Corrective Action:		Date:

Signage replaced FF 2-20 on 7-31-24
