**FORM
INSP**Rev
X/20**State of Colorado
Oil and Gas Conservation Commission**1120 Lincoln Street, Suite 801, Denver, Colorado 80203
Phone: (303) 894-2100 Fax: (303) 894-2109

693807683**FIELD INSPECTION FORM**Loc ID 316826 Inspector Name: BROWNING, CHUCK On-Site Inspection ☐ 2A Doc Num: _____**Operator Information:**ECMC Operator Number: 10841Name of Operator: AMERICAN HELIUM OPERATING LLCAddress: 600 TRAVIS STREET SUITE 5050City: HOUSTON State: TX Zip: 77002**Status Summary:**☐ THIS IS A FOLLOW UP INSPECTION☒ FOLLOW UP INSPECTION REQUIRED☐ NO FOLLOW UP INSPECTION REQUIRED**Findings:**9 Number of Comments1 Number of Corrective Actions☒ Corrective Action Response Requested**ANY CORRECTIVE ACTION(S) FROM
PREVIOUS INSPECTIONS THAT HAVE NOT
BEEN ADDRESSED ARE STILL APPLICABLE****Contact Information:**

Facility ID	Type	Status	Status Date	Well Class	API Num	Facility Name	Insp Status
263297	WELL	PR	10/01/2023	GW	113-06099	FOSSIL FEDERAL 2-18	PR

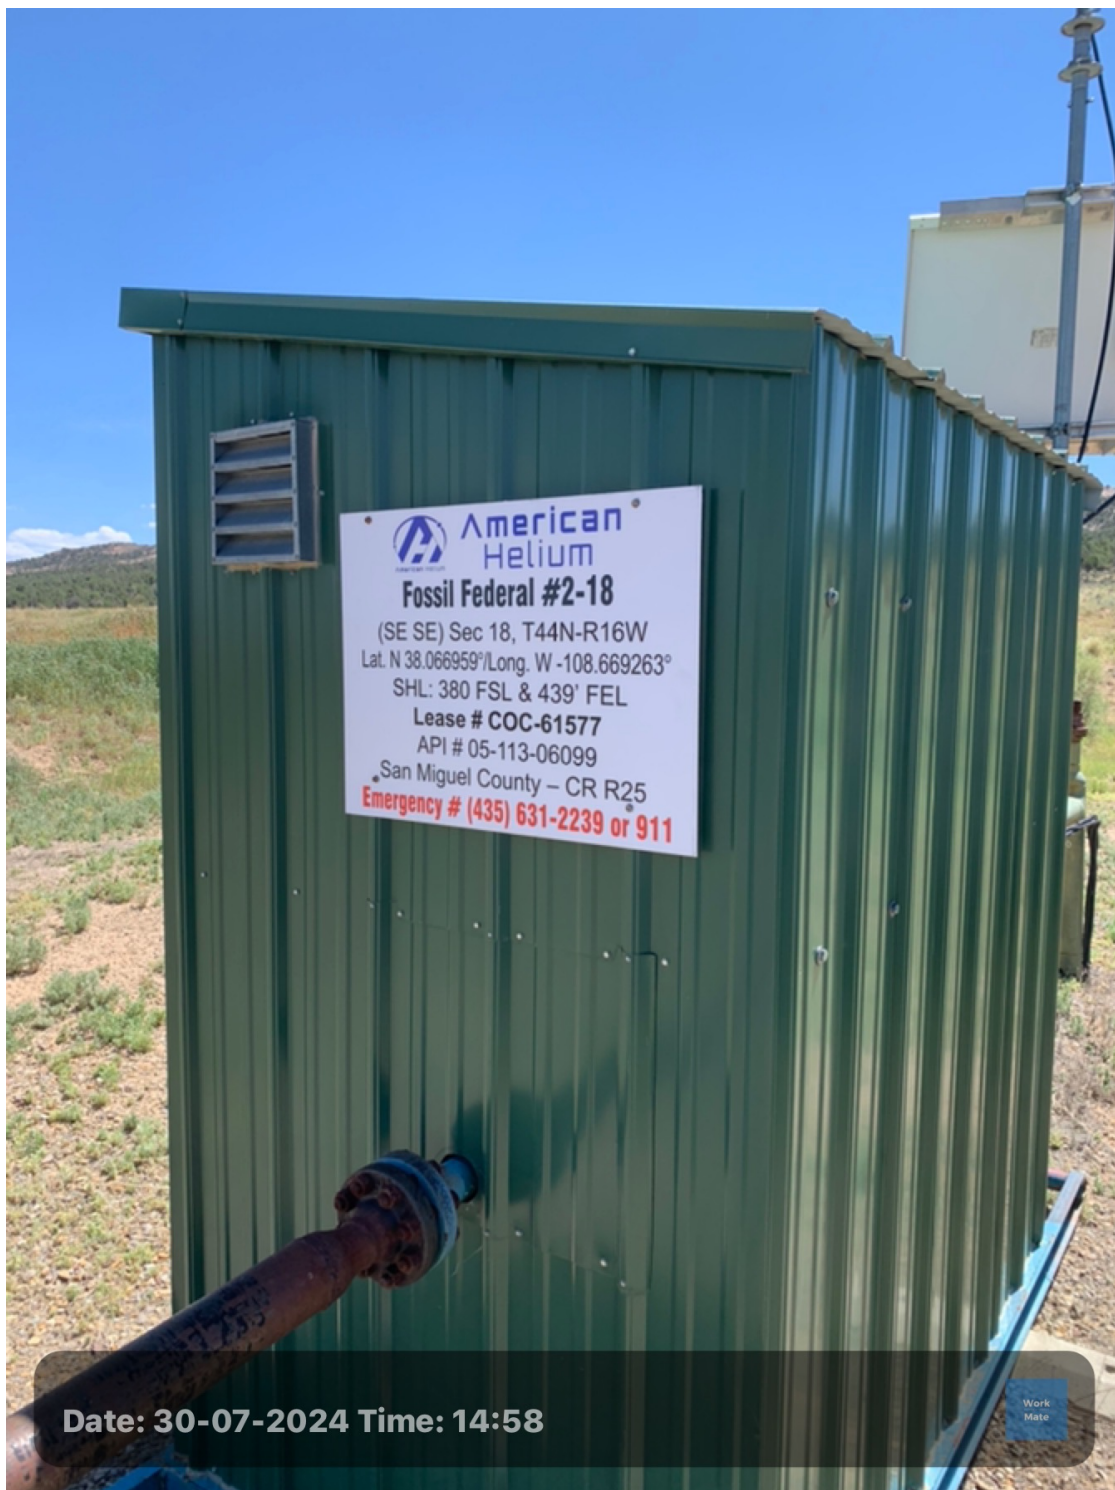
Signs/Marker:			
Type	WELLHEAD		
Comment:	Sign on meter housing		
Corrective Action:			Date:
Type	TANK LABELS/PLACARDS		
Comment:	Sign or label not posted or information inaccurate on tanks or containers or sign/label too small to read at distance or installed in place where not visible.		
Corrective Action:	Install sign to comply with Rule 605.h.		Date: 09/30/2024

Signage Replaced per order FF 2-18 on 7-30-24

Locations signage replaced FF 2-18 on 7-30-24. Please see attached photo.
