**FORM
INSP**Rev
X/20**State of Colorado
Oil and Gas Conservation Commission**1120 Lincoln Street, Suite 801, Denver, Colorado 80203
Phone: (303) 894-2100 Fax: (303) 894-2109

693807701**FIELD INSPECTION FORM**Loc ID 316820 Inspector Name: BROWNING, CHUCK On-Site Inspection ☐ 2A Doc Num: _____**Operator Information:**ECMC Operator Number: 10841Name of Operator: AMERICAN HELIUM OPERATING LLCAddress: 600 TRAVIS STREET SUITE 5050City: HOUSTON State: TX Zip: 77002**Status Summary:**☐ THIS IS A FOLLOW UP INSPECTION☒ FOLLOW UP INSPECTION REQUIRED☐ NO FOLLOW UP INSPECTION REQUIRED**Findings:**7 Number of Comments1 Number of Corrective Actions☒ Corrective Action Response Requested**ANY CORRECTIVE ACTION(S) FROM
PREVIOUS INSPECTIONS THAT HAVE NOT
BEEN ADDRESSED ARE STILL APPLICABLE****Contact Information:**

Facility ID	Type	Status	Status Date	Well Class	API Num	Facility Name	Insp Status
260335	WELL	SI	06/01/2024	GW	113-06087	ANDY'S MESA FEE 21	SI

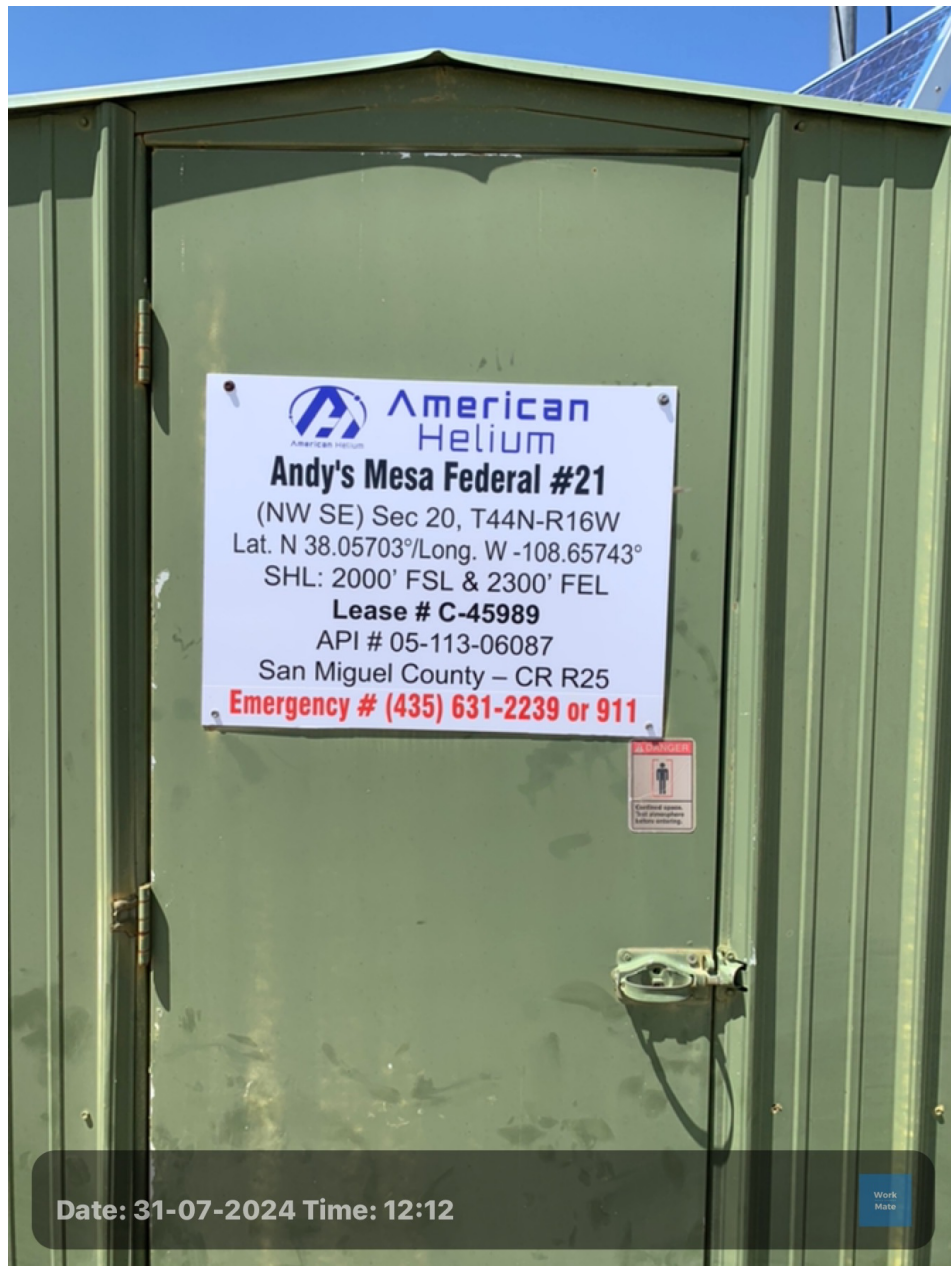
Type	WELLHEAD		
Comment:	Sign on meter housing		
Corrective Action:		Date:	
Type	TANK LABELS/PLACARDS		
Comment:	Sign or label not posted or information inaccurate on tanks or containers or sign/label too small to read at distance or installed in place where not visible.		
Corrective Action:	Install sign to comply with Rule 605.h.	Date:	09/30/2024

Signage corrected 7-31-24

Correct signage installed per order 7-30-24. Please see photo's.
