**Beeman Oil & Gas Inc.**  
**Stoddard 33-30**  
**Location ID: 423933**

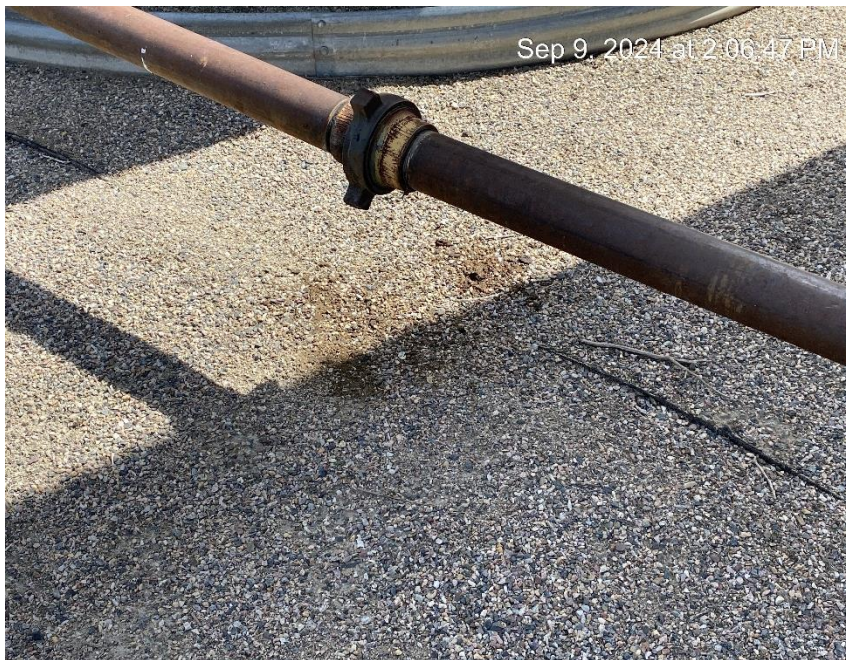
**Partially covered staining**

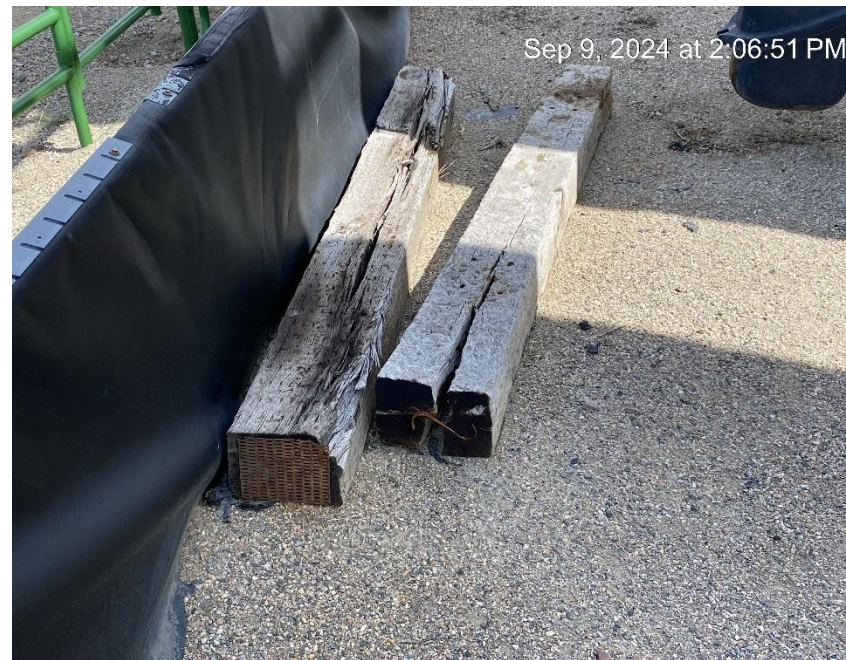
**Debris**

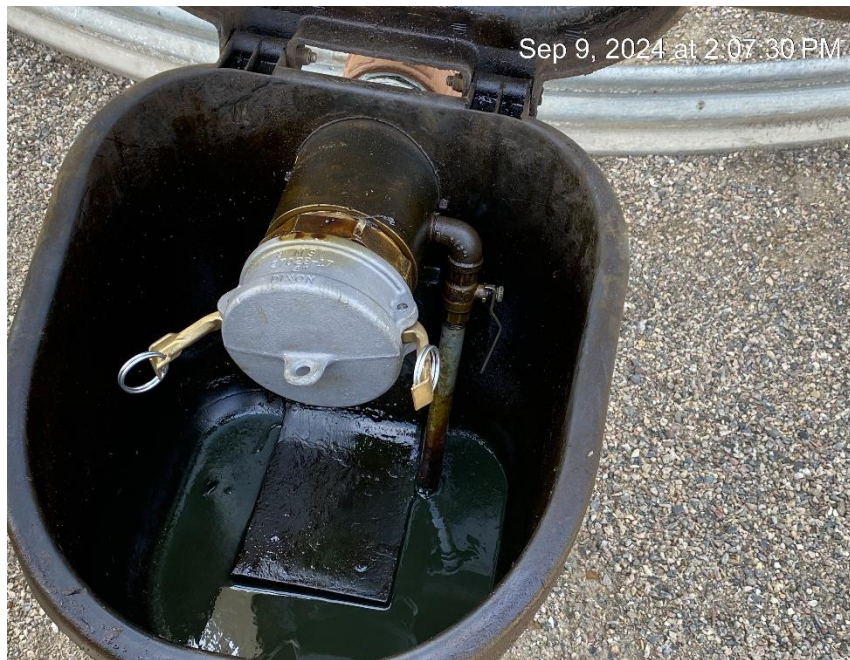
Side valve open. Load line was double-valved.

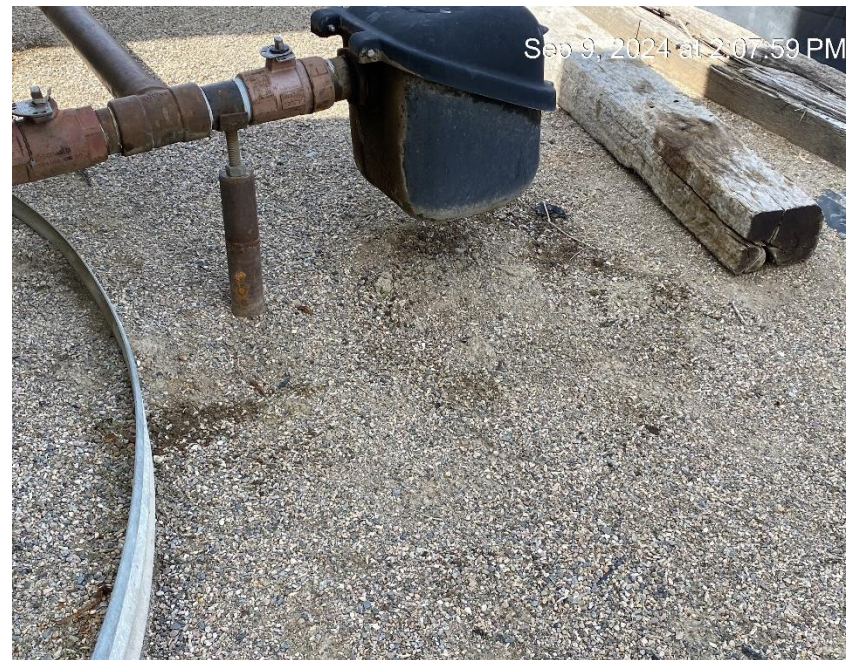
Partially covered spill

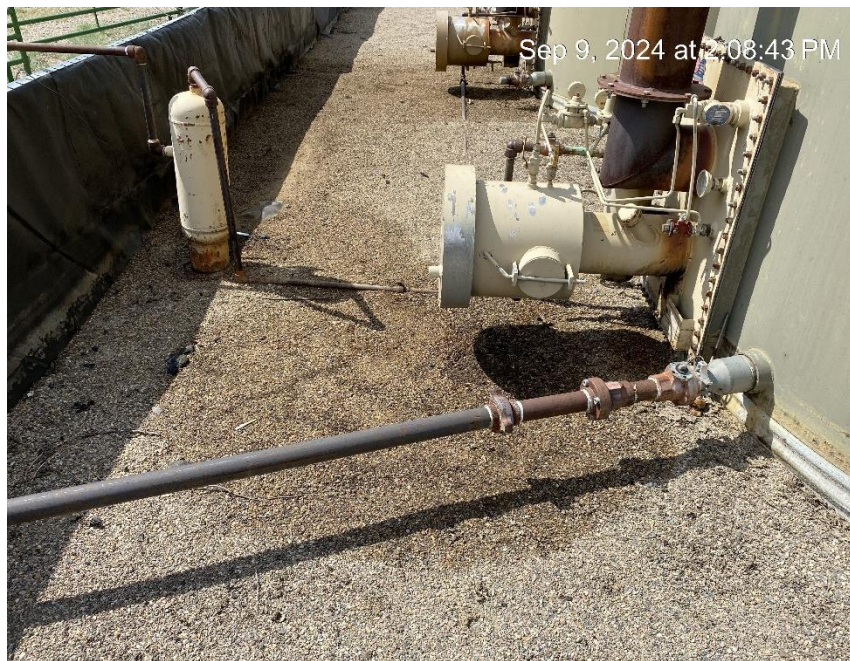
**Spill staining**

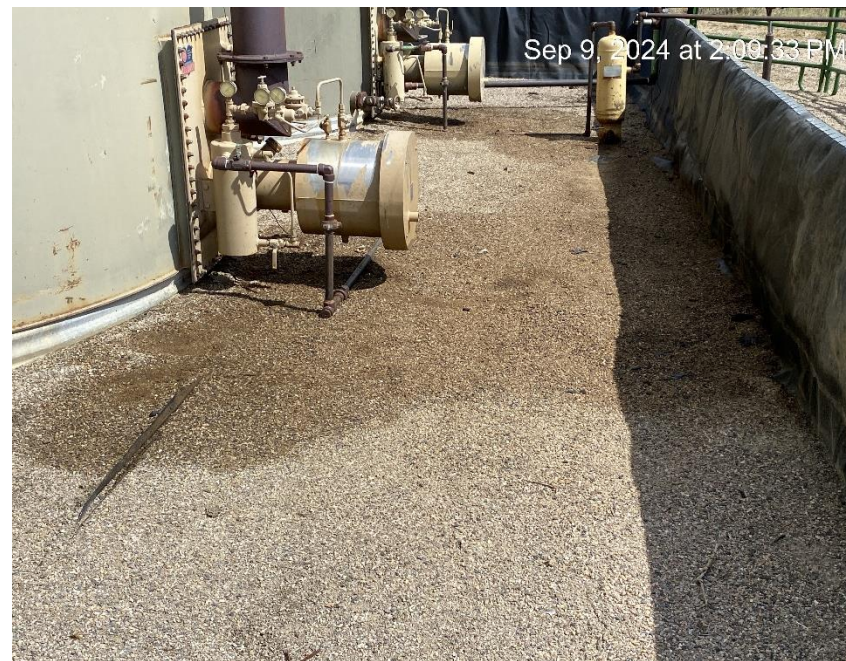
**Spill staining**

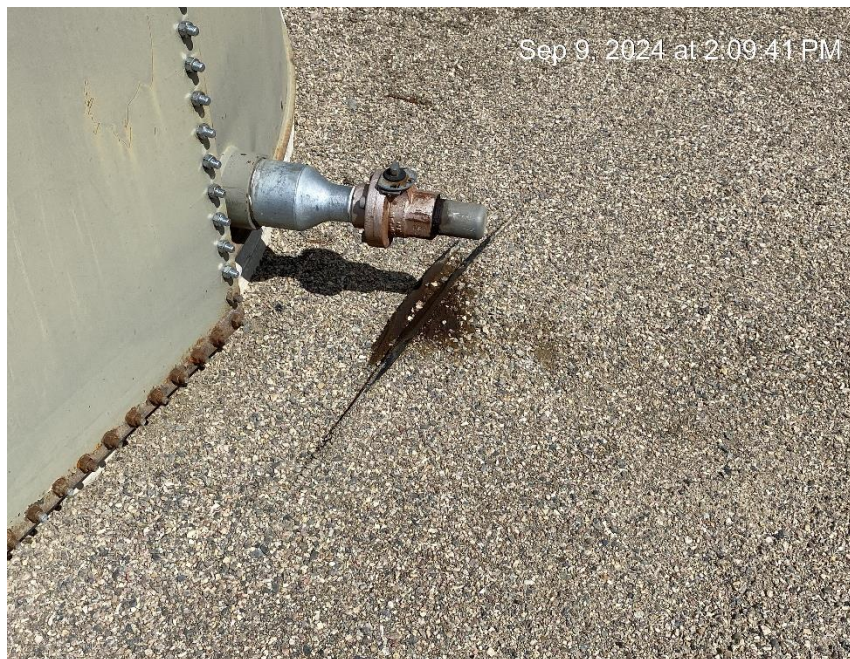
**Staining**

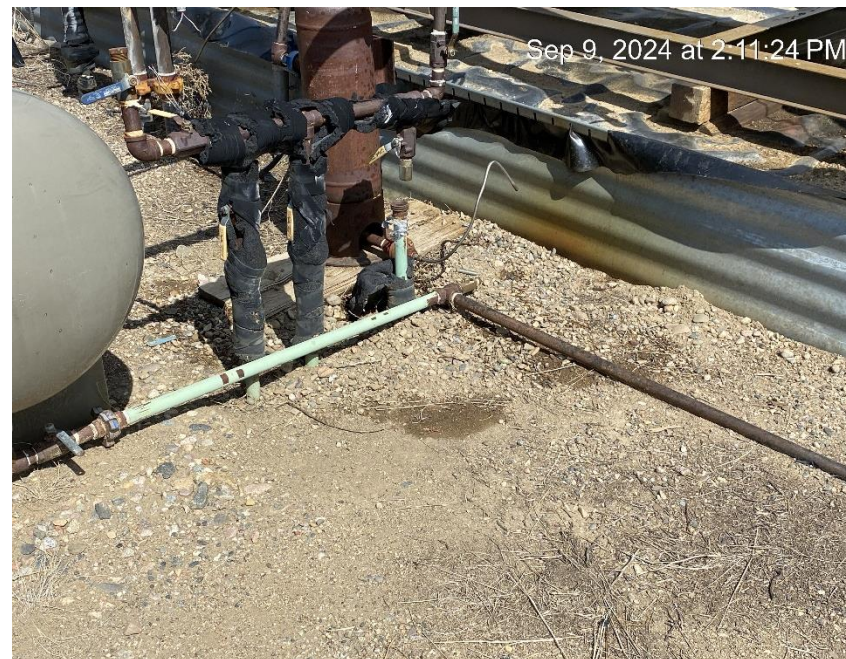
**Partially covered stain.**

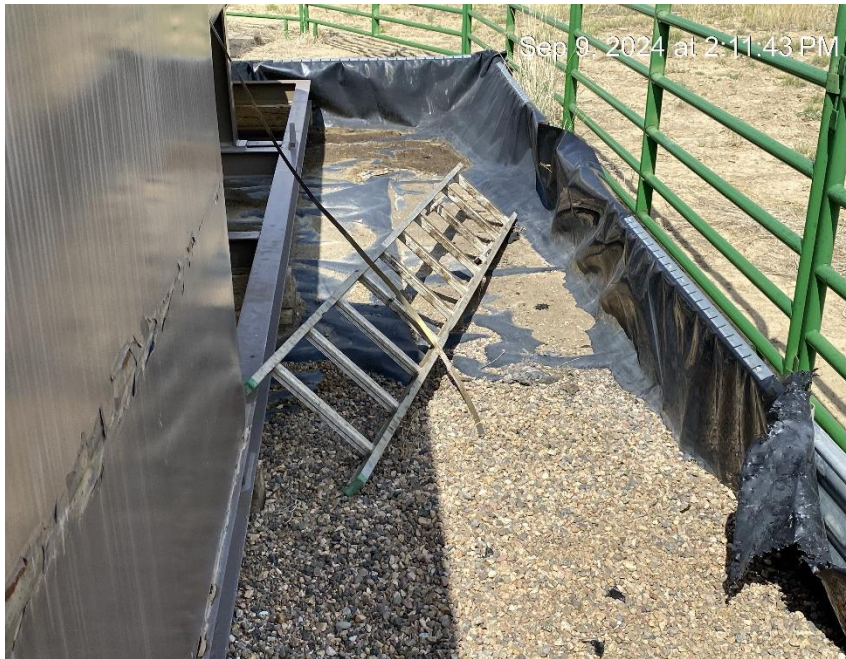
**Debris**

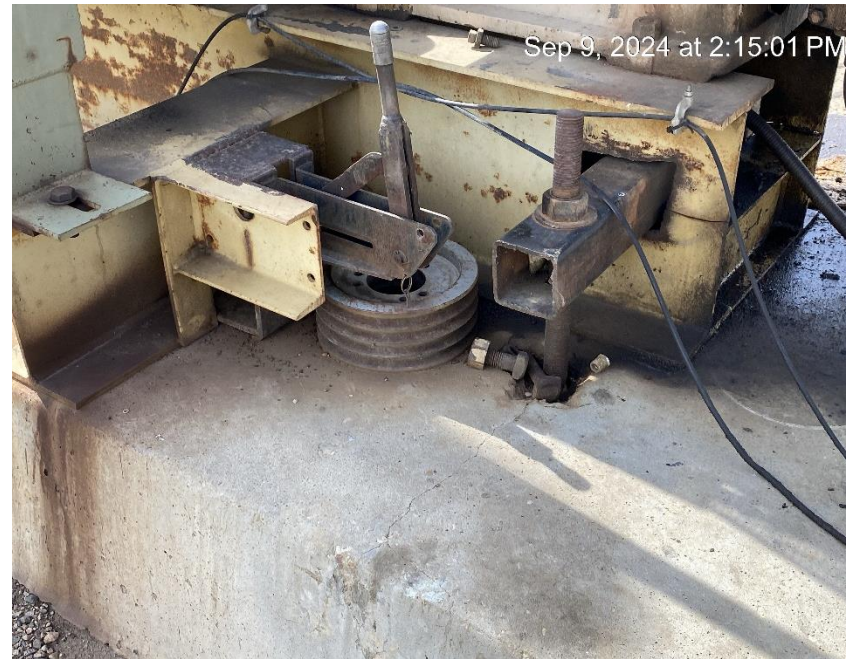
**Debris. Oily waste.**

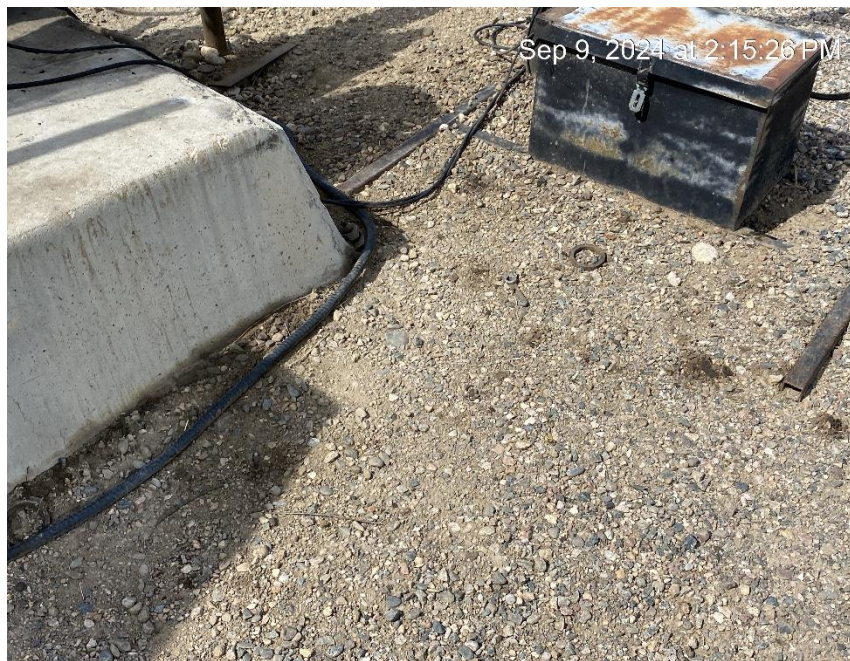
**Debris. Oily waste.**

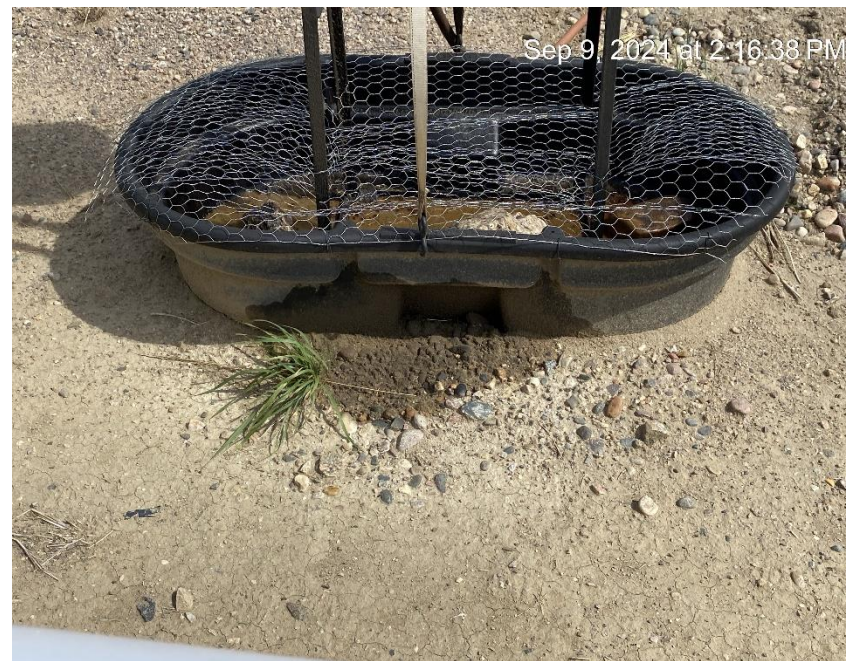
**Containment leak**

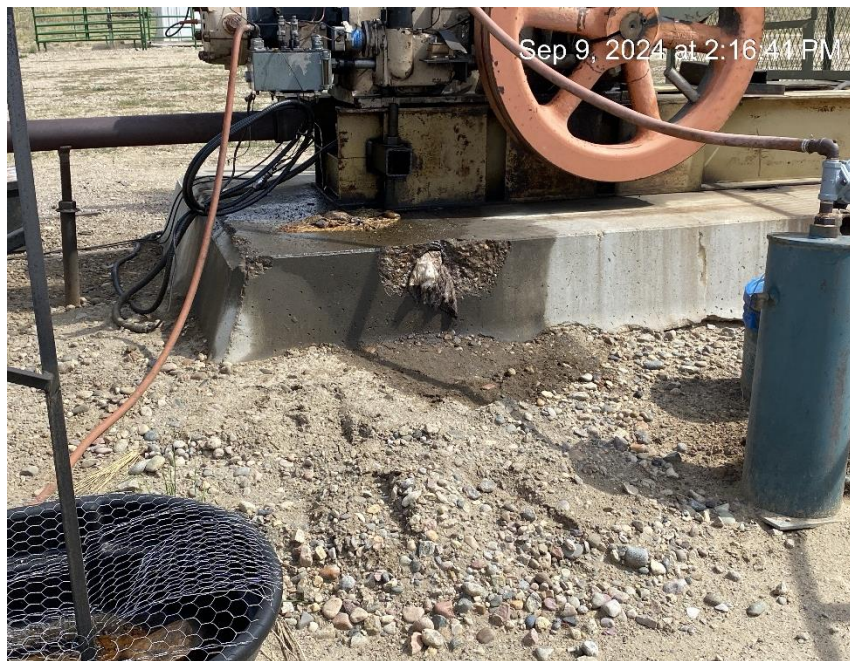
**Equipment leak. Oily waste and stained soil**

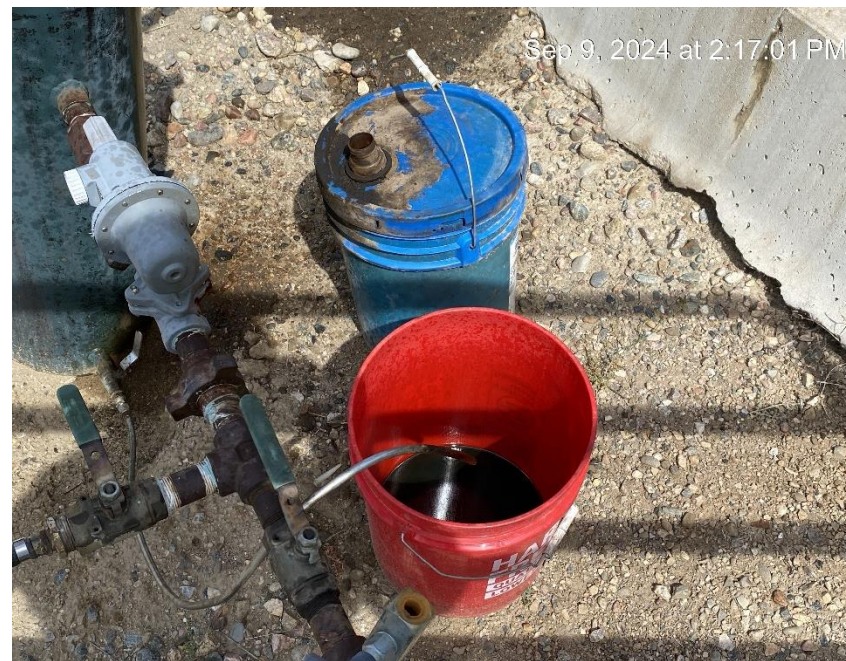
**Open to wildlife**

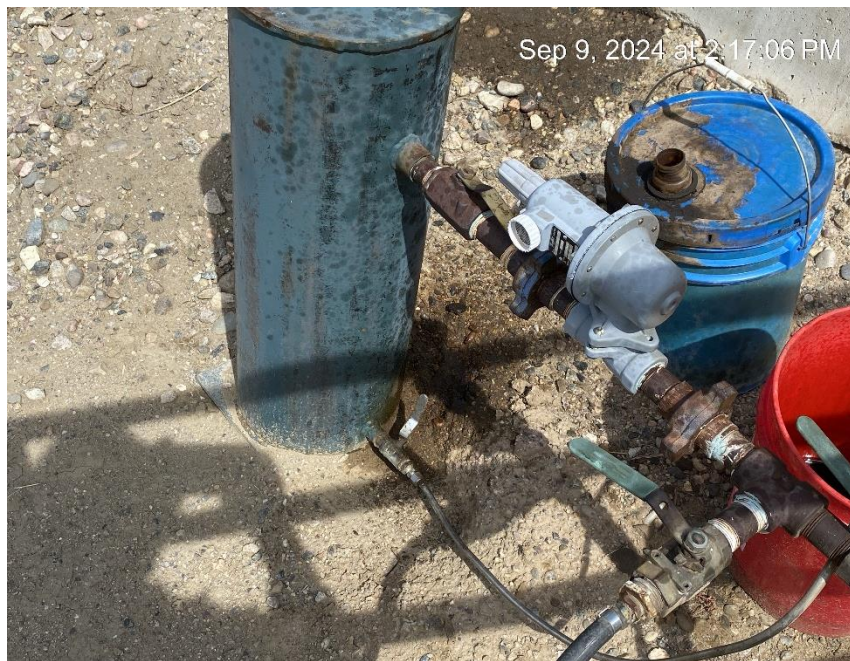
**Stained soil**

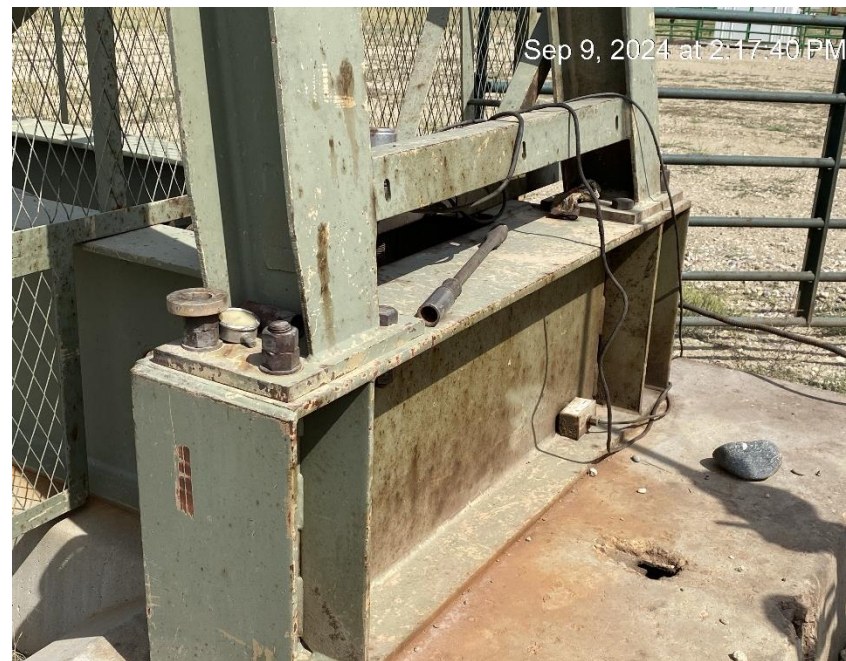
**Debris**

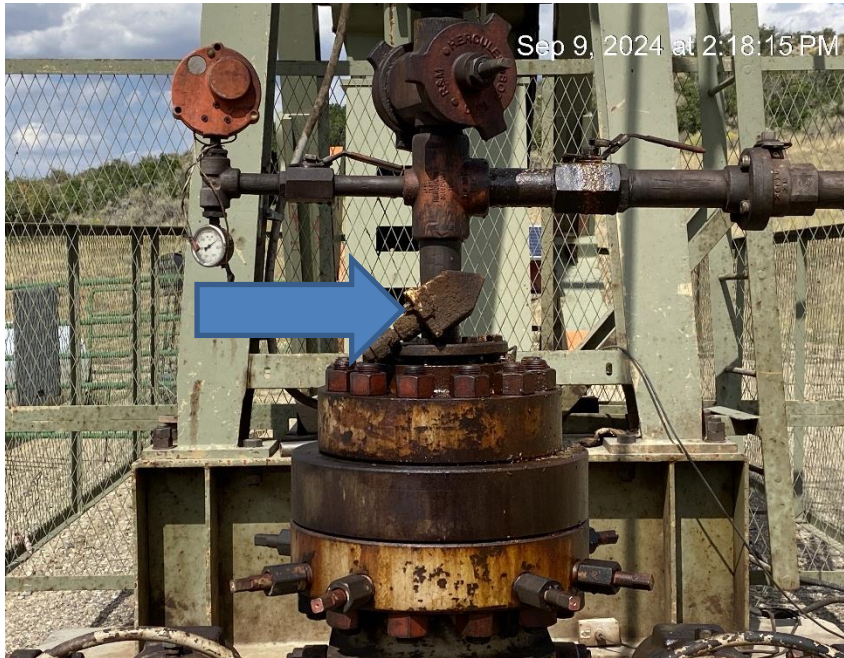
Dedris

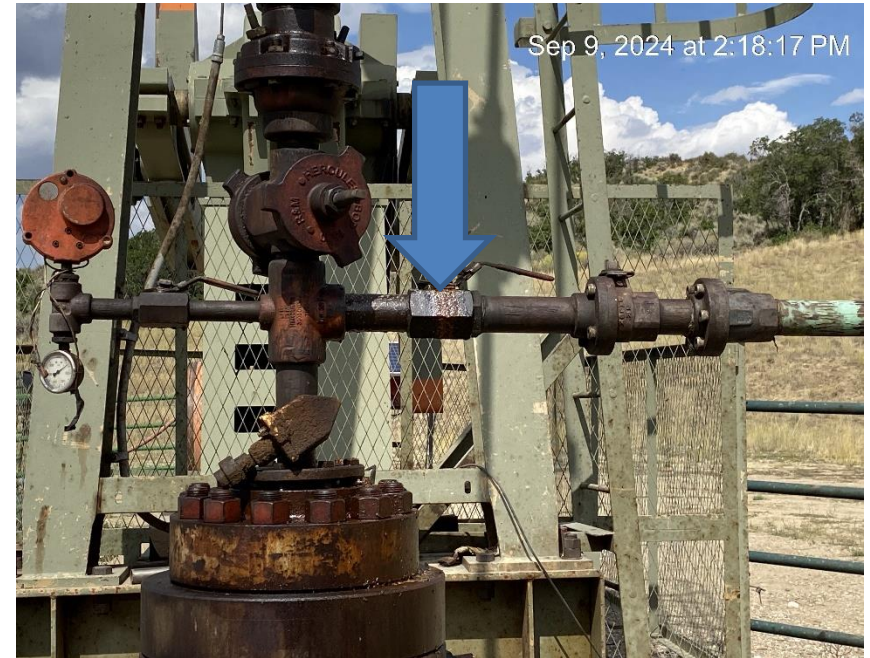
Valve leak
