Inspection Photos

Location Name: CAERUS PICEANCE LLC MCU 32-7 (G32E) Pad

Location #: 334140

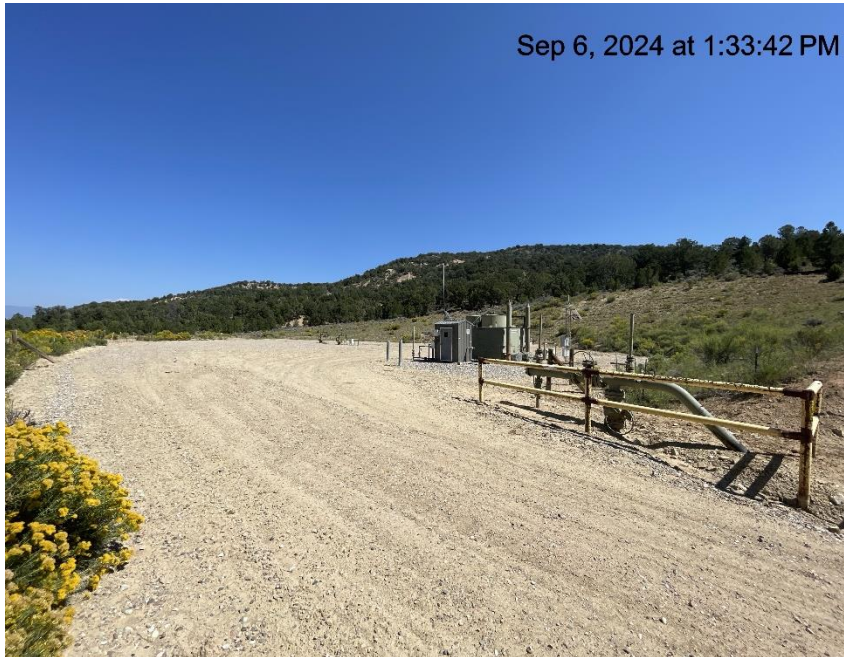
Photo # 9006 From Entrance to location

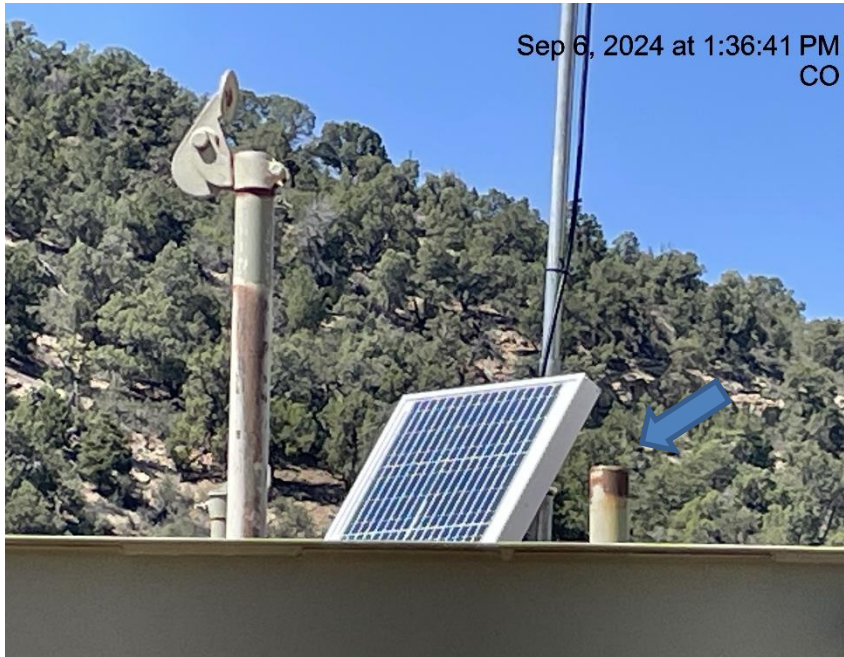
Photo # 9012 Rupture disc vent line does not comply with CECMC pressure safety device rules

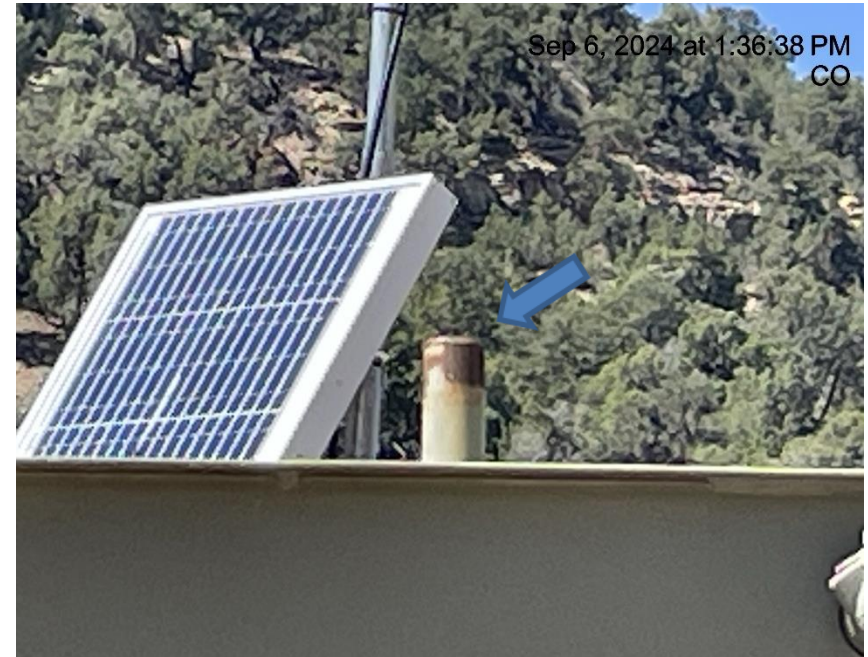
Photo # 9013 Rupture disc vent line does not comply with CECMC pressure safety device rules

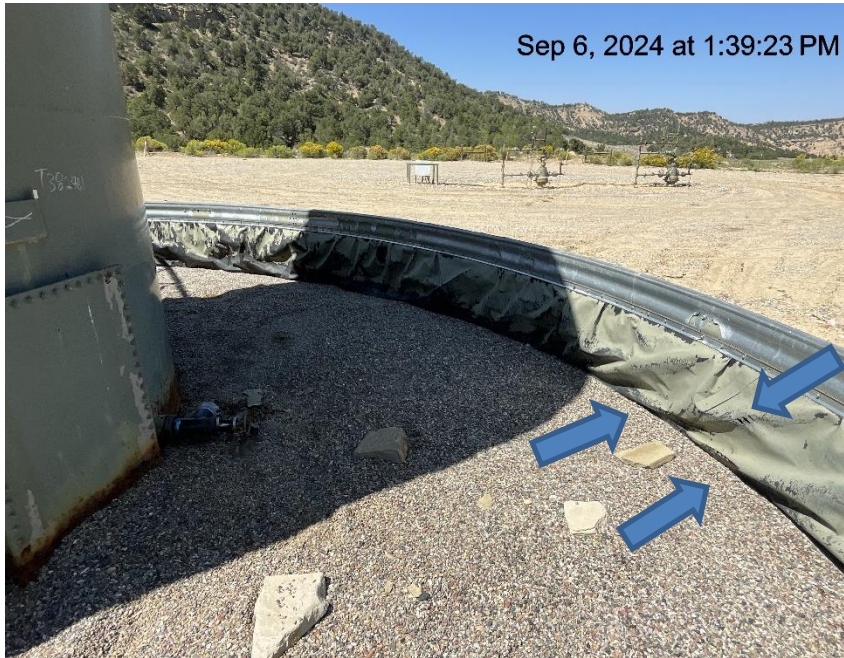
Photo # 9014 Multiple holes in liner/liner needs maintenance

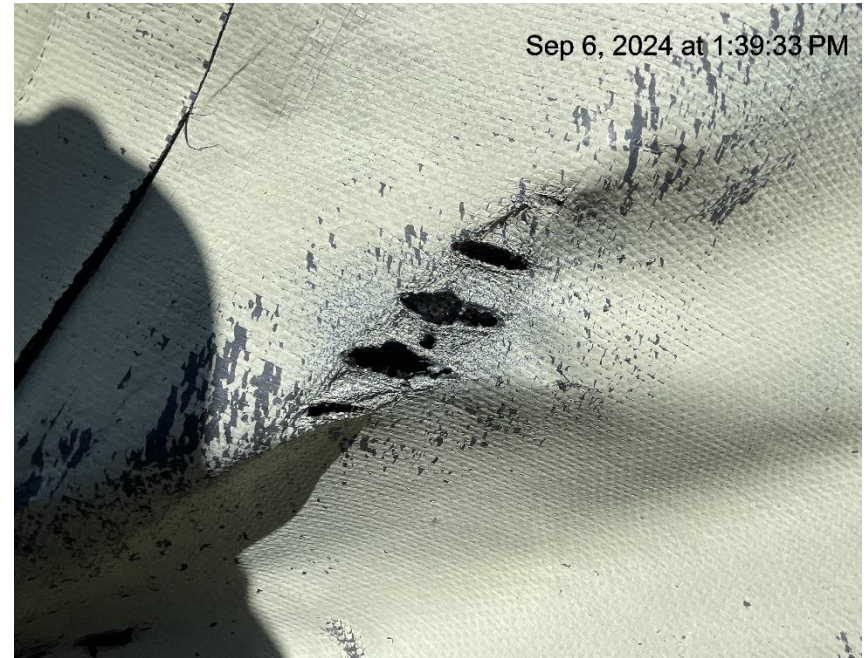
Photo # 9015 Multiple holes in liner/liner needs maintenance

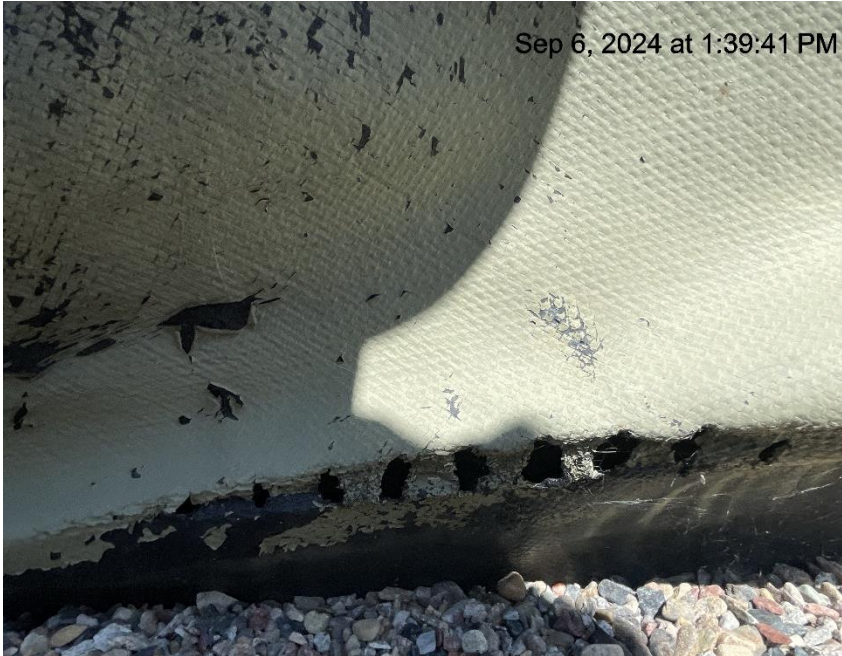
Photo # 9016 Multiple holes in liner/liner needs maintenance

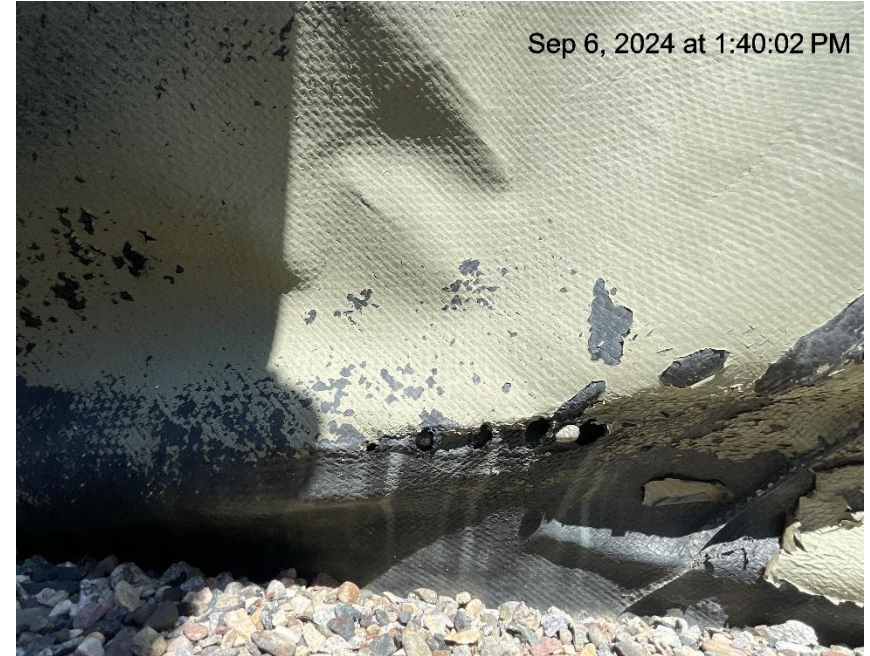
Photo # 9017 Multiple holes in liner/liner needs maintenance

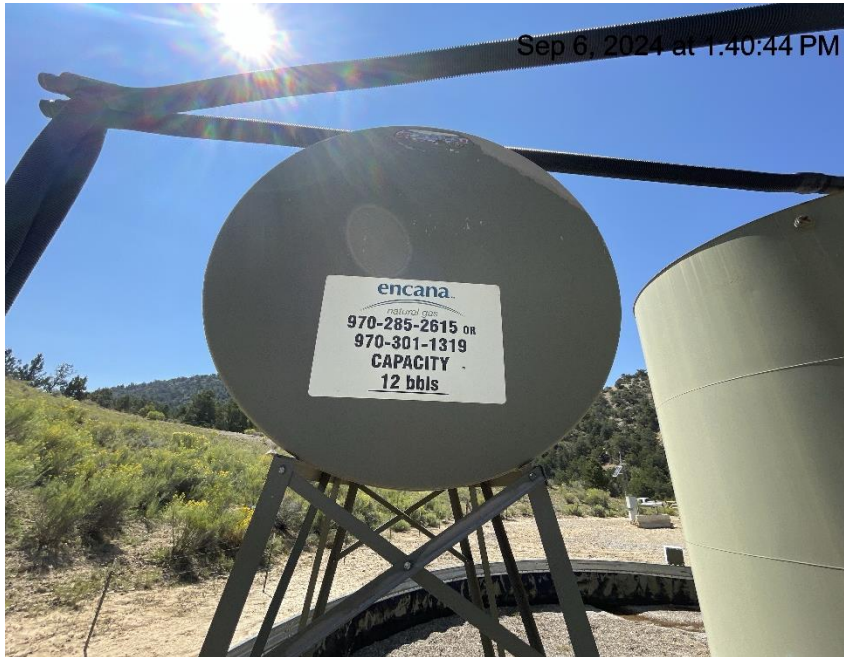
Photo # 9018 Label on methanol tank contains incorrect information/does not comply with CECMC rules

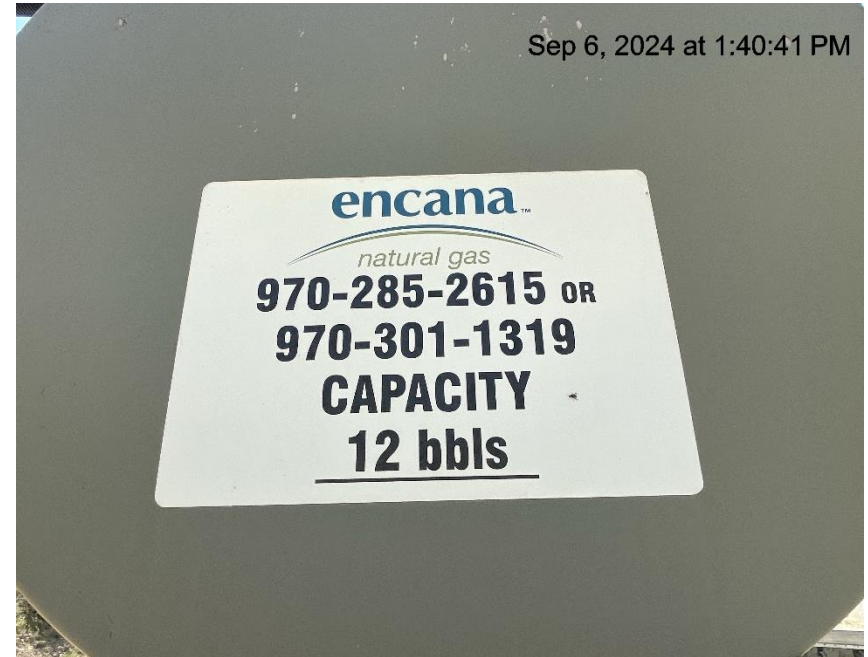
Photo # 9019 Label on methanol tank contains incorrect information/does not comply with CECMC rules
