FIELD INSPECTION FORM

Loc ID 316802 Inspector Name: BROWNING, CHUCK On-Site Inspection 2A Doc Num: _____

ECMC Operator Number: 10841
Name of Operator: AMERICAN HELIUM OPERATING LLC
Address: 600 TRAVIS STREET SUITE 5050
City: HOUSTON State: TX Zip: 77002

Facility ID	Type	Status	Status Date	Well Class	API Num	Facility Name	Insp Status
232814	WELL	SI	03/01/2024	GW	113-06003	ANDY'S MESA-FEDERAL 4	SI

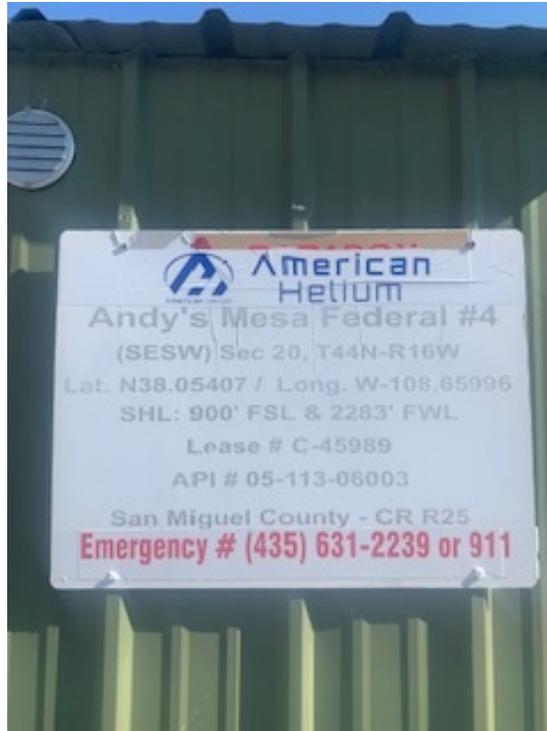
Signs/Marker:			
Type	TANK LABELS/PLACARDS		
Comment:	Sign or label not posted or information inaccurate on tanks or containers or sign/label too small to read at distance or installed in place where not visible.		
Corrective Action:	Install sign to comply with Rule 605.h.		Date: 09/30/2024
Type	WELLHEAD		
Comment:	Sign on meter housing		
Corrective Action:			Date:

FF 4 locatin ID signage at meter house. Signage showing signs of fade. New sign on order 9-9-24.
