**Antler Energy LLC
Pole Gulch 6
Location ID: 312865**

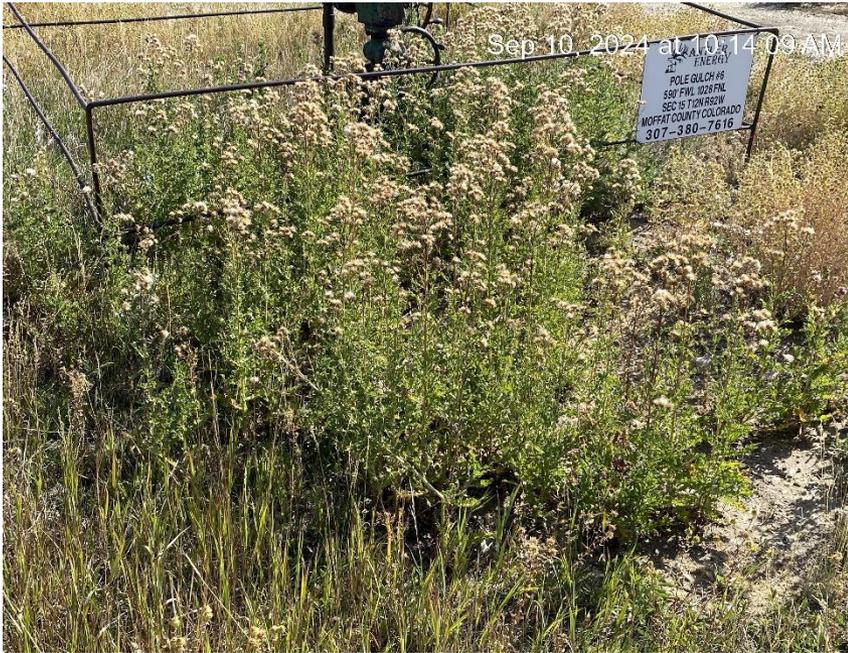
Noxious weed growth

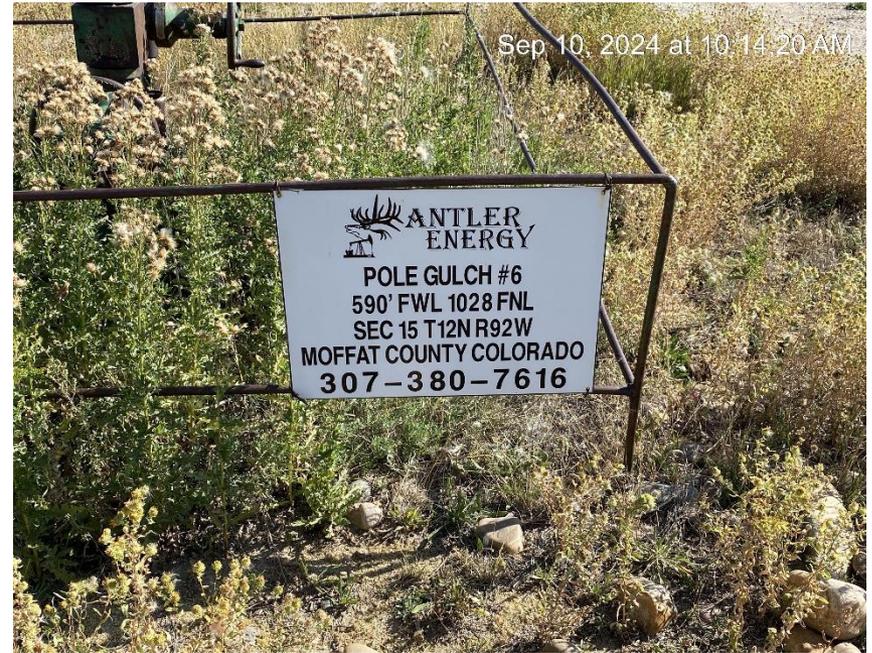
Well sign missing required information

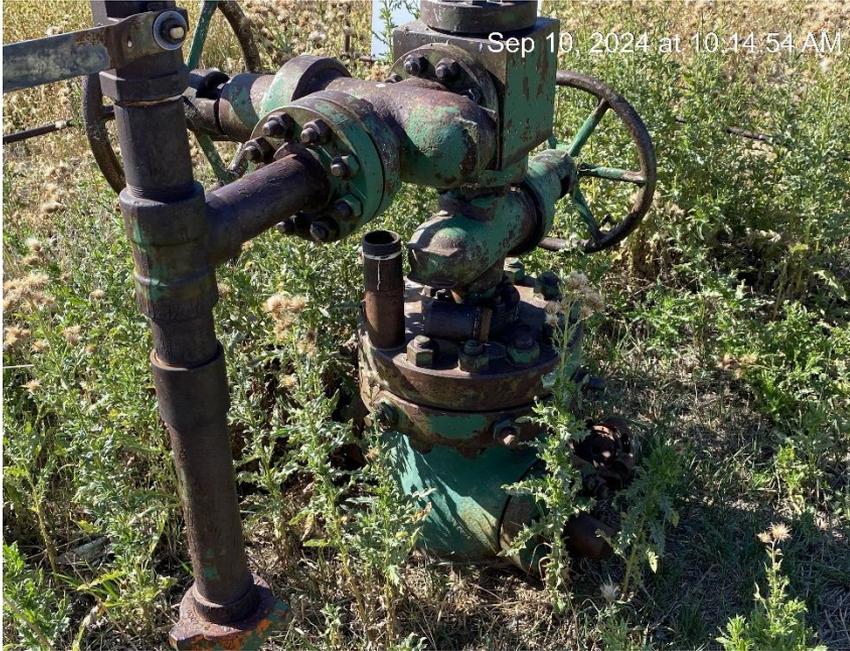
Debris

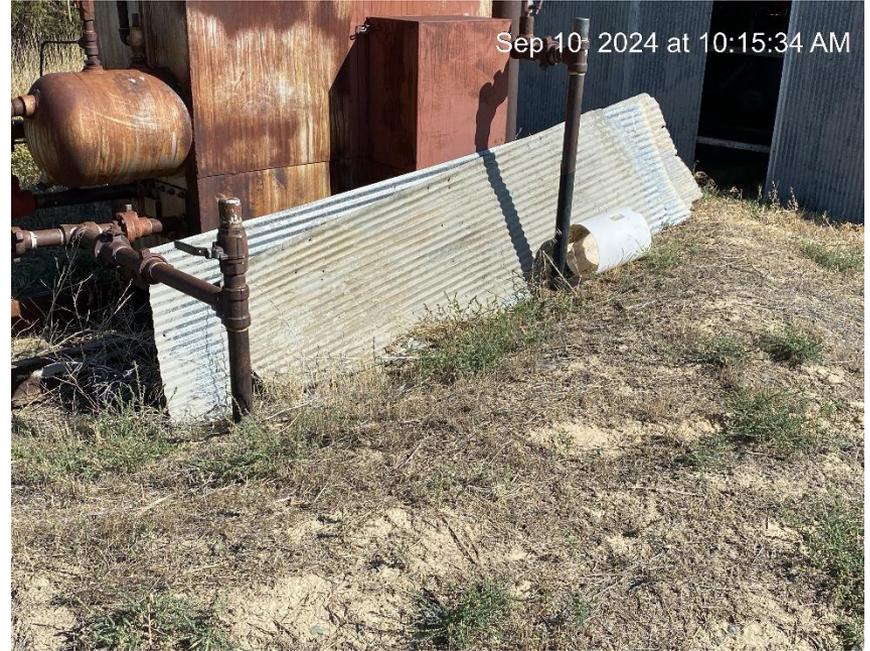
Debris

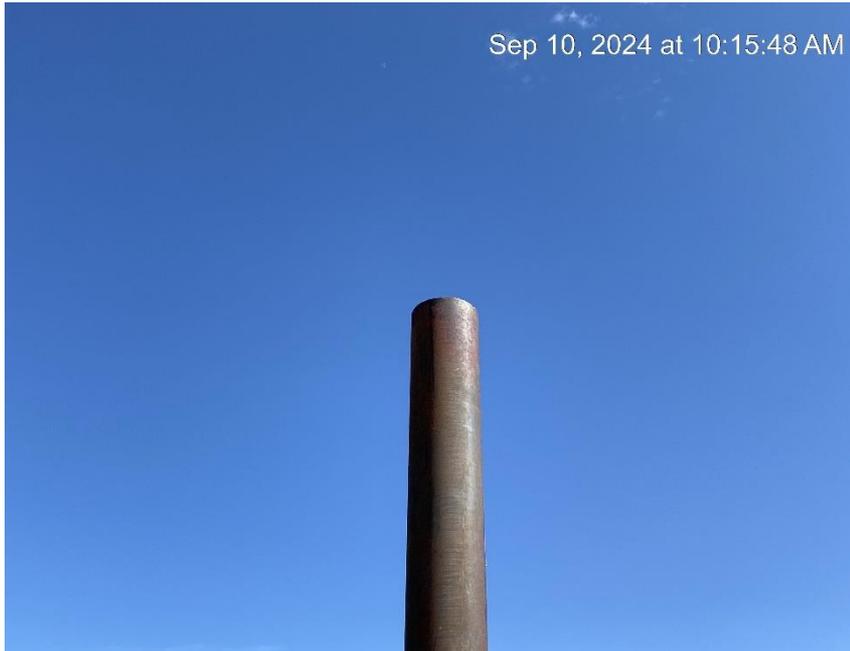
Stack missing bird protection

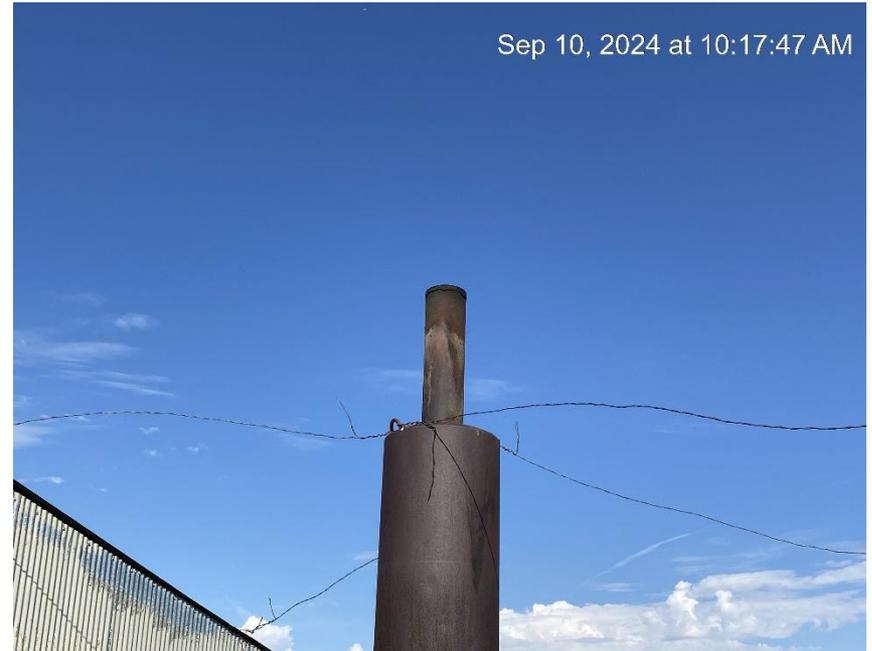
Stack missing bird protection

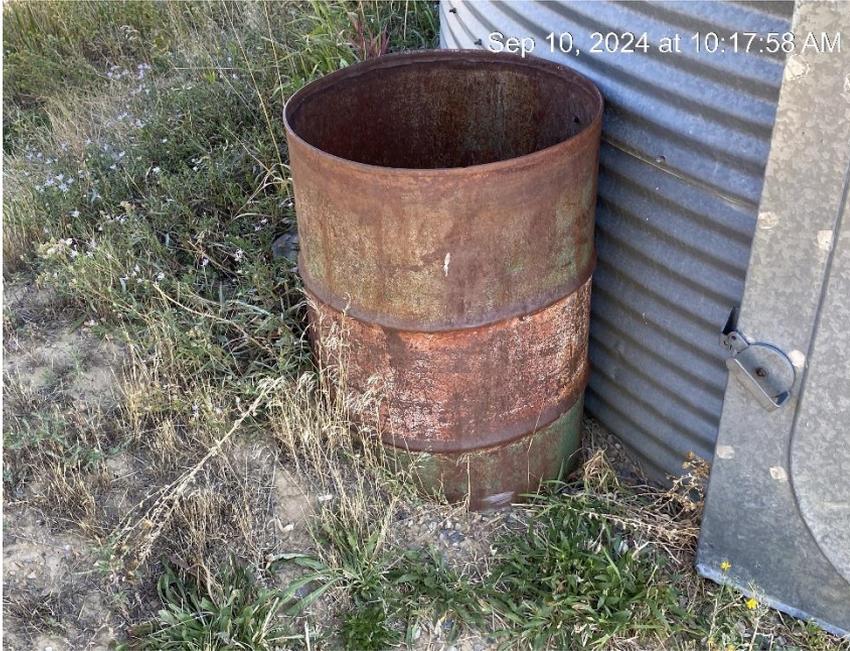
Debris

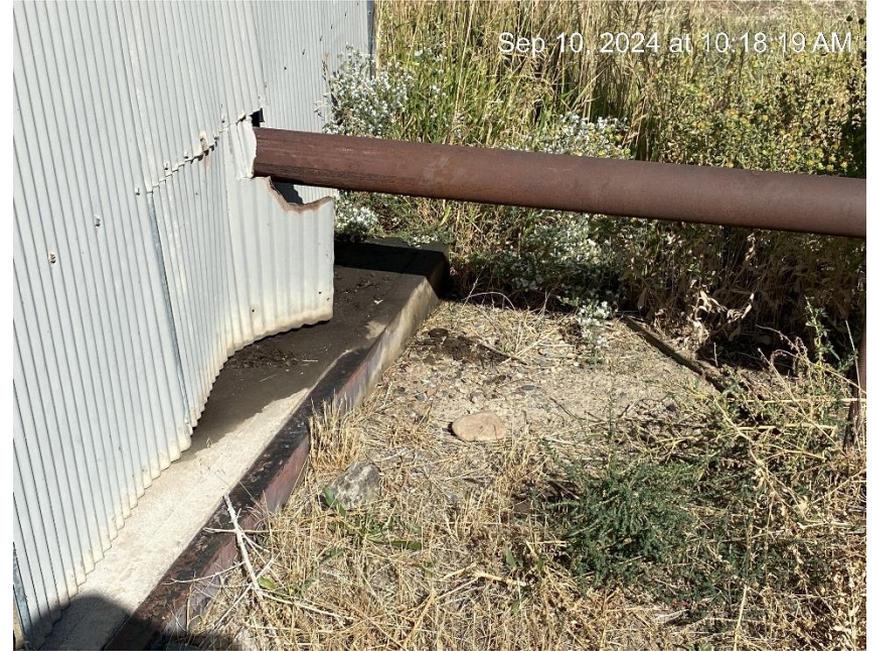
Oily waste and staining

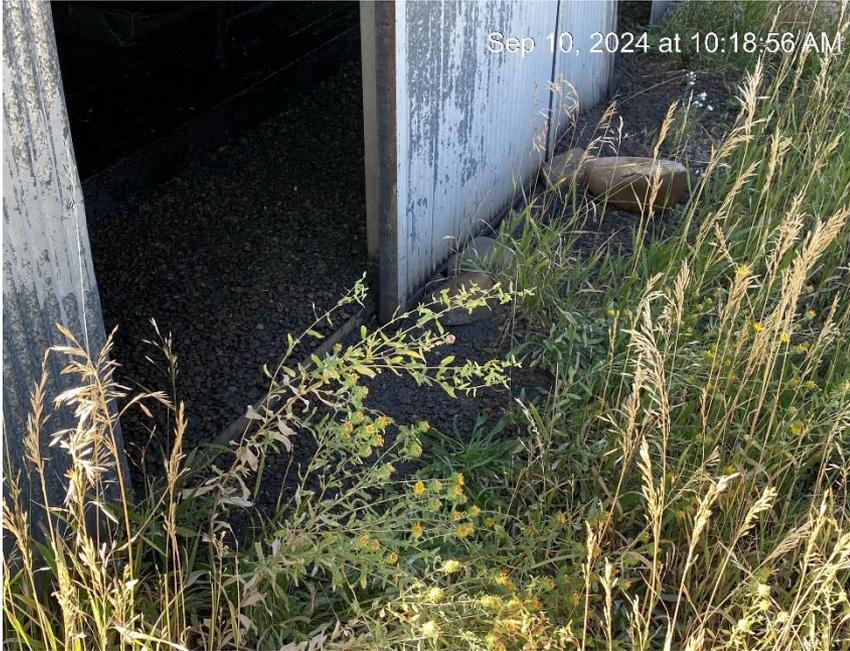
Oily waste and staining

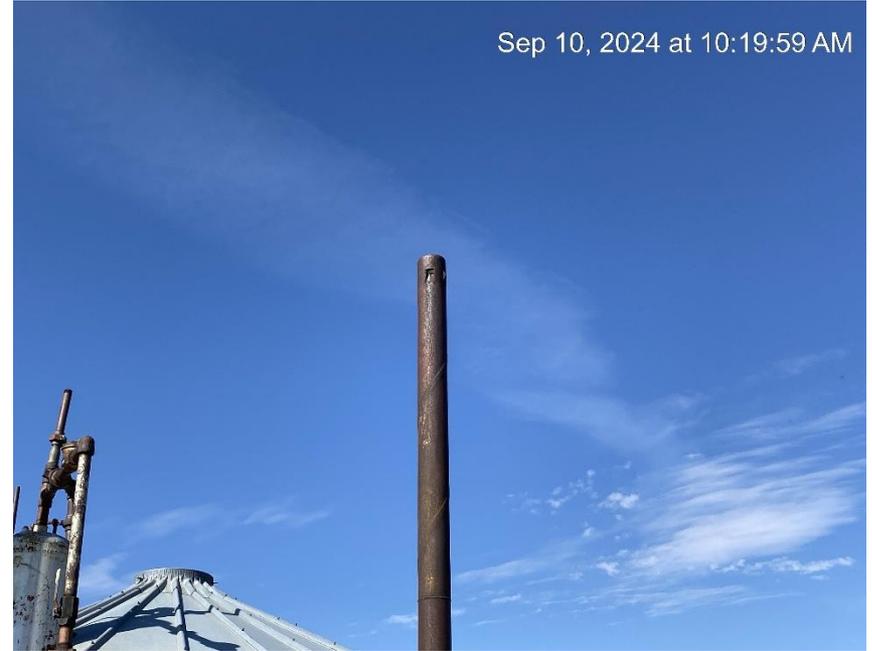
Stack missing bird protection

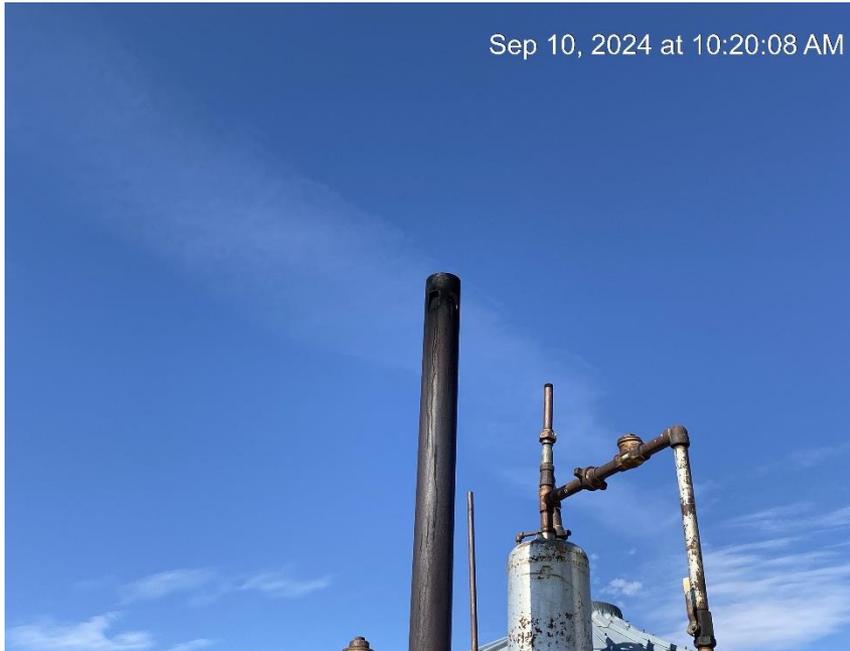
Stack missing bird protection

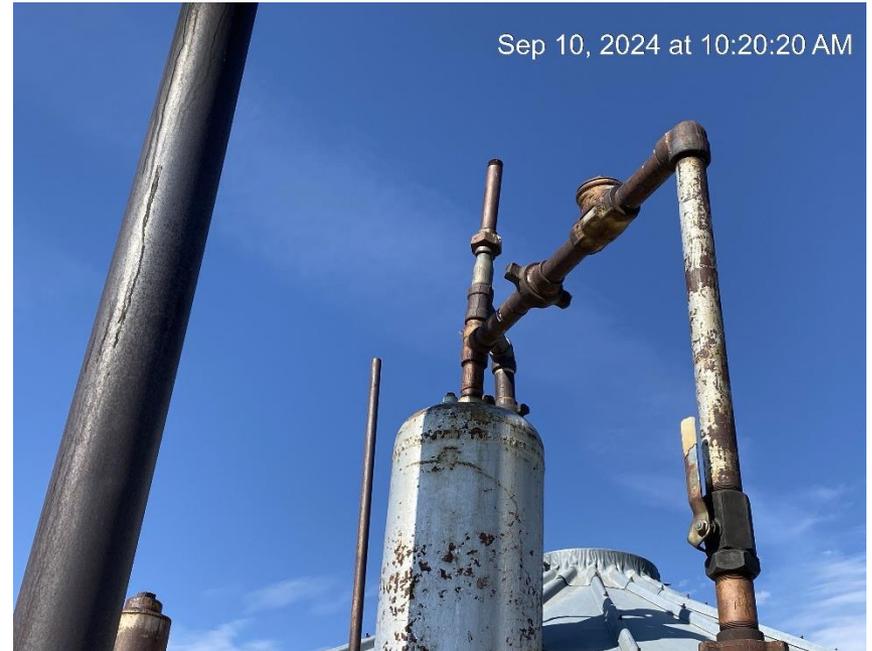
Relief risers missing protective caps

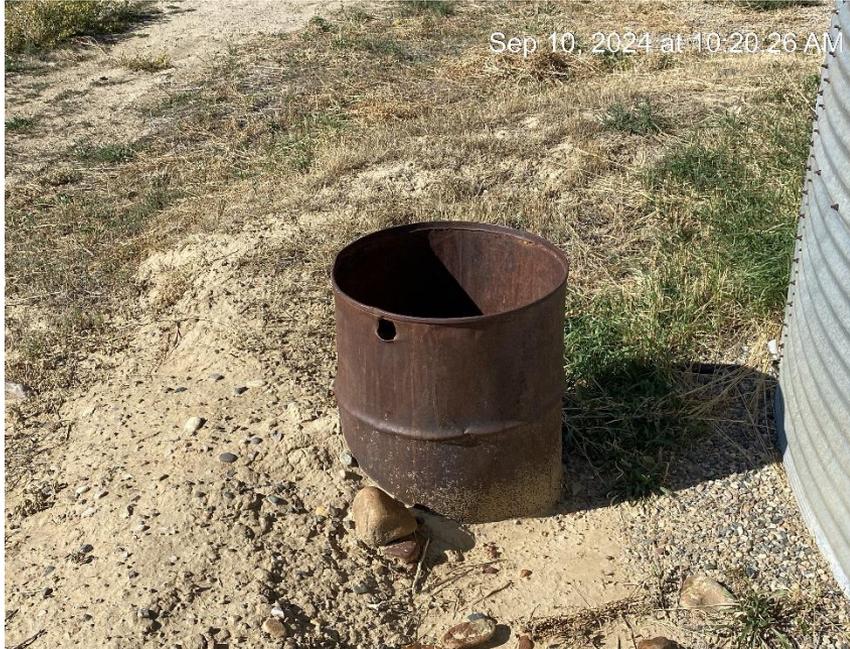
Debris

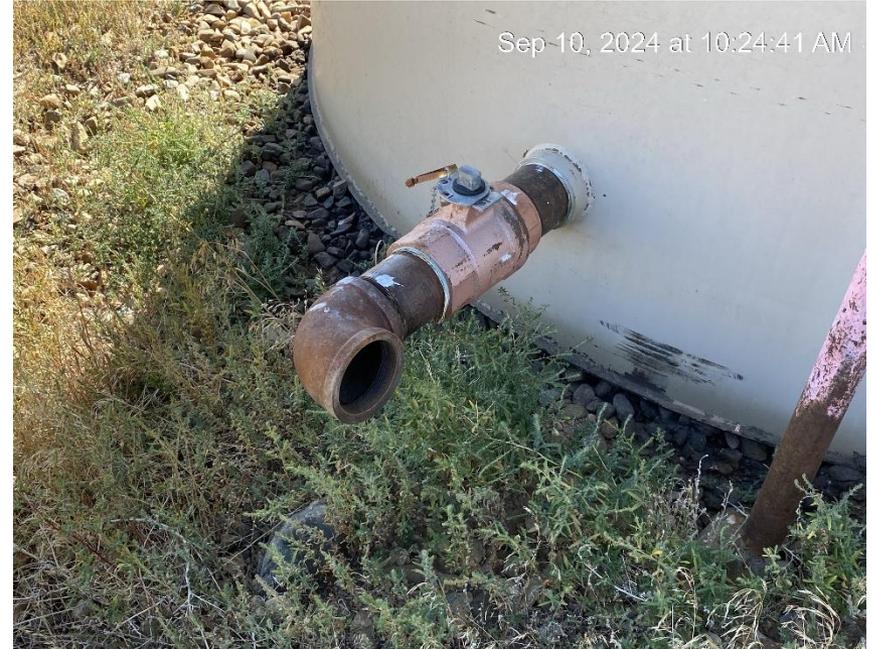
Open ended loadline

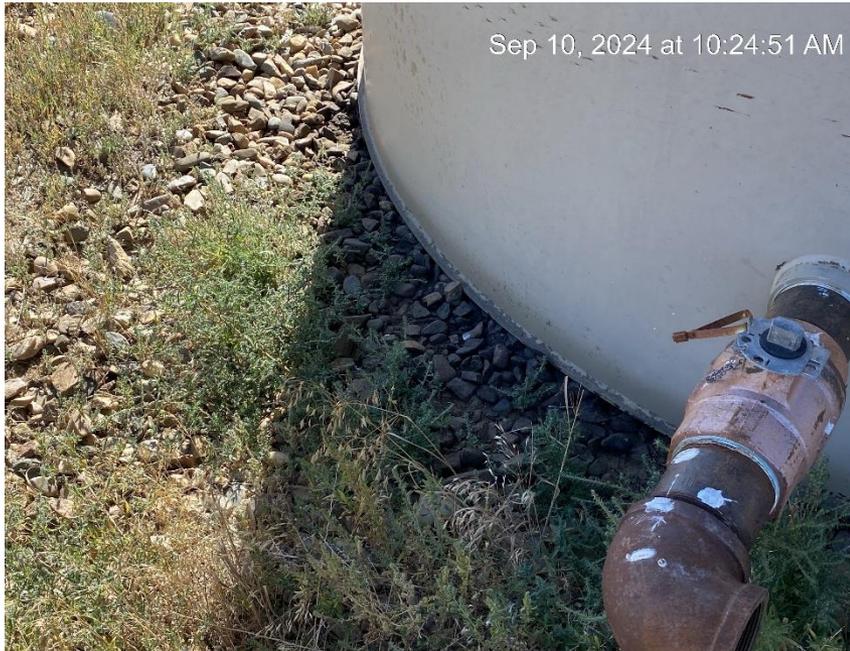
Soil staining

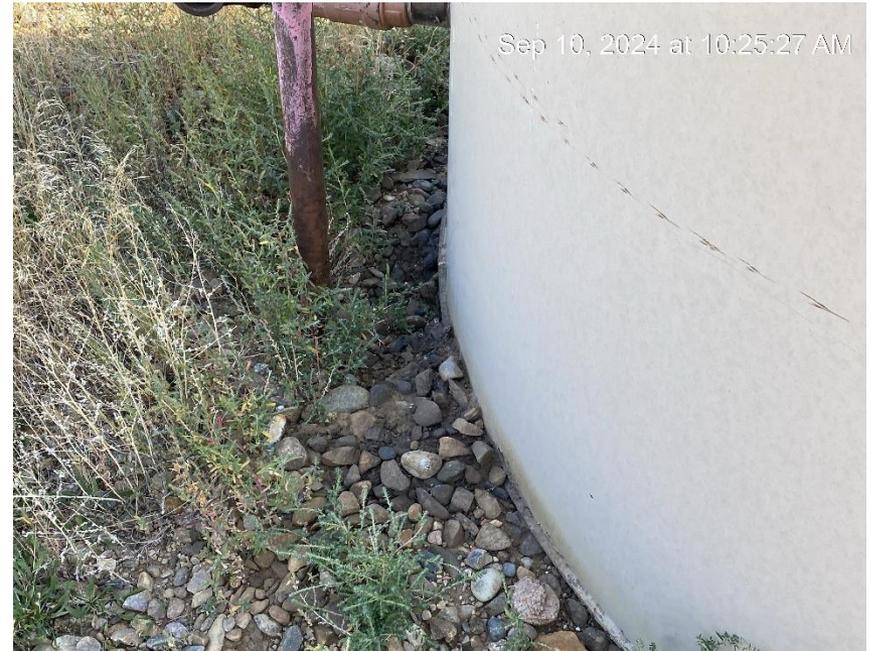
Soil staining

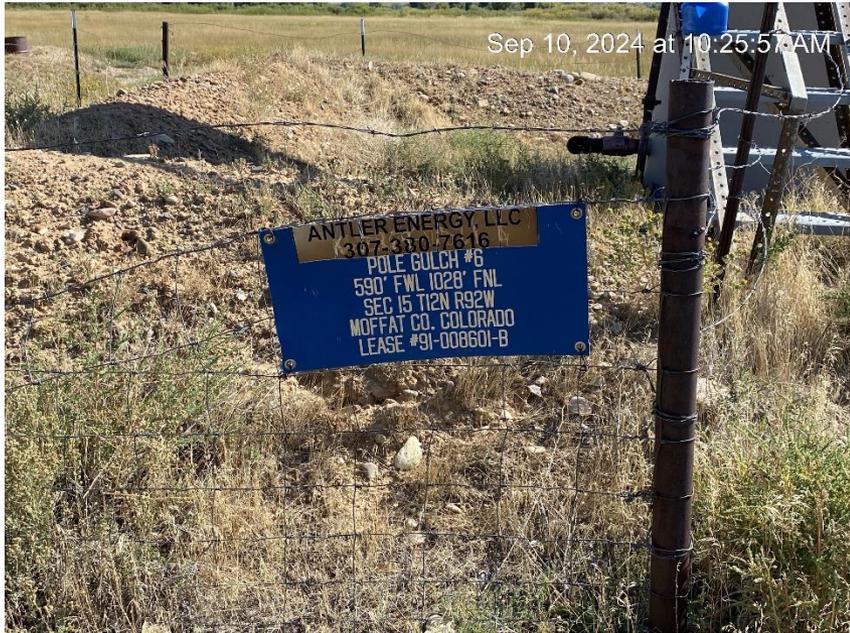
Tank battery sign missing required information
