**FORM
INSP**Rev
X/20**State of Colorado
Oil and Gas Conservation Commission**1120 Lincoln Street, Suite 801, Denver, Colorado 80203
Phone: (303) 894-2100 Fax: (303) 894-2109

FIELD INSPECTION FORMLoc ID 333206 Inspector Name: BROWNING, CHUCK On-Site Inspection ☐ 2A Doc Num: _____**Operator Information:**

Name of Operator: AMERICAN HELIUM OPERATING LLC

Facility ID	Type	Status	Status Date	Well Class	API Num	Facility Name	Insp Status
256996	WELL	PR	03/01/2024	GW	113-06073	FOSSIL FEDERAL 2-19	PR
260195	WELL	SI	02/01/2024	GW	113-06083	FOSSIL FEDERAL 1-19	SI
266030	WELL	SI	10/01/2021	GW	113-06118	FOSSIL FEDERAL 4-19	SI

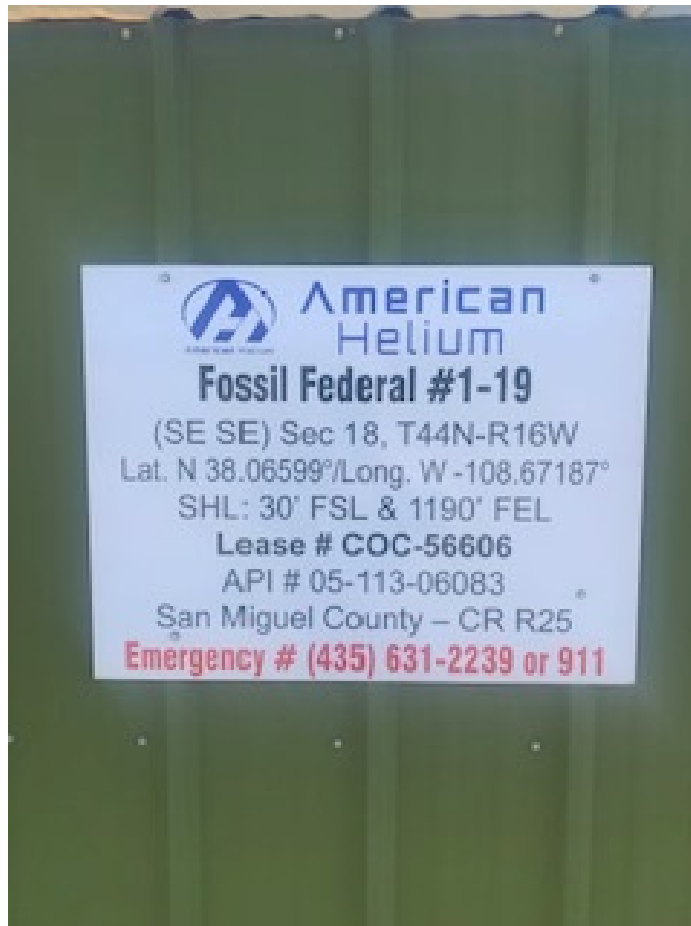
FF 1-19 location ID sign at meter.

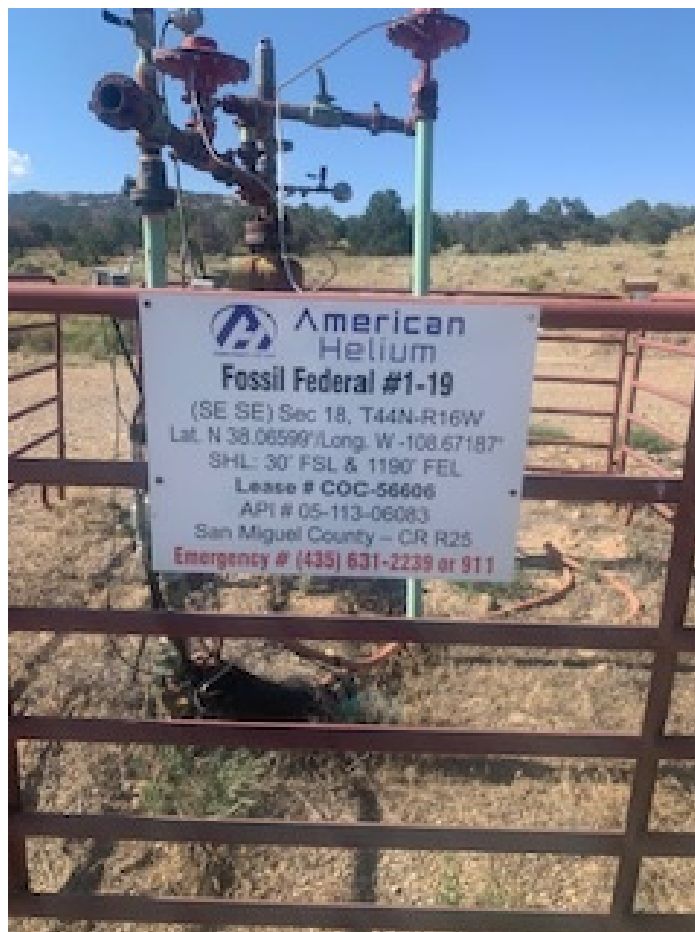
FF 1-19- location ID sign at well.

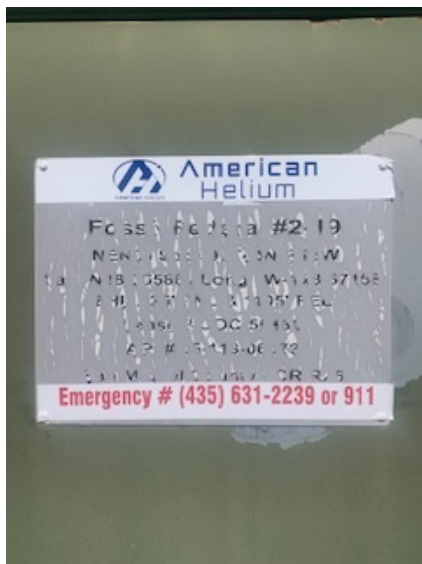
FF 2-19 location ID signage on meter house on order for replace 9-9-24

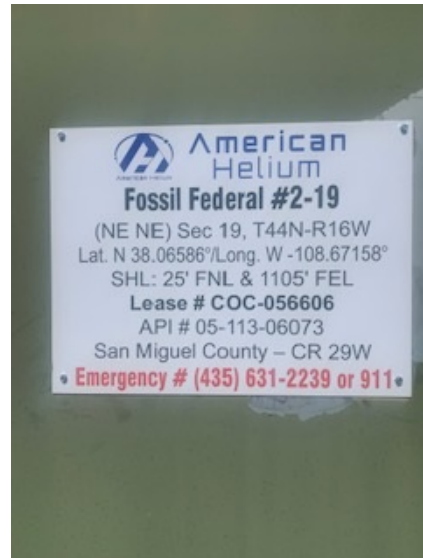
Sign replaced on meter FF 2-19. 9-10-24

FF 2-19 meter house ID sign replaced. 9-10-24. Please see photo.

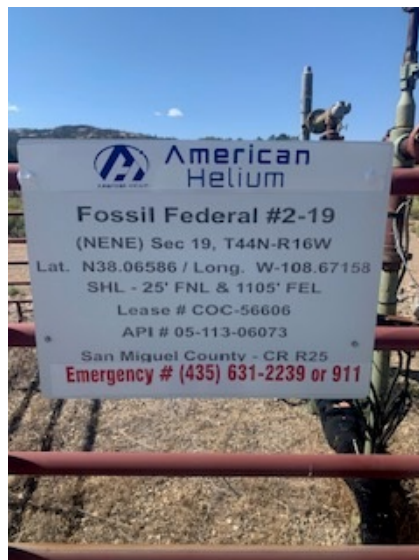
FF 2-19 location ID signage at well head

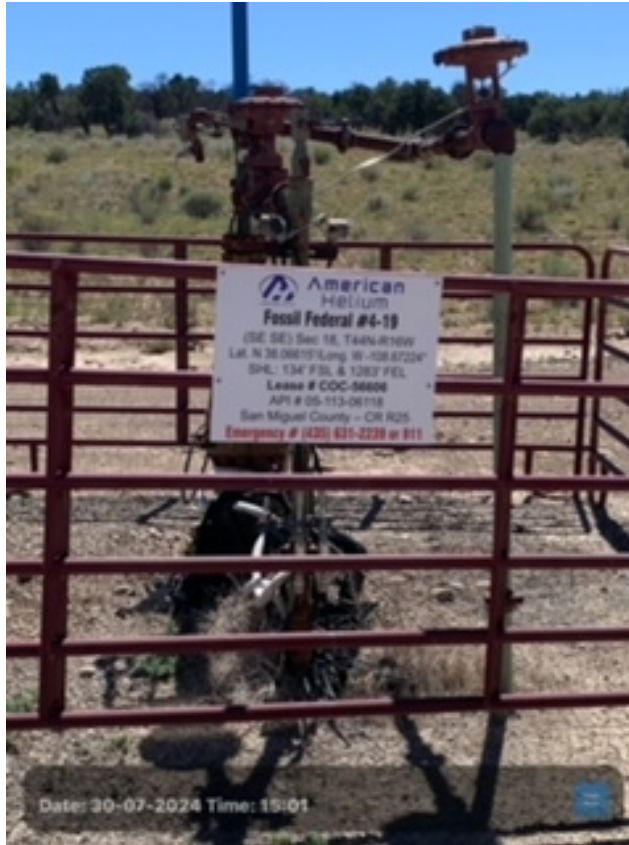
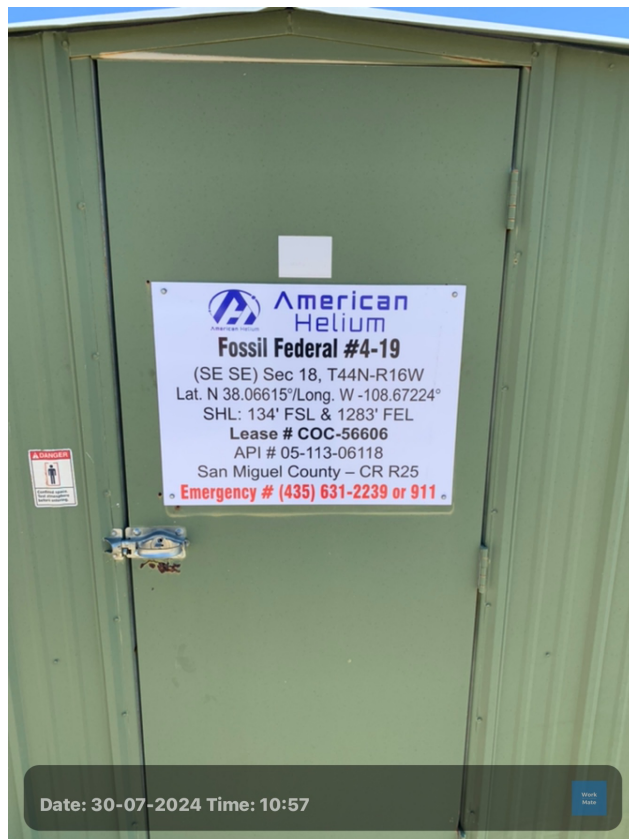
FF 4-19 Signage Replaced 7-30-24

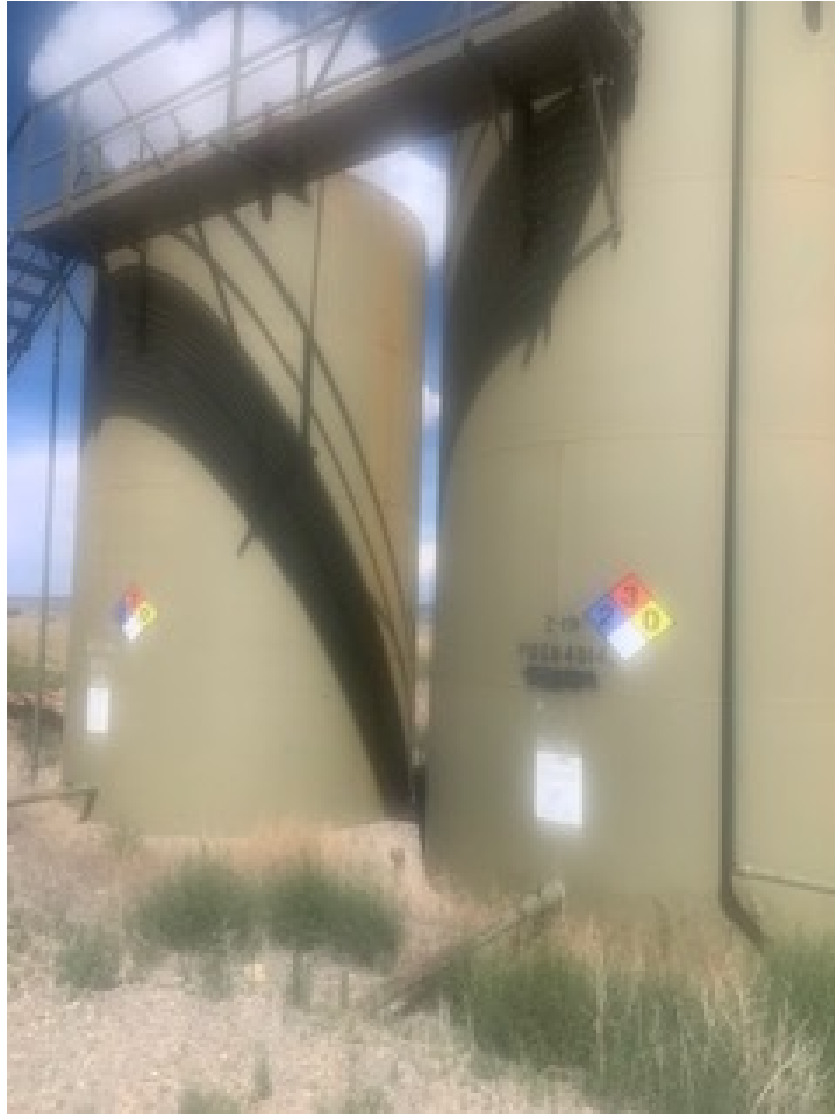
Signs/Marker:			
Type	TANK LABELS/PLACARDS		
Comment:	Sign not legible Sign not updated to reflect current operator		
Corrective Action:	Install sign to comply with Rule 605.g.	Date:	09/30/2024
Type	WELLHEAD		
Comment:	Signs on meter housings		
Corrective Action:		Date:

Placards installed on production tanks FF 1-19, 2-19 and 4-19. 9-10-24

FF 2-19, 4-19, 1-19 Tank labels installed. 9-10-24 Please see photo's.
