Operator: CPR

Location Name: CHAVEZ 61N65W / 4 SWSE HZ PAD

Loc ID: 428697

Inspection: 708201513

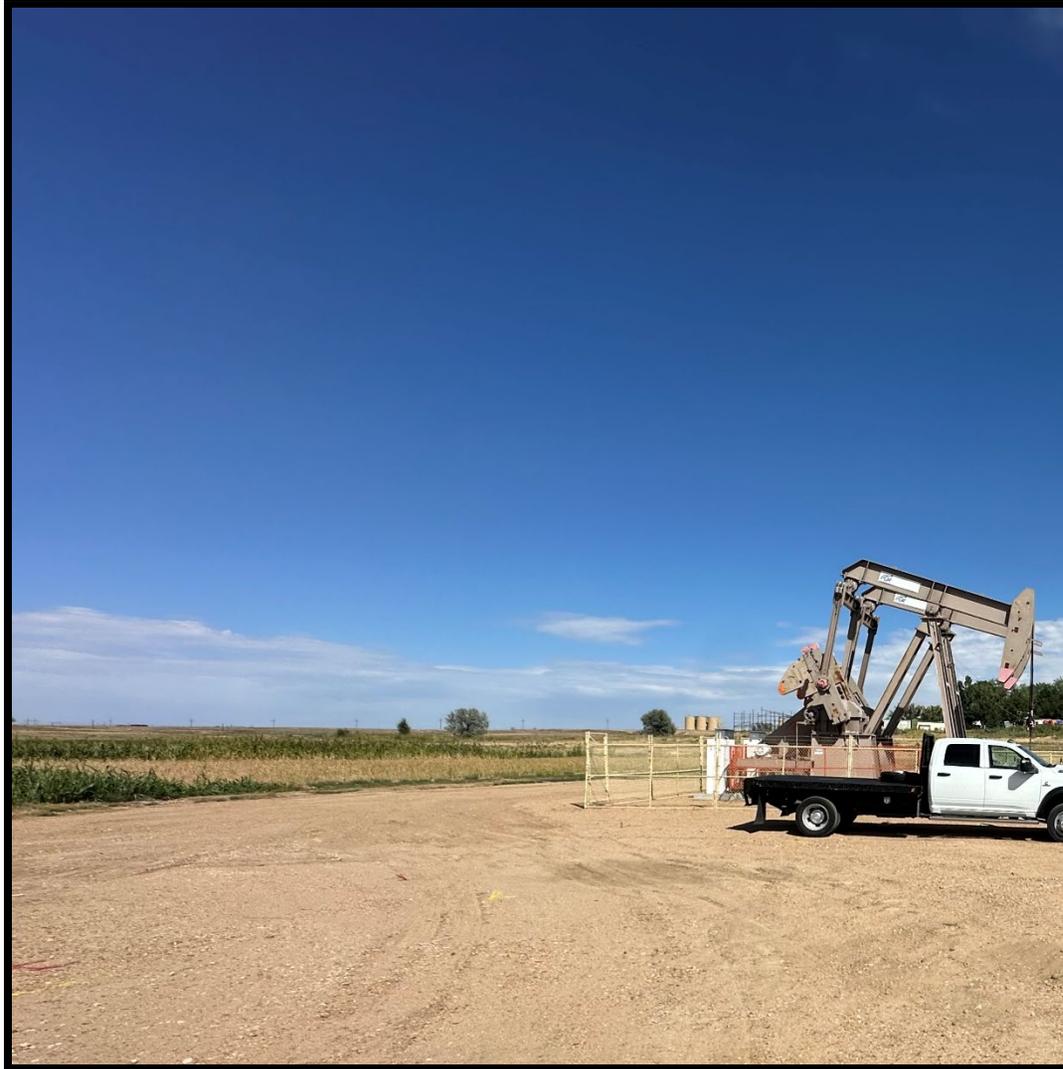
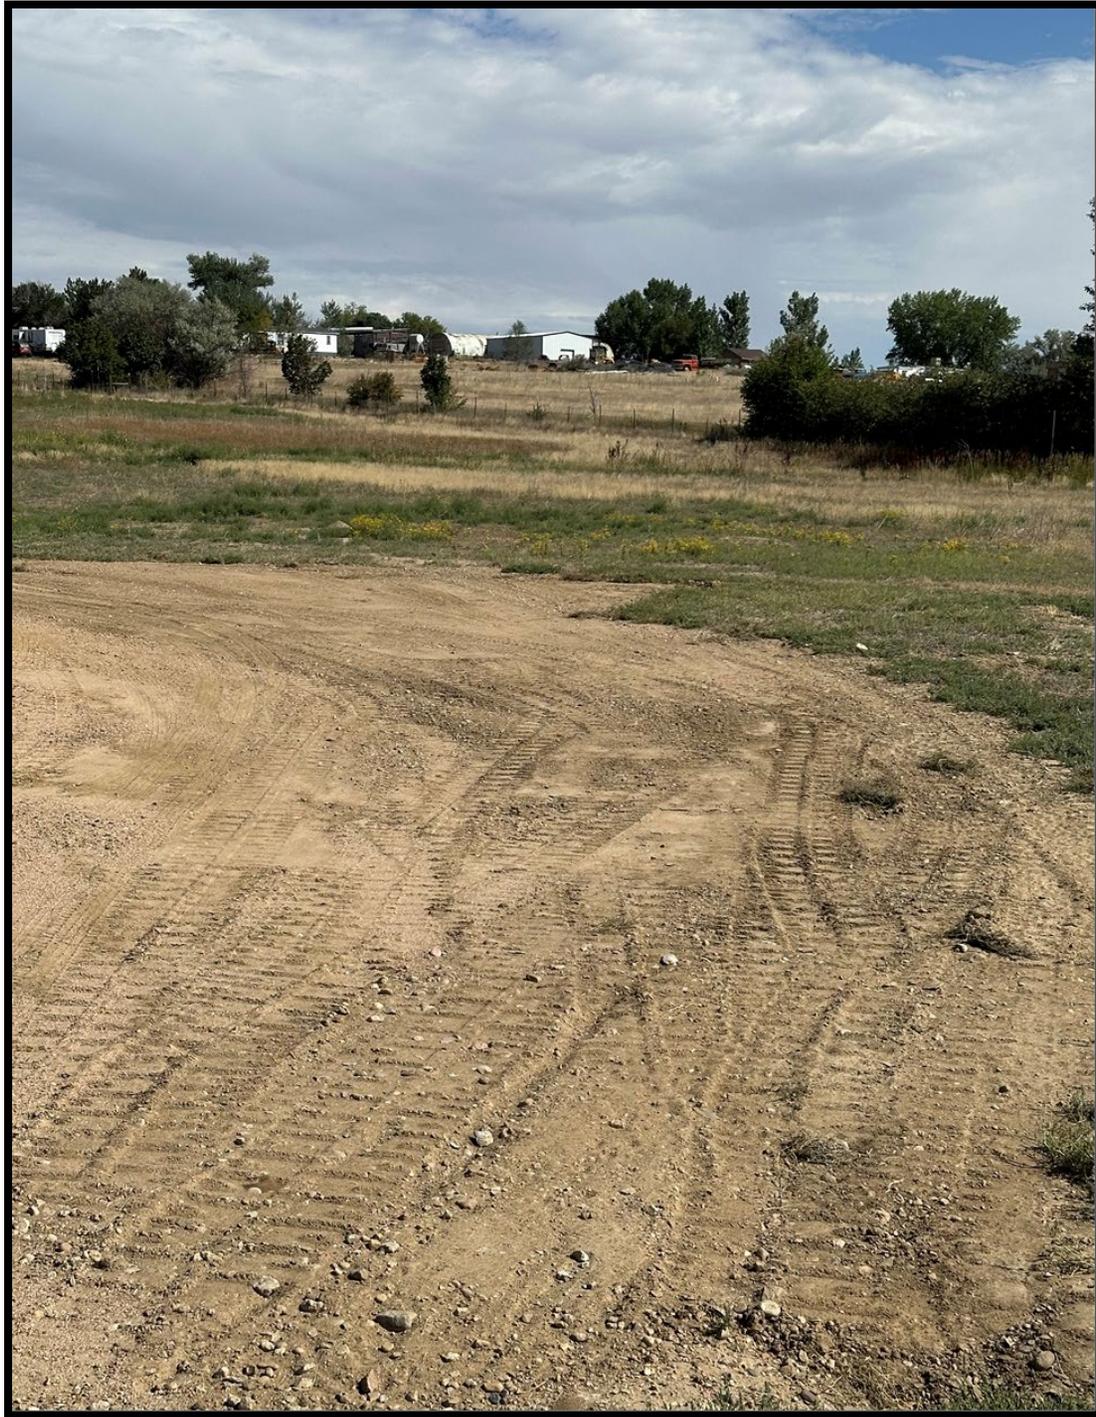
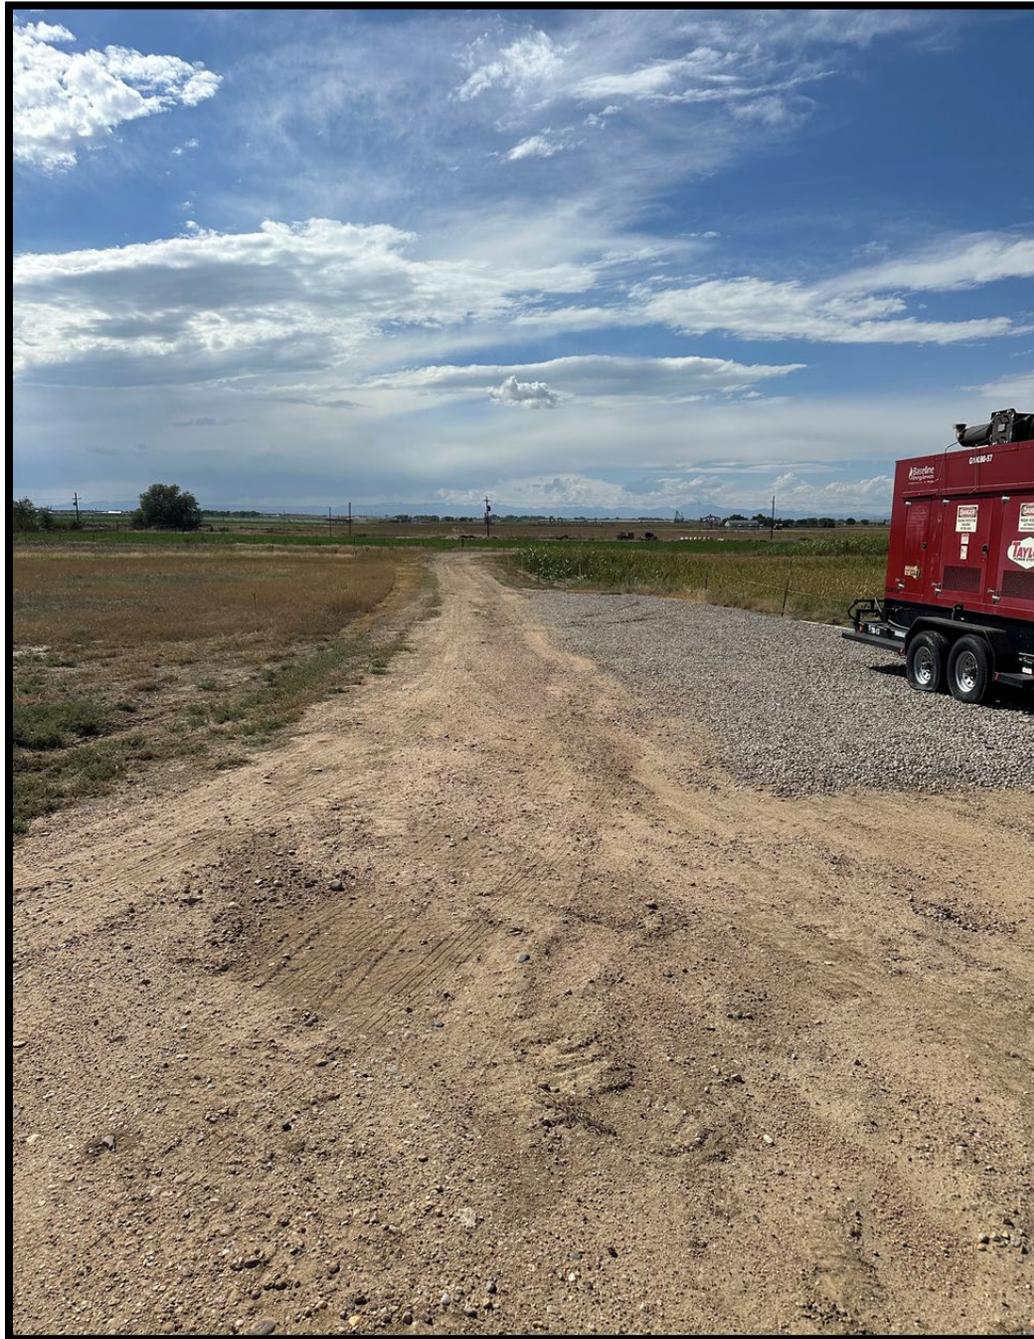
CA: This location does not comply with Rule 1003. It was observed that the disturbance area has been reduced for areas only need for production operations, however, undesirable vegetation (kochia and Russian thistle) was observed throughout the disturbance areas. The southern interim areas do not appear to be progressing towards reclamation standards and regulations with little evidence of desirable perennial vegetation observed. The northern portion appears to have been converted into cropland with poor crop growth observed. Refer to attached inspection photos. Perform reclamation in accordance with Rule 1003.

CA: This location does not comply with Rule 1002.f. During this inspection it was observed that the production areas are experiencing erosion degradation (e.g riling) with off location sediment transport observed in the interim areas. Additional stormwater repairs and/or implementation of additional control measures required. Refer to attached inspection photos. Comply with Rule 1002.f.

CA Resolution: Operator has reported that the identified disturbed areas have been appropriately addressed and seeded. The location has also been mowed and weeds removed.

CA Resolution: Operator has reported that identified areas of erosion have been appropriately repaired to comply with Rule 1002.f.
