Inspection Photos

Operator: PETROLEUM RESOURCE
MANAGEMENT CORP - 10421

Location ID: 436485

Inspection Doc: 696206212

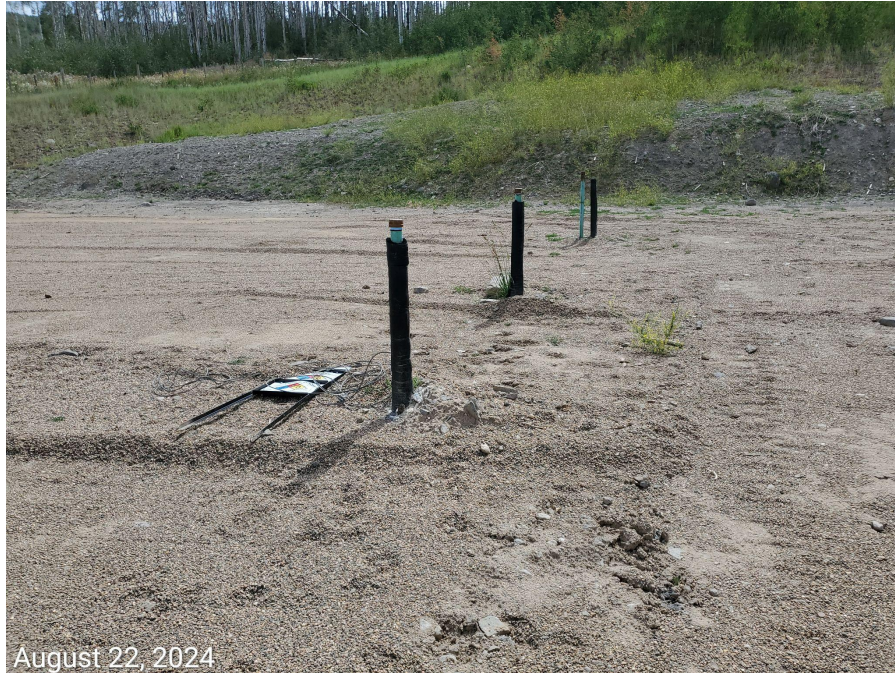
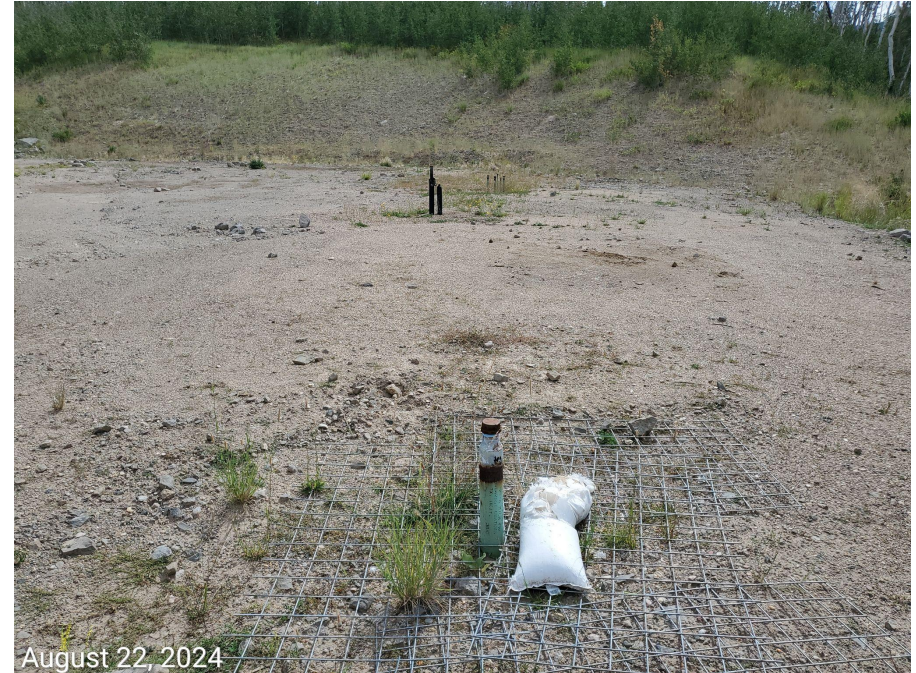
Photo 1: Photos examples showing unused riser equipment remains on the Location. Risers require removal.

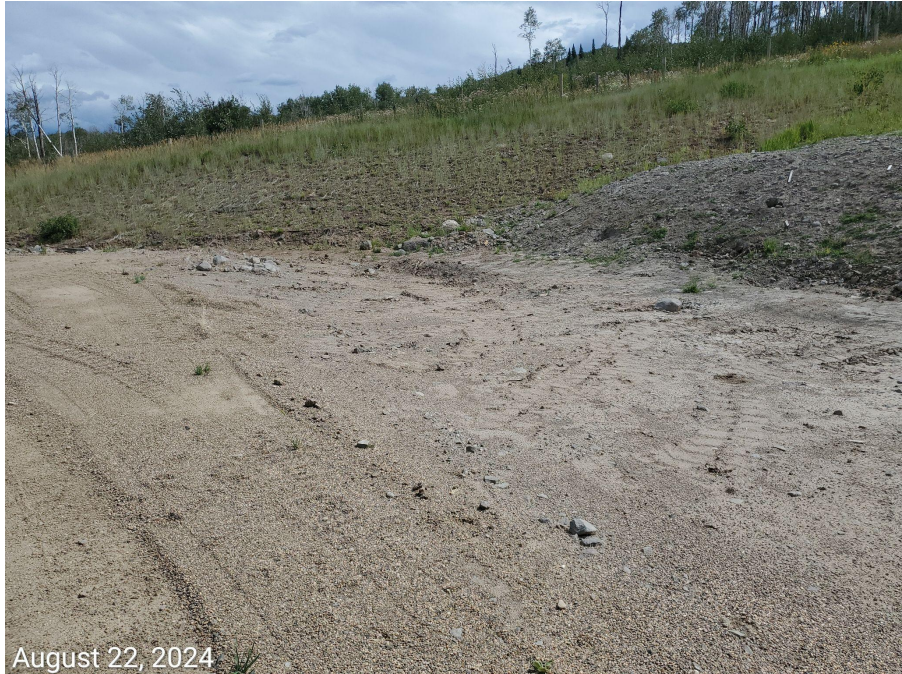
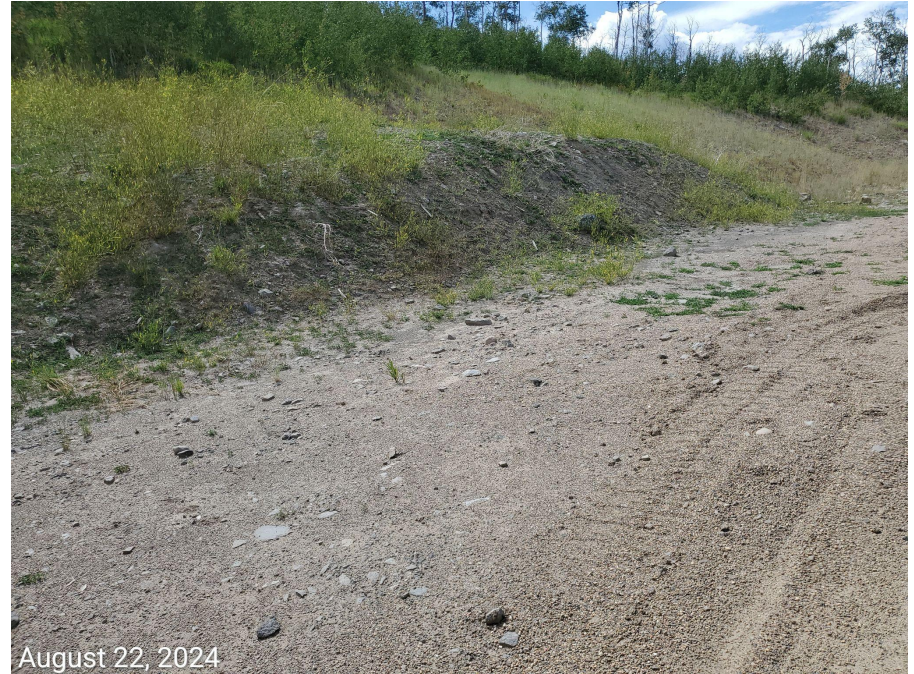
Photo 2: Photos taken from the cut slope on the south end of the Location. Photos show cutting materials remain stored on the Location, and that containment measures to prevent the E&P waste from migrating off-site, as well as from impacting stormwater runoff, and surface water have not been implemented.

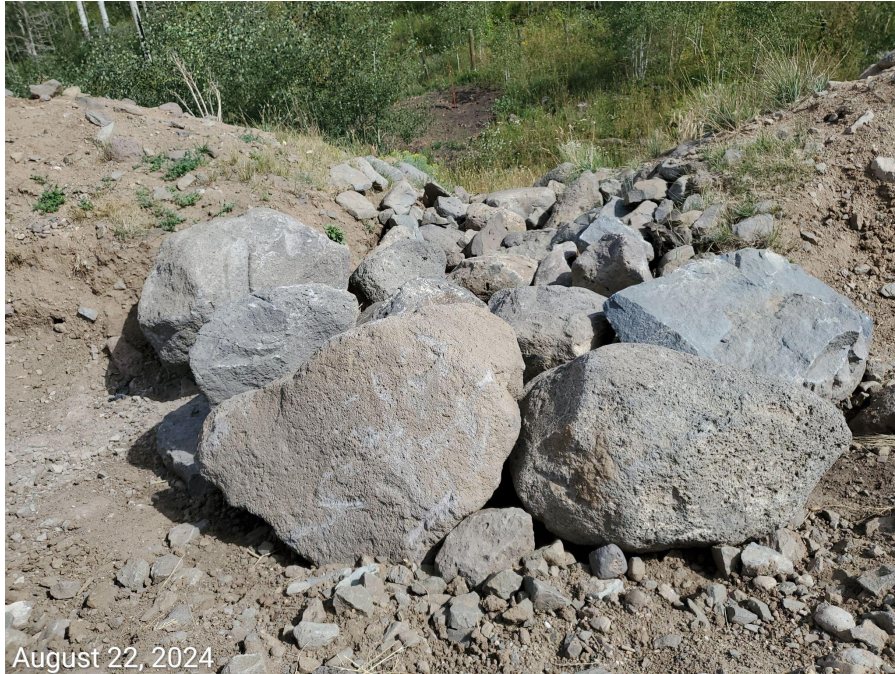
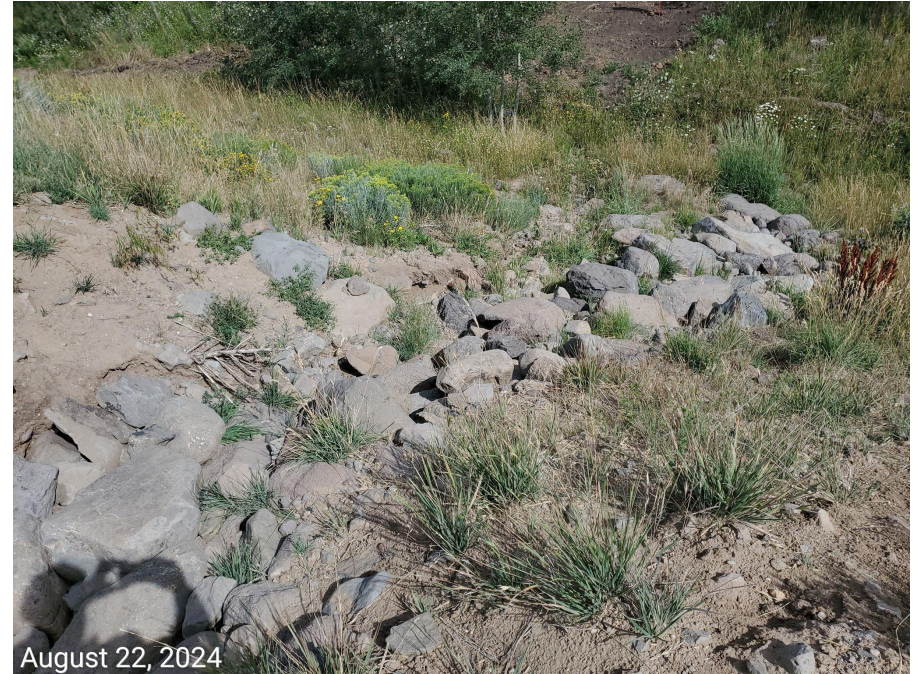
Photo 3: Photos taken from the east end of the Location. Outlets on the north and east end of the Location have not been installed or maintained per good engineering practice; geotextile lining in conjunction with multiangular rip-rap material has not been implemented per good engineering practice; stormwater degradation to the walls of the outlets has persisted.

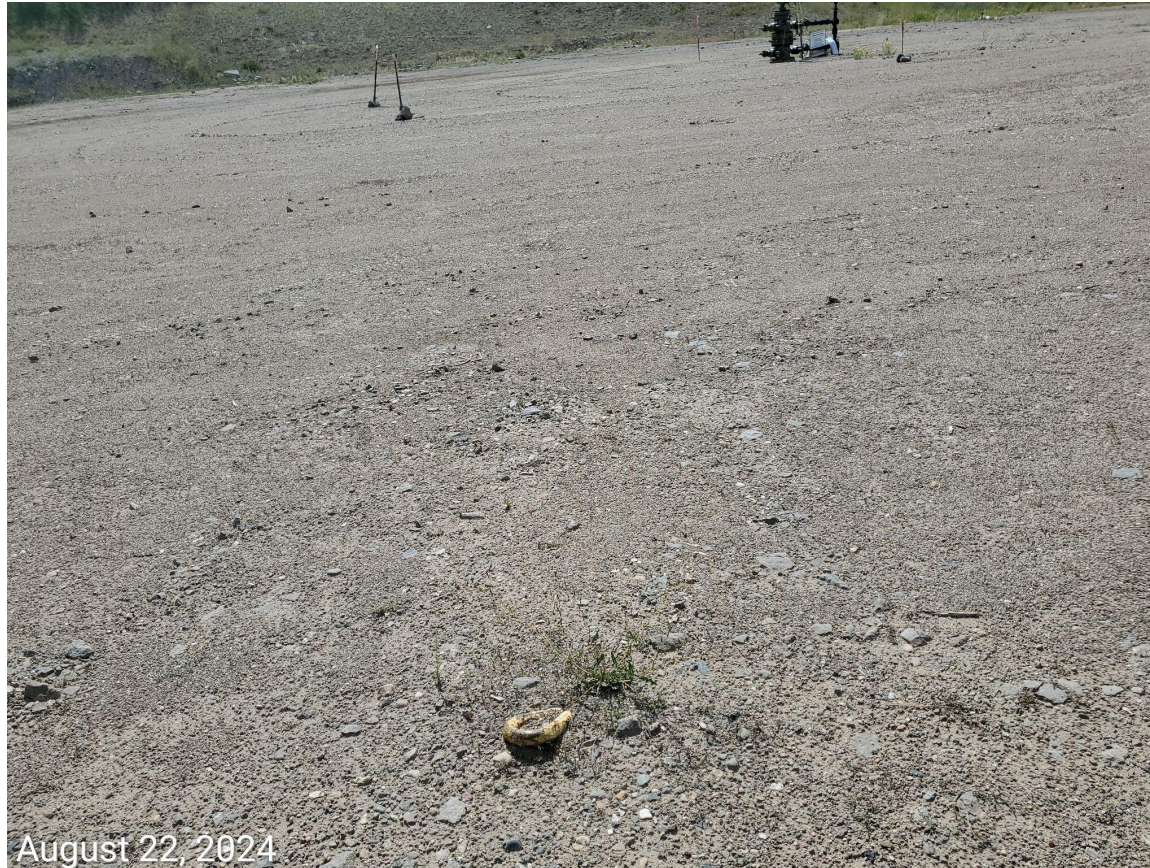
Photo 4: Photo example showing anchors on Location remain unmarked.

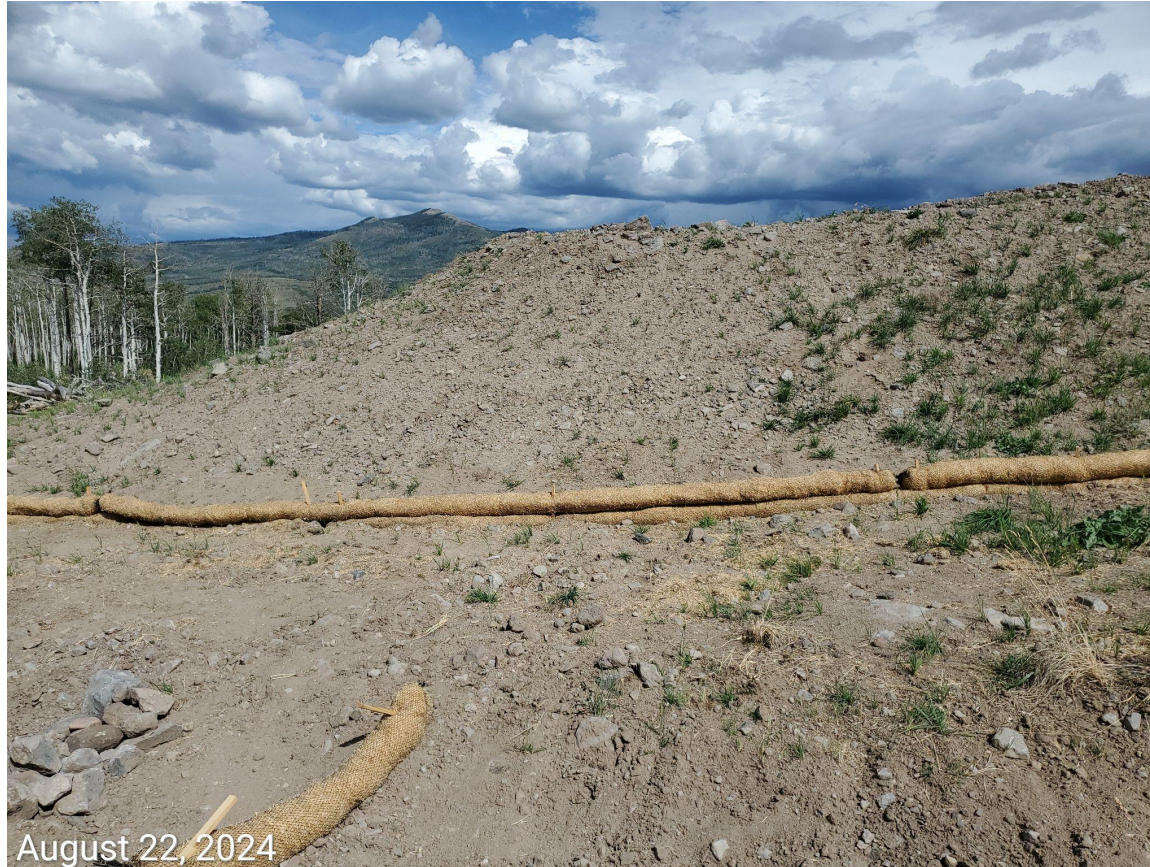
Photo 5: Photo taken from the fill slopes. Slopes on the north end of the Location remain predominantly bare; Operator has since stacked a 2nd erosion log on top of the wattles previously placed, however, BMPs to minimize erosion and degradation at the slope not been implemented.

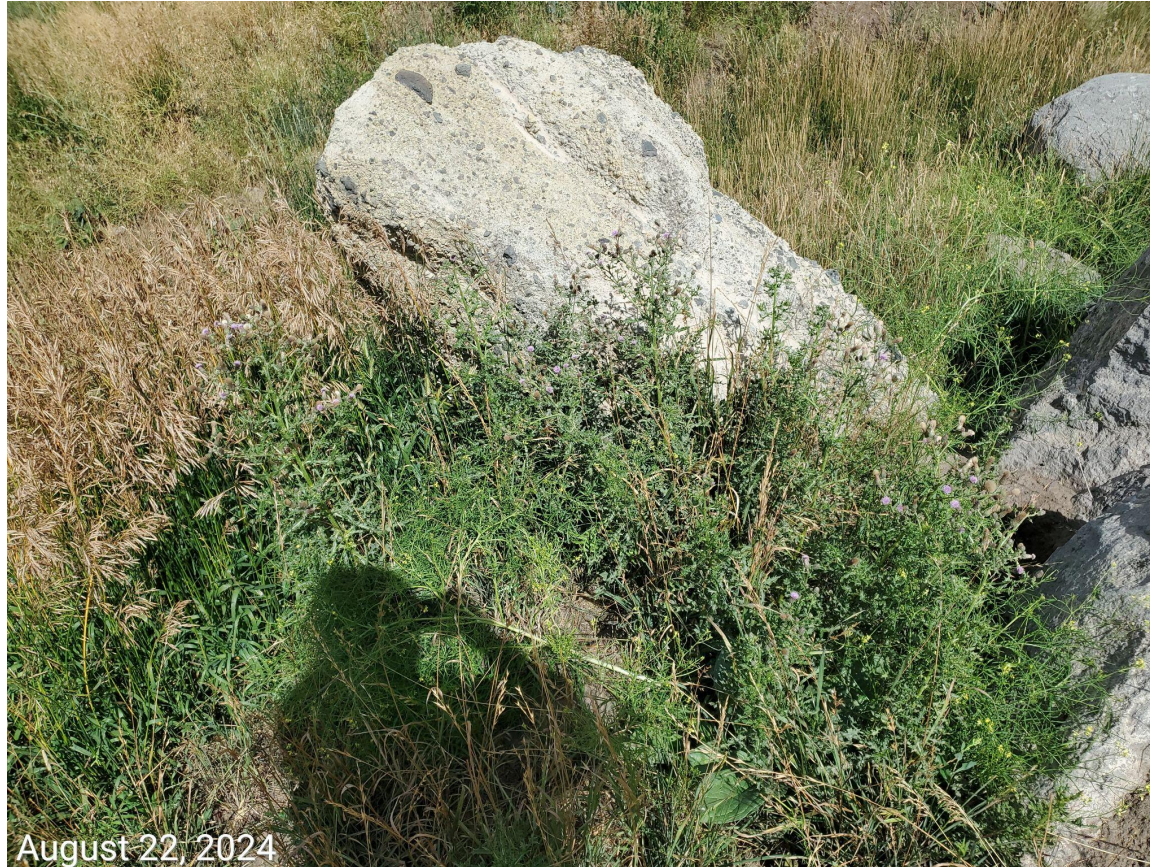
Photo 6: Photos 6-8 example showing Noxious weeds have continued to establish and spread on Location; Canada thistle (seen in photo) have matured on the Location, and was in the process of seeding out at time of inspection. Weeds observed through the Cut and Fill slopes of the location.

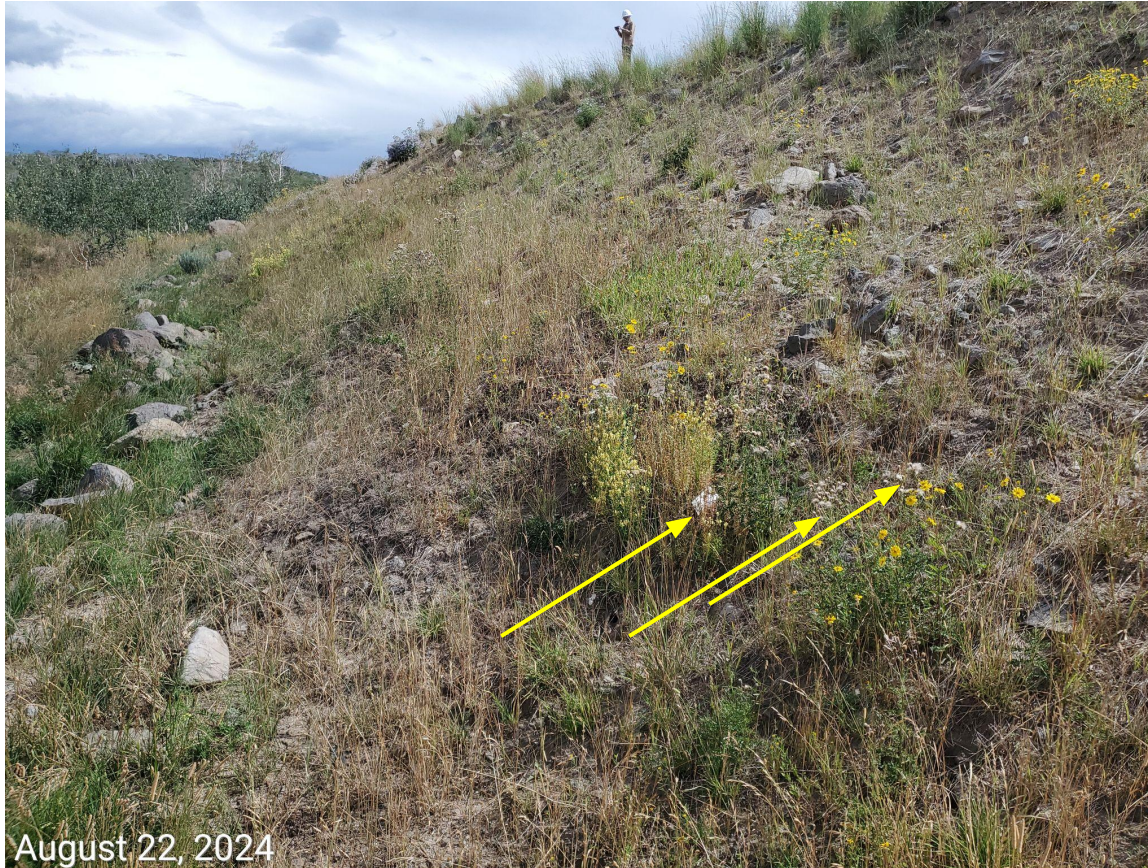
Photo 7: See comments under photo 6. Vegetation in photo with “white top” is Canada thistle, the white material are the plants seeds that were dispersing at time of inspection.

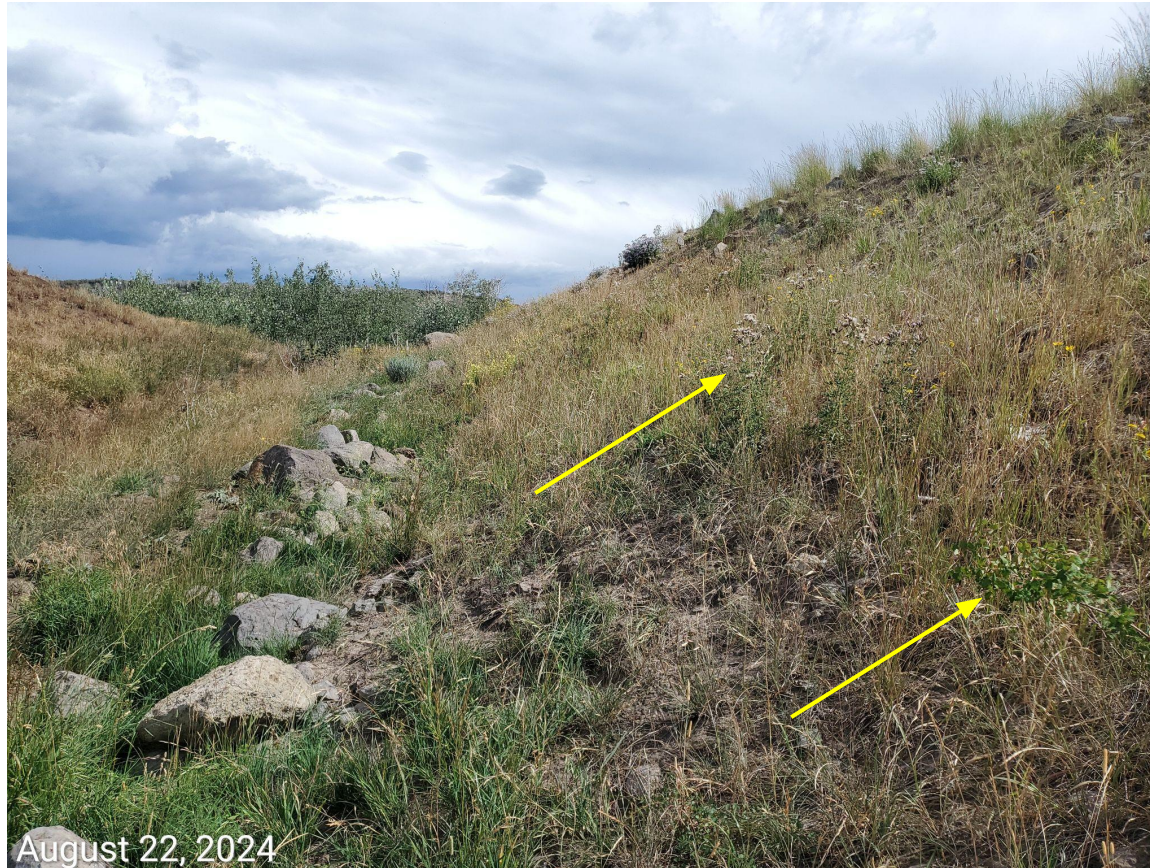
Photo 8: See comments under photo 6. Vegetation in photo with “white top” is Canada thistle, the white material are the plants seeds that were dispersing at time of inspection.
