WELL NAME: PACHFINDER C-11-12 #2, API #: 071-06221, INSP. # 695110249

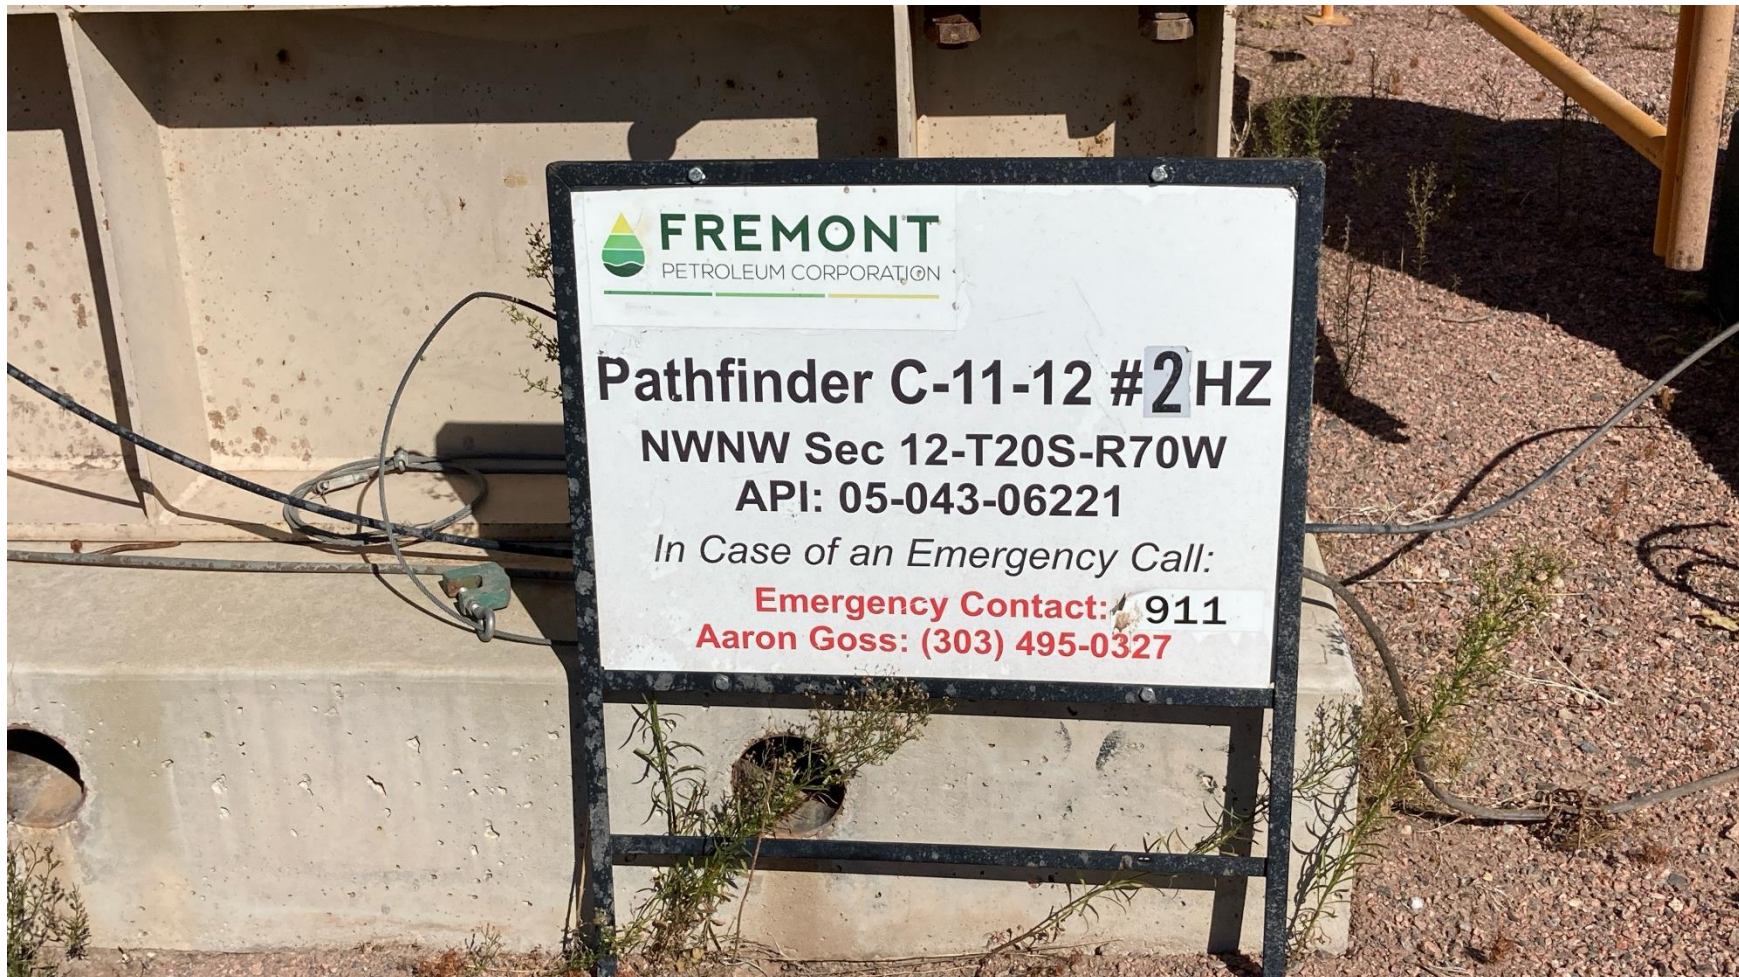
PHOTO 1: WELL SIGN

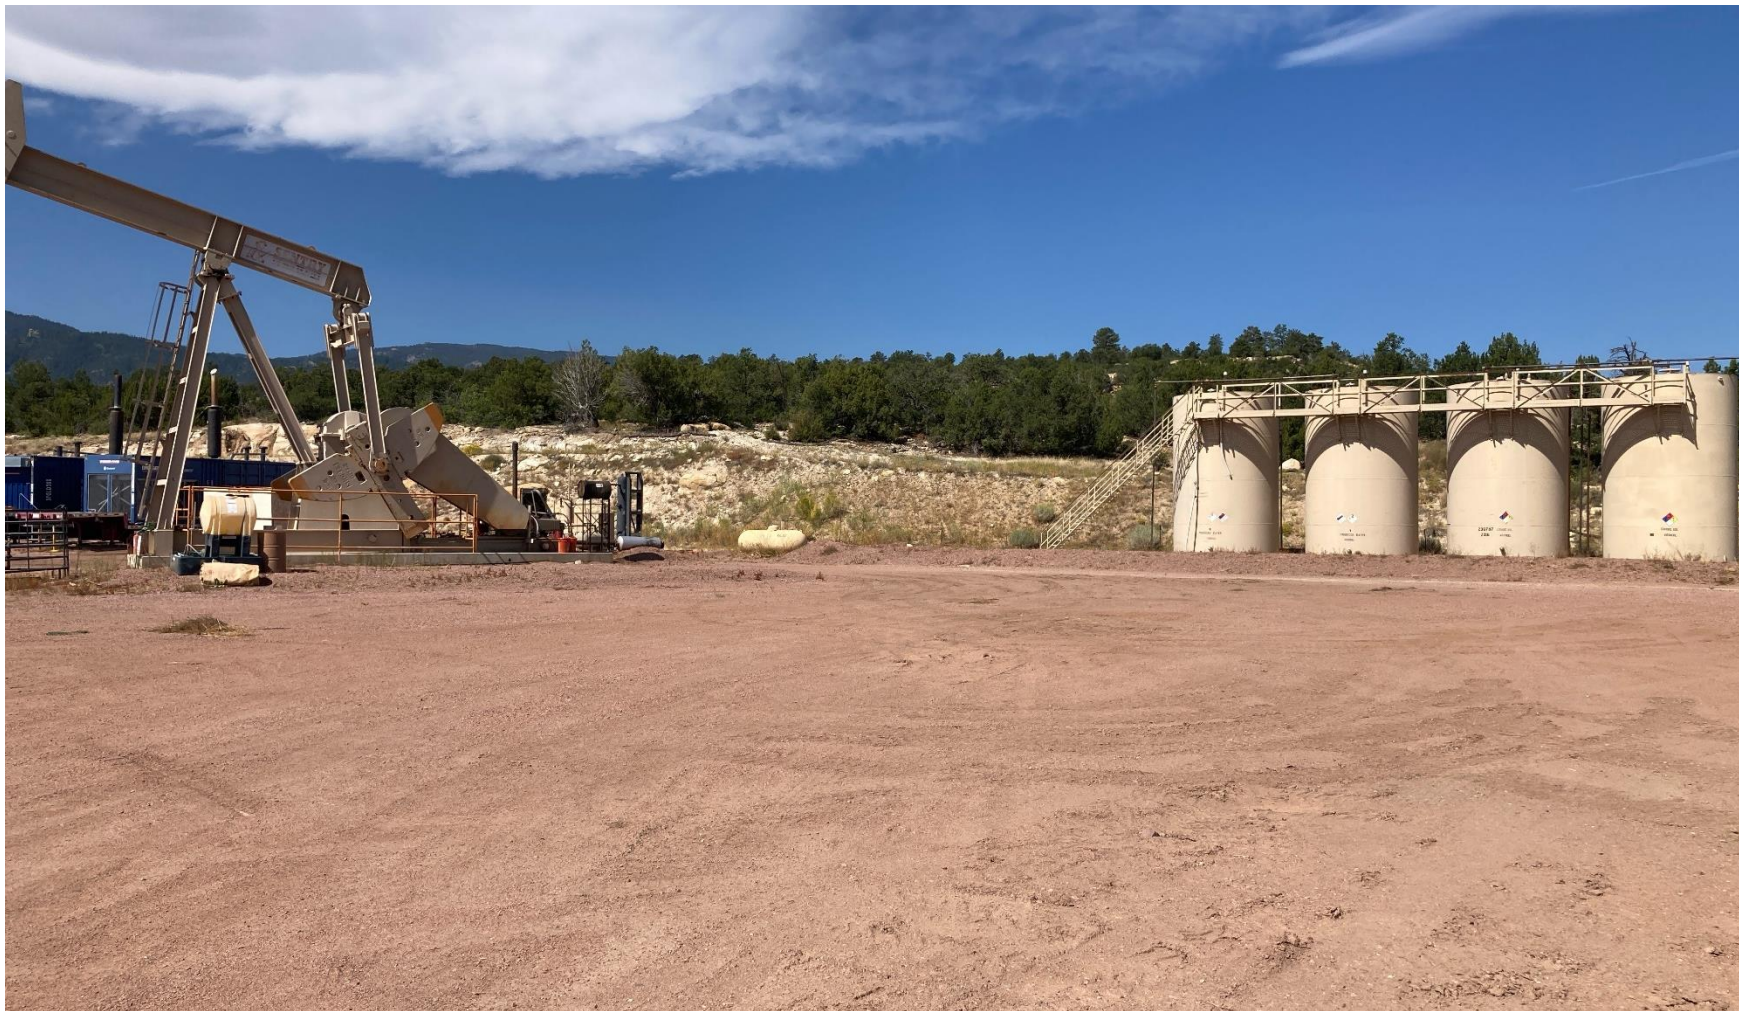
PHOTO 2: LOCATION

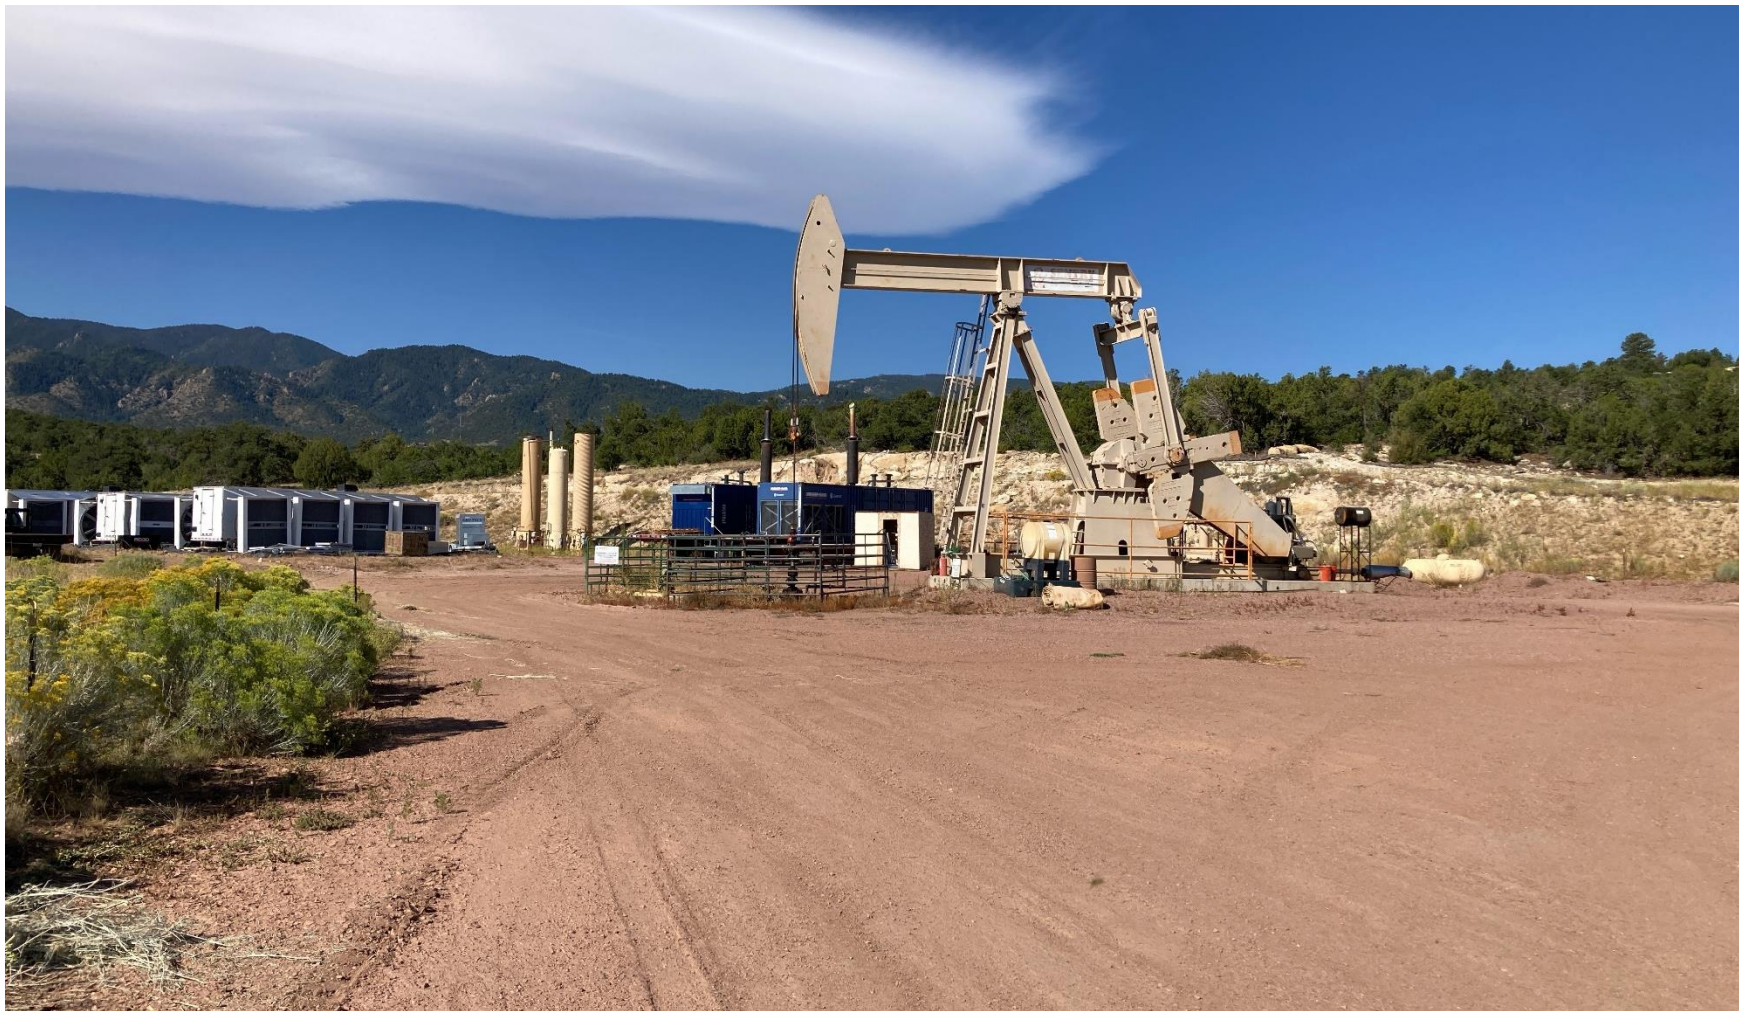
PHOTO 3: LOCATION

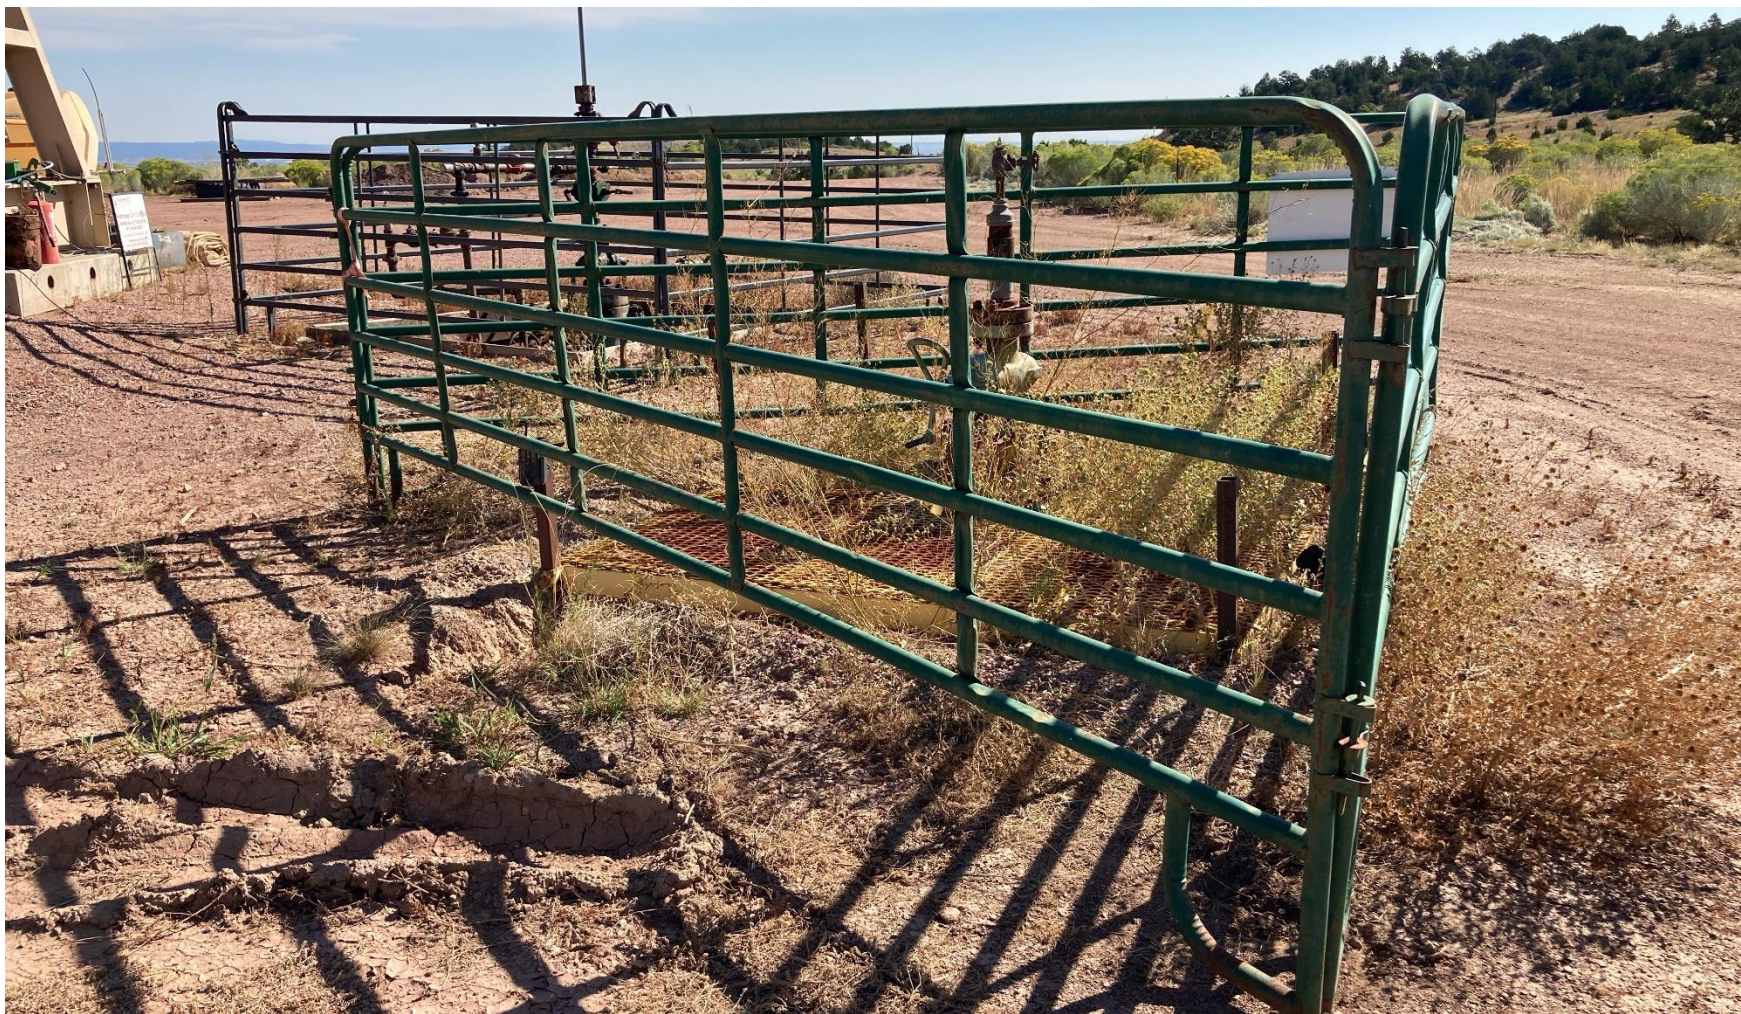
PHOTO 4: WELLHEAD AND EQUIPMENT

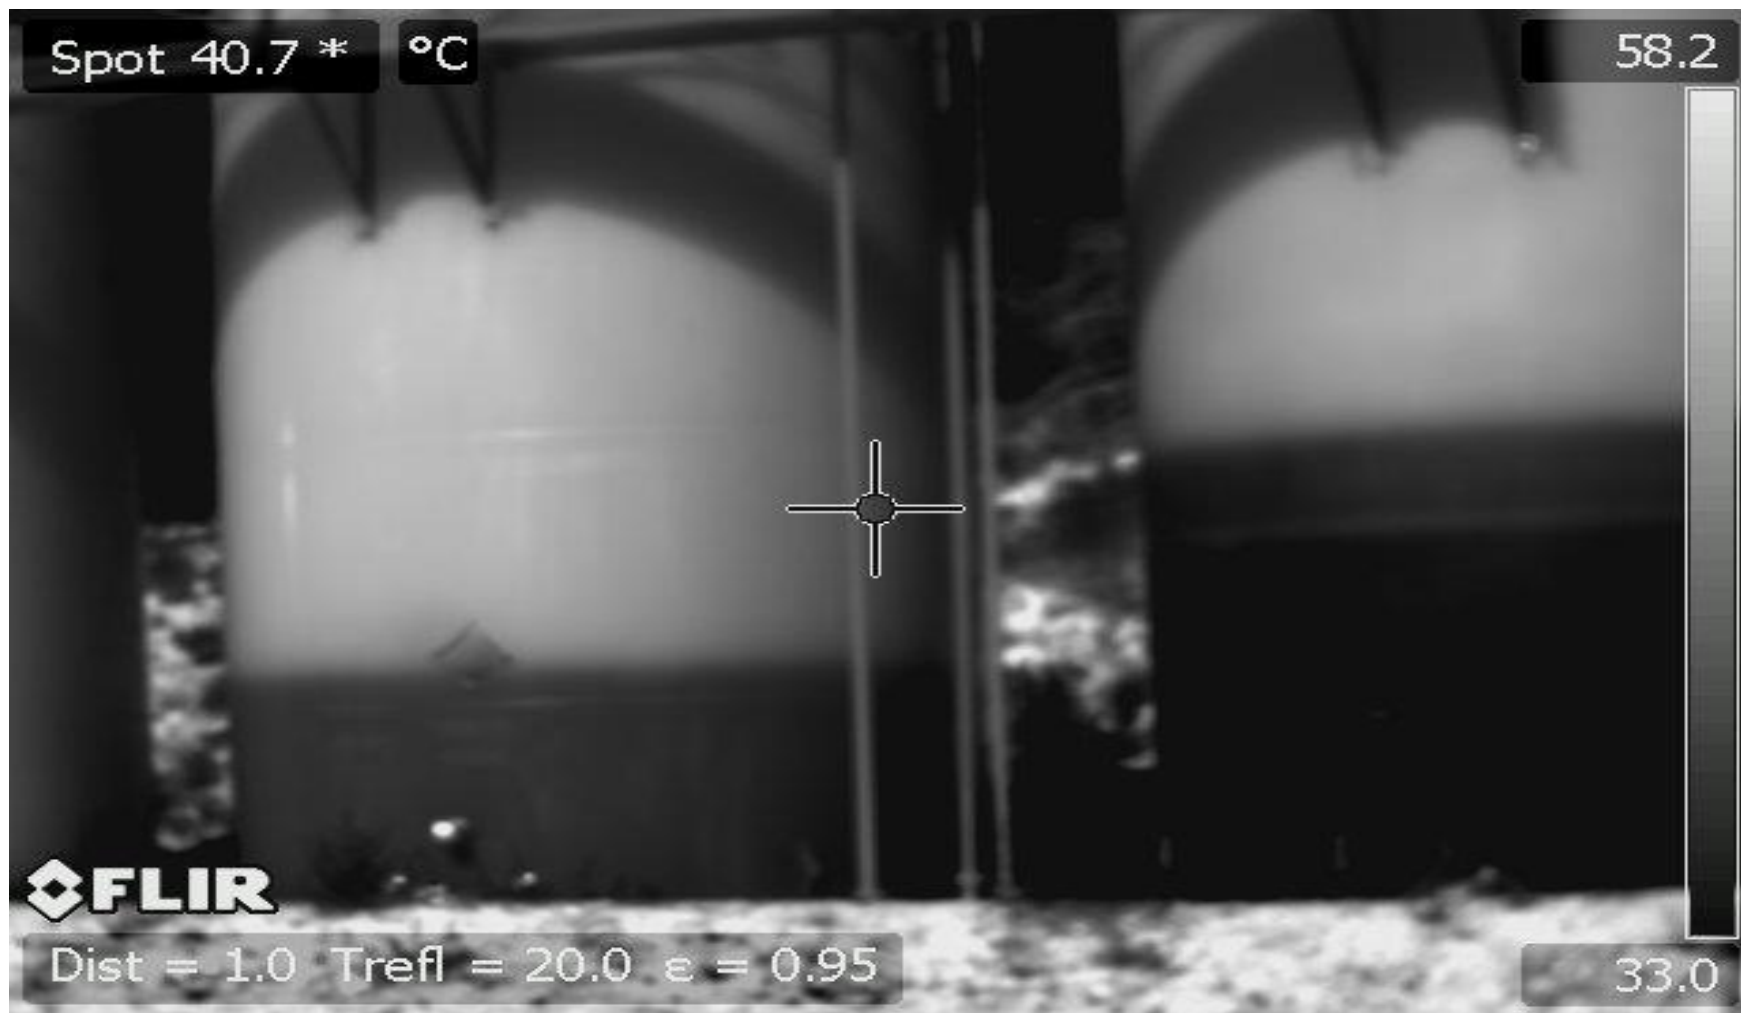
PHOTO 6: FLUID LEVEL INSIDE CRUDE OIL TANKS, PHOTO FROM FLIR CAMARA.

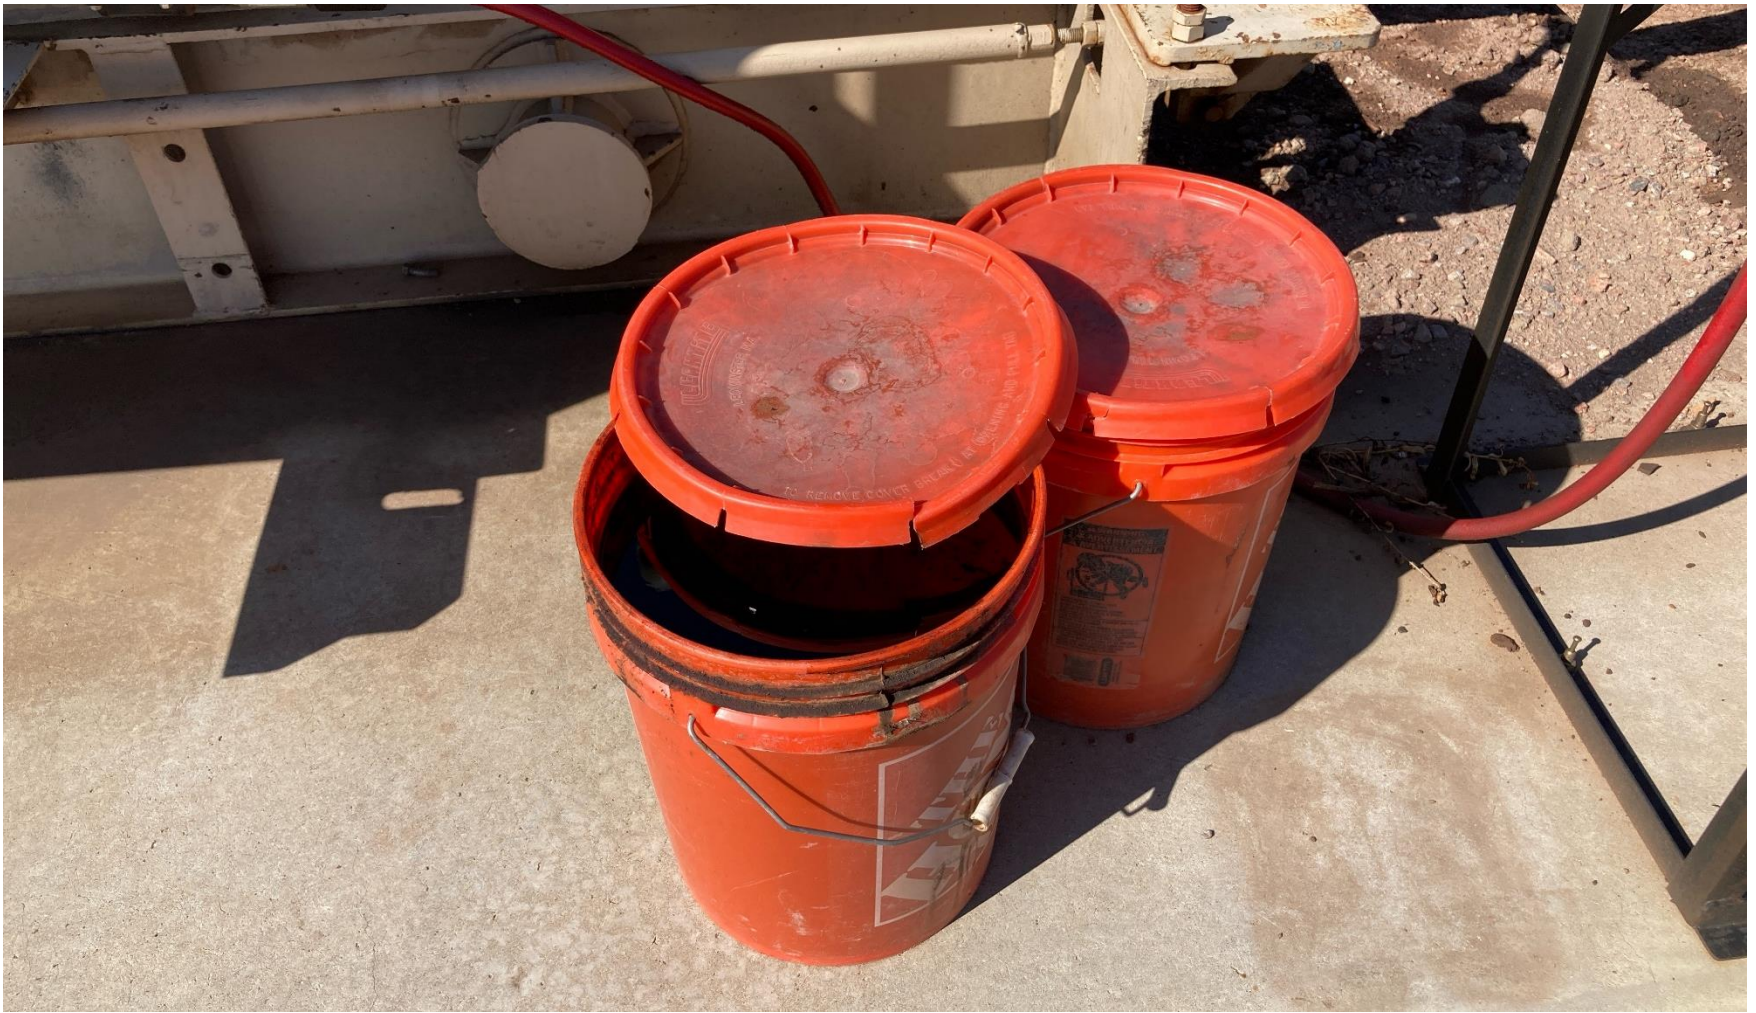
PHOTO 7: TRASH, IT APPEARS TO BE UNED ENGINE OIL IN TWO 5 GAL. BUCKETS NEAR PRIME MOVER. REMOVE ALL TRASH FROM LOCATION PER RULE 606. CA DATE 9-18-2024.

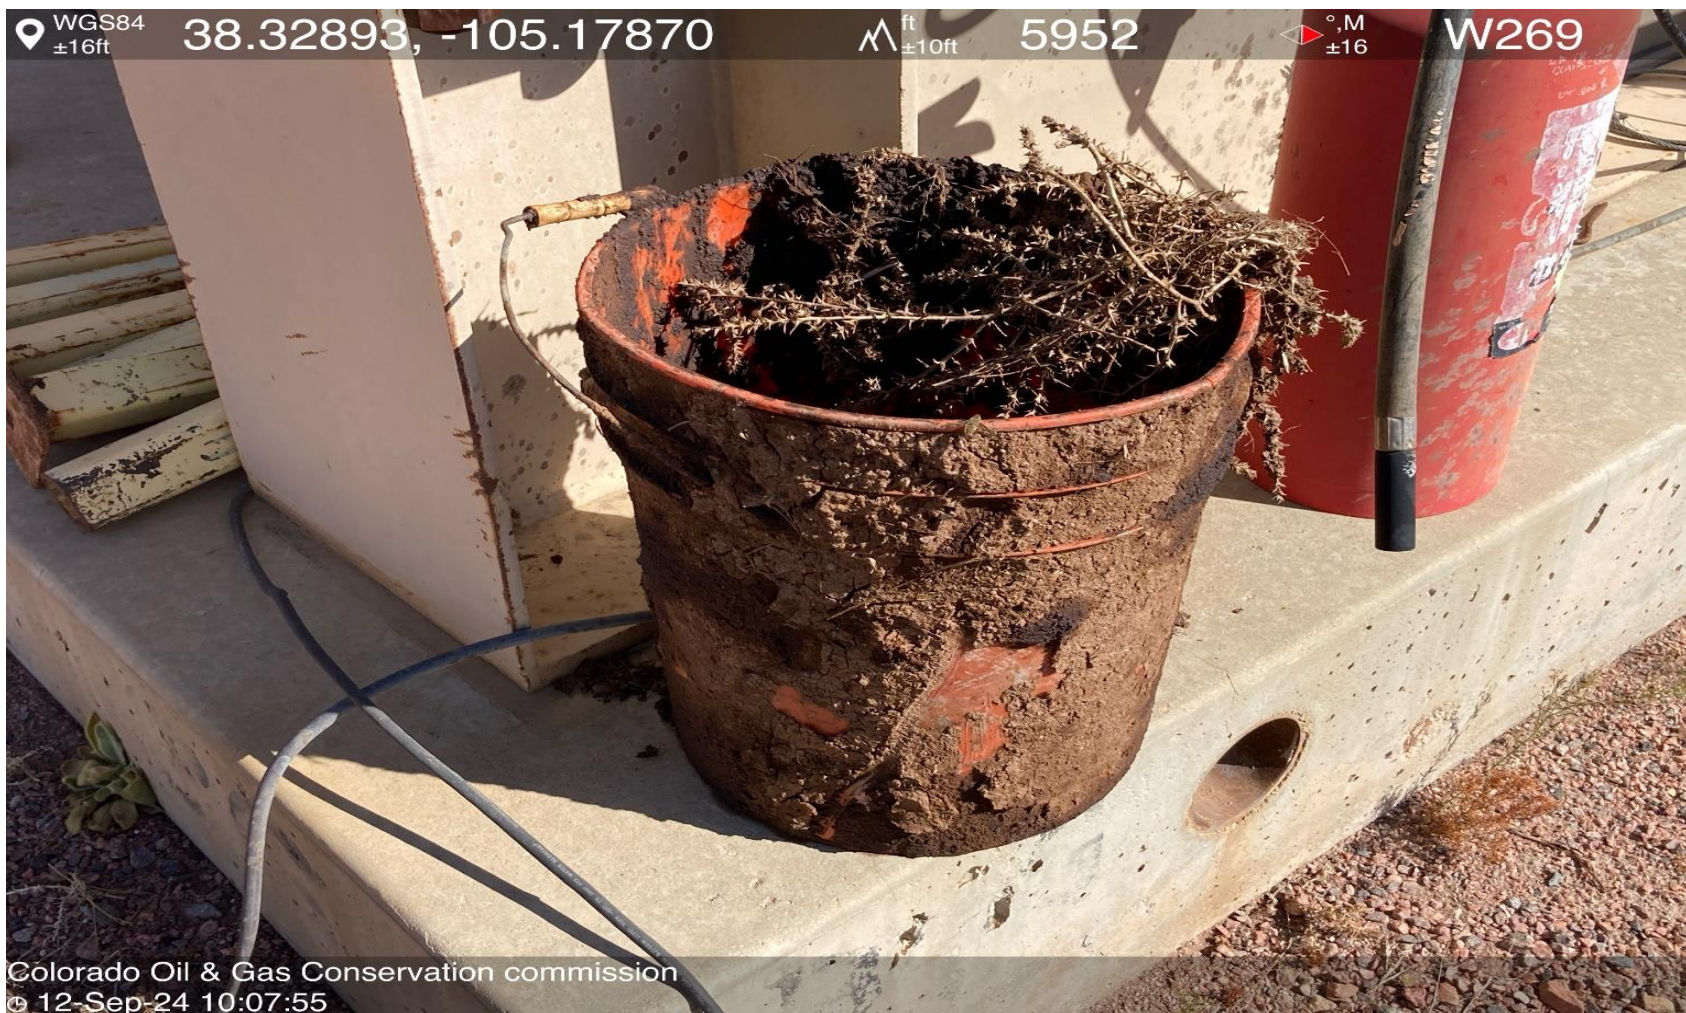
PHOTO 8: TRASH 5 GAL. BUCKETS NEAR WELLHEAD. REMOVE ALL TRASH FROM LOCATION PER RULE 606. CA DATE 9-18-2024.

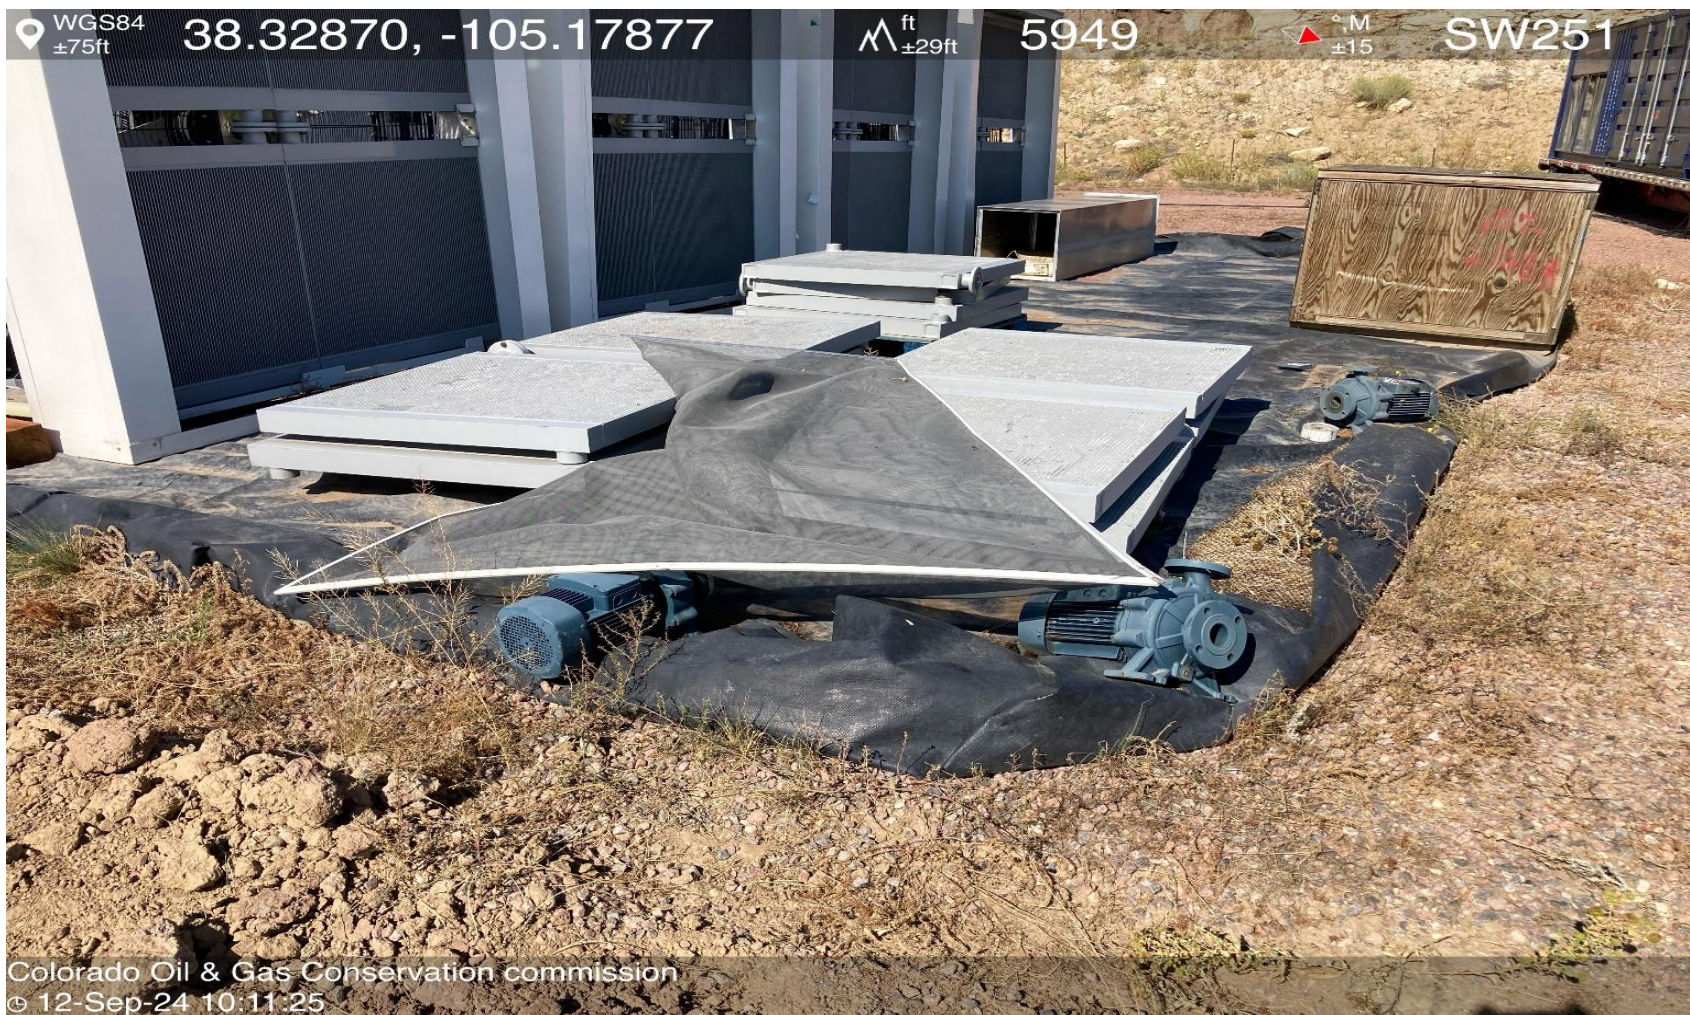
PHOTO 9: TRASH, SOME KIND OF SCREEN IS DAMAGED. REMOVE ALL TRASH FROM LOCATION PER RULE 606. CA DATE 9-18-2024.

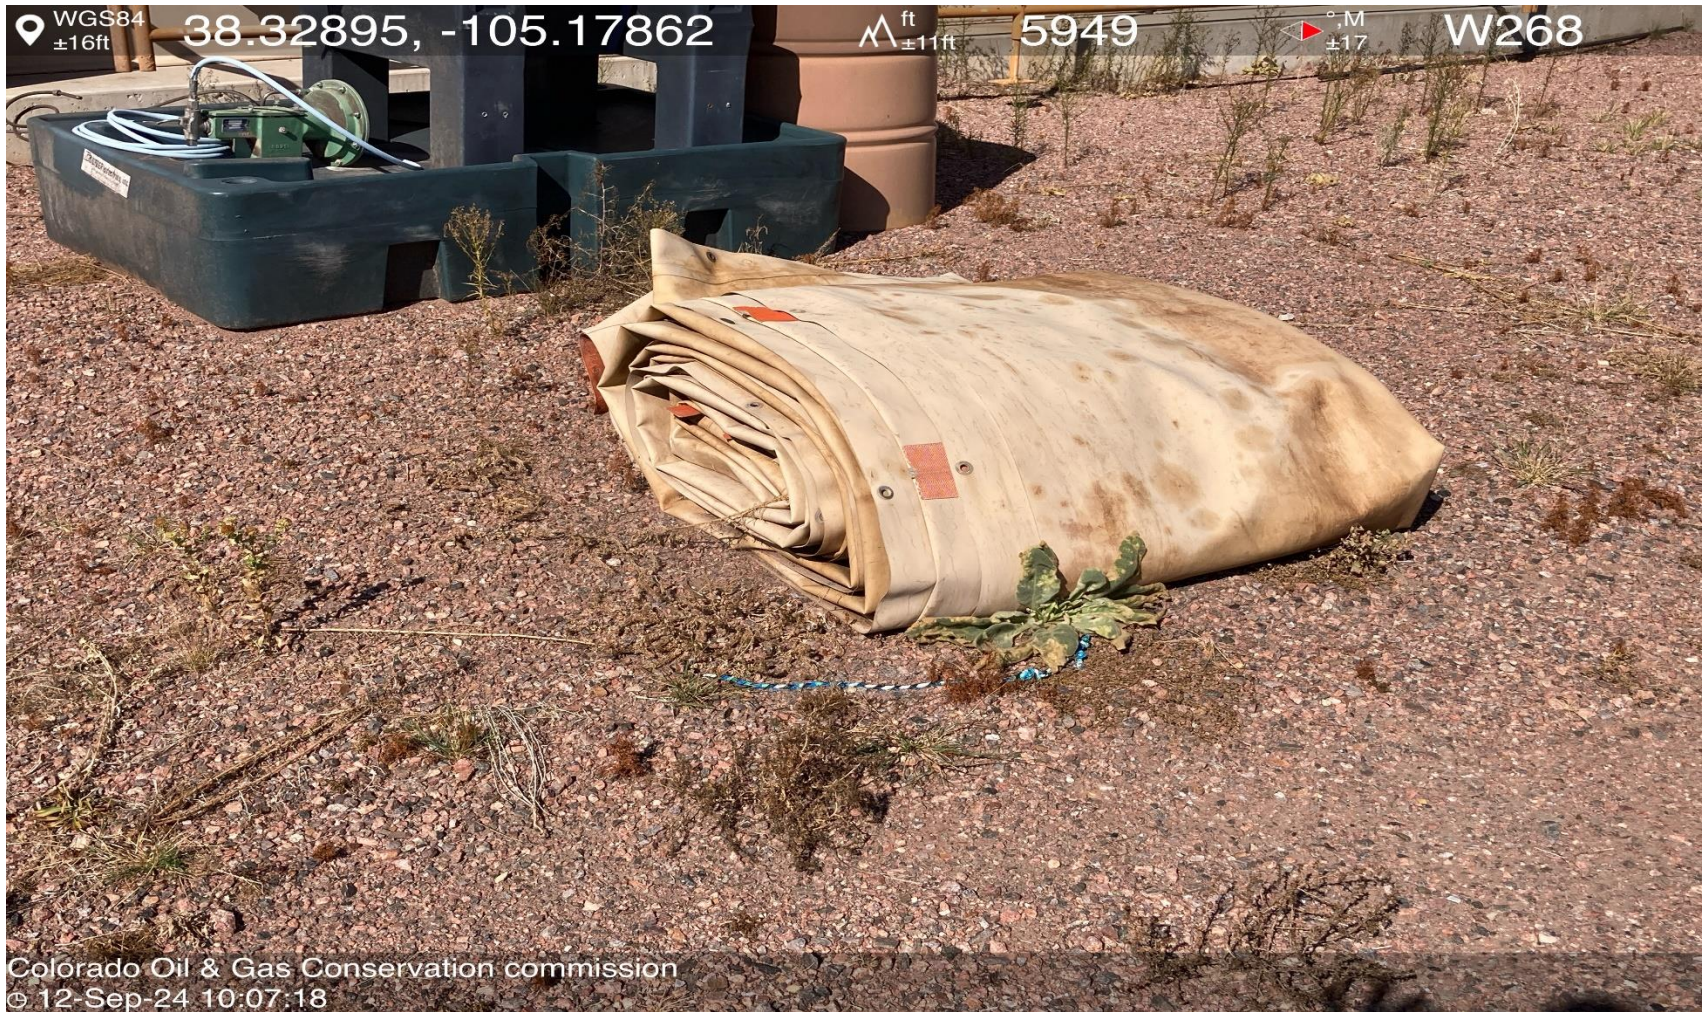
PHOTO 10: UNUSED EQUIPMENT STORED ON LOCATION (CANVAS TARP). REMOVE ALL UNUSED EQUIPEMENT FROM LOCATION PER RULE 606. CA DATE 9-18-2024.

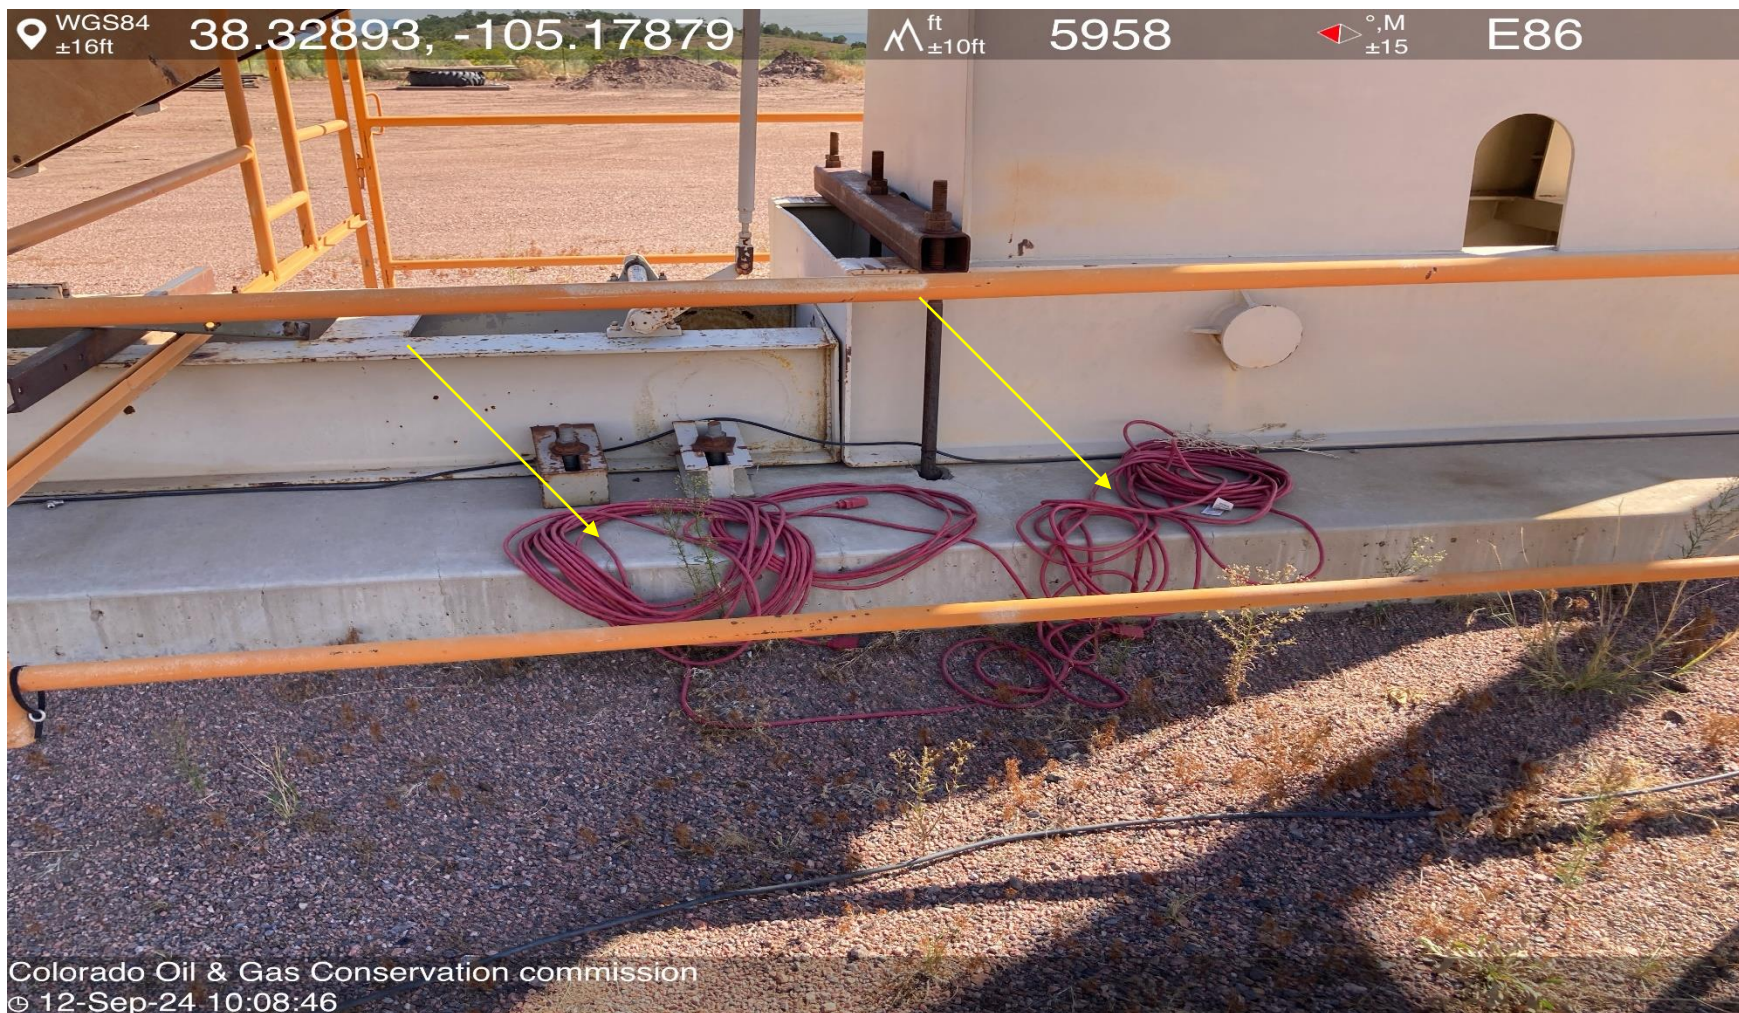
PHOTO 11: UNUSED EQUIPMENT STORED ON LOCATION (POWER CORD). REMOVE ALL UNUSED EQUIPEMENT FROM LOCATION PER RULE 606. CA DATE 9-18-2024.

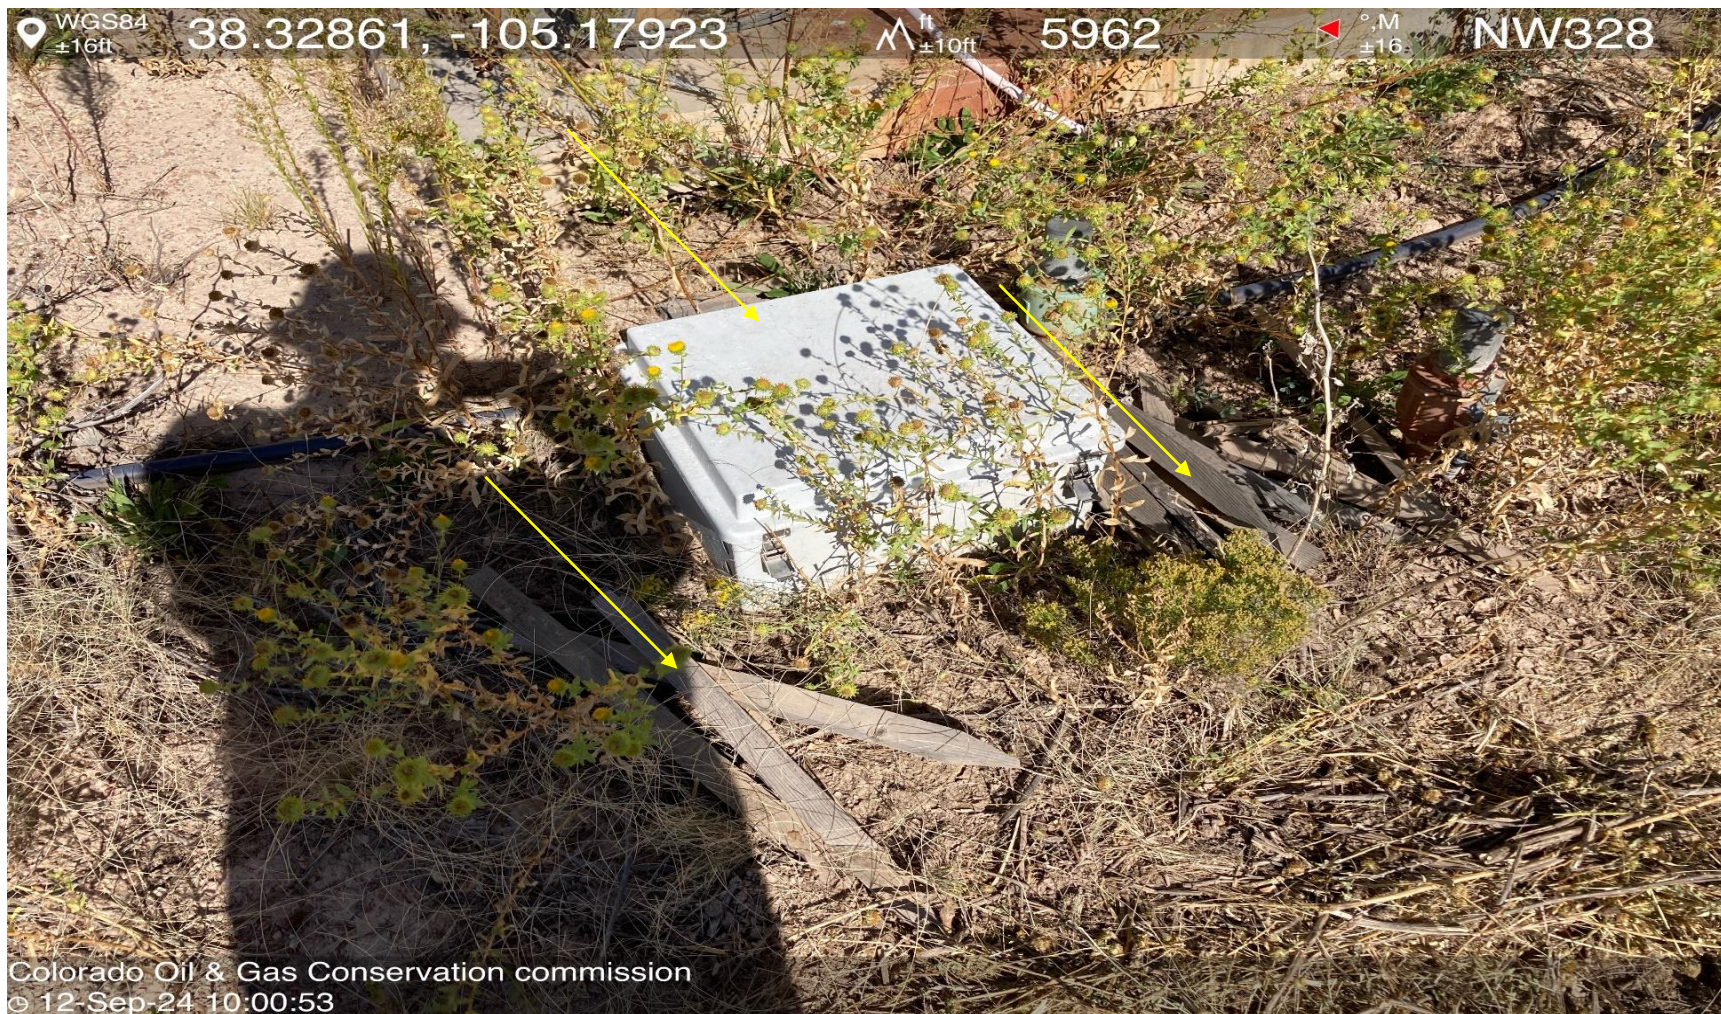
PHOTO 12: UNUSED EQUIPMENT STORED ON LOCATION (EMPTY FIBERGLASS BOX AND SOME WATTLE STAKES). REMOVE ALL UNUSED EQUIPEMENT FROM LOCATION PER RULE 606. CA DATE 9-18-2024.

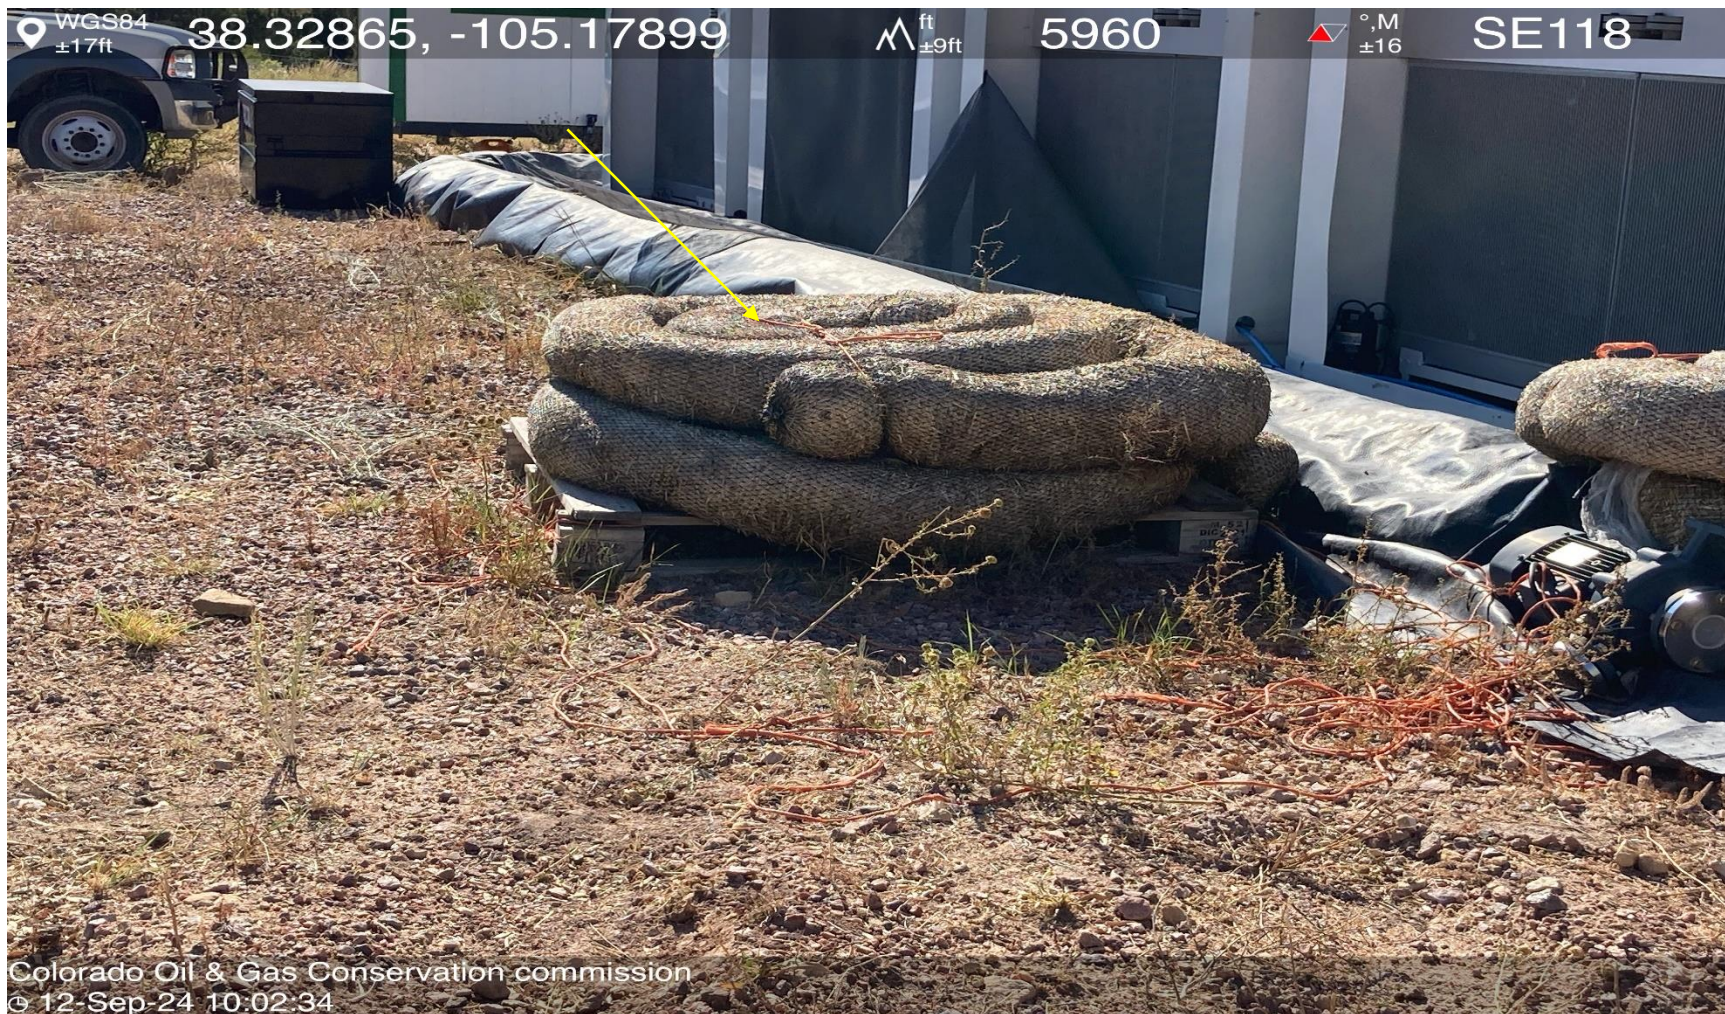
PHOTO 13: UNUSED EQUIPMENT STORED ON LOCATION (PALLET OF WATTLES). REMOVE ALL UNUSED EQUIPEMENT FROM LOCATION PER RULE 606. CA DATE 9-18-2024.

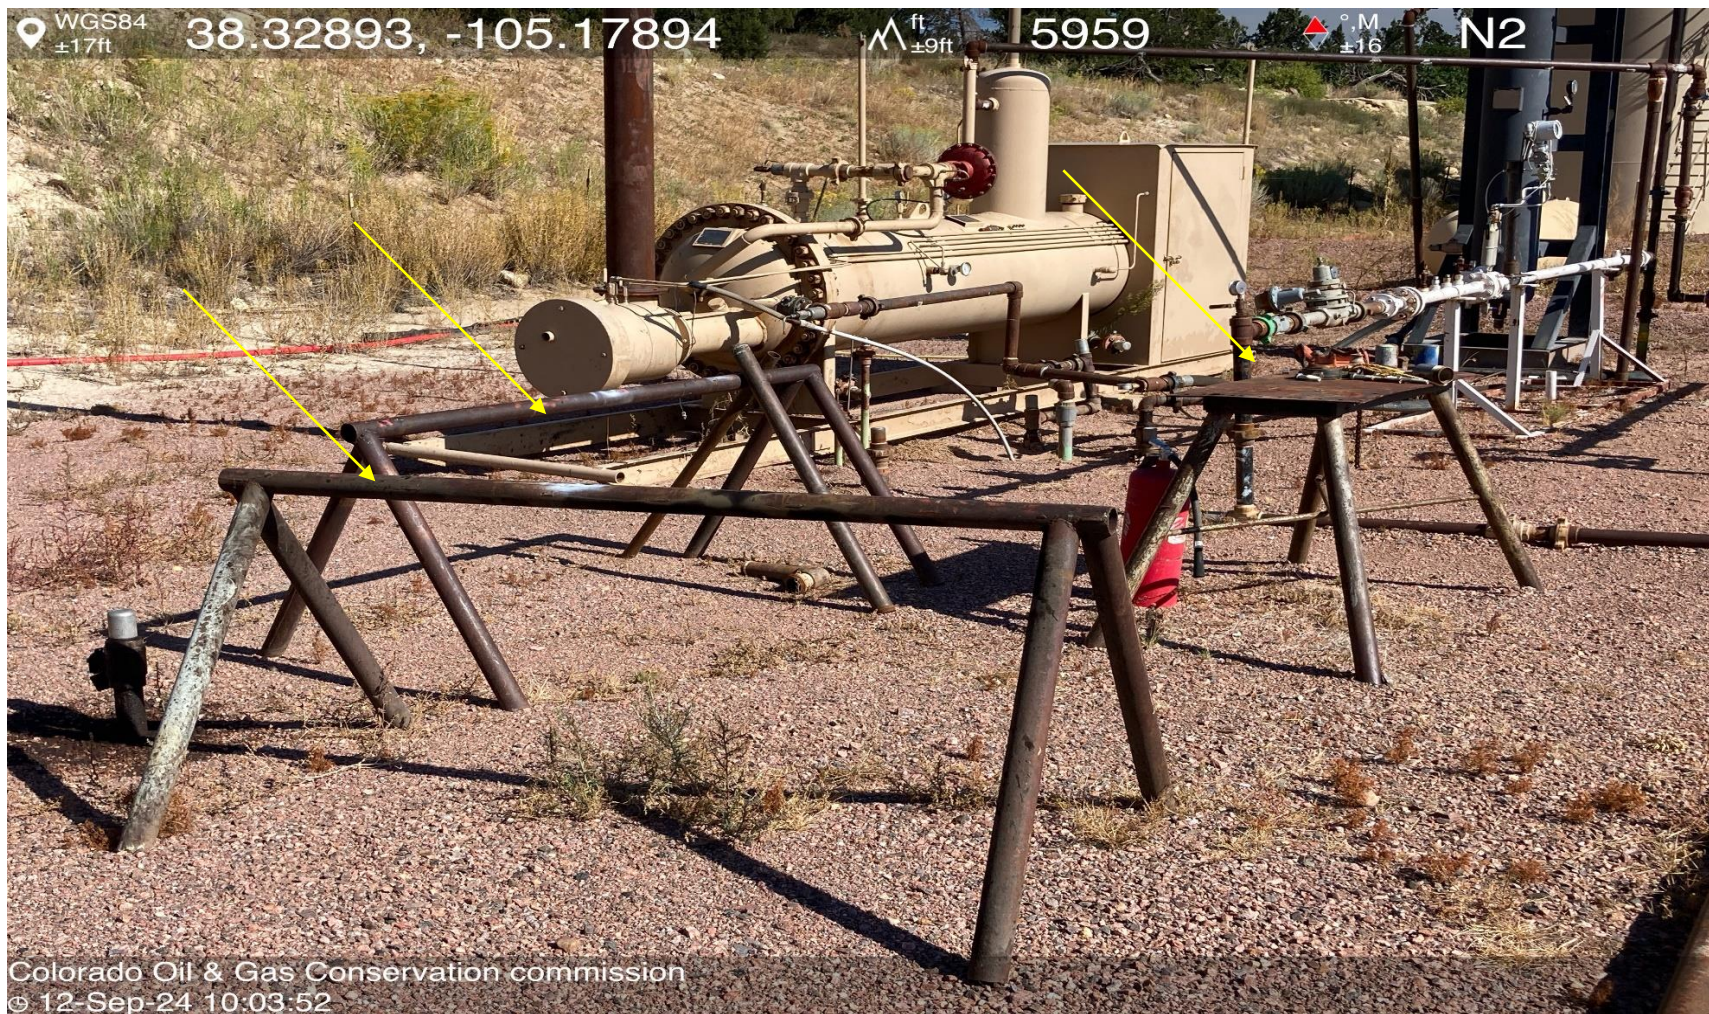
PHOTO 14: UNUSED EQUIPMENT STORED ON LOCATION (WORK BENCH AND SAW HORSES). REMOVE ALL UNUSED EQUIPEMENT FROM LOCATION PER RULE 606. CA DATE 9-18-2024.
