WELL NAME: PACHFINDER C-11-12 #2, API #: 071-06221, INSP. # 695110249

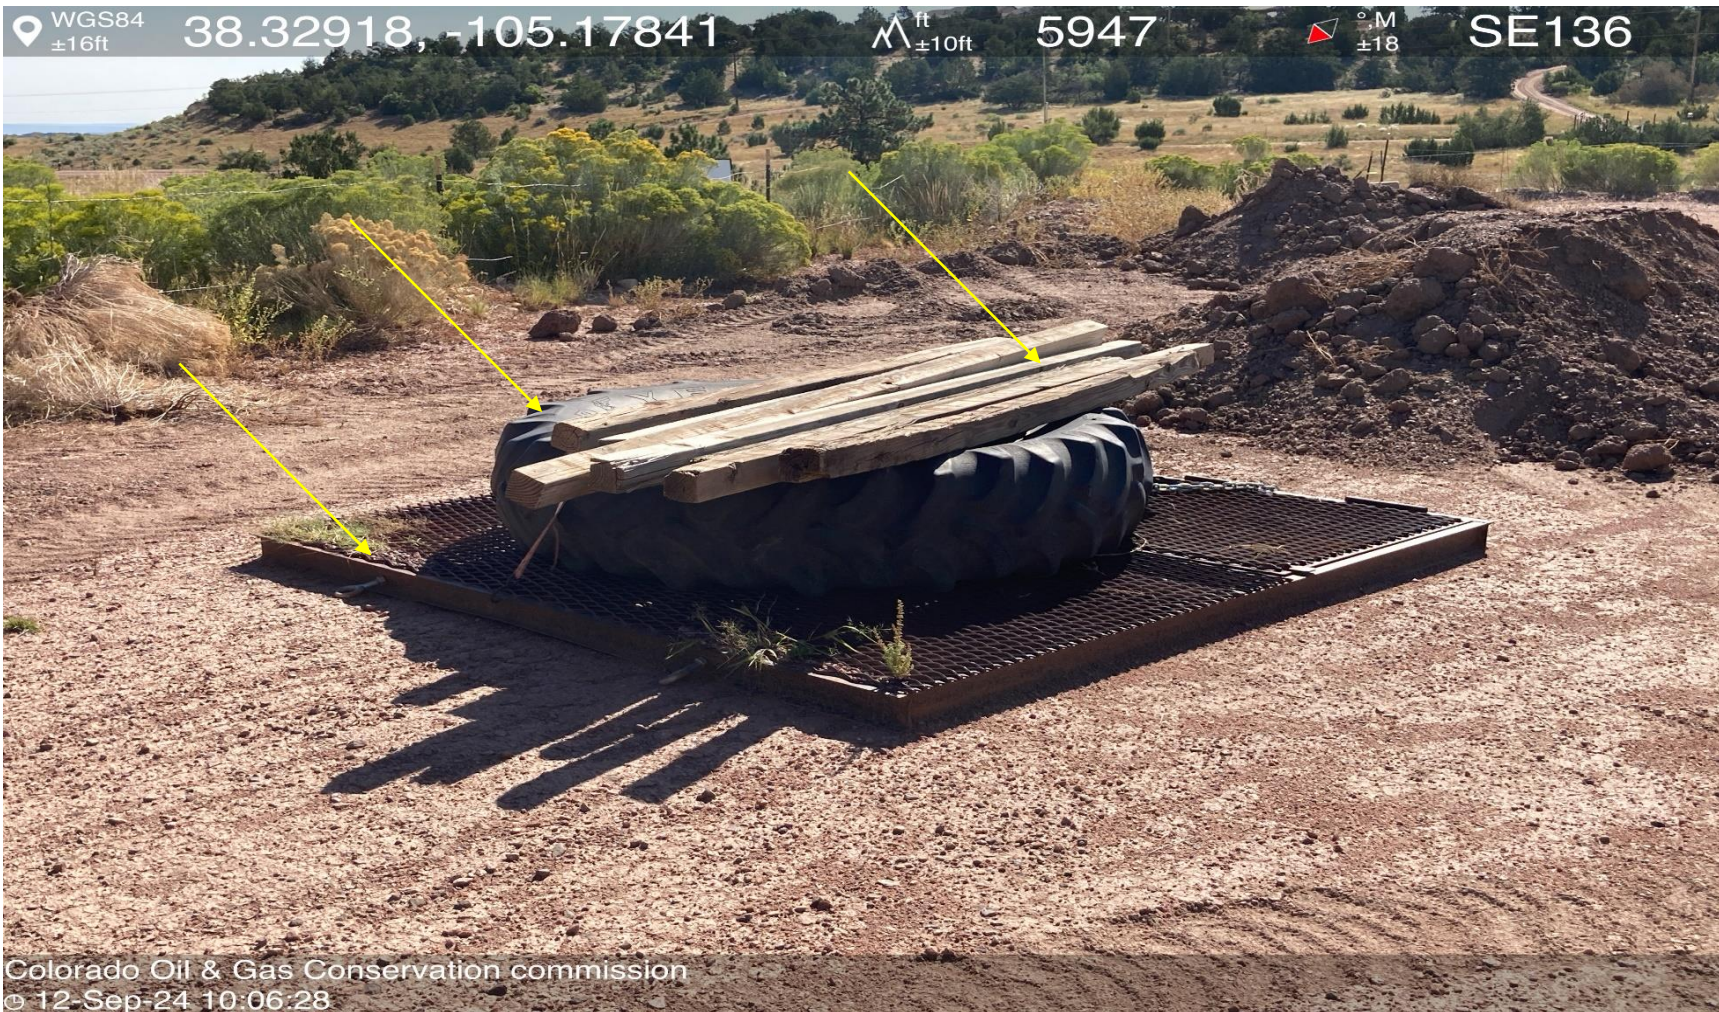
PHOTO 15: UNUSED EQUIPMENT STORED ON LOCATION (TRACKOR TIRE, WOOD AND APPEARS TO BE DECK OFF OF A WORKOVER RIG). REMOVE ALL UNUSED EQUIPEMENT FROM LOCATION PER RULE 606. CA DATE 9-18-2024.

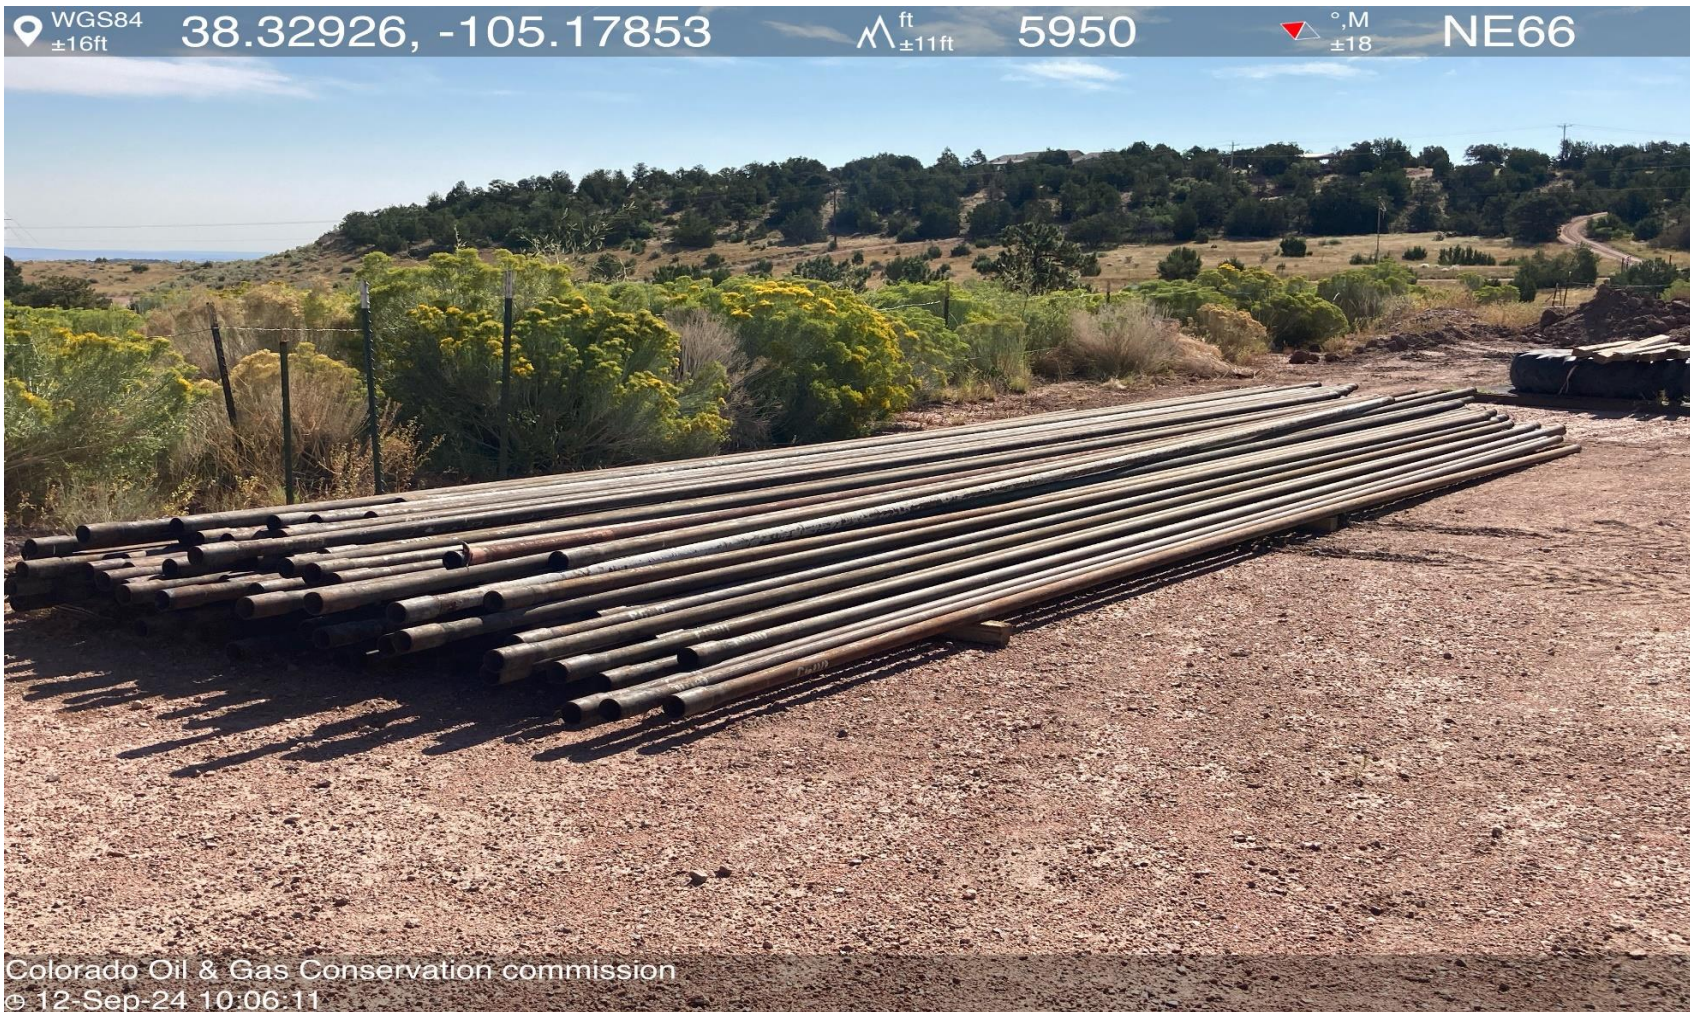
PHOTO 16: UNUSED EQUIPMENT STORED ON LOCATION (APPEARS TO BE 2 3/8" TUBING). REMOVE ALL UNUSED EQUIPEMENT FROM LOCATION PER RULE 606. CA DATE 9-18-2024.

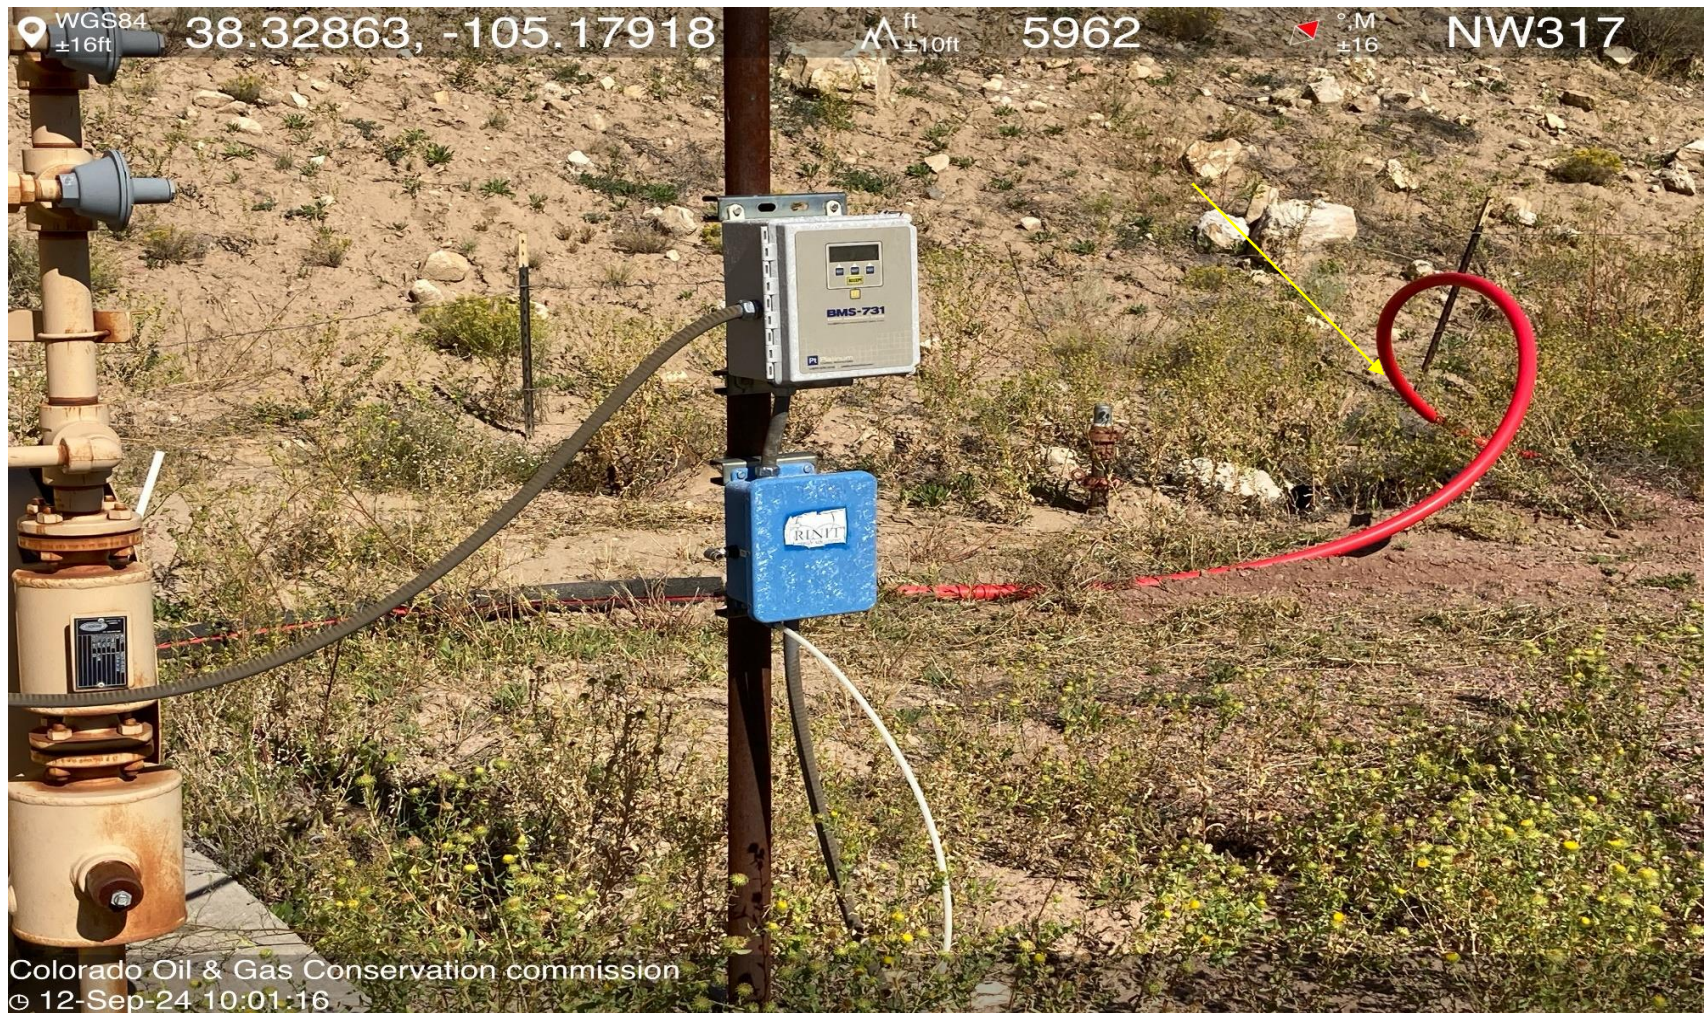
PHOTO 17: UNUSED EQUIPMENT STORED ON LOCATION (ORANGE 2" POLY PIPE CONNECTED TO PRODUCED WATER TANK IS NOT CONNECTED ON SOUTH END). REMOVE ALL UNUSED EQUIPEMENT FROM LOCATION PER RULE 606. CA DATE 12/12/2024.

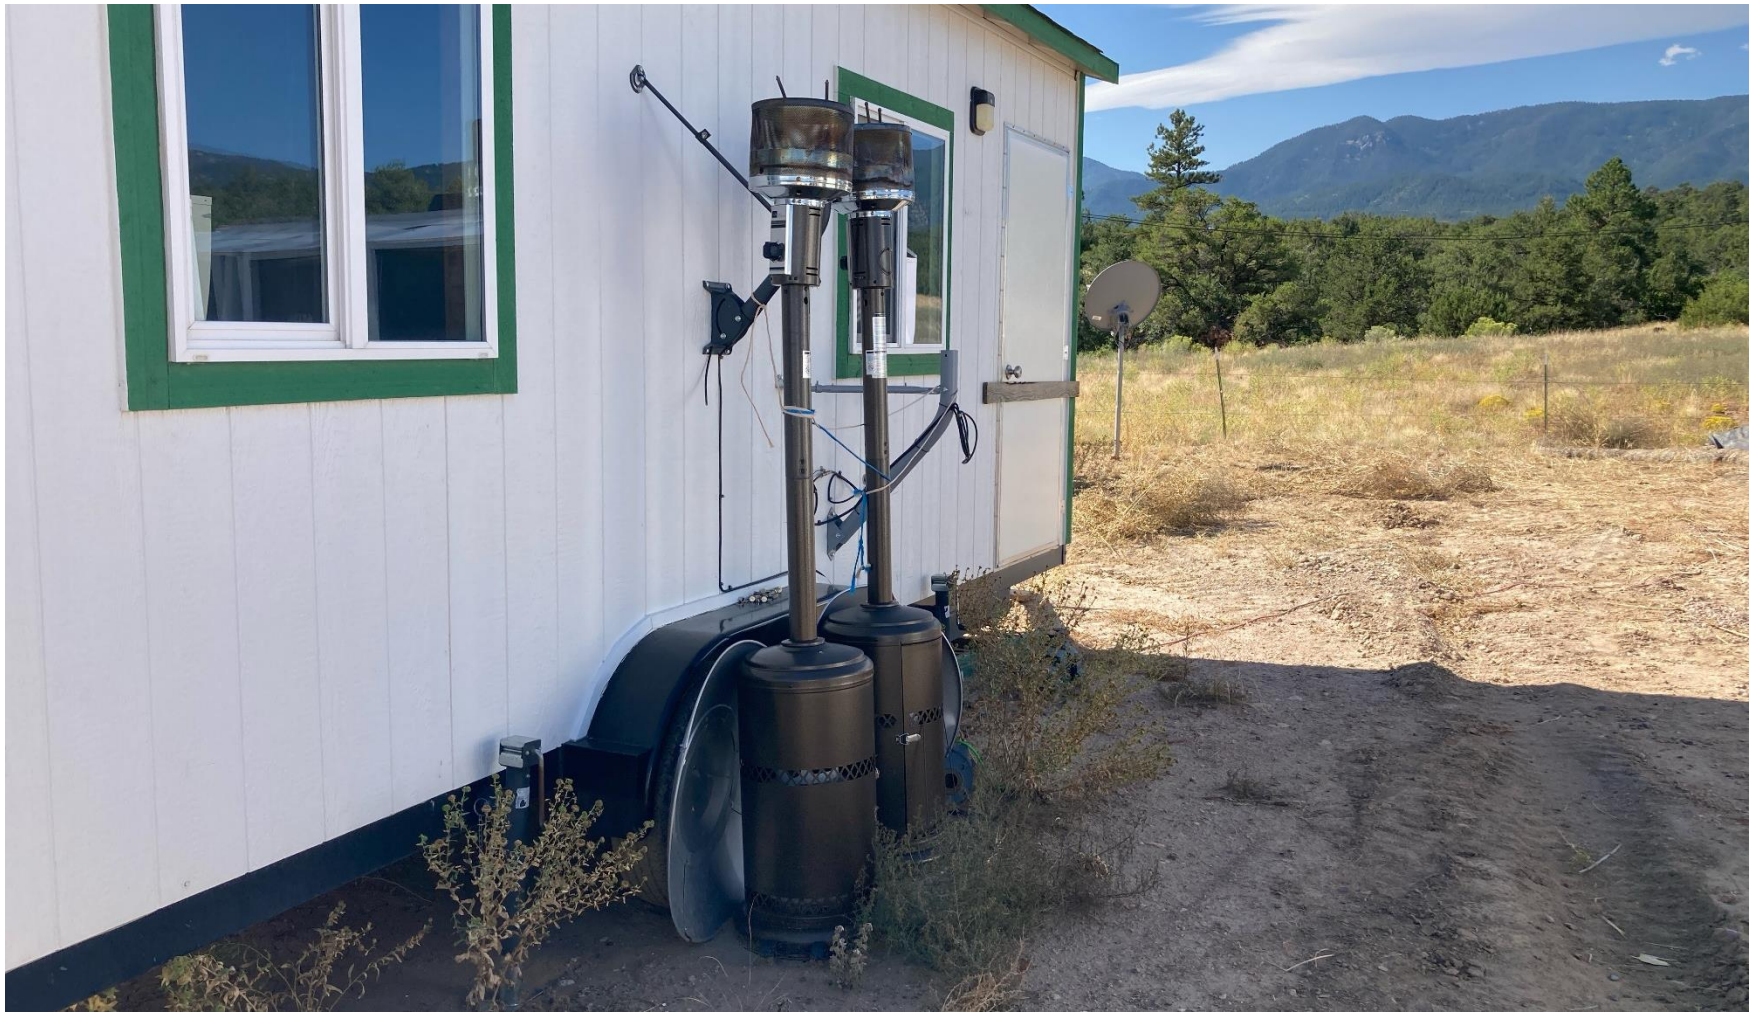
**PHOTO 18: UNUSED EQUIPMENT STORD ON LOCATION (OFFECE AND HEATERS). REMOVE UNUSED EQUIPMENT PER RULE 606.
CA DATE 12/12/2024.**

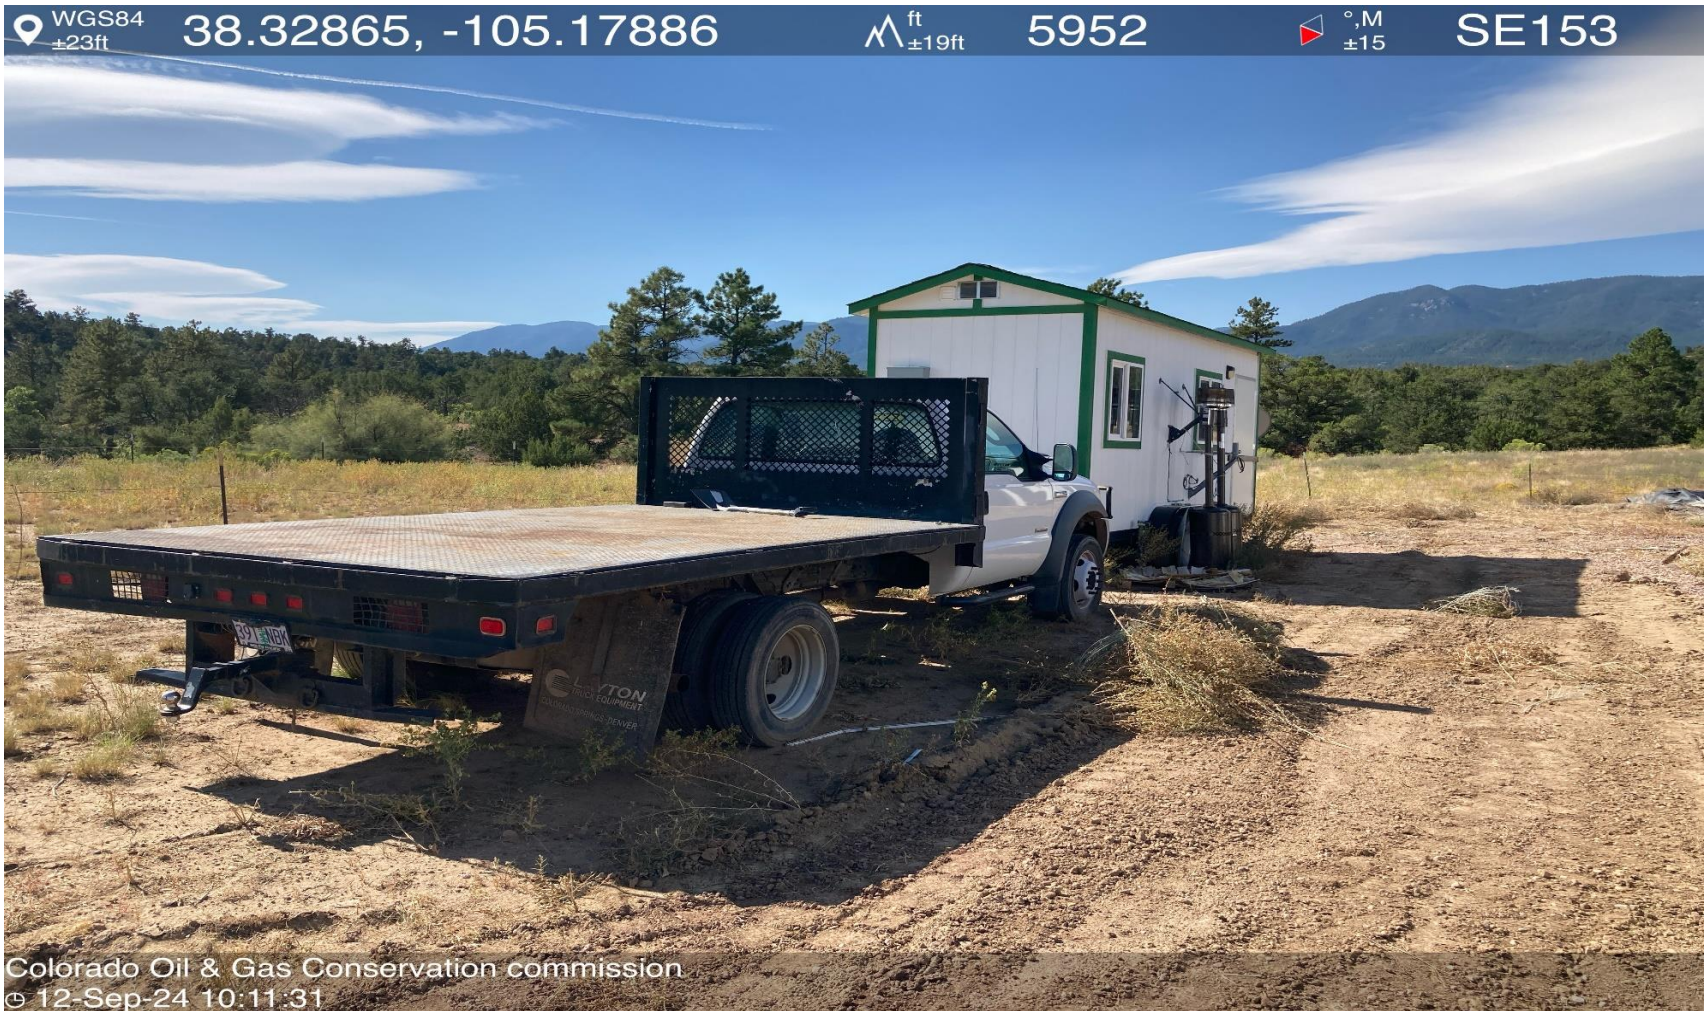
PHOTO 19: UNUSED EQUIPMENT STORD ON LOCATION (TRUCK, OFFECE AND HEATERS). REMOVE UNUSED EQUIPMENT PER RULE 606. CA DATE 12/12/2024.

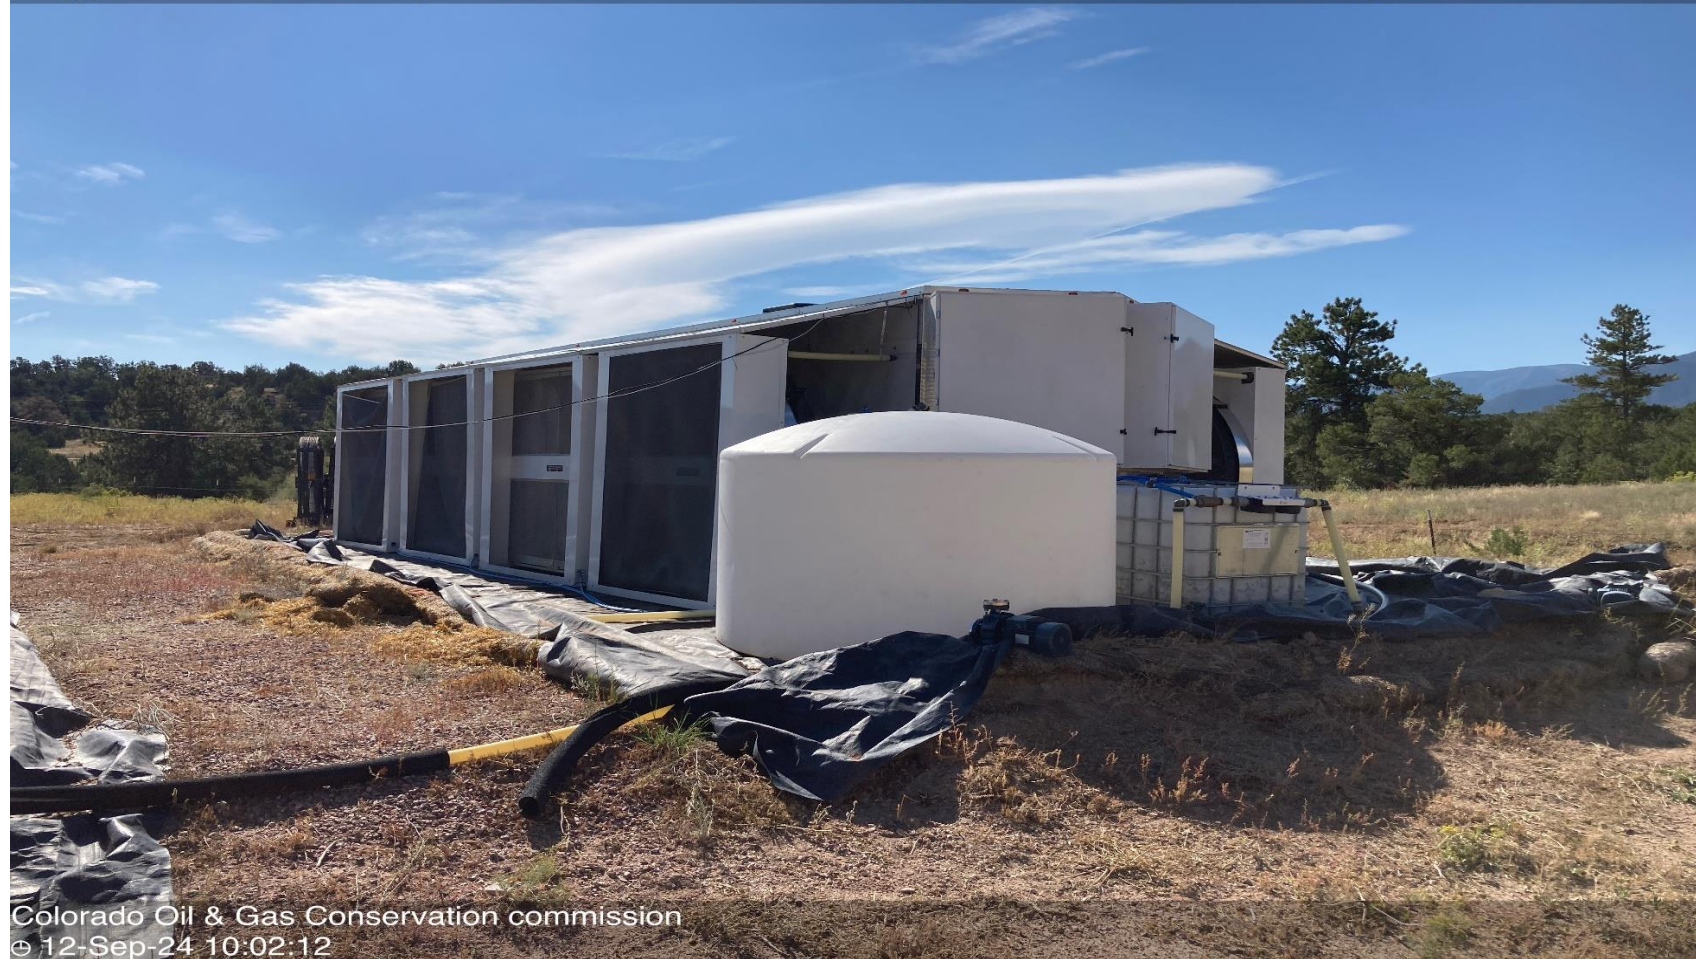
PHOTO 20: UNUSED EQUIPMENT STORD ON LOCATION (MINING COOLER UNITS AND TANKS). REMOVE UNUSED EQUIPMENT PER RULE 606. CA DATE 12/12/2024.

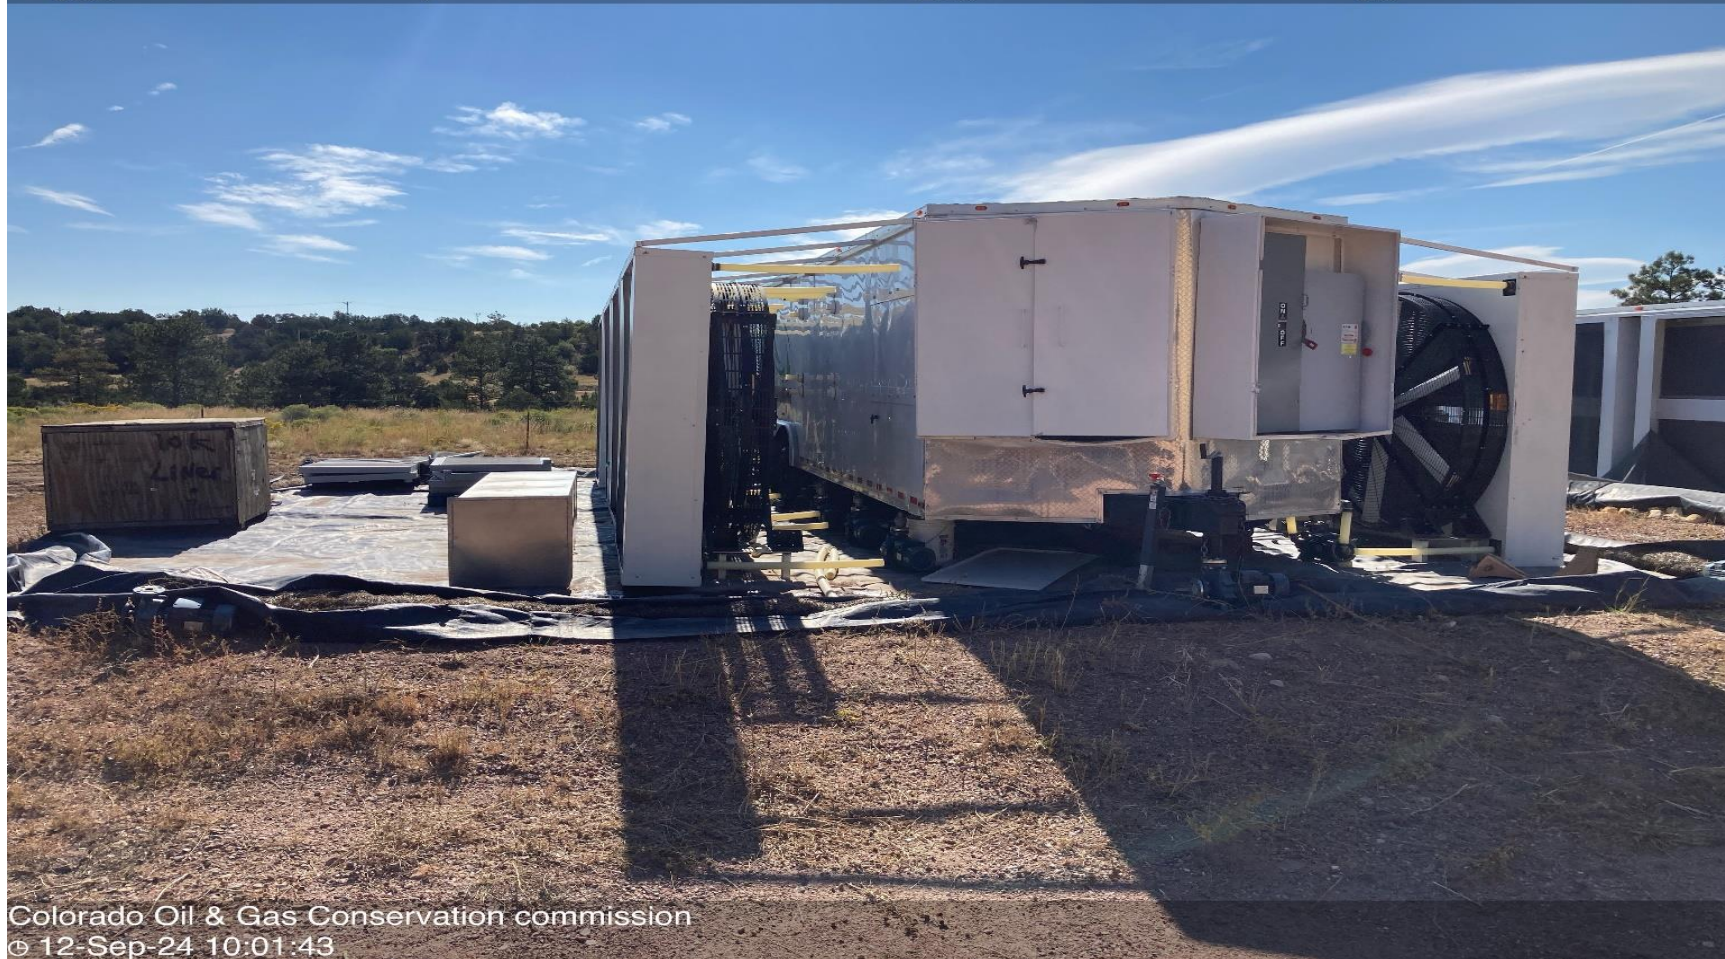
PHOTO 21: UNUSED EQUIPMENT STORD ON LOCATION (MINING COOLER UNITS AND TANKS). REMOVE UNUSED EQUIPMENT PER RULE 606. CA DATE 12/12/2024.

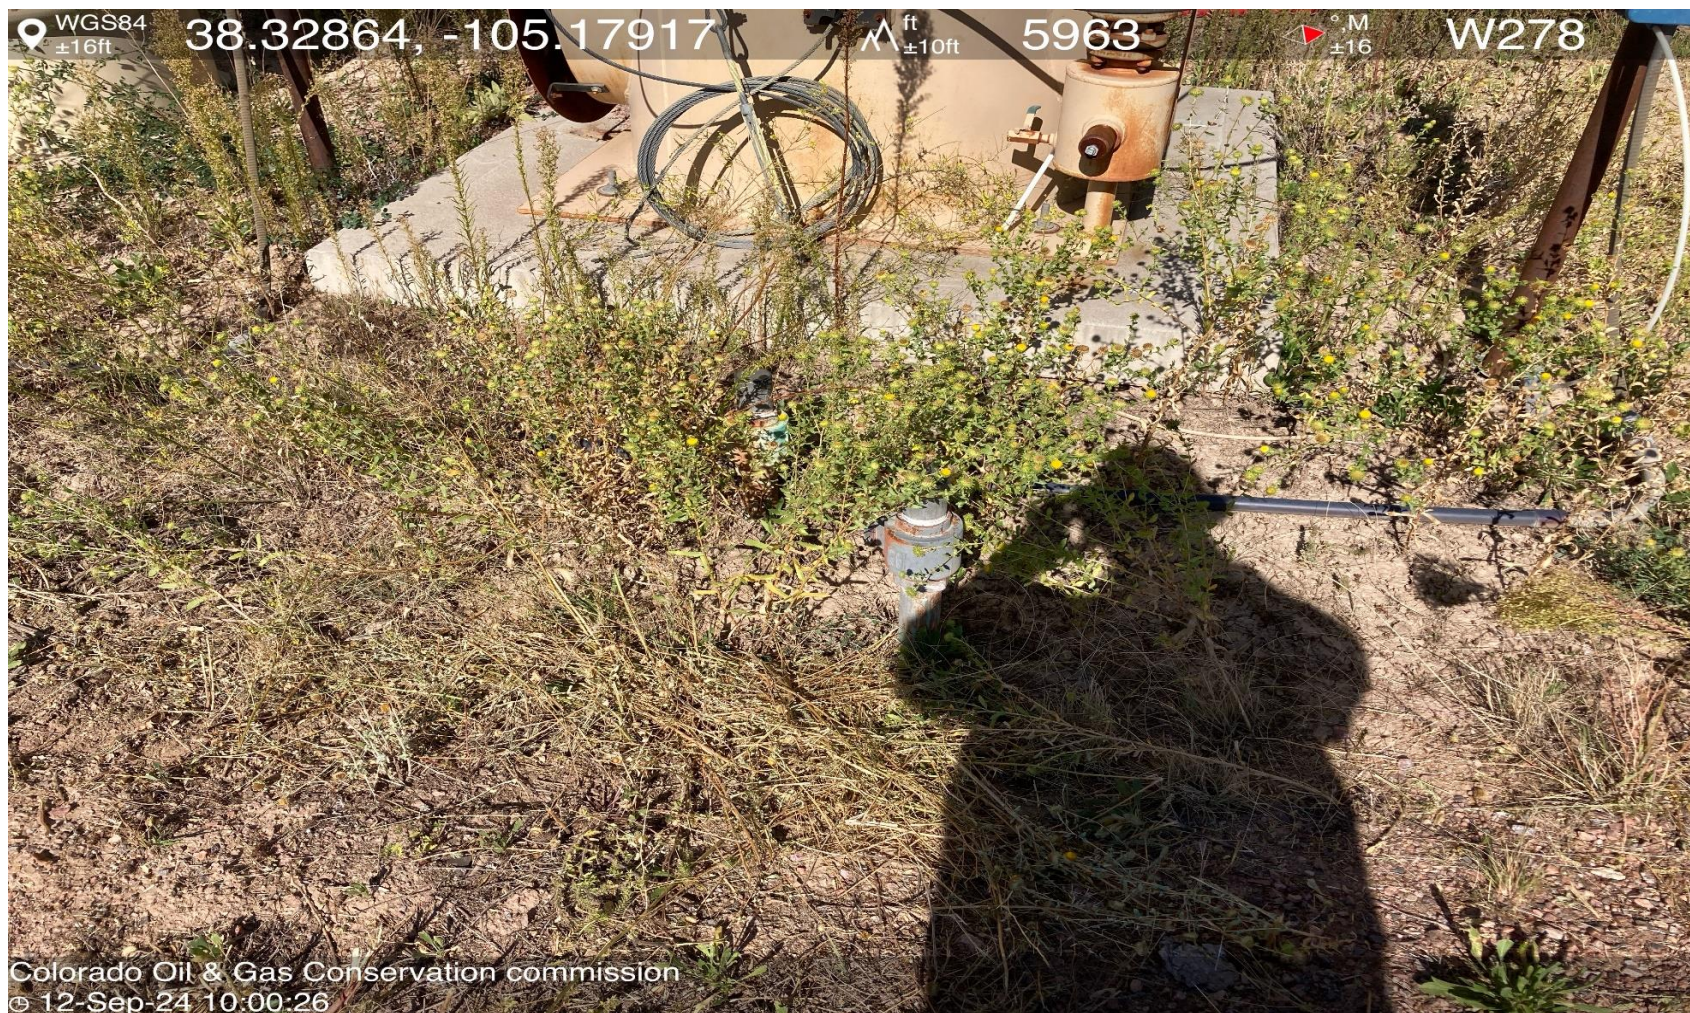
PHOTO 22: UNUSED EQUIPMENT (UNUSED RISERS BY ECD'S). REMOVE OR MARK UNUSED RISERS PER RULE 606. CA DATE 10-12-2024.

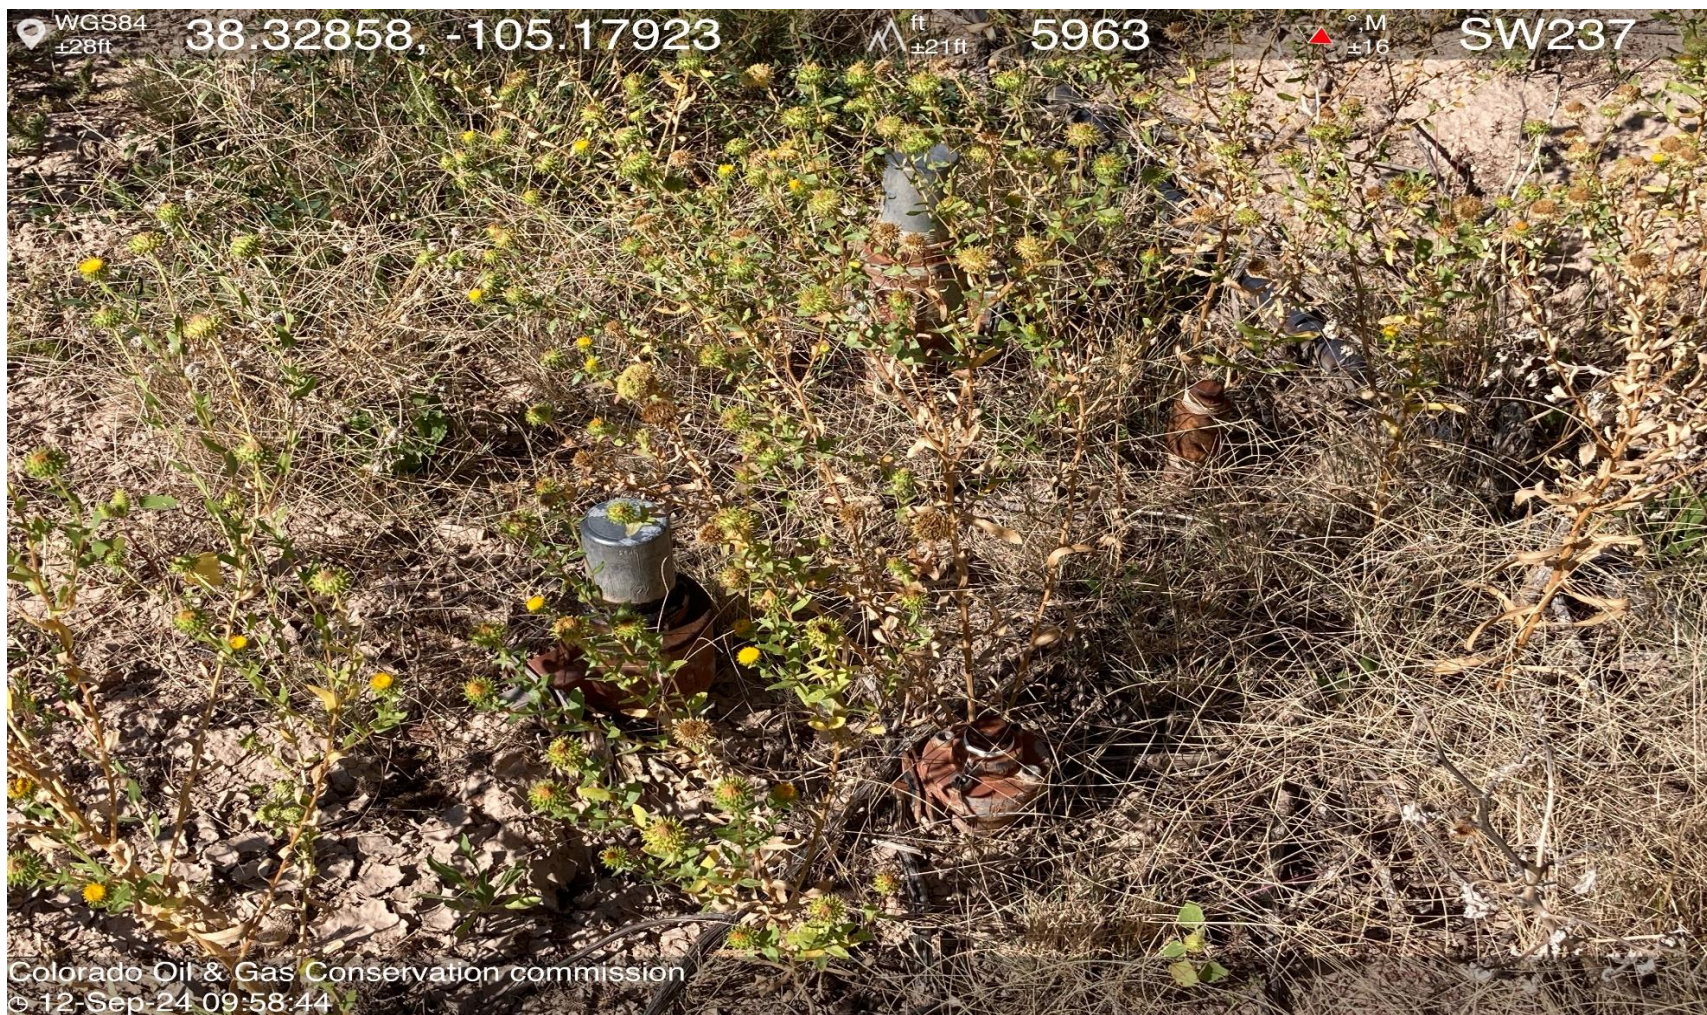
PHOTO 23: UNUSED EQUIPMENT (UNUSED RISERS BY ECD'S). REMOVE OR MARK UNUSED RISERS PER RULE 606. CA DATE 10-12-2024.

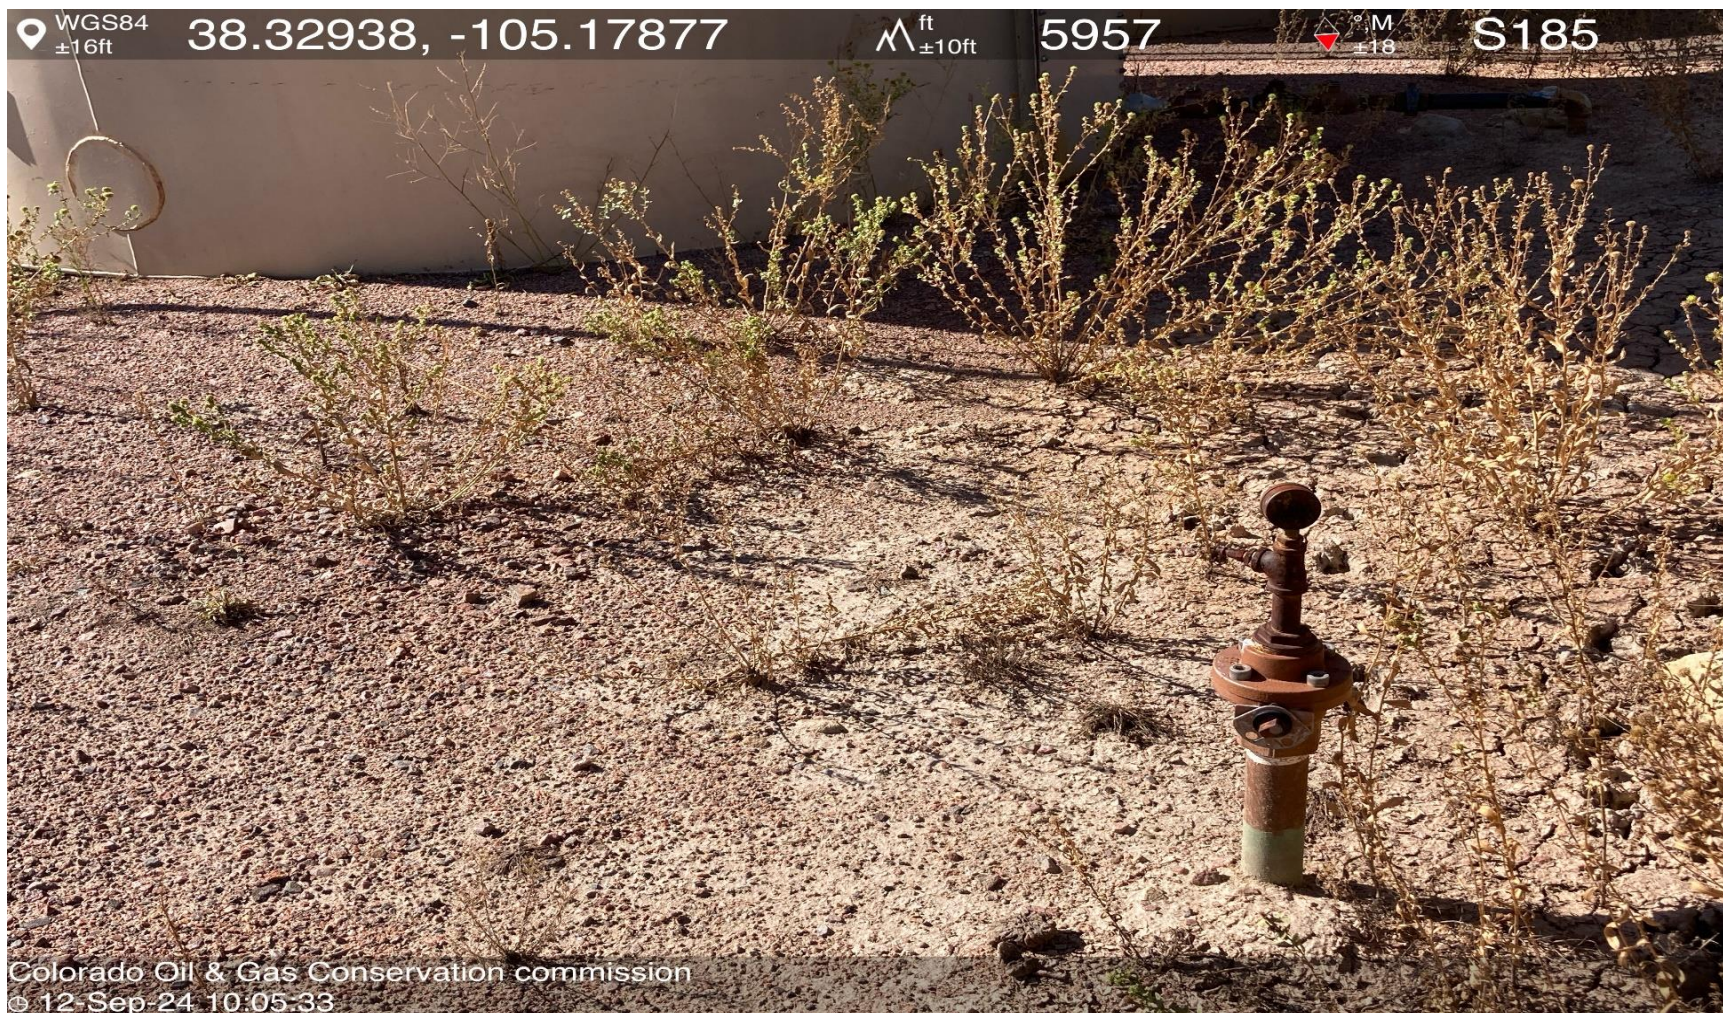
**PHOTO 24: UNUSED EQUIPMENT (UNUSED RISER NEAR CRUDE OIL TANKS). REMOVE OR MARK UNUSED RISERS PER RULE 606.
CA DATE 10-12-2024.**

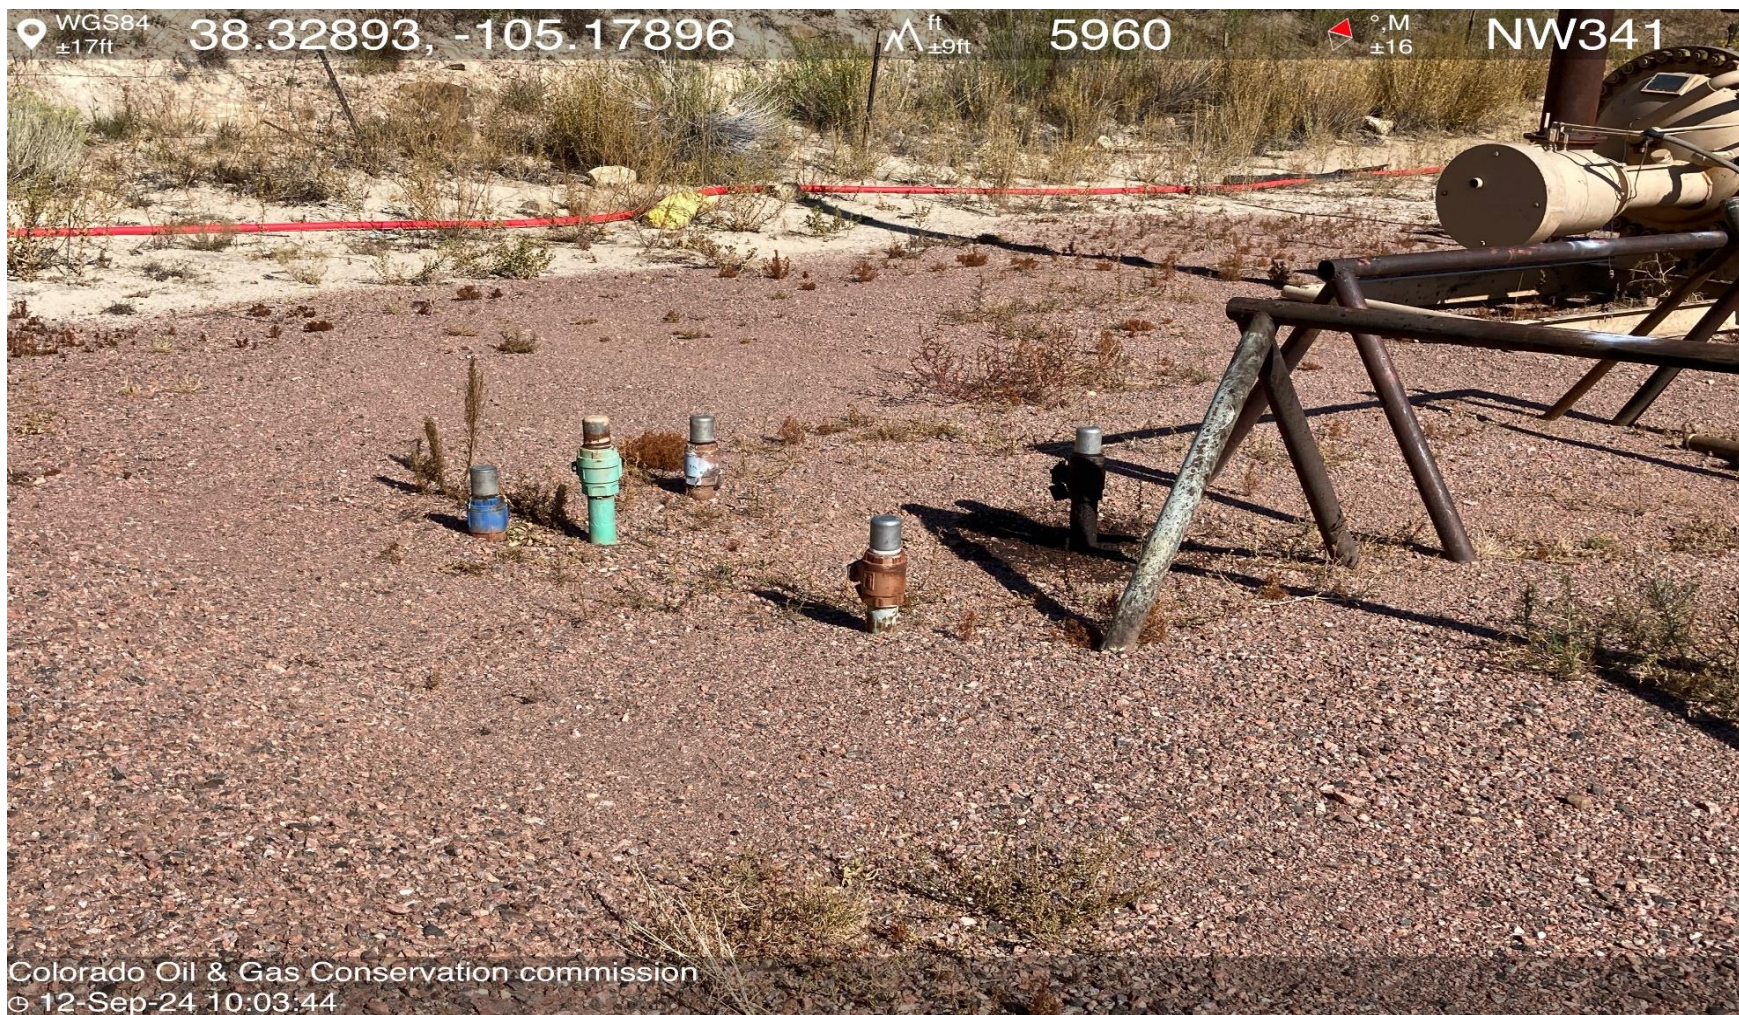
PHOTO 24: UNUSED EQUIPMENT (UNUSED RISER NEAR HEATED SEPARATOR). REMOVE OR MARK UNUSED RISERS PER RULE 606. CA DATE 10-12-2024.

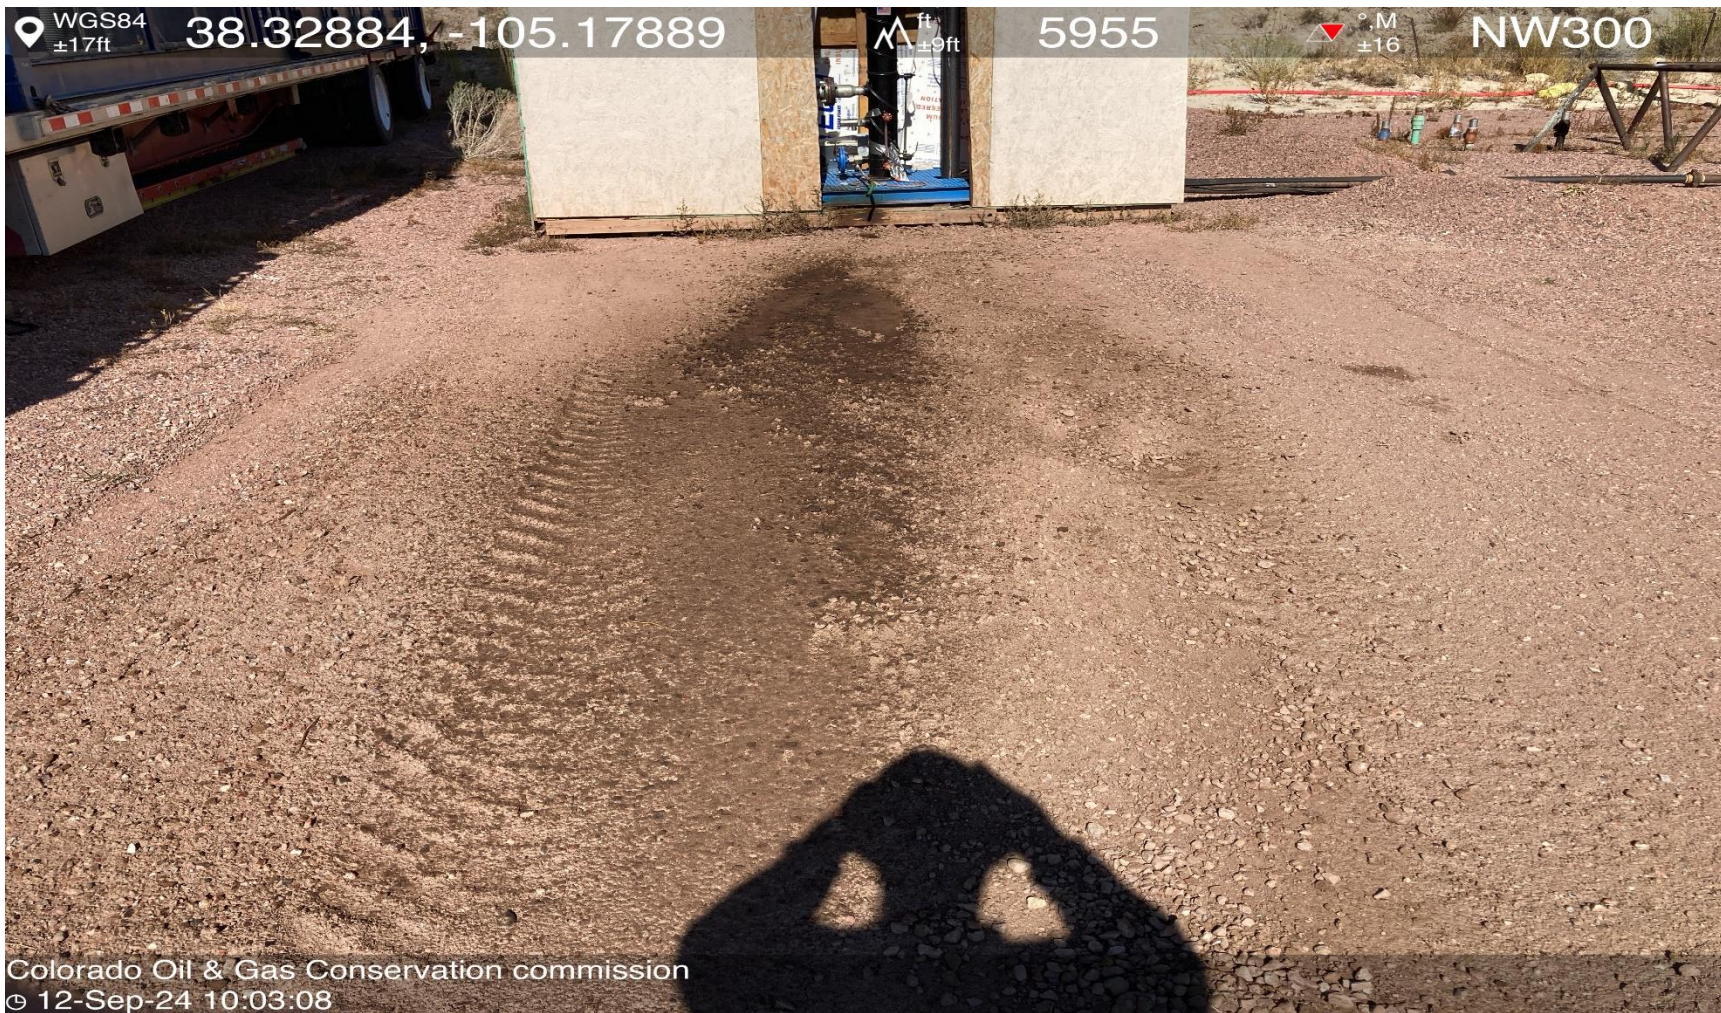
PHOTO 26: AREA OF IMPACTED SOIL APPEARS TO BE OILY WASTE FROM DRAINING SEPARATOR ON GROUND. REMOVE IMPACTED SOIL AND DISPOSE OF PROPERLY, INCREASE Self-inspection, maintenance, and good housekeeping procedures and schedules. CA DATE 10/12/2024

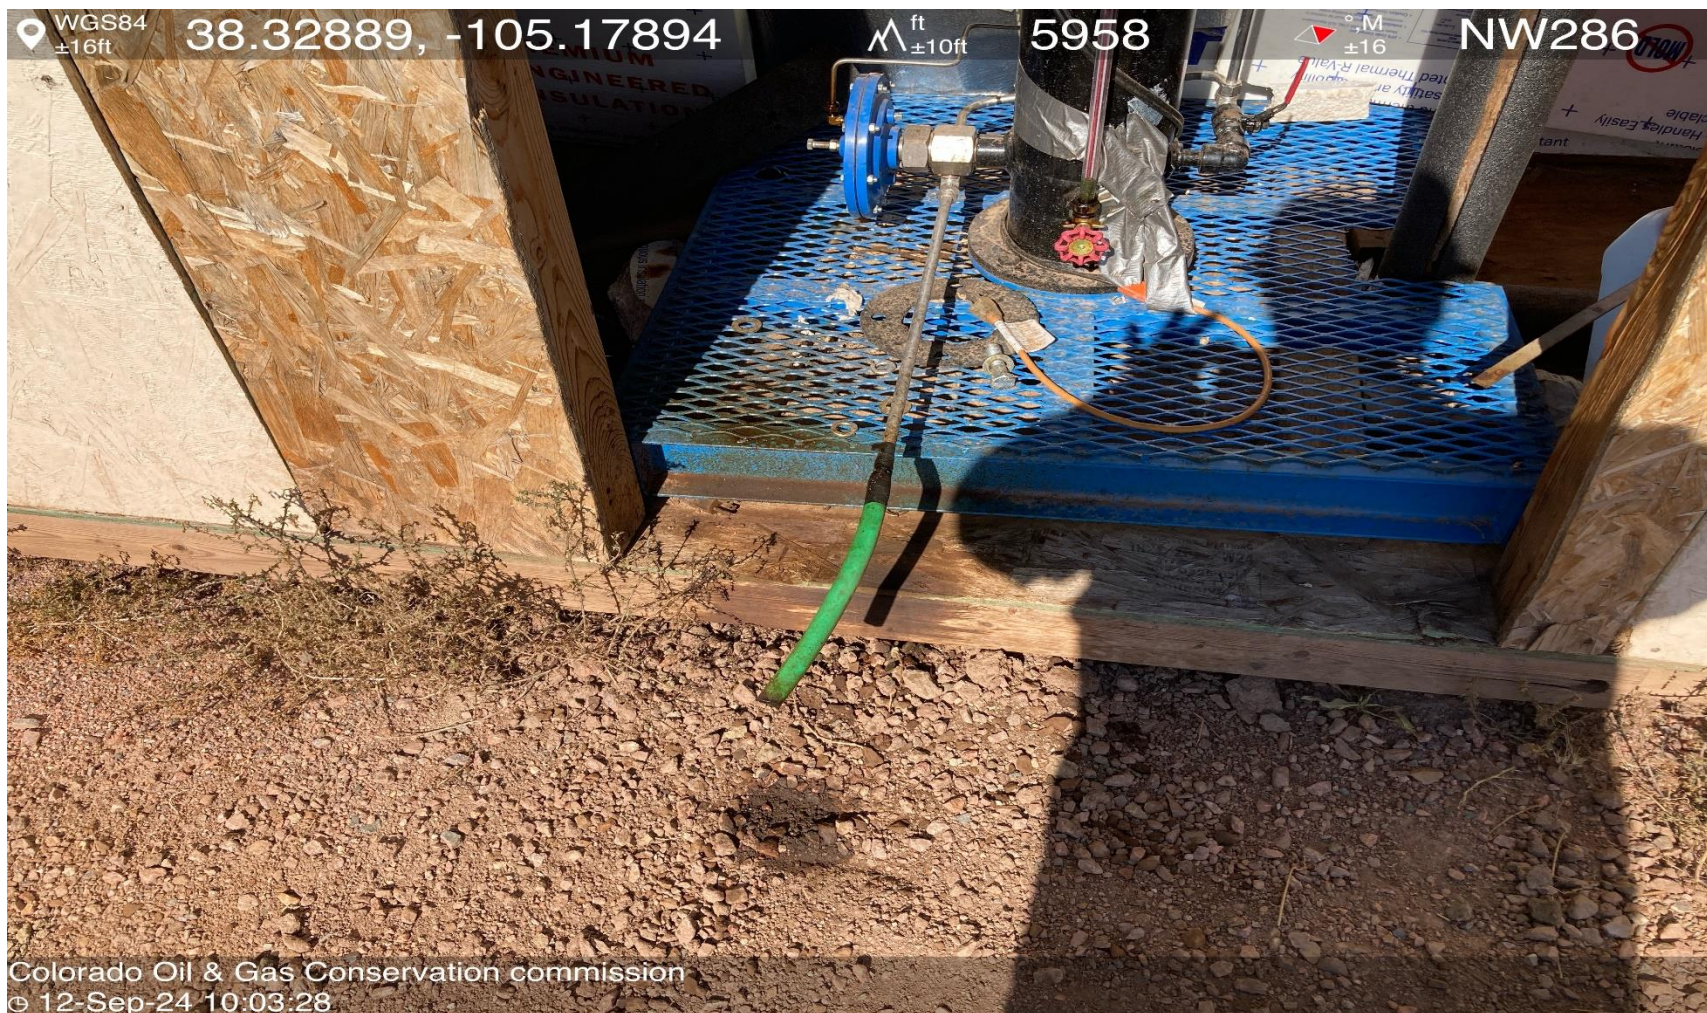
PHOTO 27: AREA OF IMPACTED SOIL APPEARS TO BE OILY WASTE FROM DRAINING SEPARATOR ON GROUND. REMOVE IMPACTED SOIL AND DISPOSE OF PROPERLY, INCREASE Self-inspection, maintenance, and good housekeeping procedures and schedules. CA DATE 10/12/2024.
