WELL NAME: PACHFINDER C-11-12 #2, API #: 071-06221, INSP. # 695110249

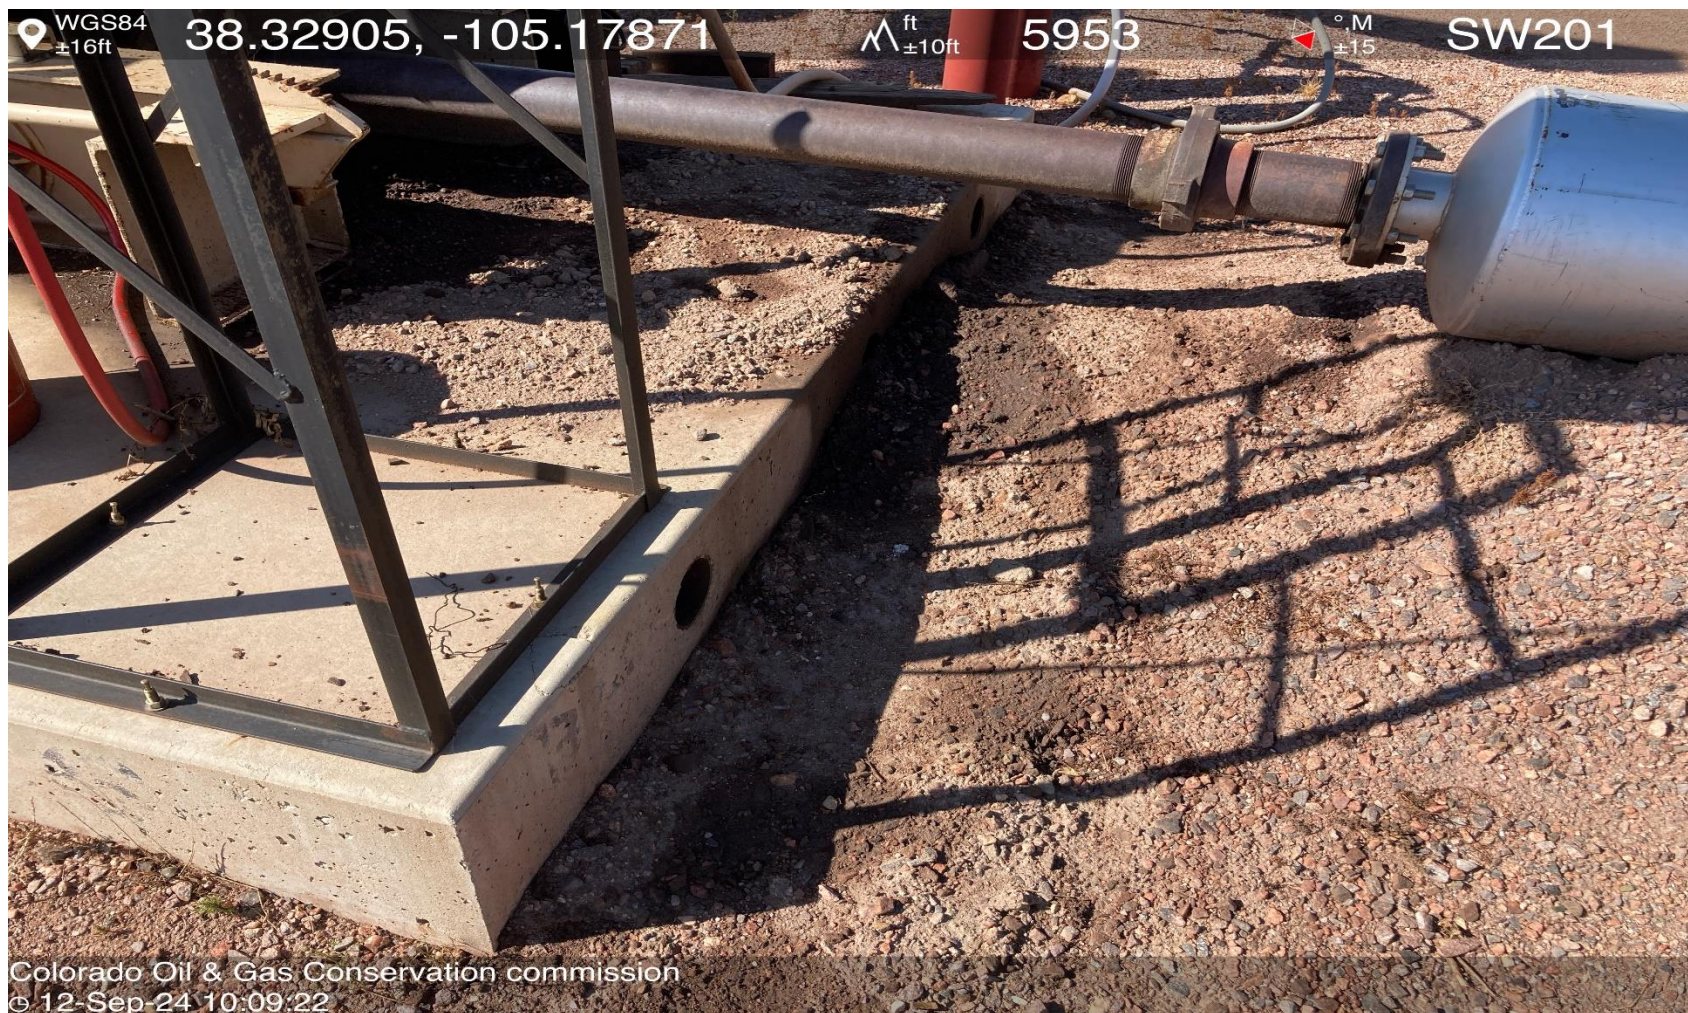
PHOTO 27: AREA OF IMPACTED SOIL NEAR LEAKING PUMPJACK MOTOR OR GEAR BOX. REMOVE IMPACTED SOIL AND DISPOSE OF PROPERLY, INCREASE Self-inspection, maintenance, and good housekeeping procedures and schedules AND REPAIR LEAKING EQUIPMENT. CA DATE 10/12/2024.
