Interim Reclamation and Stormwater Inspection

Date: 09/10/2024

Operator: IMPETRO RESOURCES LLC - 10690

Inspection Photos
Location Name: Chandler 2-15
Location ID: 317278

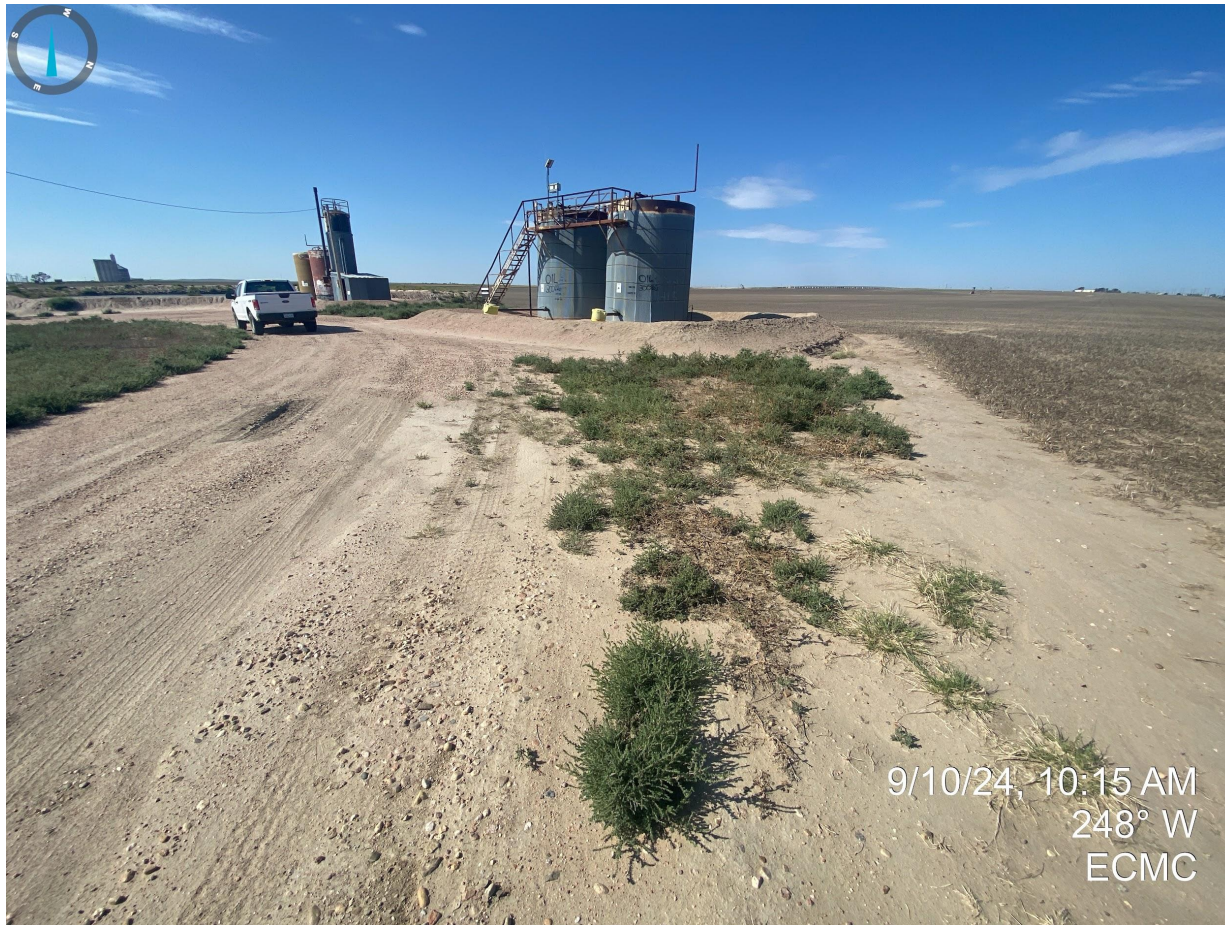
Photo 1. Undesirable vegetation (e.g. kochia and russian thistle) observed at tank battery.

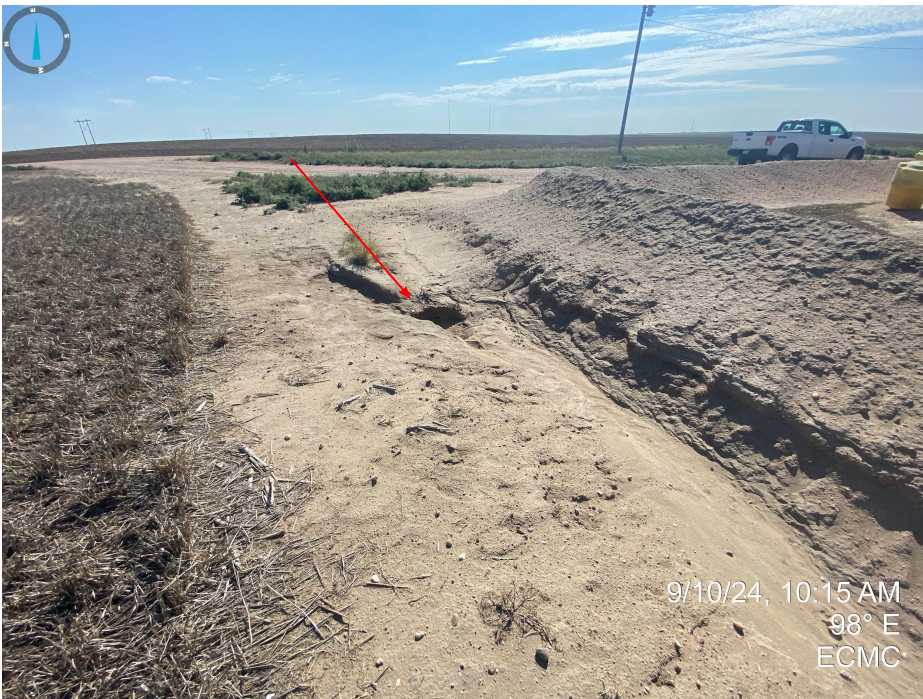
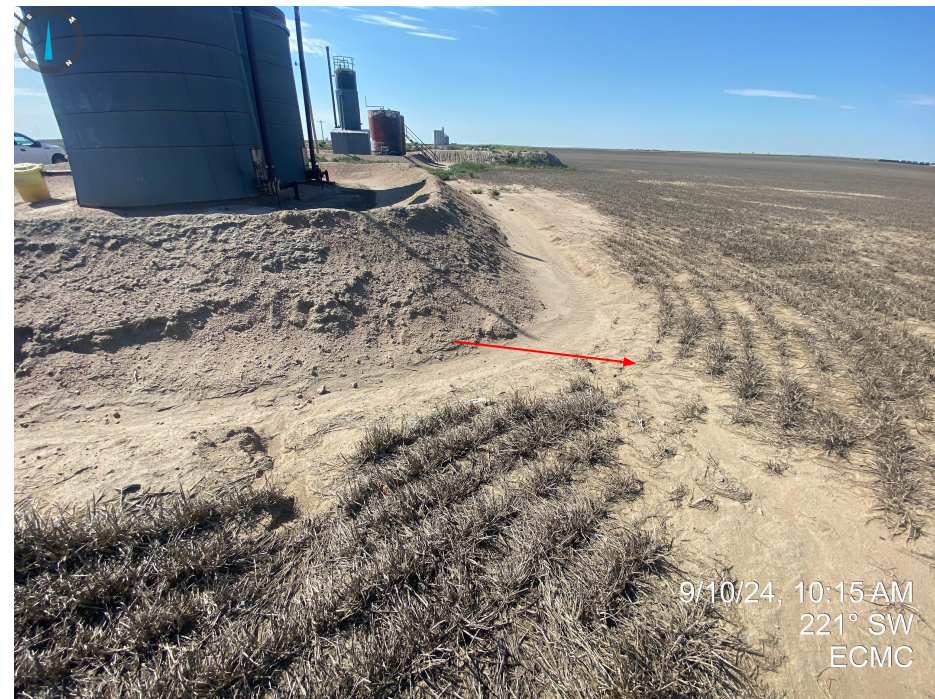
Photos 2 & 3. Erosion degradation north of tank battery (left photo) and sediment discharge into adjacent field (right). No apparent perimeter stormwater controls observed.

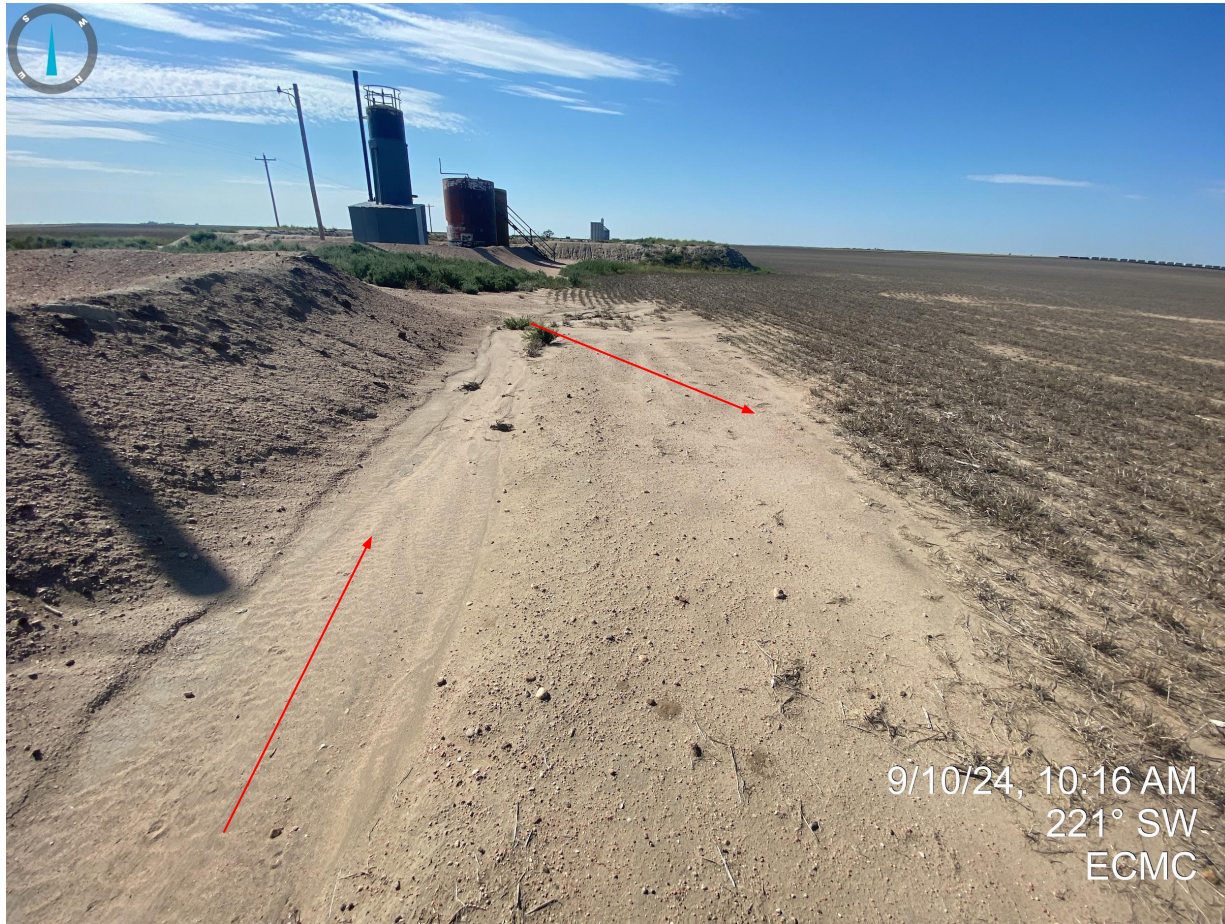
Photo 4. West side of tank battery; see comments in Photo 2 & 3.

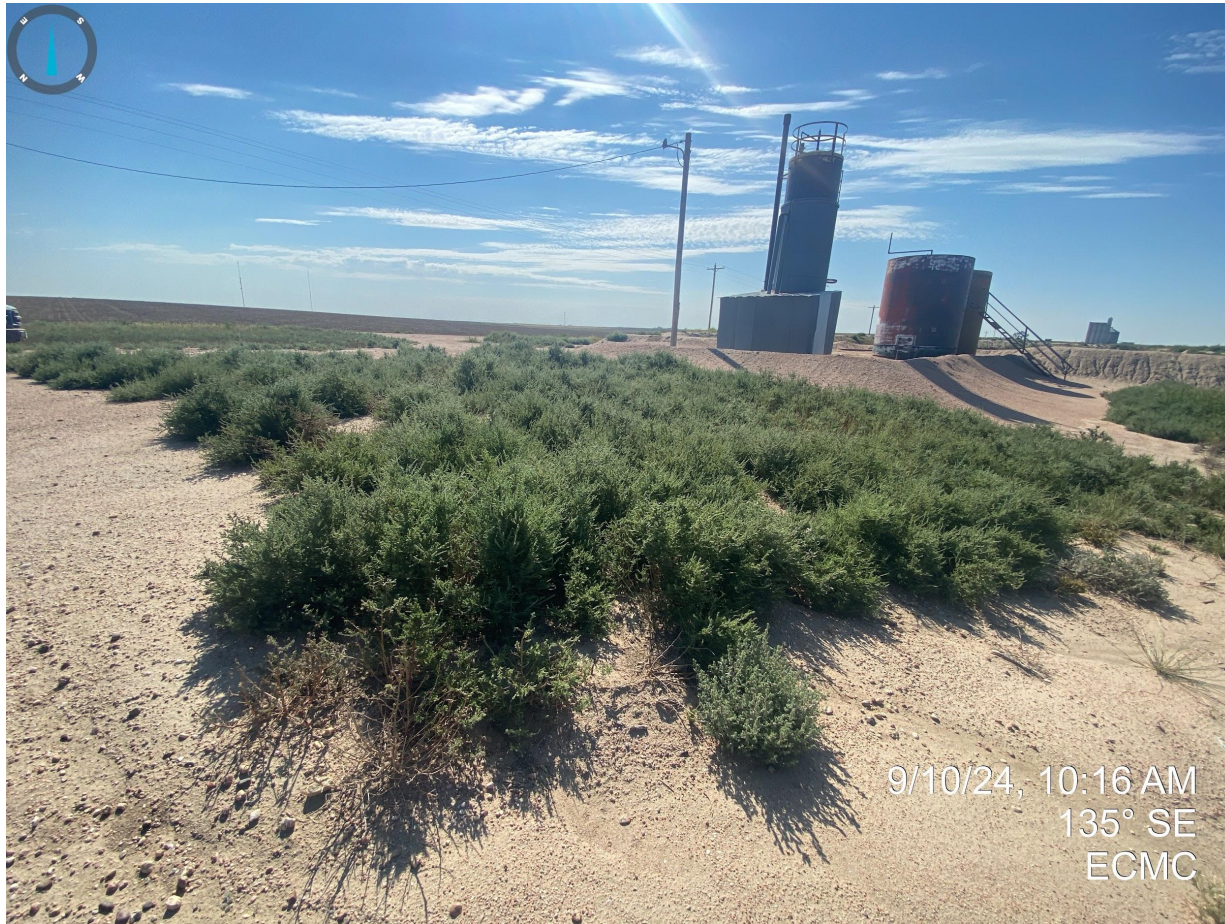
Photo 5. Undesirable vegetation (e.g. kochia and russian thistle) observed at tank battery.

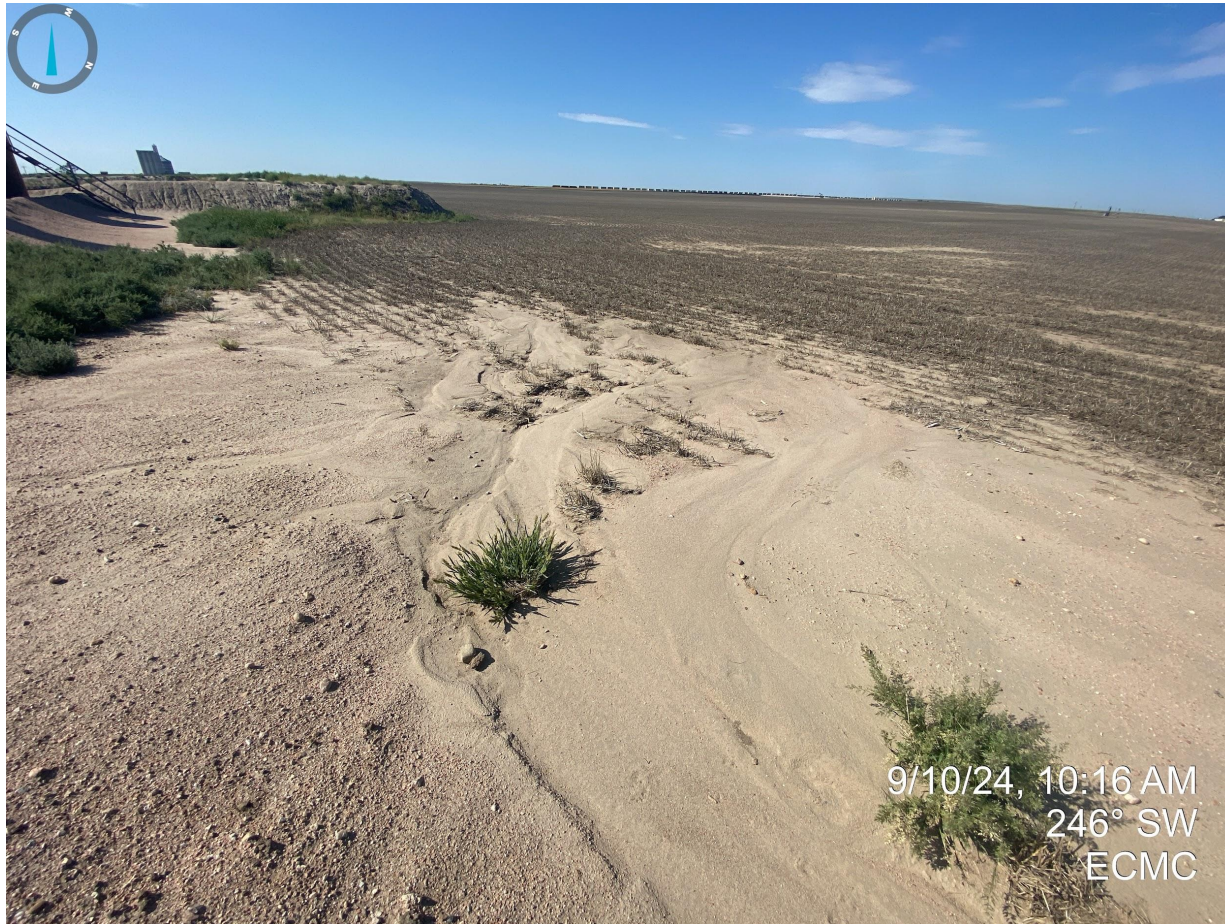
Photo 6. Erosion degradation and sediment discharge observed on the southwest corner of tank battery. No perimeter stormwater controls observed.

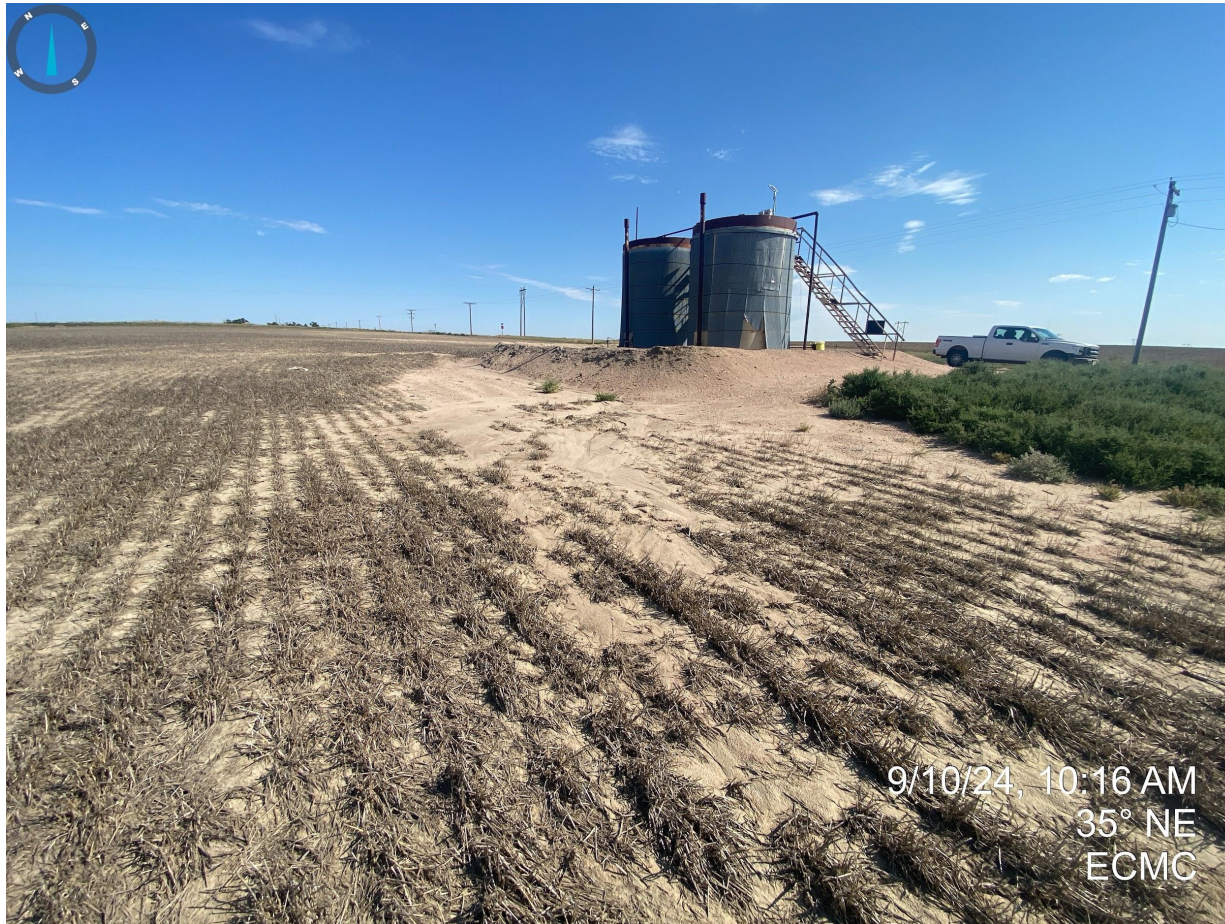
Photo 7. Continued from Photo 6, facing northeast.

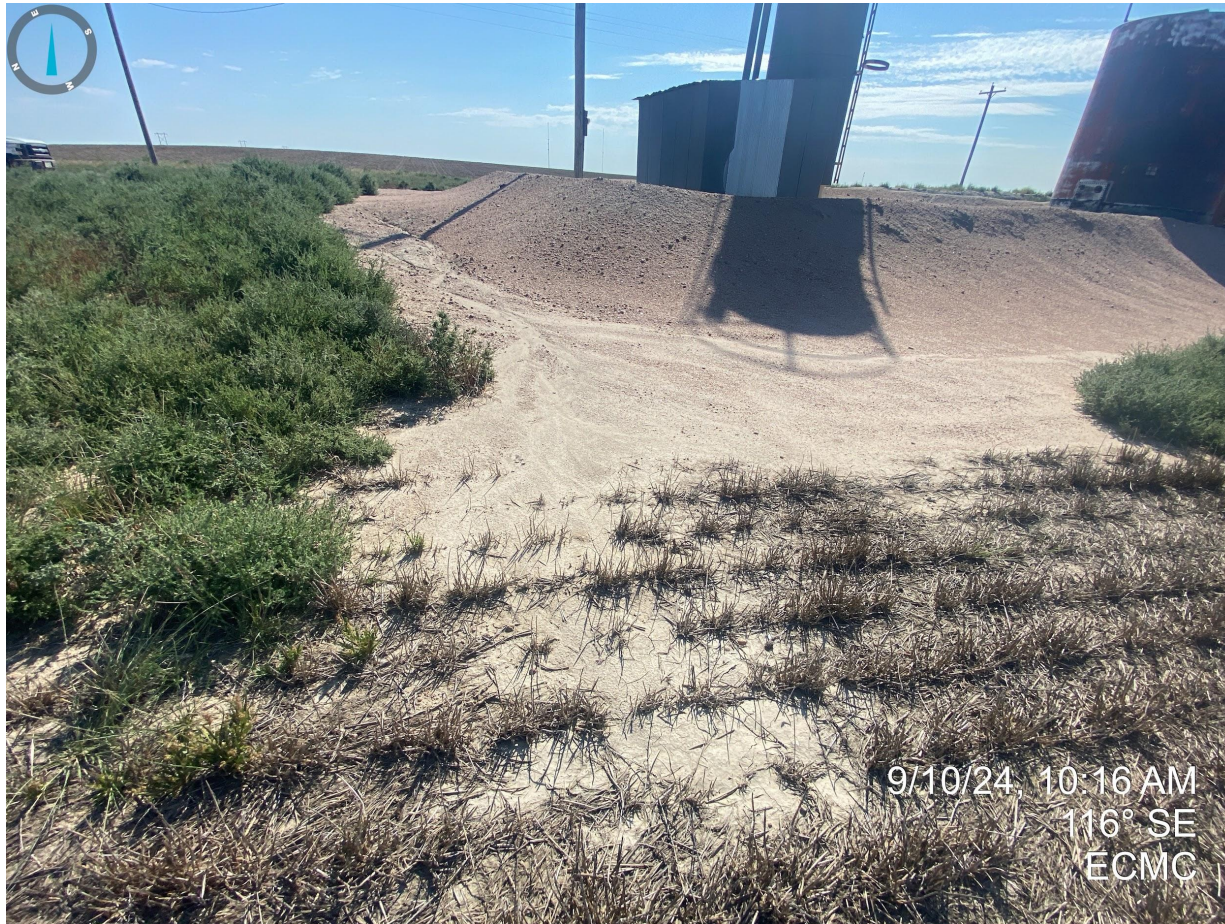
Photo 8. Erosion degradation and sediment discharge observed west of separator. No perimeter stormwater controls observed.

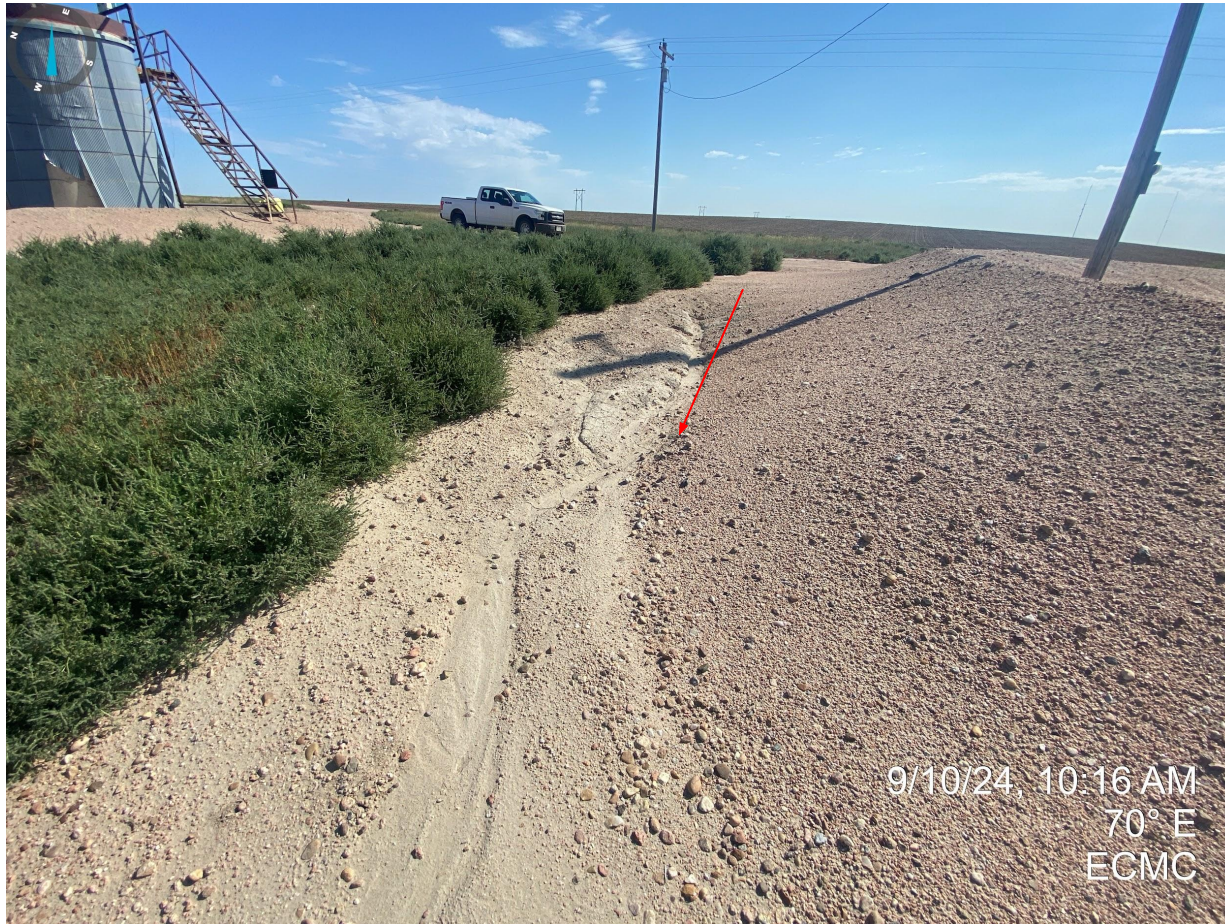
Photo 9. Continued from Photo 8, photo illustrates rill erosion.

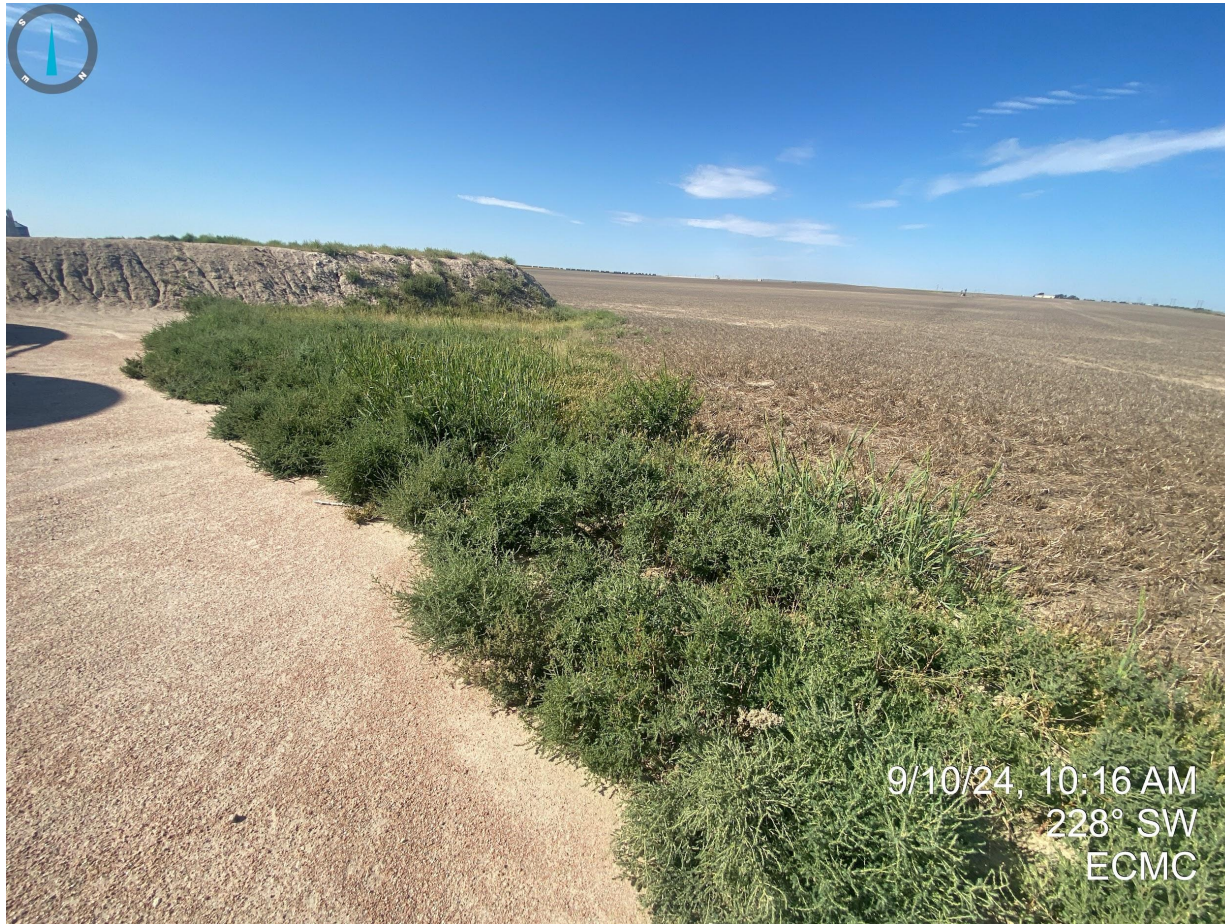
Photo 10. Undesirable vegetation observed north of pit.

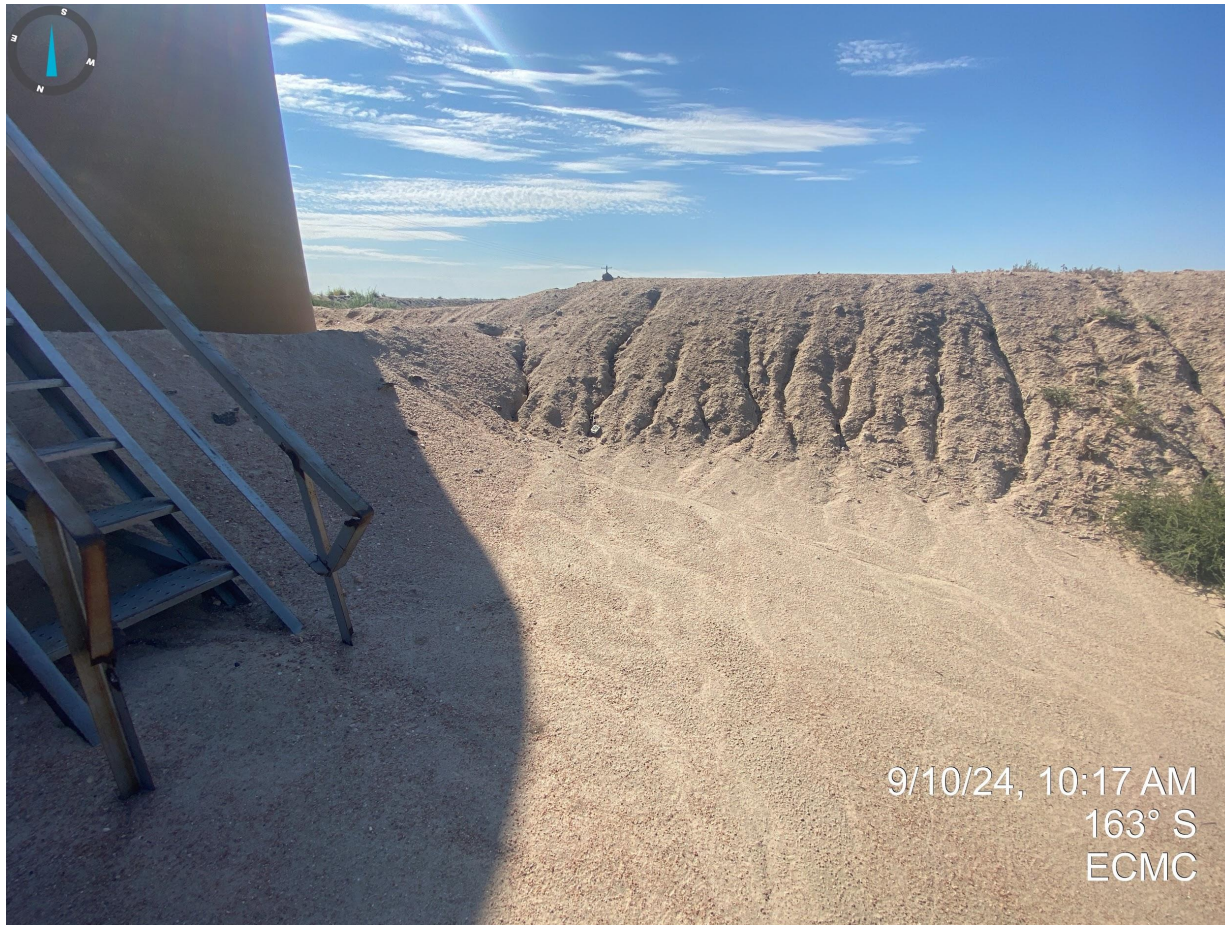
Photo 11. Erosion degradation on pit berms.

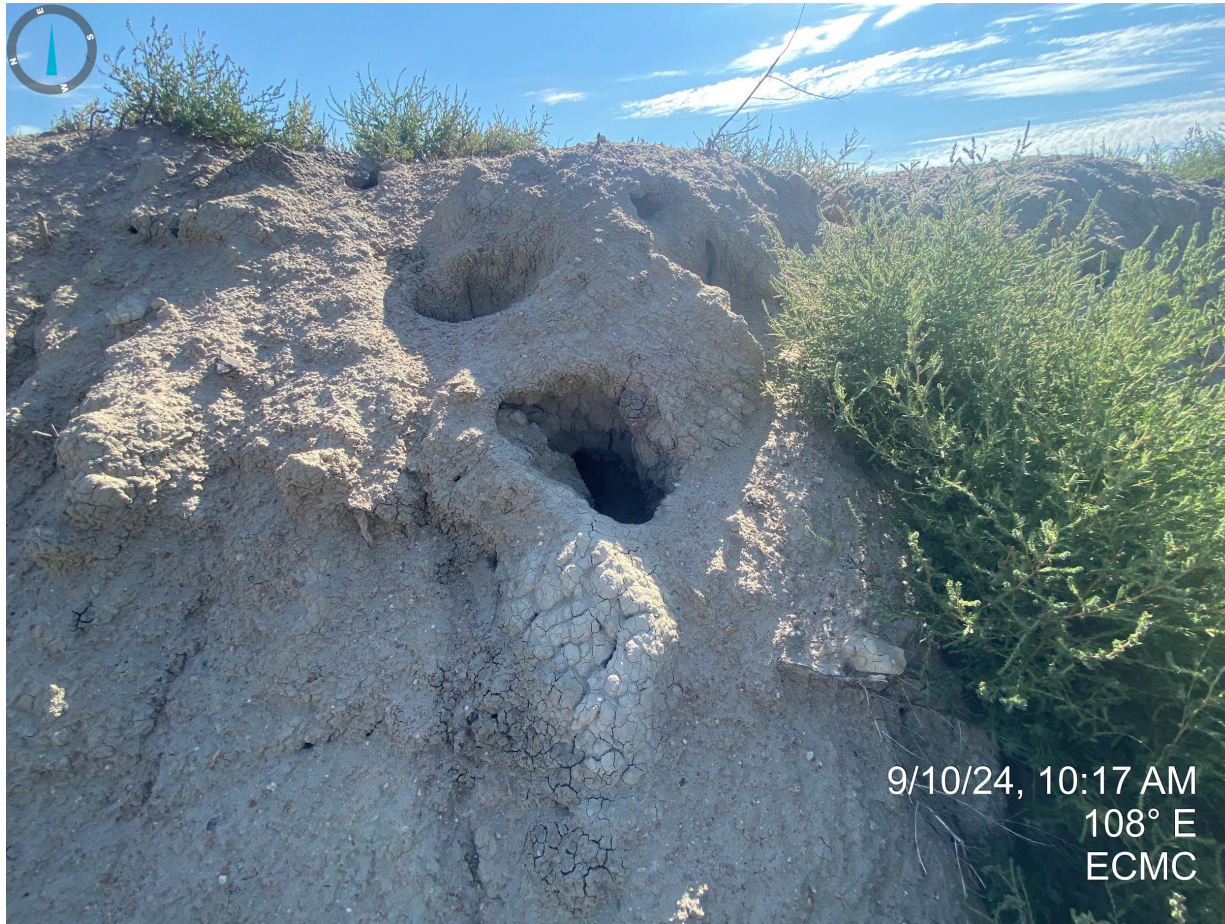
Photo 12. Close up of void in pit berm, illustrating unconsolidated material.

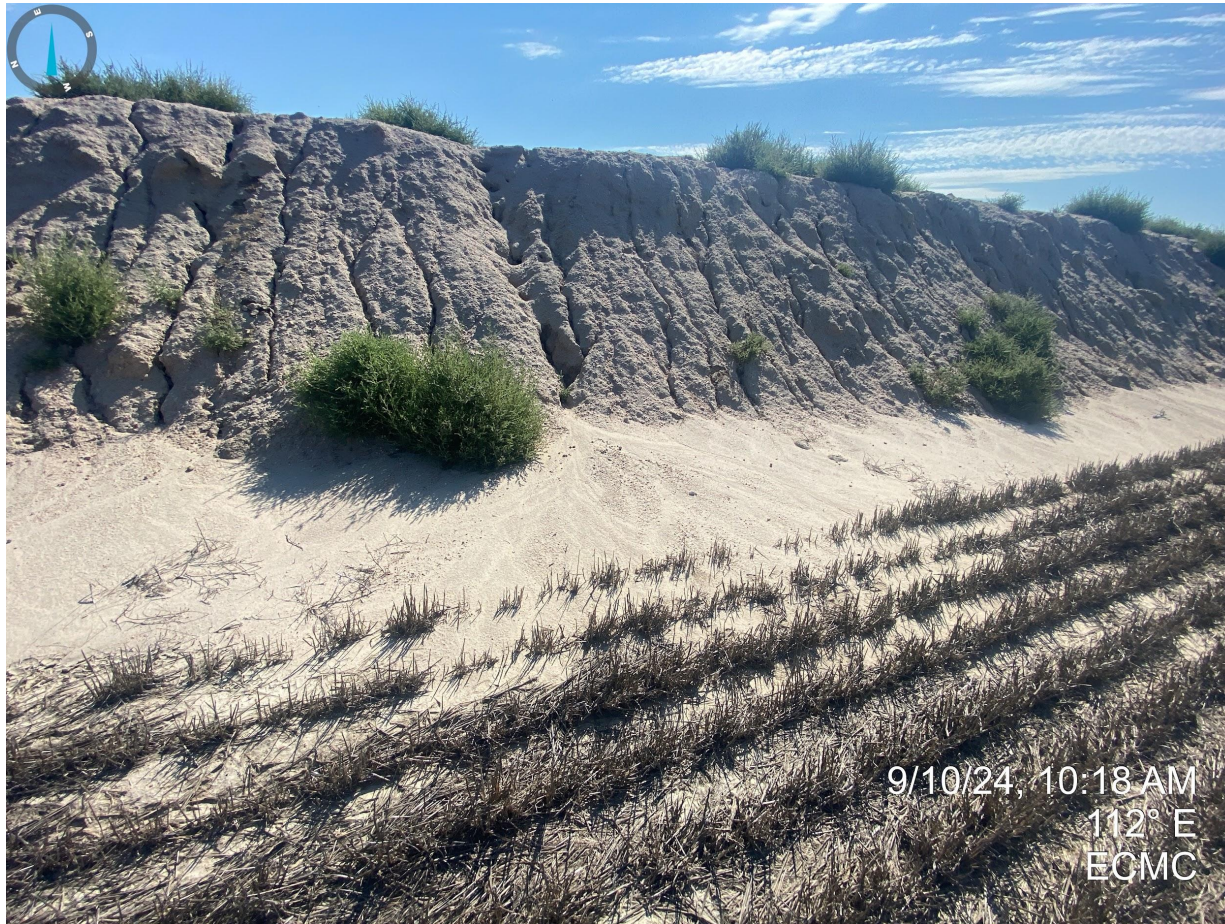
Photo 13. Western pit berm; evidence of sediment transport and erosion degradation. No apparent perimeter stormwater controls observed.

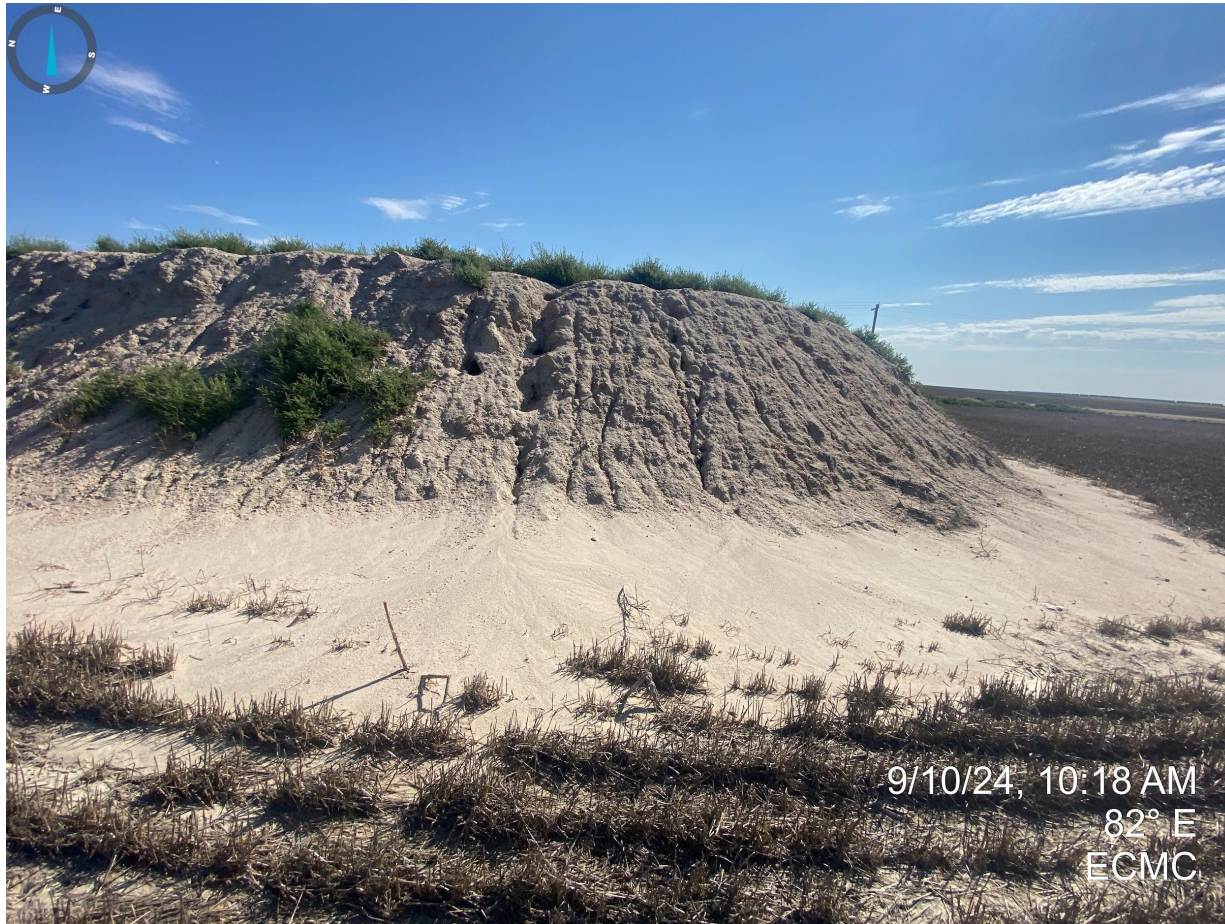
Photo 14. Southwest corner of pit; see comments in Photo 13.

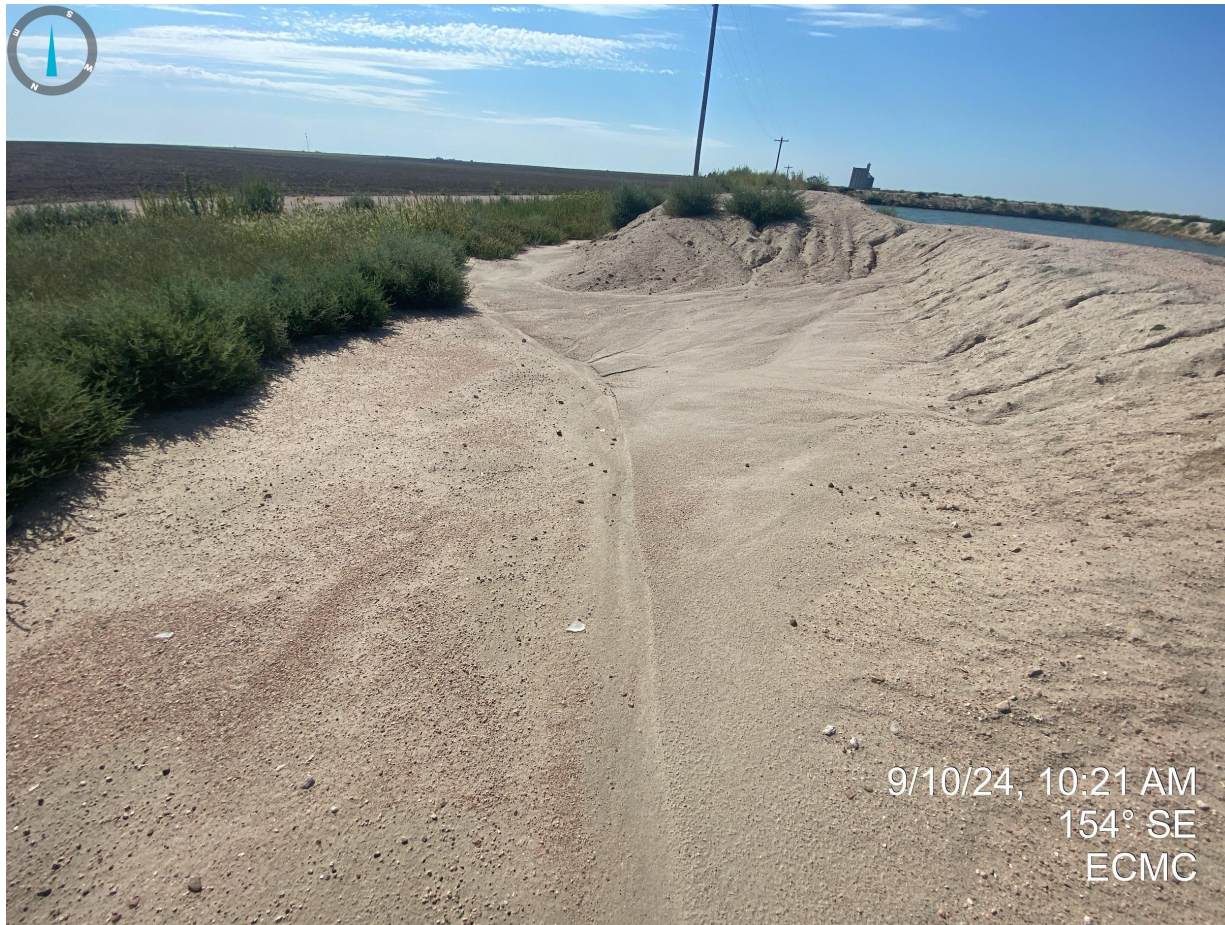
Photo 15. Erosion degradation on northeast corner of pits.

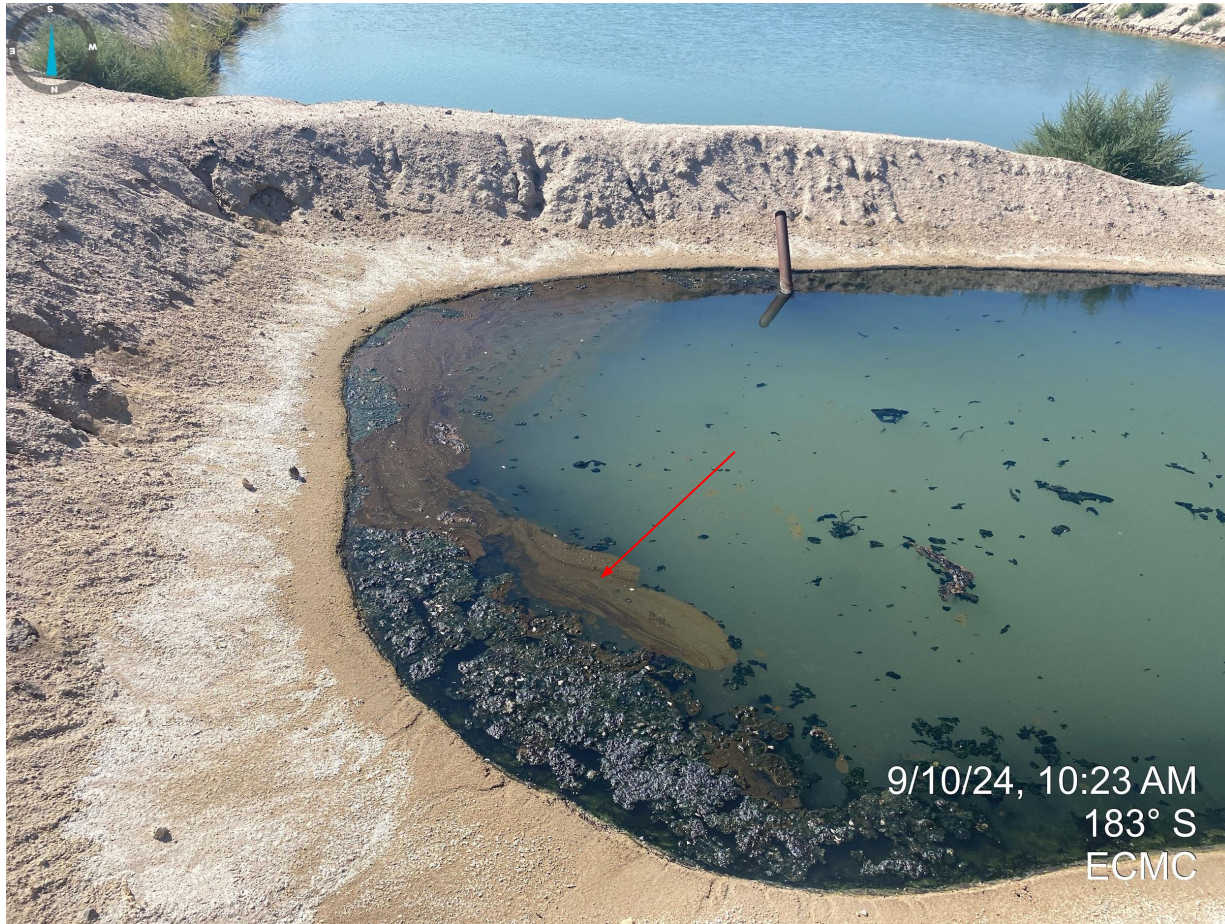
Photo 16. Visible hydrocarbon at pit.

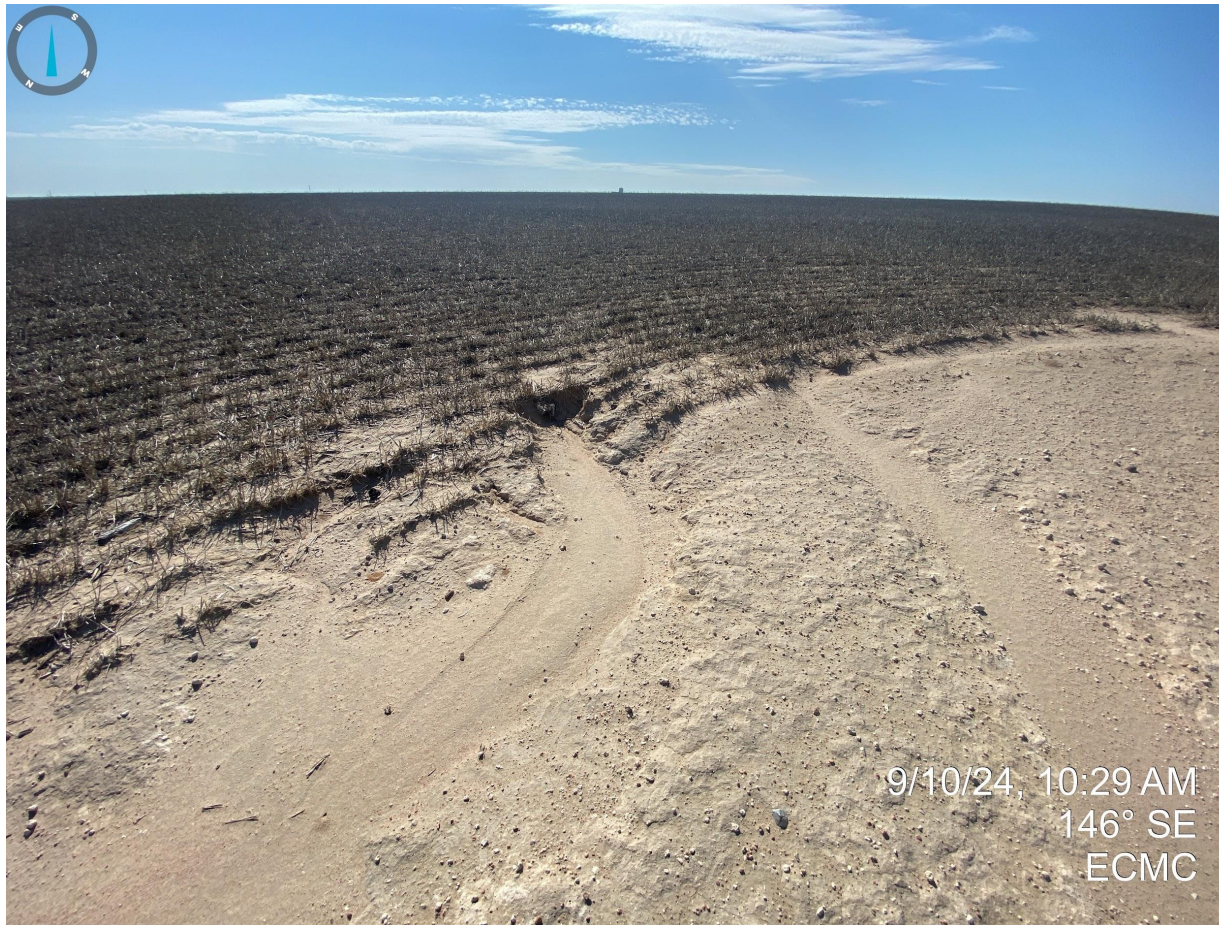
Photo 17. Erosion degradation at well API 121-10211, south side of location.

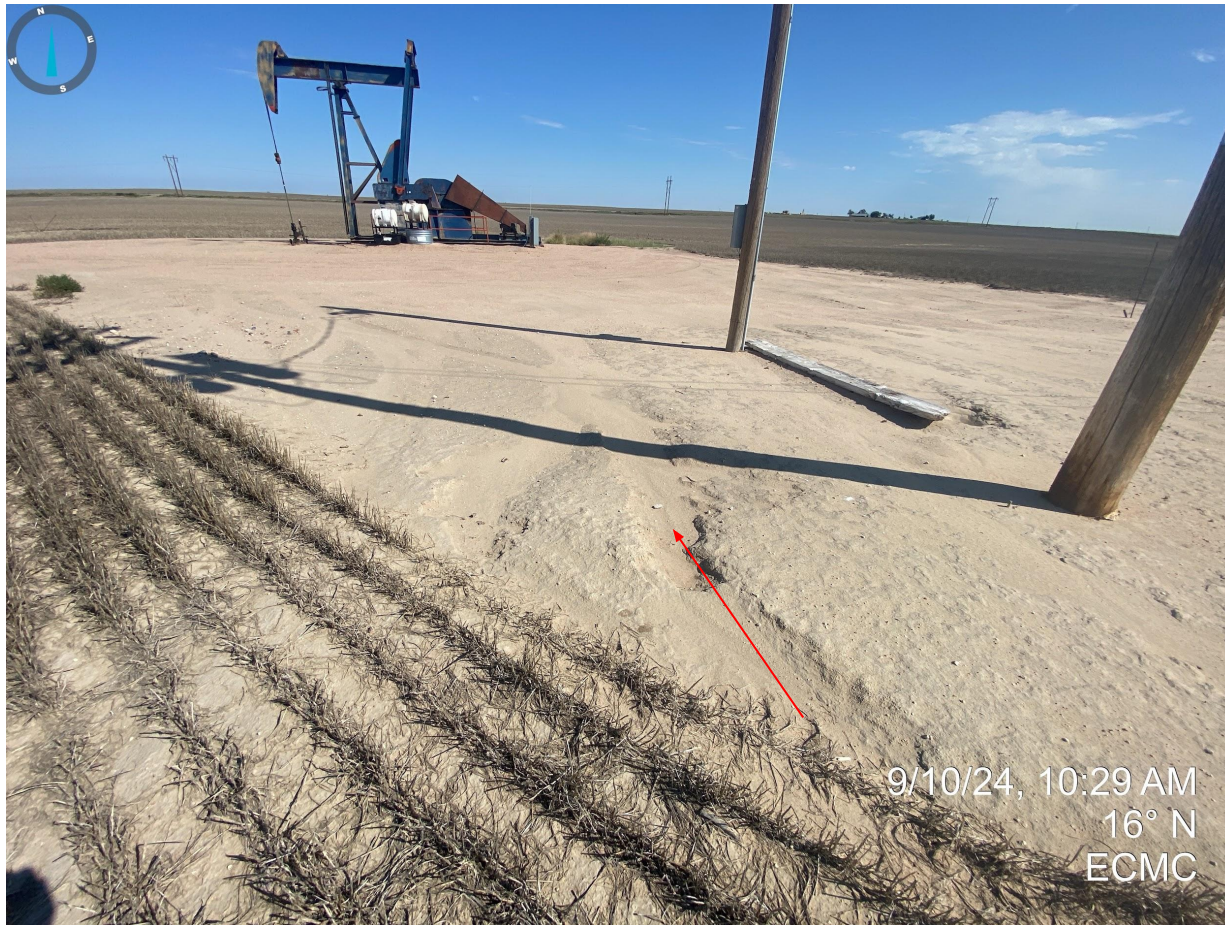
Photo 18. Erosion degradation at well API 121-10211, south side of location.
