Inspection Photos

Location Name: CAERUS PICEANCE LLC CEDAR SPRINGS RANCH 2-14 (N2W) Pad

Location #: 324114

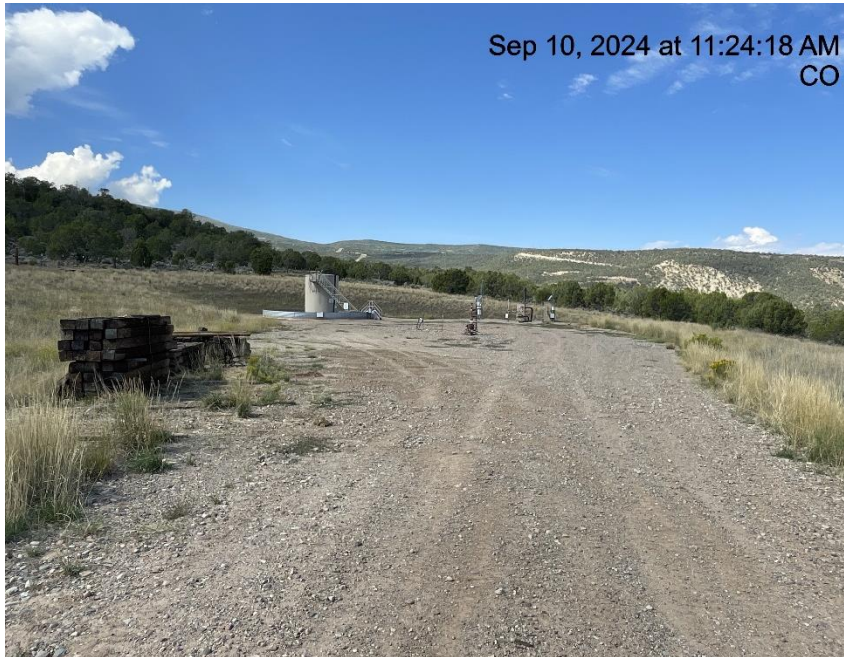
Photo # 9388 From Entrance to location

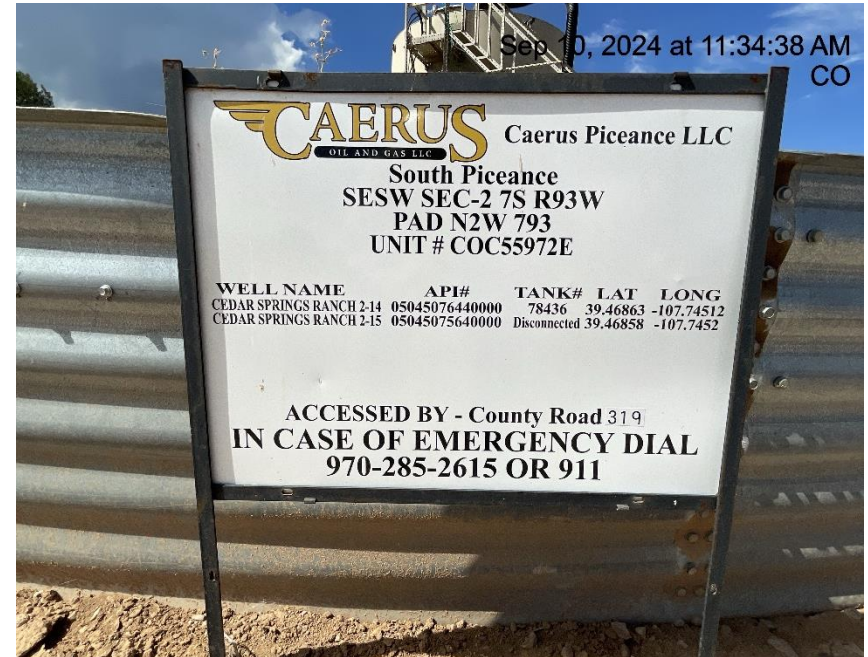
Photo # 9389 Location

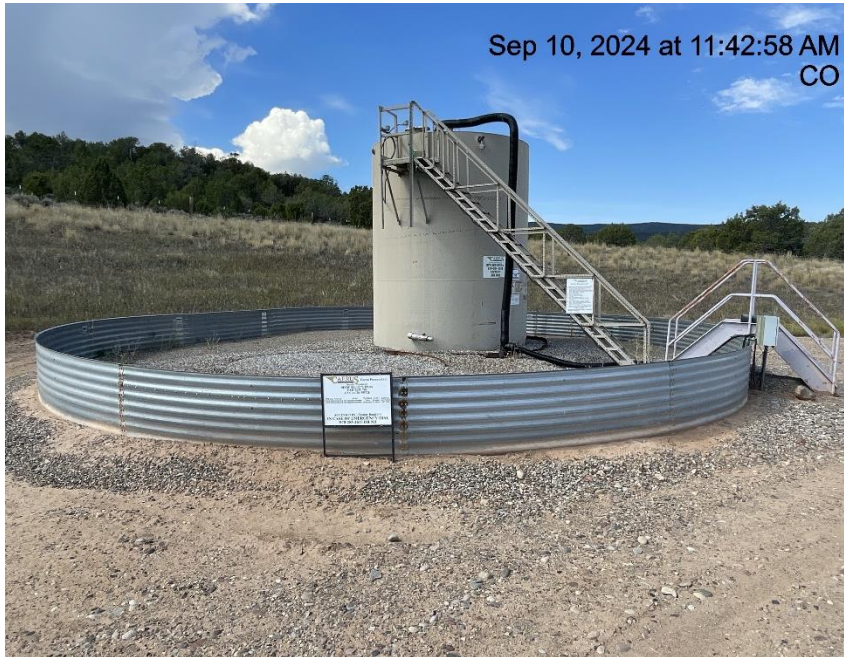
Photo # 9390 Location

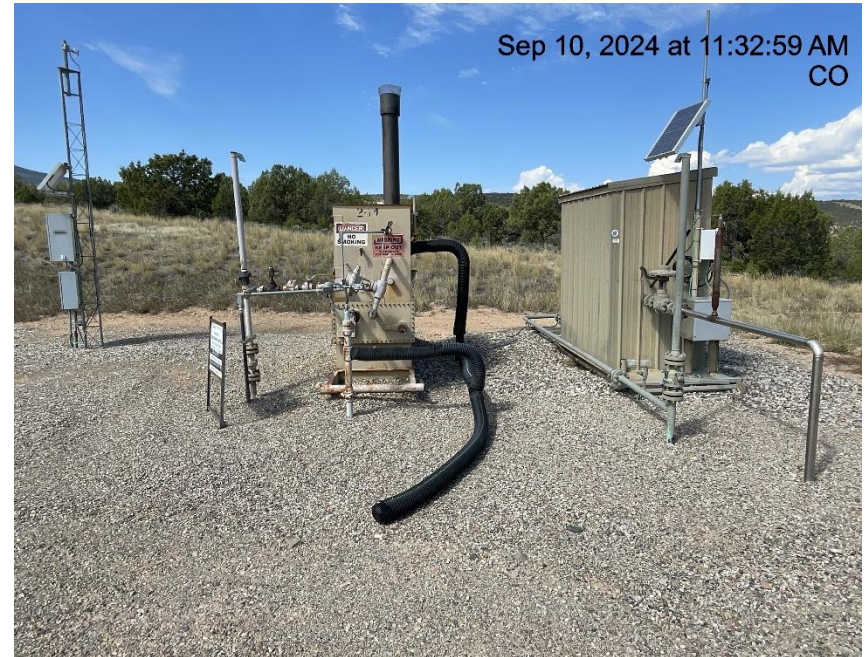
Photo # 9391 Location

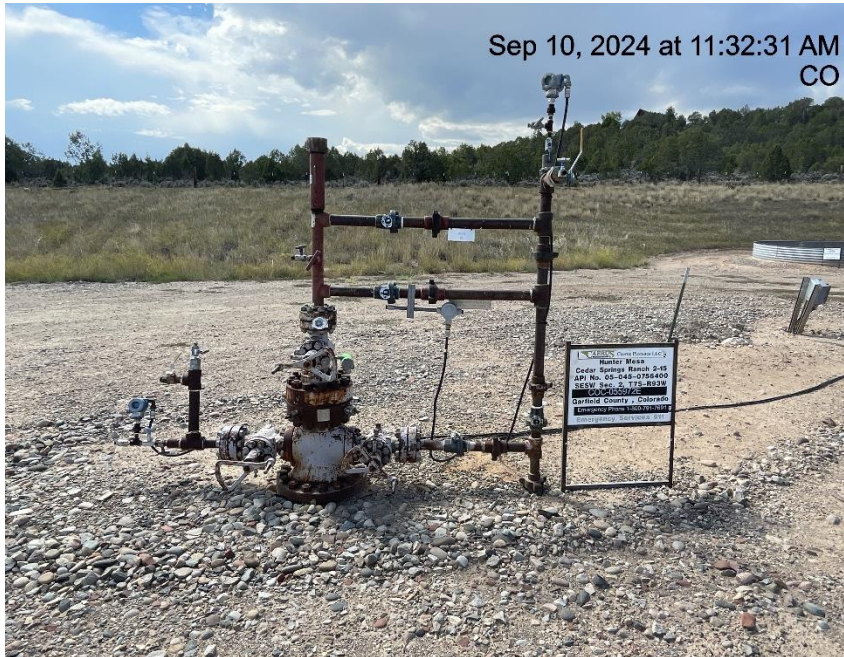
Photo # 9392 Location

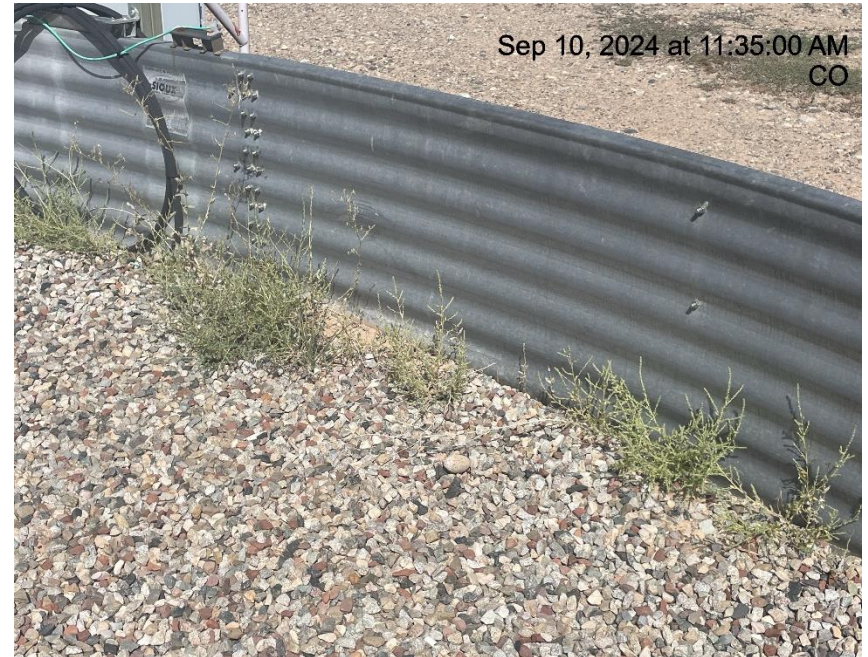
Photo # 9393 Weeds in secondary containment

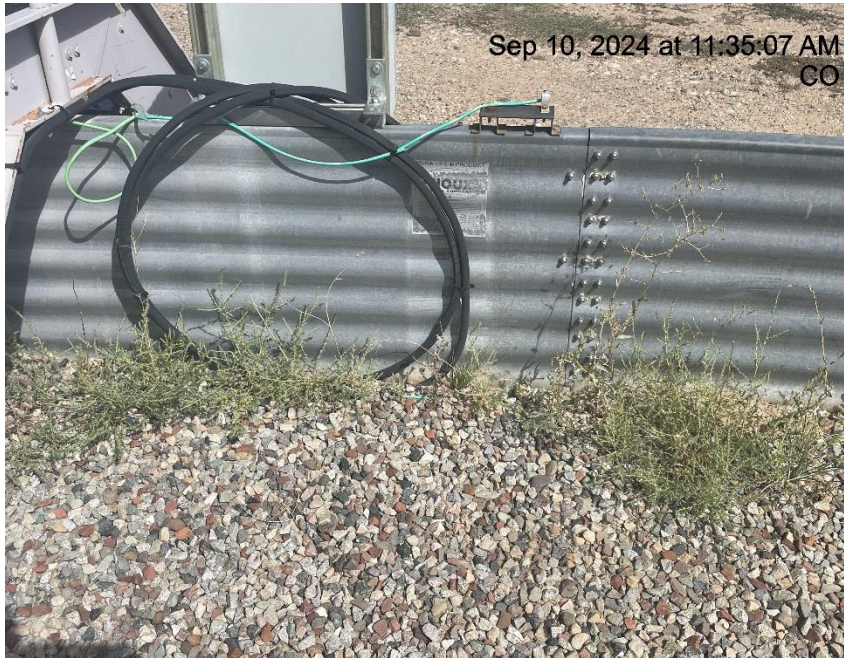
Photo # 9394 Weeds in secondary containment

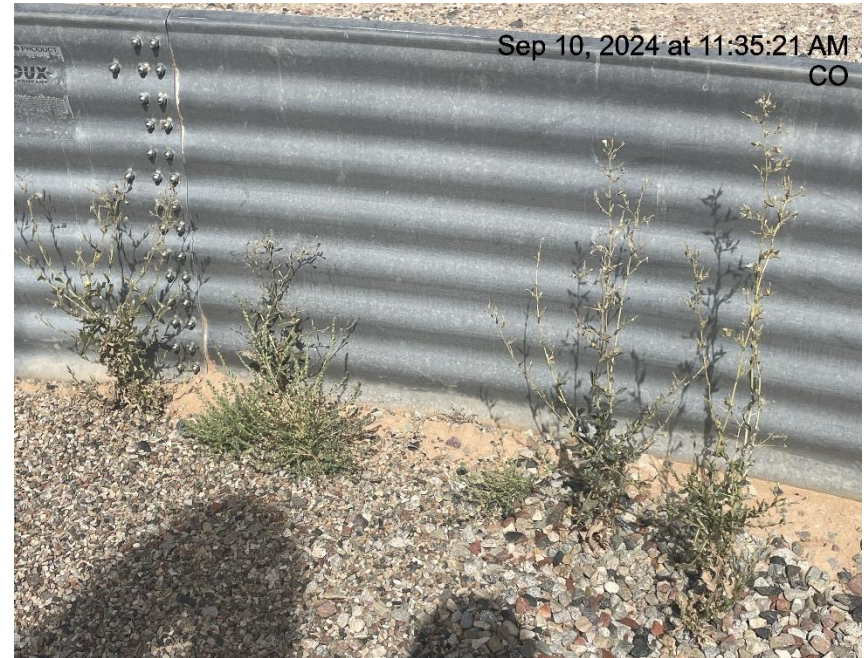
Photo # 9395 Weeds in secondary containment

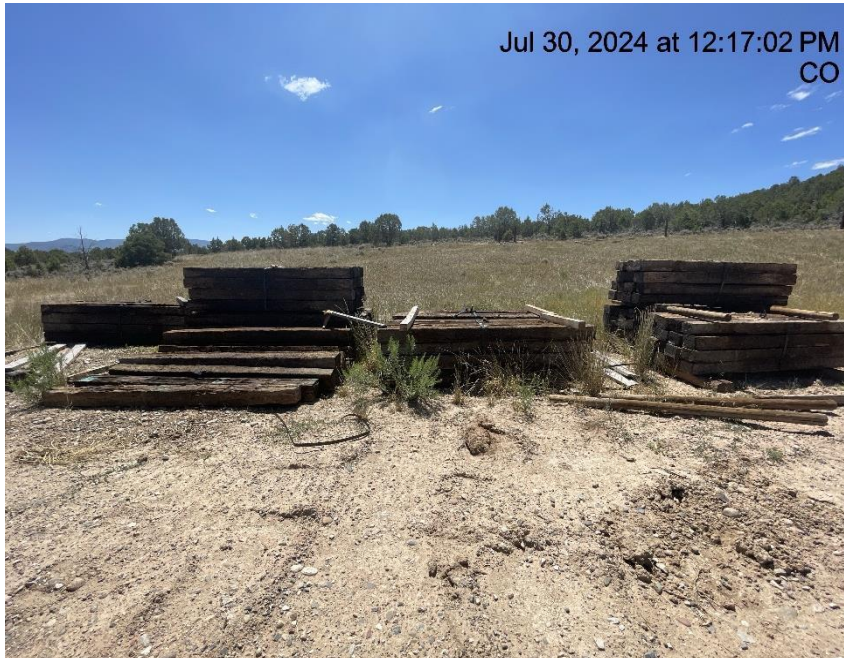
Photo # 3993 From inspection 708904246 conducted on 07/30/2024 Stored supplies on location & in the interim area

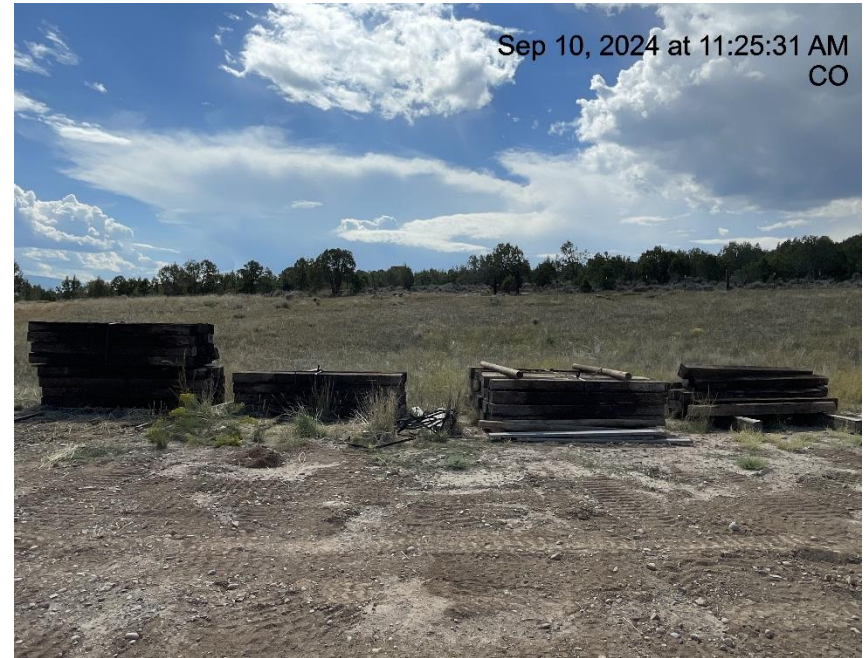
Photo # 9396 Stored supplies on location & in the interim area

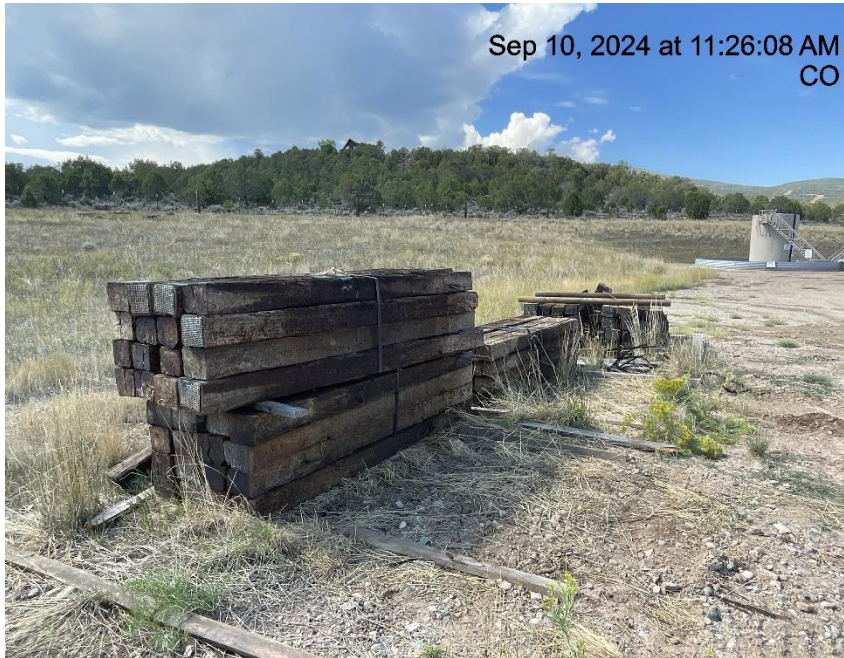
Photo # 9397 Stored supplies on location & in the interim area

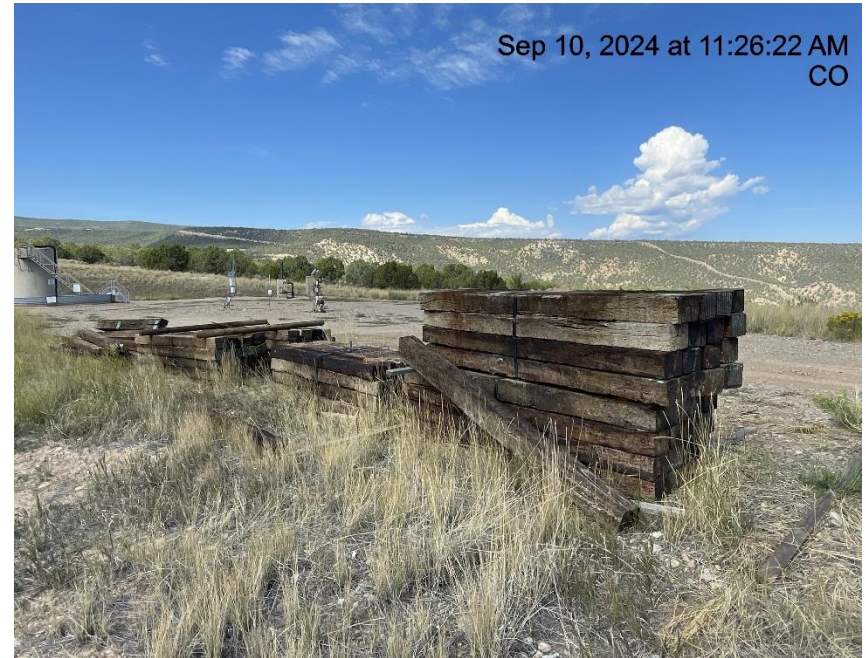
Photo # 9398 Stored supplies on location & in the interim area

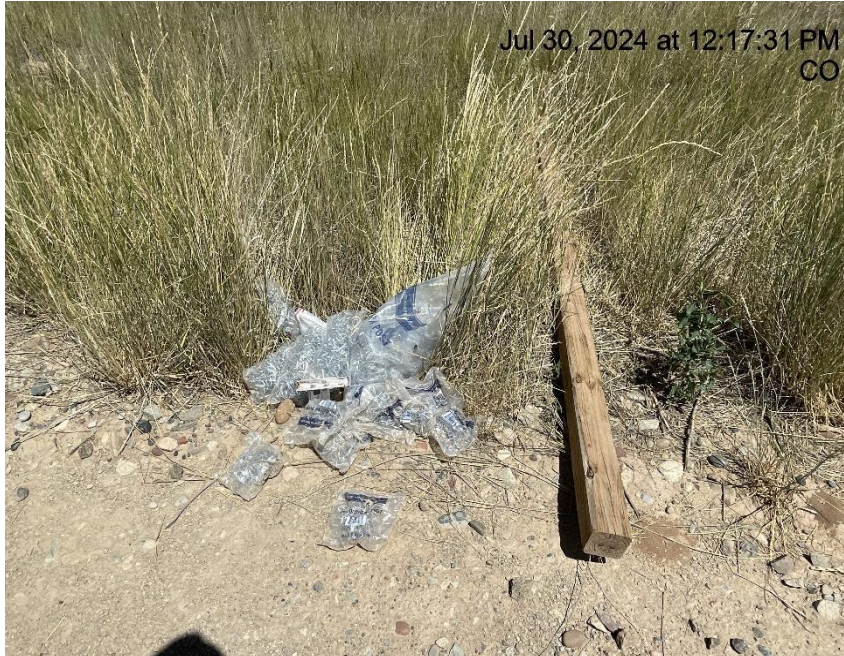
Photo # 3994 From inspection 708904246 conducted on 07/30/2024 Stored supplies

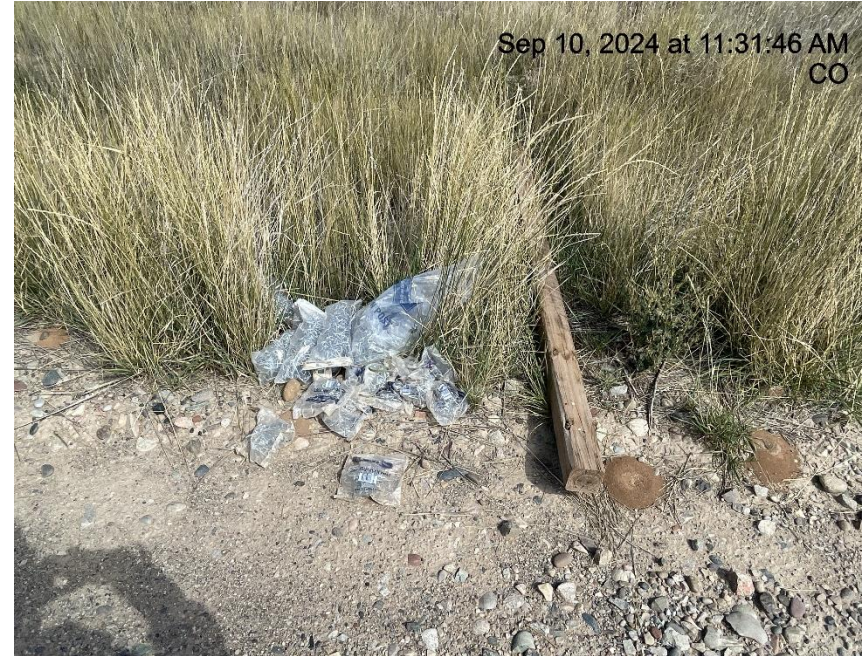
Photo # 9399 Stored supplies

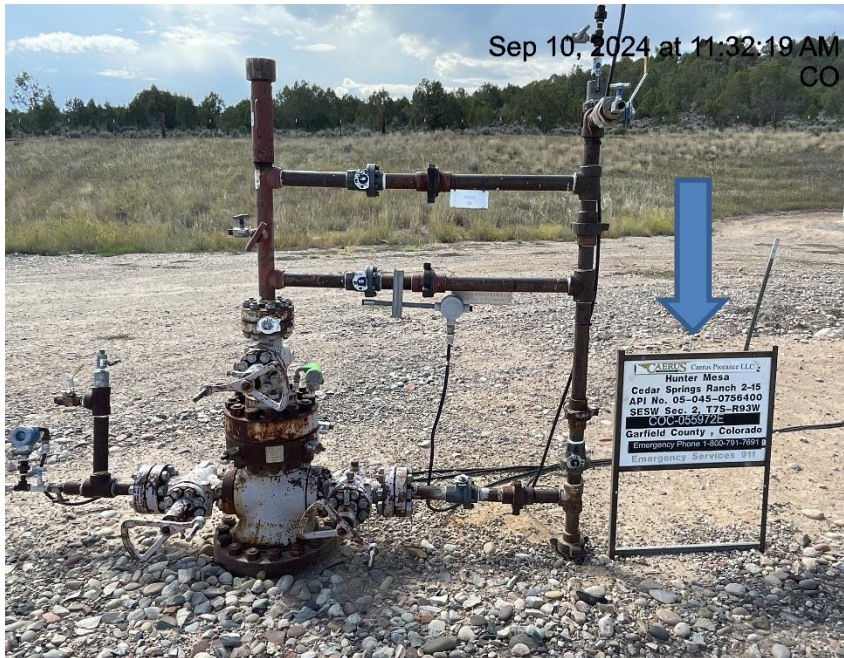
Photo # 9400 Wellhead sign has incorrect well # & API #
